SURVEY STATEMENT NARRATIVE ANNEX

Name of vessel: **PRESIDENT EISENHOWER**
Owner: **President Eisenhower Trust**
IMO Number: **9295220**

Survey station: **Long Beach**
Place of survey: **Oakland, California(USA)**
Survey started: **2024-02-08**
Survey completed: **2024-02-14**
Lead surveyor's name: **Nair, Dinesh**
Surveyor: **Read, Philip M**

Damage Survey

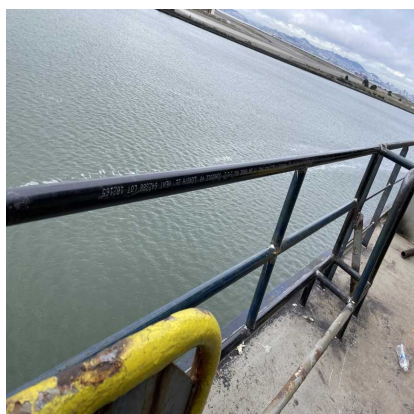
1. Guard rails on ship's port side, forward upper platforms were damaged.
2. Six double container lashing sockets and two single (elongated) sockets found damaged. (4 each at fr. 82 and 86) - Port side hatch cover area

Guard rail on port side

Repair work on guard rails completed, a condition of class issued for the remaining work.

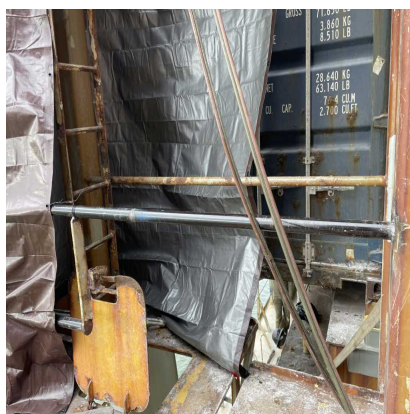
Guard rails lower platform repaired

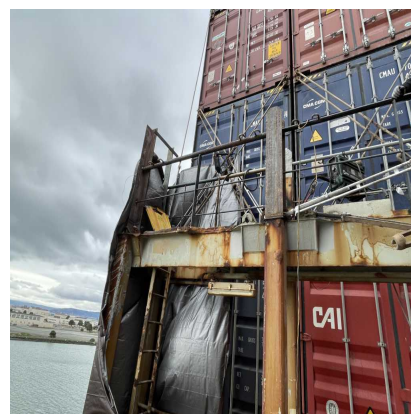
Guard rails on upper platform repaired

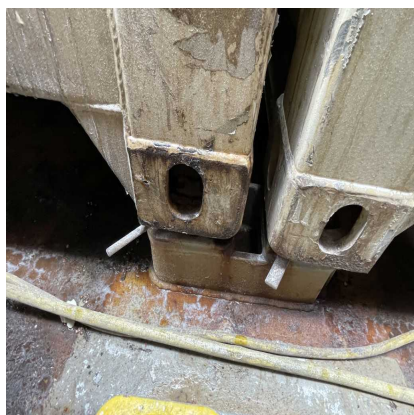
8. Containers on center hatch cover were not removed since no damage were noted on containers. All lashing sockets were visually inspected and found no damage.

Lashing sockets no damage on center hatch cover (typ)

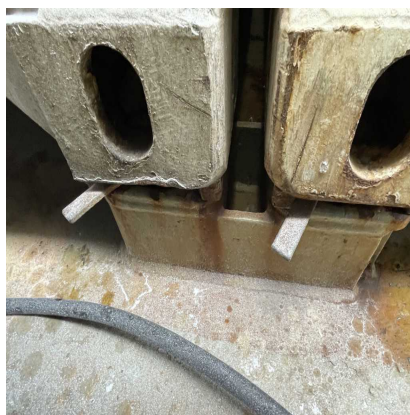
Lashing sockets on starboard side hatch cover no damage (typ)

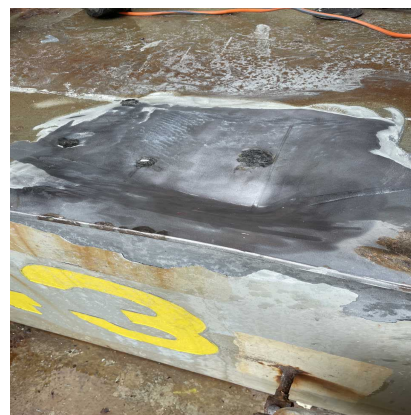
3. Local deformation (approx. 300mm x 300 mm with 70 mm deep) noted on port side hatch cover, away from lashing sockets, NDT done and no crack detected.

Local deformation on hatch cover 300x300x70mm deep

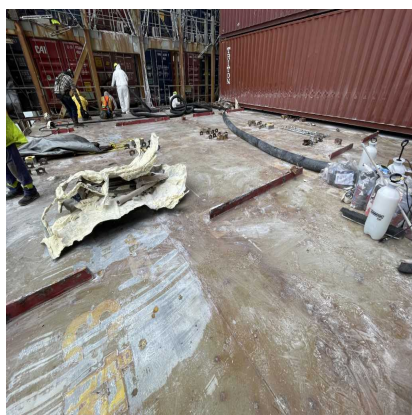
Port side hatch cover after cleaning

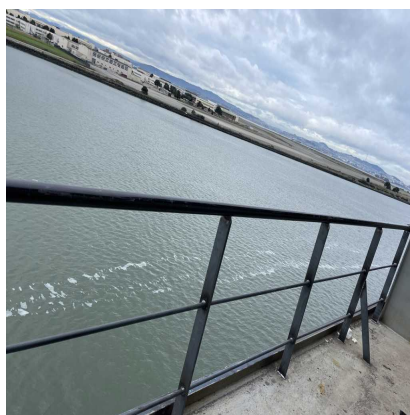
Side guard rails repaired

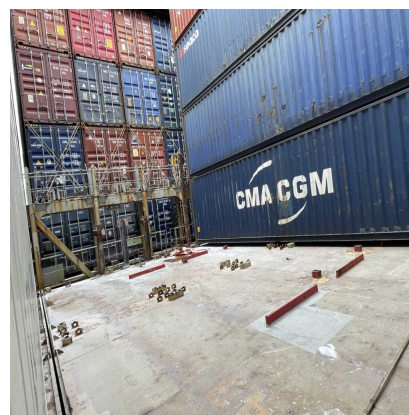
6. Starboard hatch cover: The area where containers were damaged were cleared (Cell nos. 05,07,09) hatch cover and lashing sockets were visually inspected and found in good order.

Starboard side hatch cover after removal of containers Cell nos 05,07,09

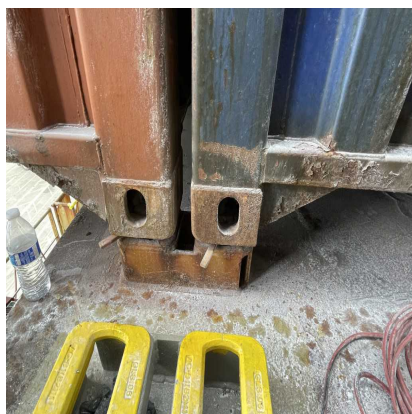
Stbd side hatch cover lashing sockets with no damage (typ)

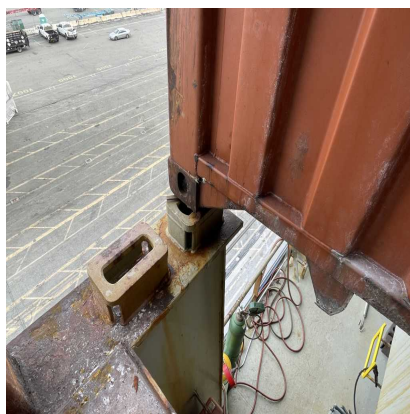
Stbd side lashing sockets

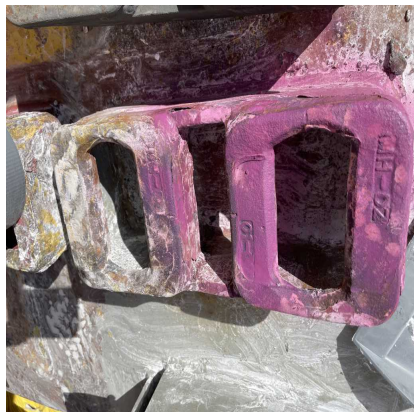
- Damage noted on fixed lashing plate (3 nos: one single and another double type)
- Three container lashing double sockets damaged at aft side of port hatch cover and one single type. Three container lashing double sockets damaged at fwd. side of port hatch cover and one single type
- Platform at Fr 84 and light post at fr. 86 damaged (port side).

Damaged double socket (Typ)

Damaged six numbers double type container lashing sockets and two single (elongated type) sockets to be replaced. Lashing platform at Fr. 84 and light post on lashing platform ford at fr. 86 to be repaired. Until the repair work is completed and inspected , containers should not be loaded on bay# 43 on port side hatch cover.

Welding to be done by approved welders, certificates and WPS to be forwarded to DNV for review in advance.

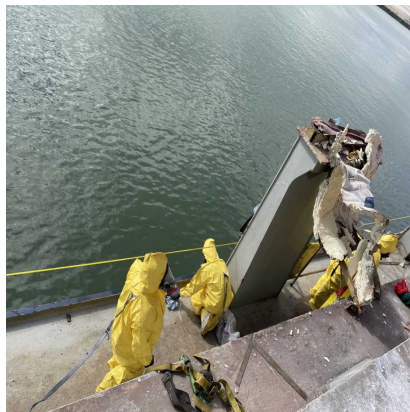
Damaged lashing platform

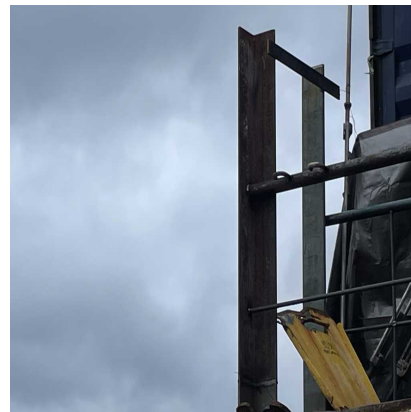
Damaged Light post on lashing platform

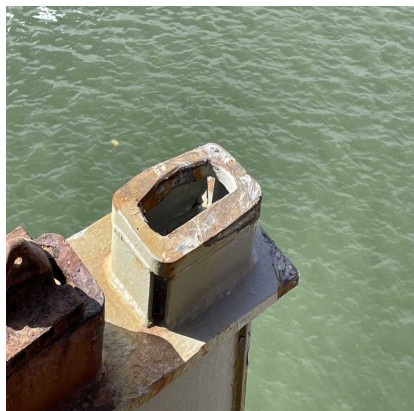
Damaged single socket(typ)

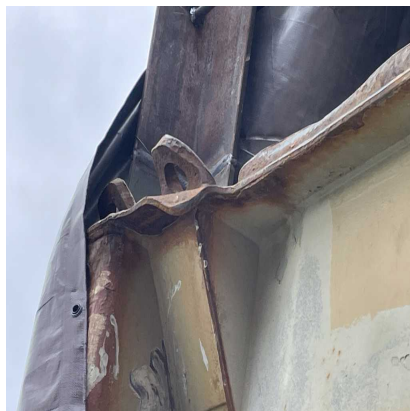
Fixed lashing plate damage on lashing platform fwd. near fr. 86 (3 nos)
