National Transportation Safety Board
Washington, D.C. 20594

Emergency Response Group Factual Report
PLD18FR002 Natural Gas Pipeline Release – Atmos Energy
Dallas, Texas
February 23, 2018
(24 pages)

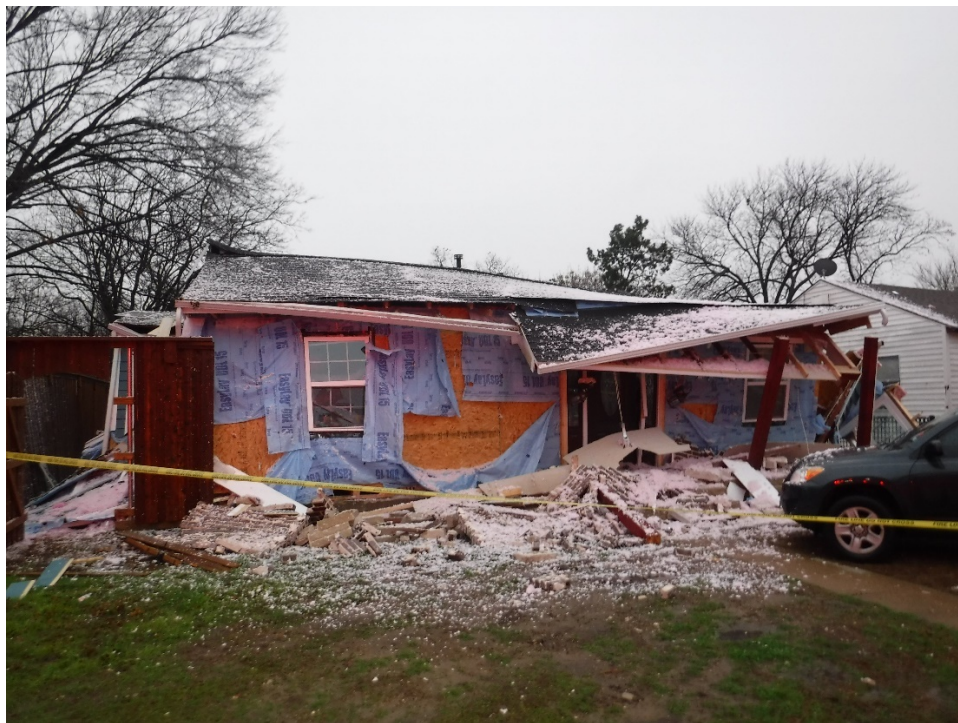
Figure 1: House 3534 Espanola Drive after the explosion on February 23, 2018

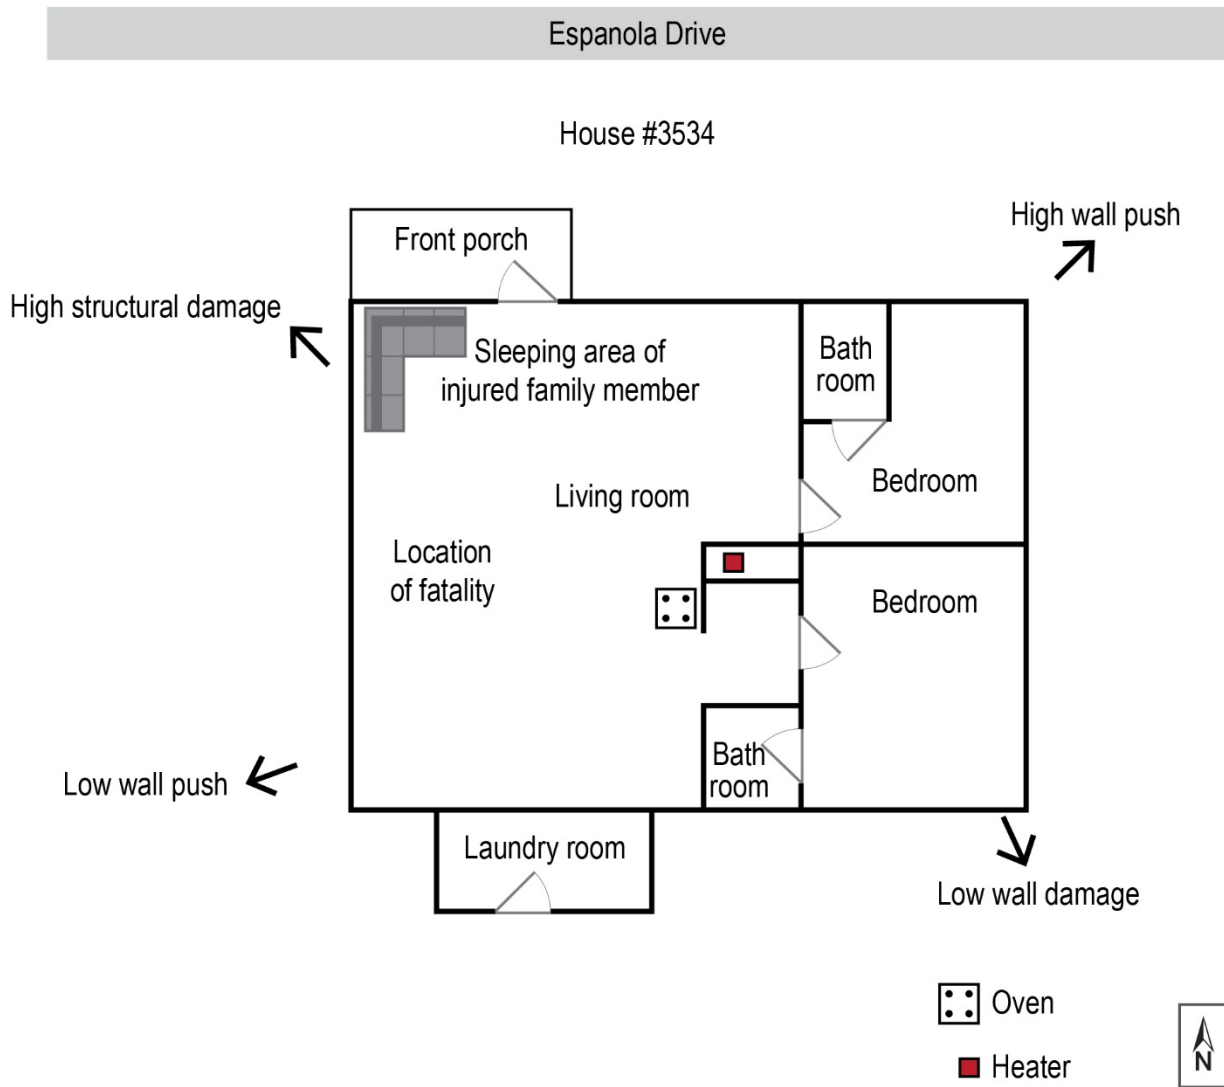
Figure 2: NTSB recreation of the DFR floor plan of 3534 Espanola Drive, Post-Accident

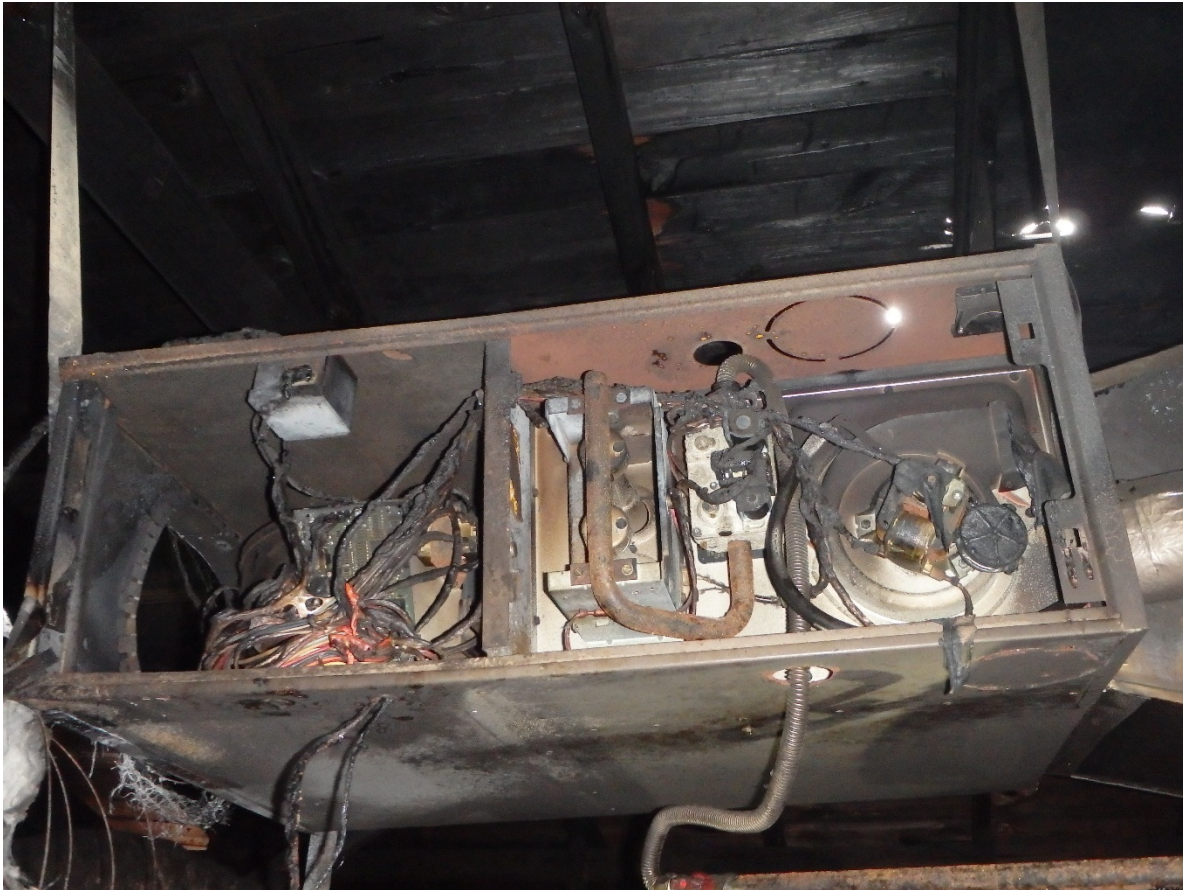
Figure 4: Post-incident photo of the furnace in 3527 Durango Drive on February 21, 2018. (Courtesy of DFR)

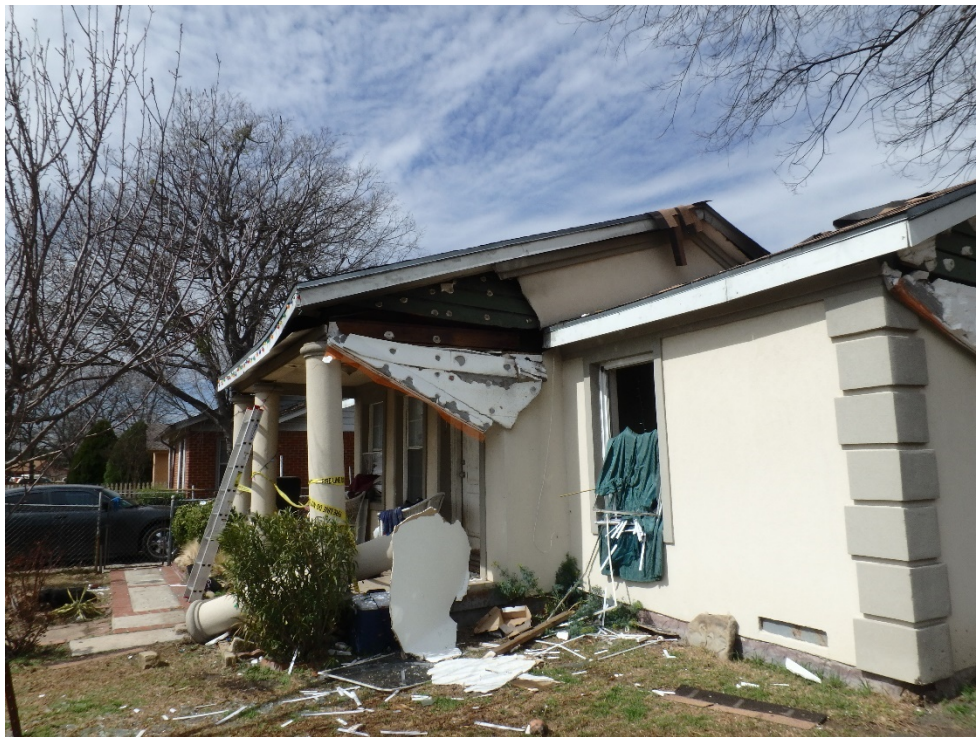
On February 21, at 5:49 a.m., the Dallas Fire-Rescue (DFR) dispatch received multiple emergency calls for a structure fire at 3527 Durango Drive (See Figure 4). The 9-1-1 calls from neighbors reported that a house “exploded,” and they observed smoke coming out. The first engine arrived at 5:53 a.m. and the firefighter on that engine told NTSB investigators that the fire was coming from the back of the house. He observed the roof blown off and was not involved in the fire. He said that normally, during house fire events, the roof falls into the house. He noticed that glass was broken outside of the house and sheetrock had been knocked down from the interior of the house onto the floors, as well as outside the exterior of the house. Upon this realization, the firefighter turned off the gas supply at the meter behind the house and requested for gas and electric utilities to respond at 5:59 a.m. Two other firefighters, the safety officer and the IC, told NTSB investigators that the post fire structural conditions of the house could have resulted from an explosion or from the kind of construction that was used to build the exterior walls. The DFR IC did note the bulging of the house walls.¹³

Figure 5: House 3527 Durango Drive after the February 21, 2018 incident²³

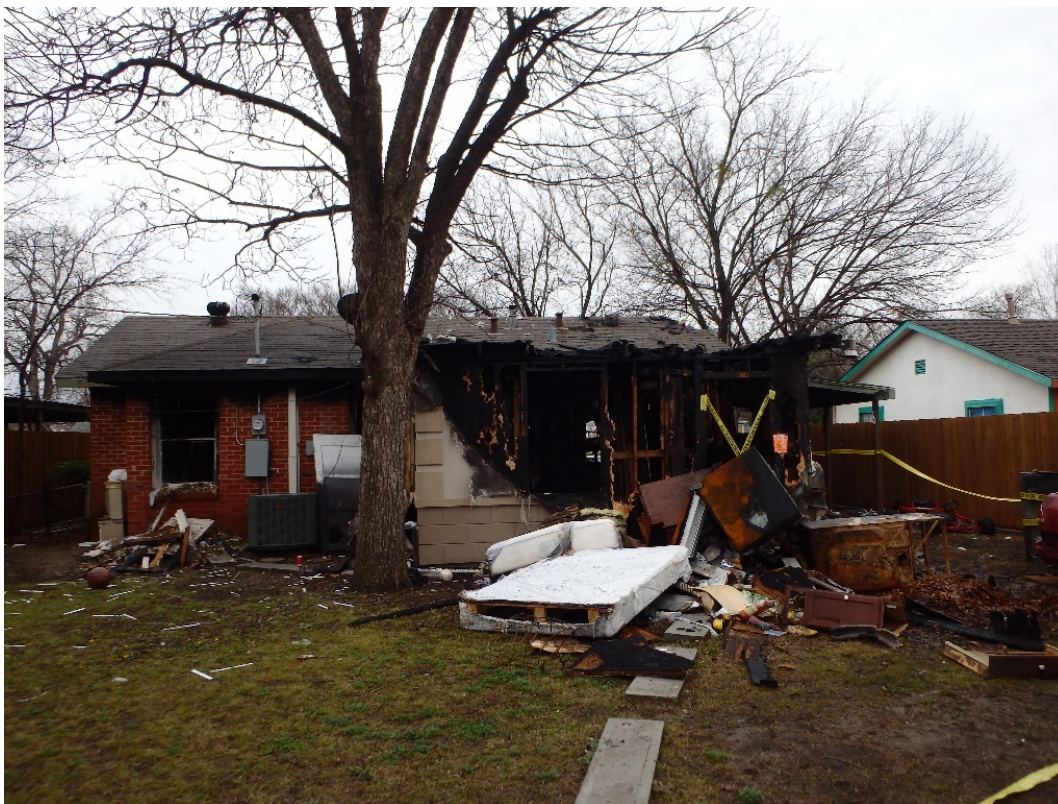
The fire investigation report stated that the fire traveled vertically to the attic, igniting nearby combustible cabinets and surrounding structural members, causing significant fire and smoke damage resulting in a total loss.²⁶ A DFR arson investigator interviewed the homeowner who reported that at the time of the fire, he was home alone in the kitchen, located towards the rear of the house. He was boiling water on the stove top when he noticed flames from the stove turning red and growing out of control. The burner then flashed over him, resulting in him suffering second-degree burns to his right arm and leg. He was subsequently transported to Parkland Hospital. The arson investigator also spoke to other family members who said the stove was only a year old and had no previous problems.²⁷ The Arson report also indicated that a neighbor voluntarily provided a statement that she had been experiencing issues with her gas service lately and told the arson investigator that she also observed red flames from her stove. The neighbor told arson investigators that she contacted Atmos on February 16, 2018 and asked if there were any gas issues in the neighborhood. The dispatcher told her Atmos was unaware of any issues. The DFR arson report classified this incident as “undetermined.”²⁸

Figure 6: The back of house 3515 Durango Drive after the fire on February 22, 2018.³⁰
