Alaska Marine Surveyors, Inc.

August 23, 2022

RE: F/V CHALLENGER- Capsize - DOL: 08/07/22
Assured: Alward Fisheries LLC
Final Damage Report DV3261 "Hull & Machinery"

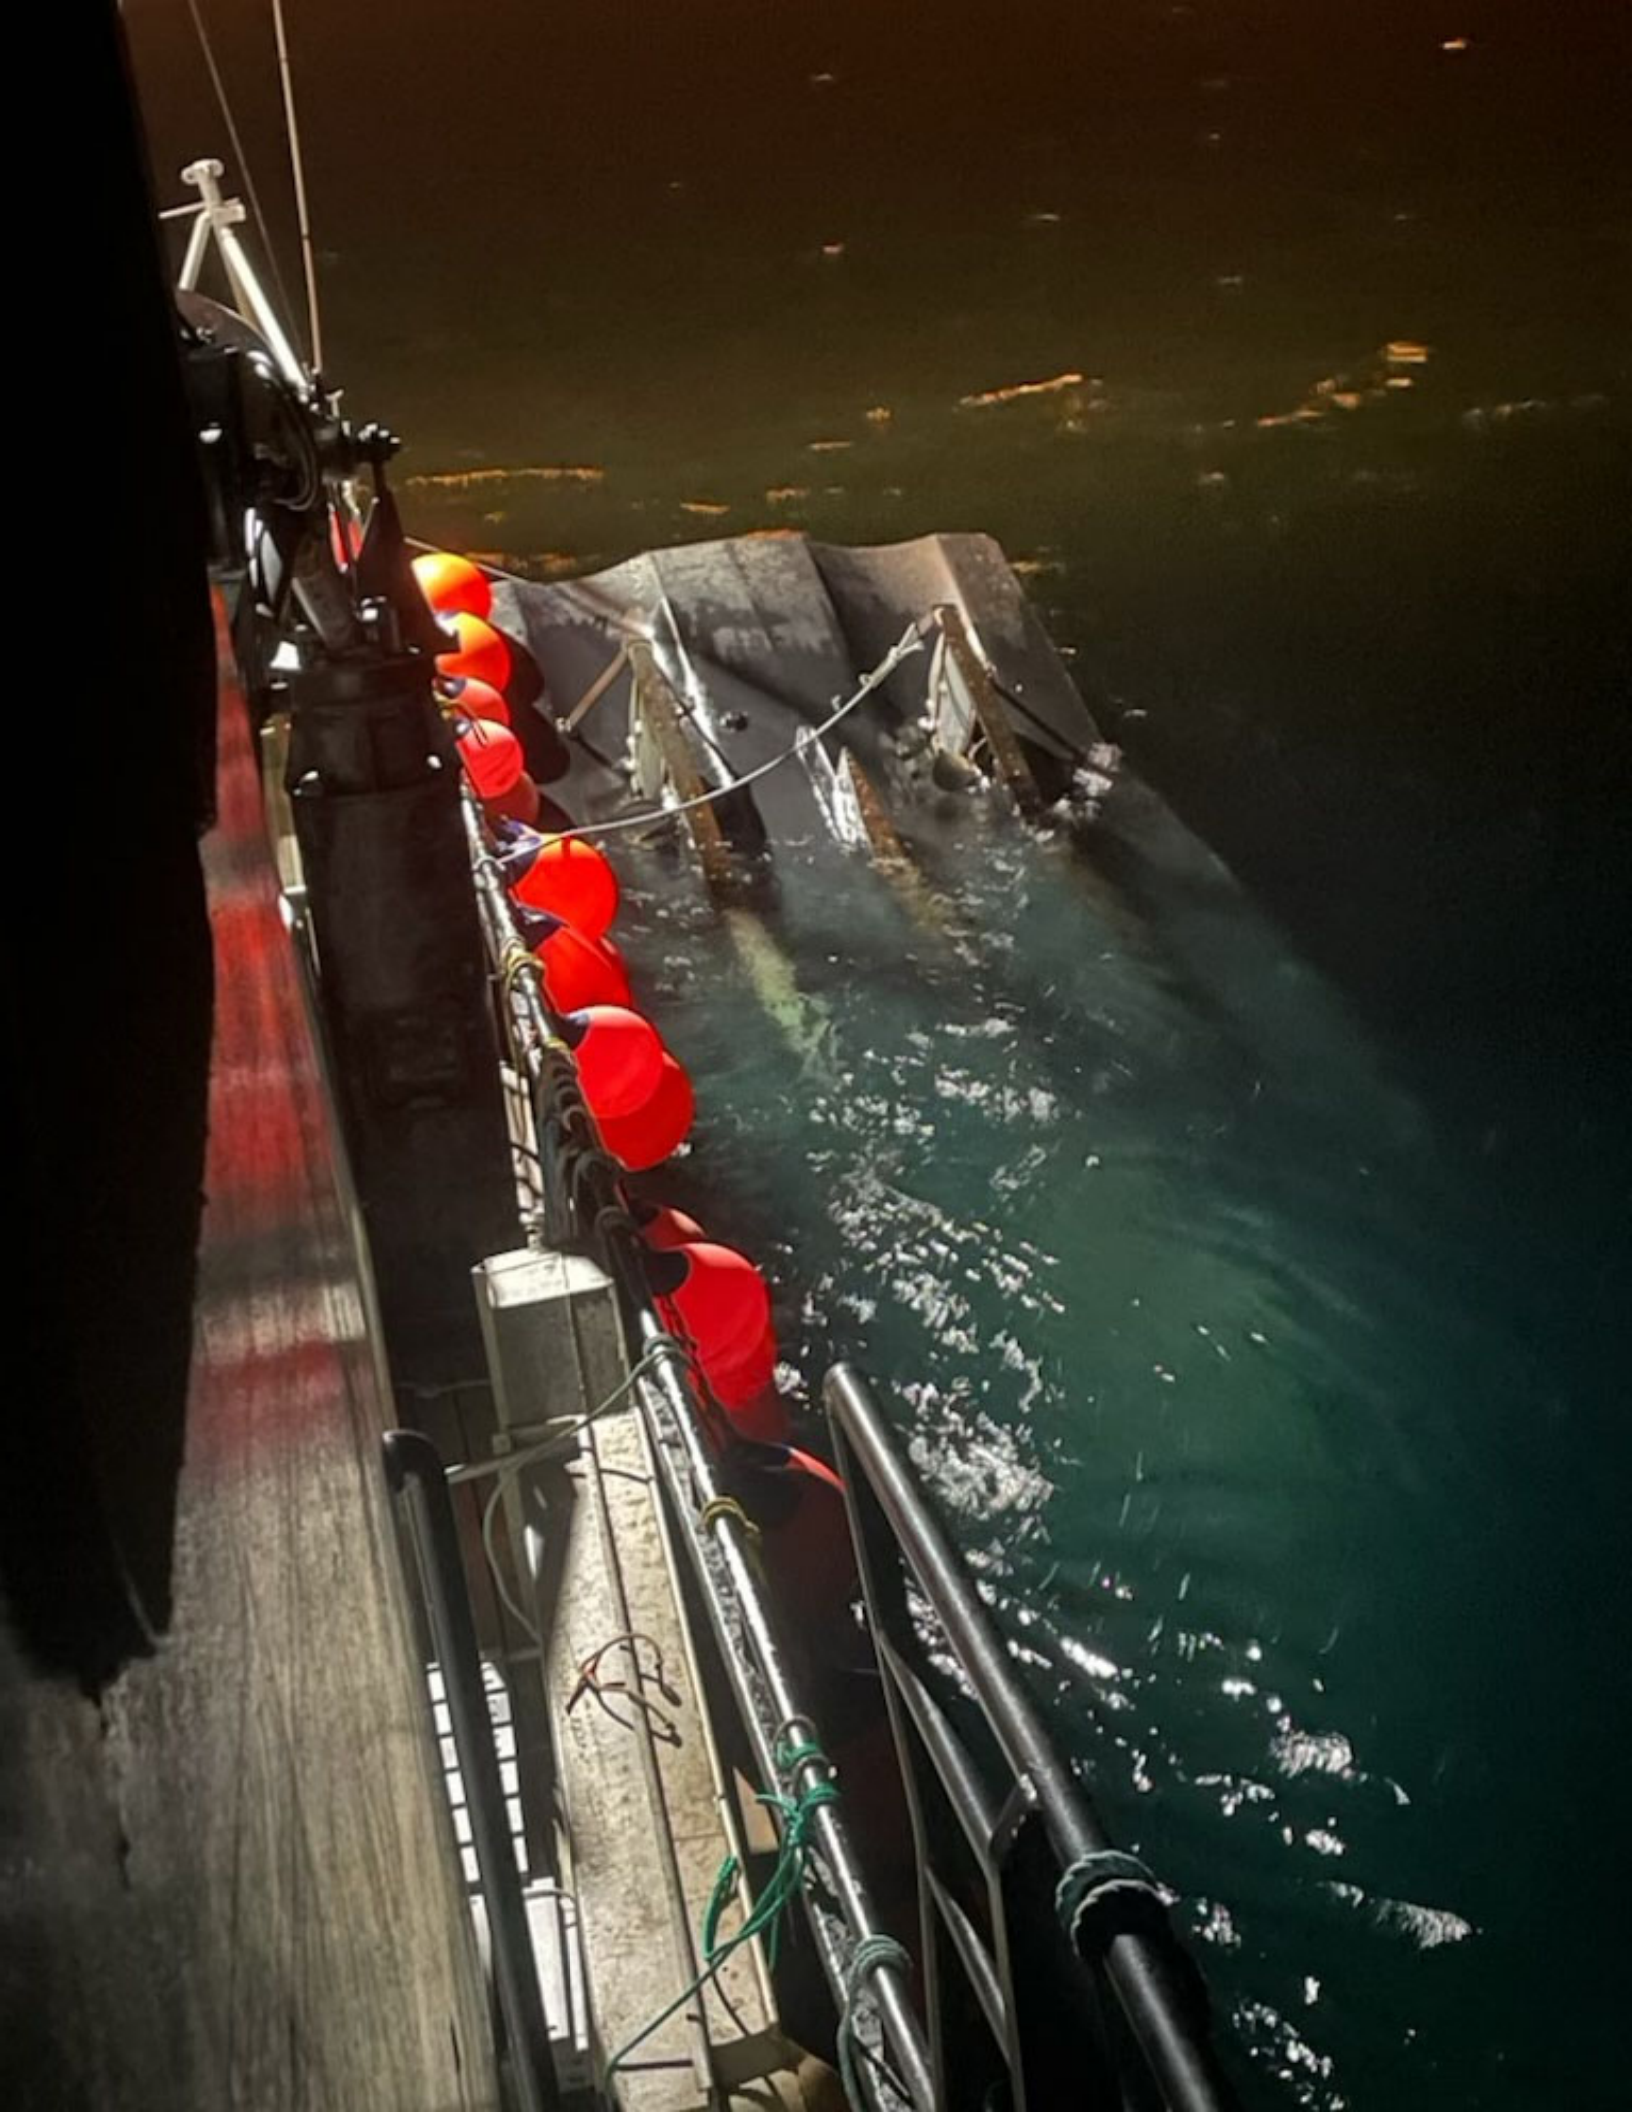
The F/V Challenger is currently capsized and fully ingressed with saltwater, with all electrical, machinery, equipment and finishes submerged under water and determined unreliable for further serviceability.

The cause of damage appears to be due to navigational error whereby the vessel’s captain reportedly struck an uncharted rock. This is difficult to suggest this was due to operator error as the rock was not charted on the navigational system and may have not been visible by the captain’s view.

Repairs are not recommended.

So, it is the undersigned marine surveyor’s opinion, the F/V Challenger be considered a Constructive Total Loss (CTL).
