Underwater Services, Inc.

Reference: The dive team was called out for a running gear inspection of MV CC Portland located at Martin Energy Harbor Island.

Description of Services: August 7, 2022

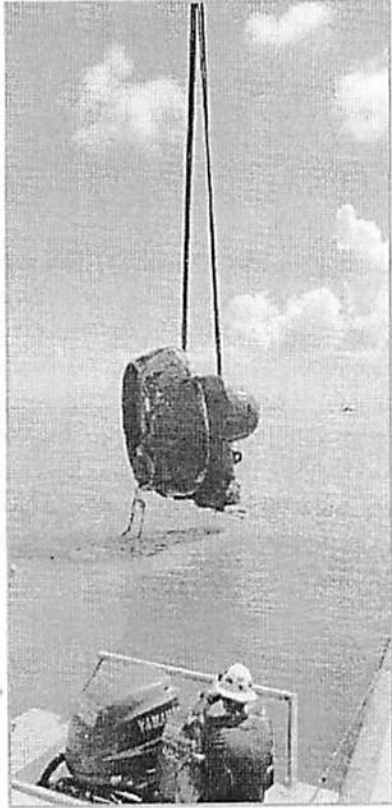
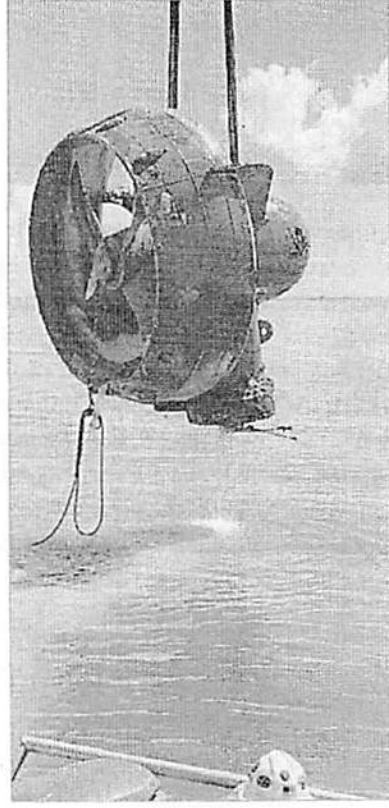
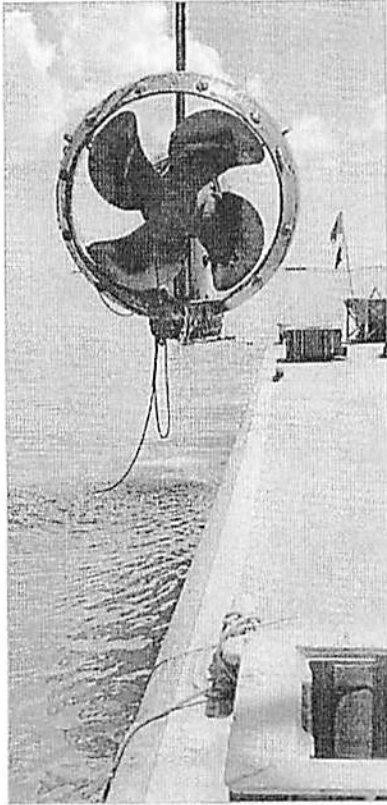
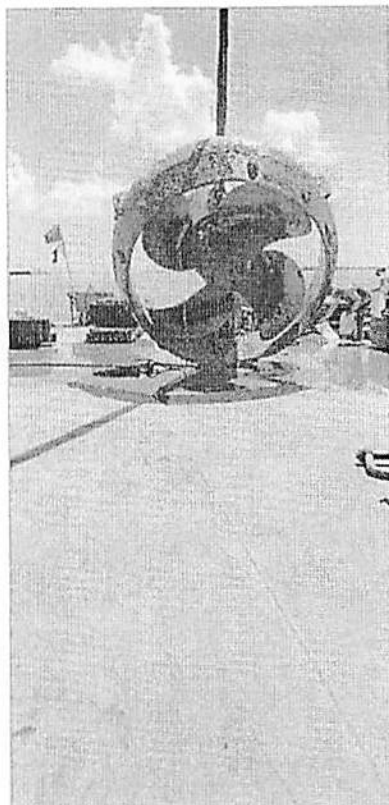
Photos.

The starboard drive was completely gone and the studs were broken off in the holes. The diver inspected the hull and reported 3 starboard coolers were damages extensively. One support bracket was ripped away with a 4"x3" hole noted, no differential pressure was noted. All the damage noted was documented on DVD and will be distributed to relevant agencies. At 0200, the diver was back on deck after removing the port drive line.
