## MEMORANDUM FOR CEMVS-OD-N

SUBJECT: Melvin Price Locks and Dam, M/V Kevin Michael Incident of 19 March 2021, Report of Damage to Dam Tainter Gates

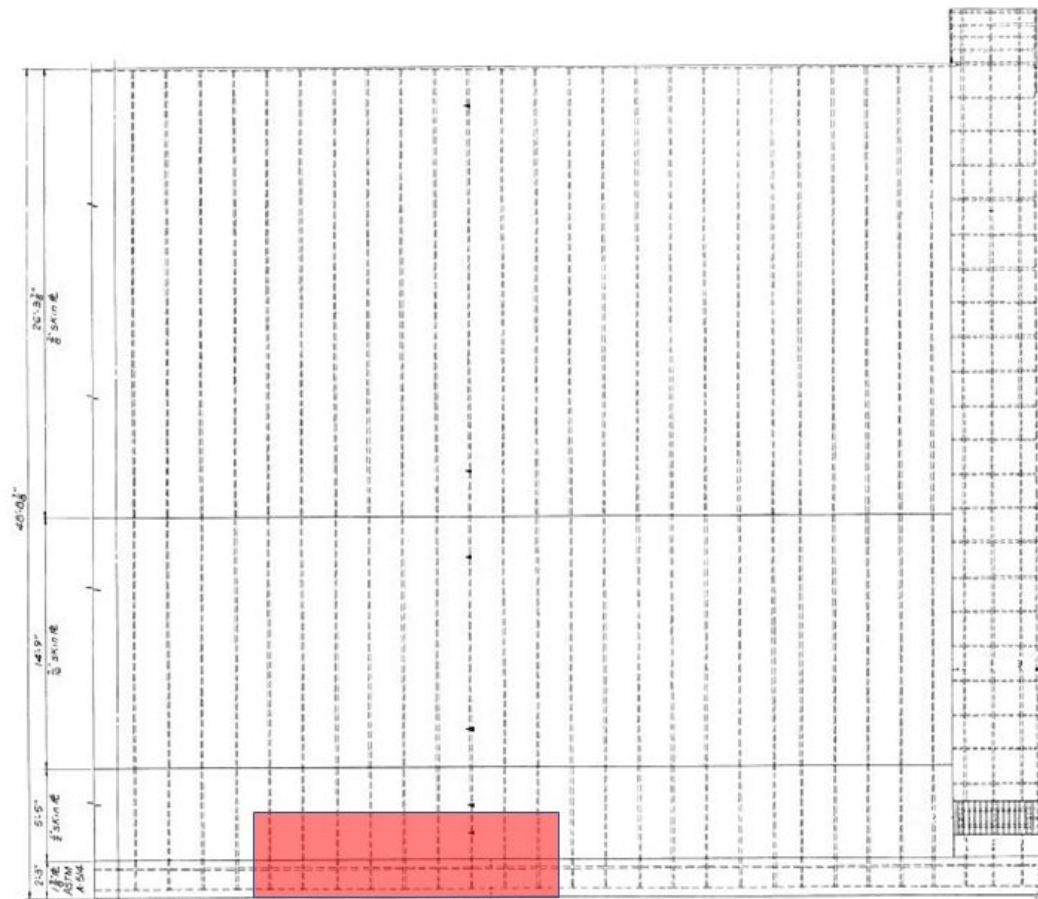
- b. Tainter Gate #5. The impact caused a perforation and deformation of the skin plate assembly at the bottom edge of the gate (Figure 1, Photo 3 and Photo 6); the skin plate assembly at the bottom edge of the gate consists of the 1/2" skin plate, 1 3/8" bottom plate, and 1" vertical plate (Figure 2). The start of the deformation in the skin plate assembly is located approximately 28' from the Missouri end of the gate. The deformation in the skin plate assembly is over an

area of 4-6" high x approximately 20'-0" wide. The bottom of the gate is deformed at the bottom edge, approximately 6" downstream at its maximum point. In this 20'-0" wide area, the vertical ribs (WT12x31) are severely deformed (Photo 4). At a minimum, nine vertical ribs will require replacement. The 1" vertical plate on the skin plate assembly has completely fractured near the maximum deformation in the skin plate (Photo 5). Some of the 1/2" horizontal plates welded above the pockets formed by the skin plate assembly and the vertical ribs are deformed in the area from the incident.

Figure 1 – Gate 5 Upstream Elevation, Missouri Side of Gate (shaded area indicates location of skin plate assembly damage)

- i. Skin Plate Assembly. The deformed 1/2" skin plate, 1-3/8" bottom plate, and 1" vertical plate should be removed and replaced over the approximate width of the damaged area noted in paragraph 4.b. In order to facilitate the welding of the top skin plate splice, it is recommended that the skin plate demolition line be the horizontal skin plate splice located directly above bottom girder flange (i.e. 7'-8" above the bottom of the gate). The replacement sections of the 1/2" skin plate and 1-3/8" bottom plate should be installed with complete joint penetration welds, ground flush and smooth, and have ultrasonic testing performed. The 1" vertical plate shall be installed with complete joint penetration welds between the replacement plate and original plate. All other welding for the skin plate assembly shall be in accordance with the as-builts. The

material for the existing 1-3/8" plate is ASTM A514; the replacement 1-3/8" plate should match the existing material.

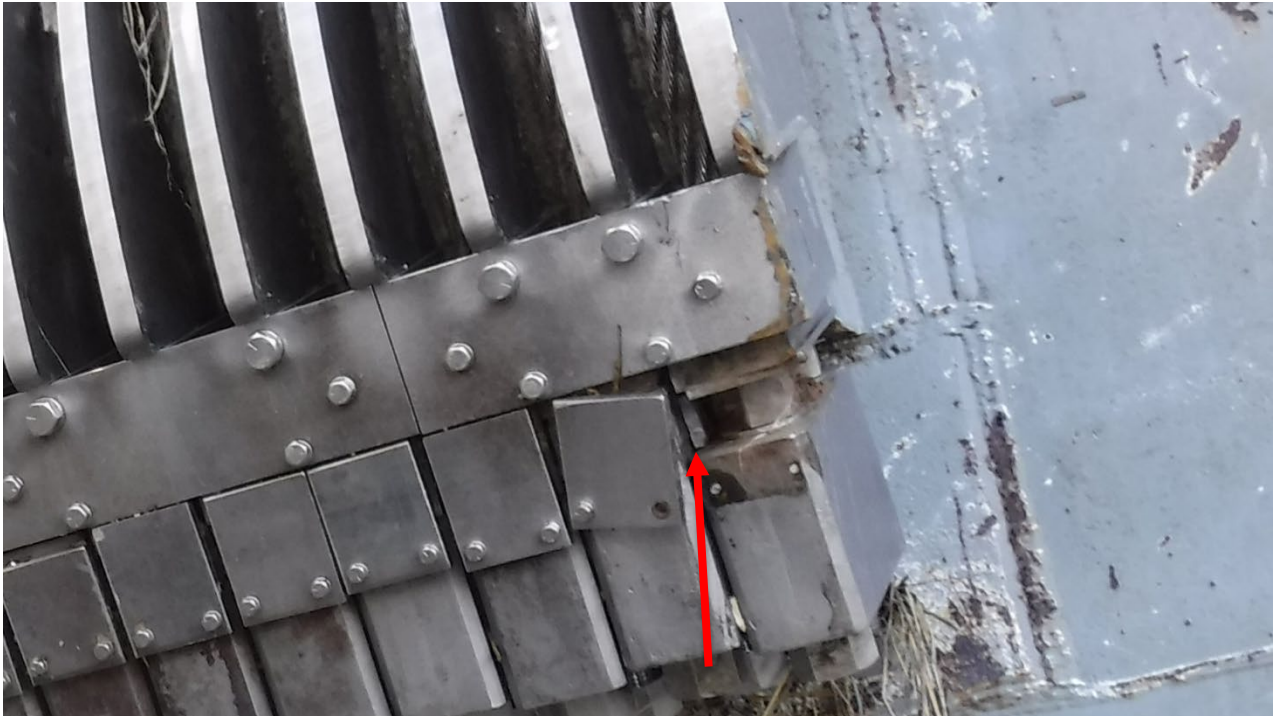
3. No appreciable damage to Tainter Gate #2 and Tainter Gate #9 was observed from the subject incident.
4. Observed damage consists of the following.
  - a. Tainter Gate #4. The wire rope connection assembly on the Illinois side of the gate was impacted. There is one missing keeper plate and minor gouges in the inboard cable connection bracket end plate (Photo 1). The impact sheared off the keeper plate bolts that are threaded into the cable socket. The nut and washer shim plate above inboard cable socket fractured approximately in half leaving the outboard side of the shim plate (Photo 2). Due to the missing portion of the nut and washer shim plate, the inboard wire rope is considered ineffective. The adjacent cable socket has a missing keeper plate bolt.

Photo 2 – Tainter Gate #4 - Zoomed in View of Fractured Nut and Washer Shim Plate on Inboard Cable Socket (Arrow indicates remaining portion of shim plate)

6. Recommended Repairs.
  - a. Tainter Gate #4. Replacement of the missing keeper plate, socket shims and missing keeper plate bolt should be completed as soon as reasonably possible. Work is required to be performed in a dewatered Tainter gate bay in order to disassemble the cable socket connection to install the new shims and properly tension the wire ropes. Due to galling of existing stainless steel items on the wire rope connection assemblies, individual items in the connection assembly may require replacement after disassembly.

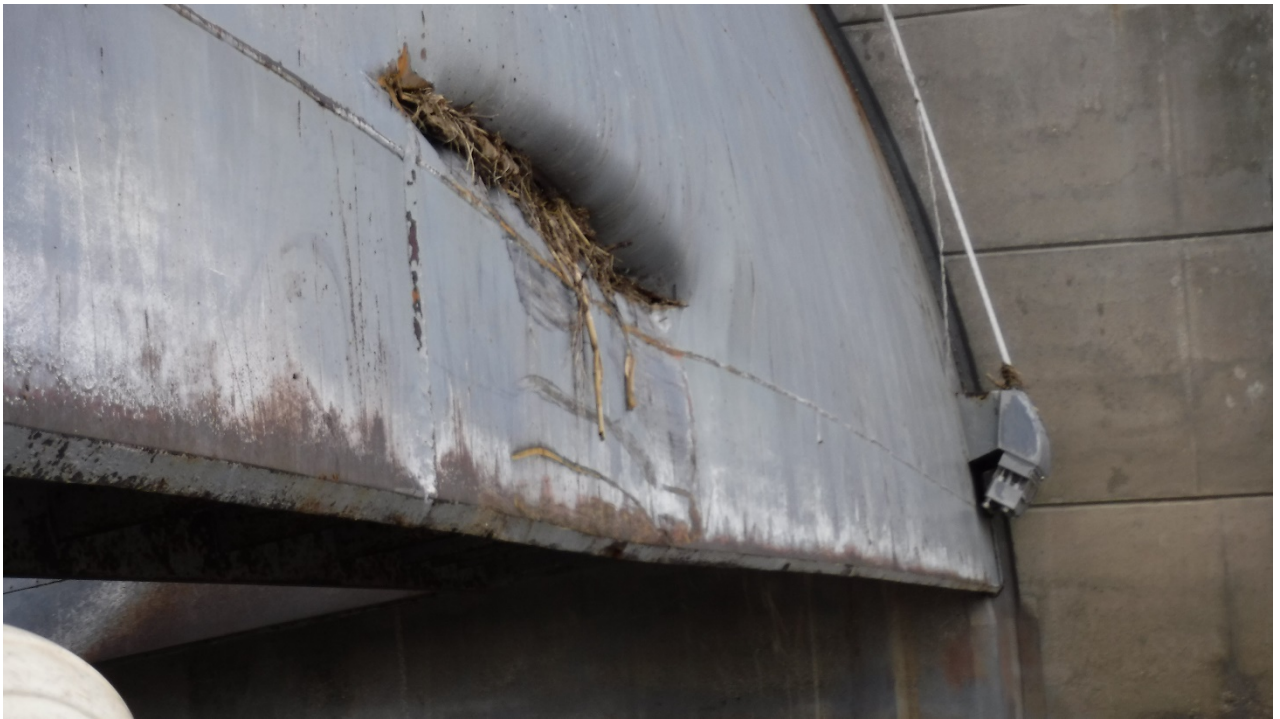
Photo 3- Tainter Gate #5 – Perforated Skin Plate

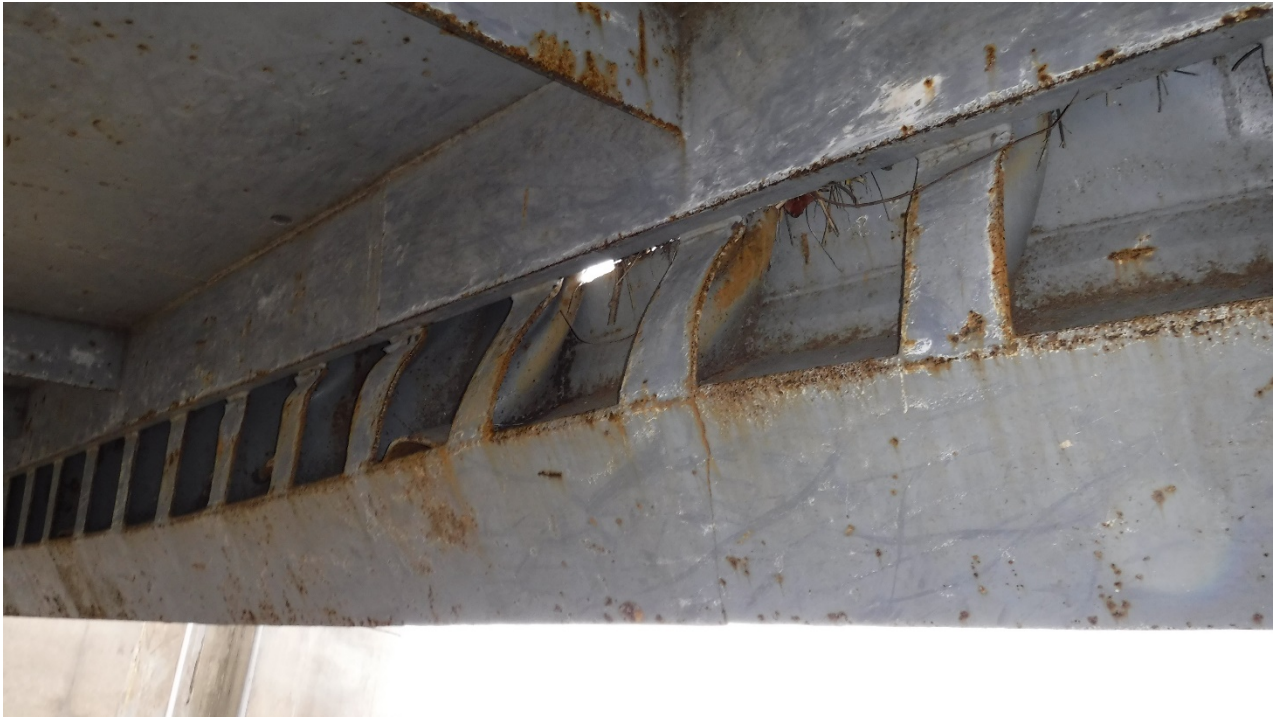
Photo 4 – Tainter Gate #5 – Deformed Vertical Ribs

- ii. Vertical Ribs. The deformed vertical ribs should be removed and replaced. In order to facilitate the welding of the top splice between the replacement vertical ribs and original vertical ribs, it is recommended that the vertical rib demolition line be located at the horizontal skin plate splice located directly above the bottom girder flange (i.e. 7'-8" above the bottom of the gate). The replacement vertical ribs shall be installed with complete joint penetration welds at the top. All other welding of the vertical ribs to the gate shall be in accordance with the as-builts. The 1/2" plates located between the stems of the vertical ribs shall also be removed and replaced; the welding of the replacement 1/2" plate shall be in accordance with the as-builts.

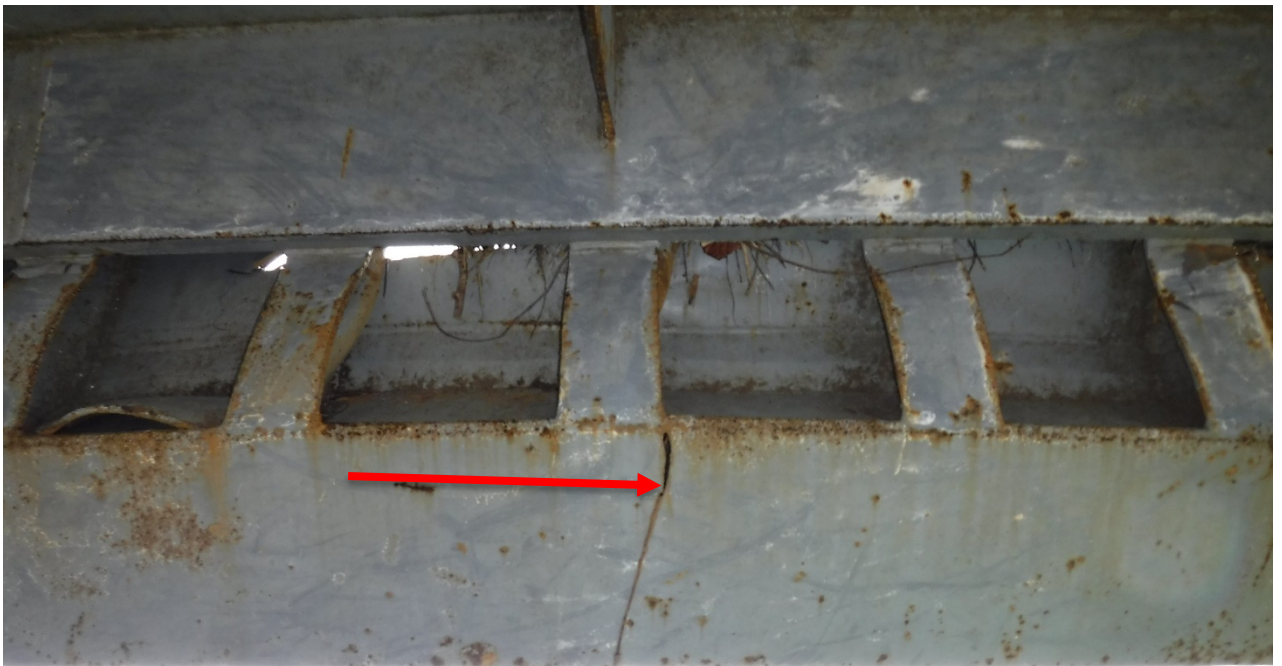
Photo 5 – Tainter Gate #5 – Fracture of 1” Steel Plate

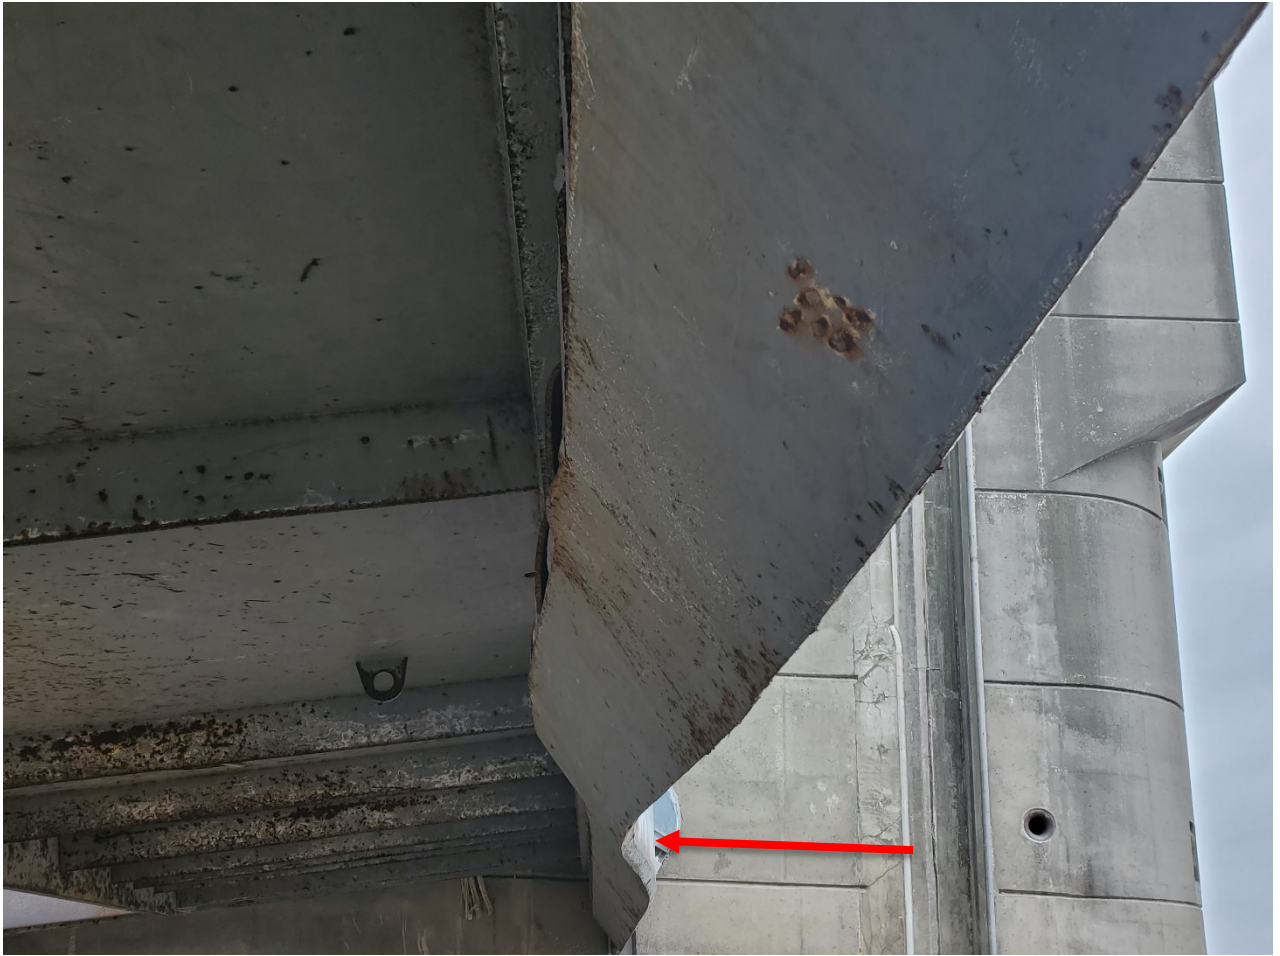
Photo 6 – Tainter Gate #5 – Approximate 6” Deformation in Bottom Portion of Skin Plate

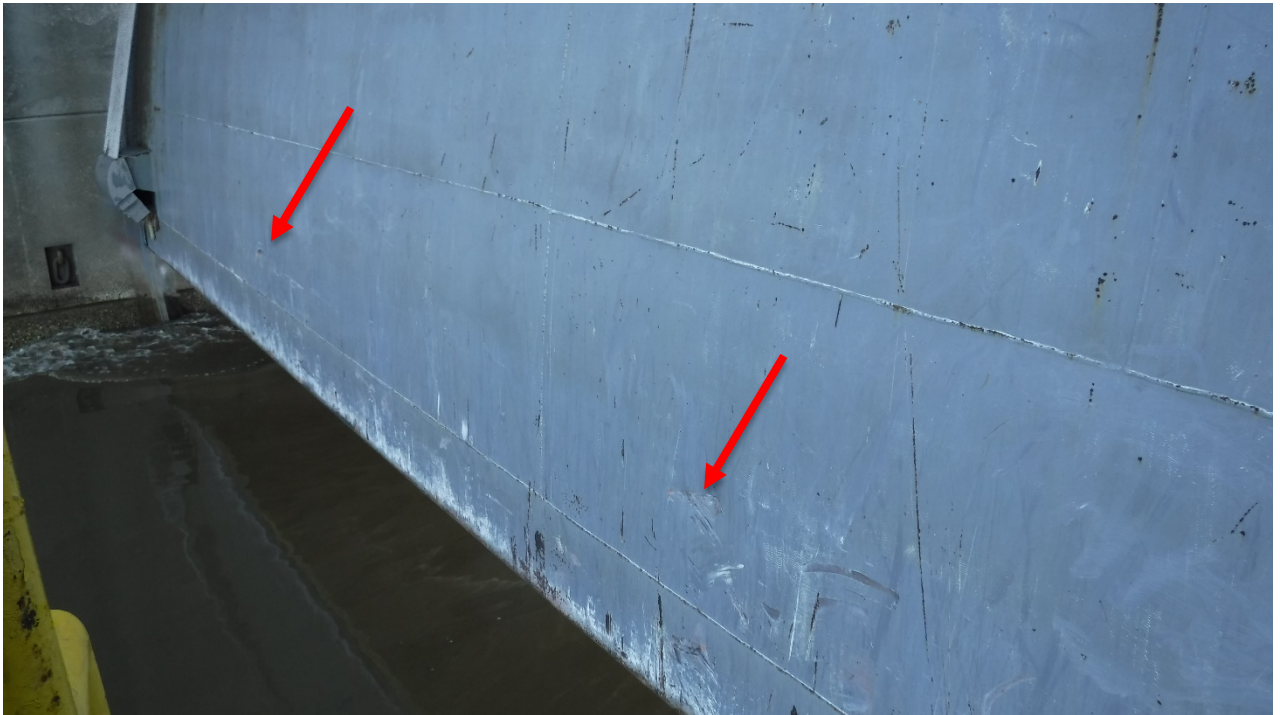
- c. Tainter Gate #7. The impact caused two deformations in the skin plate upstream of the bottom girder flange (Photo 7 and 8). The deformations are approximately 1" deep by 12" wide. Slight gouges were noted on the bottom edge of the gate that resulted from the incident (Photo 9). Repairs to these areas will not be necessary.

Photo 7 – Tainter Gate #7 – Deformations in Skin Plate

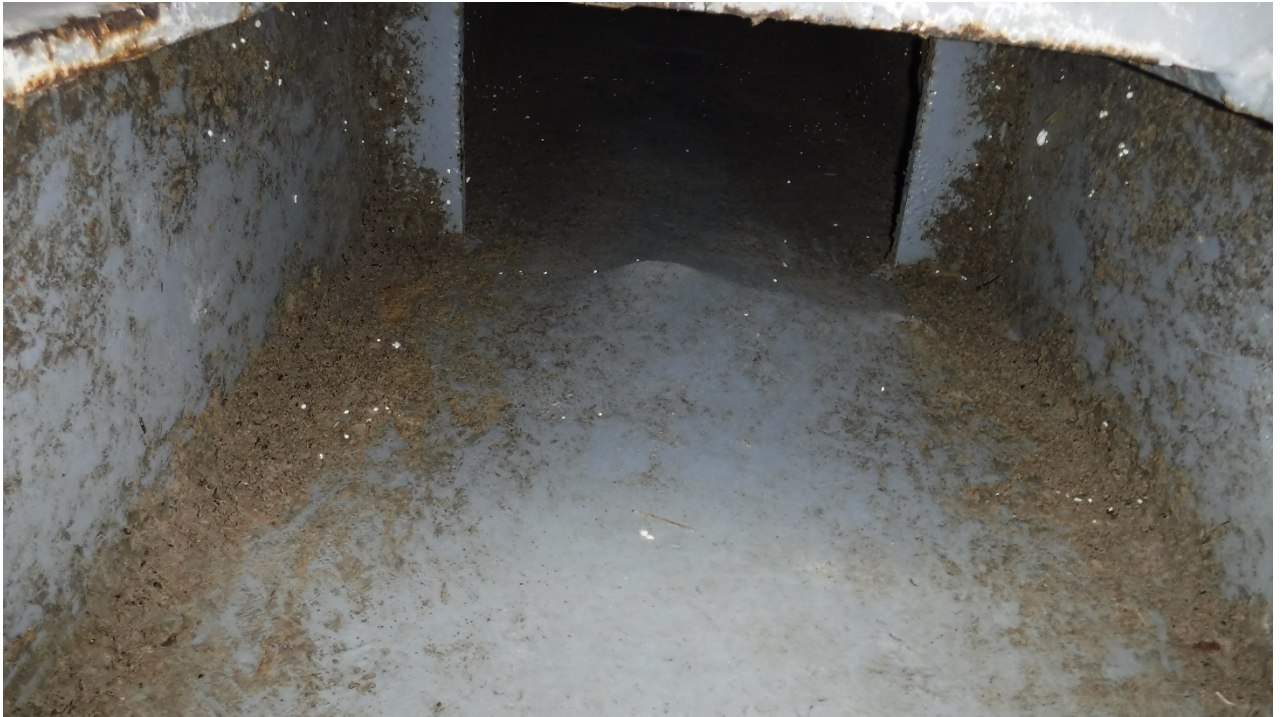
Photo 8 – Tainter Gate #7 - Deformation in Skin Plate (view on downstream side of skin plate between vertical ribs)

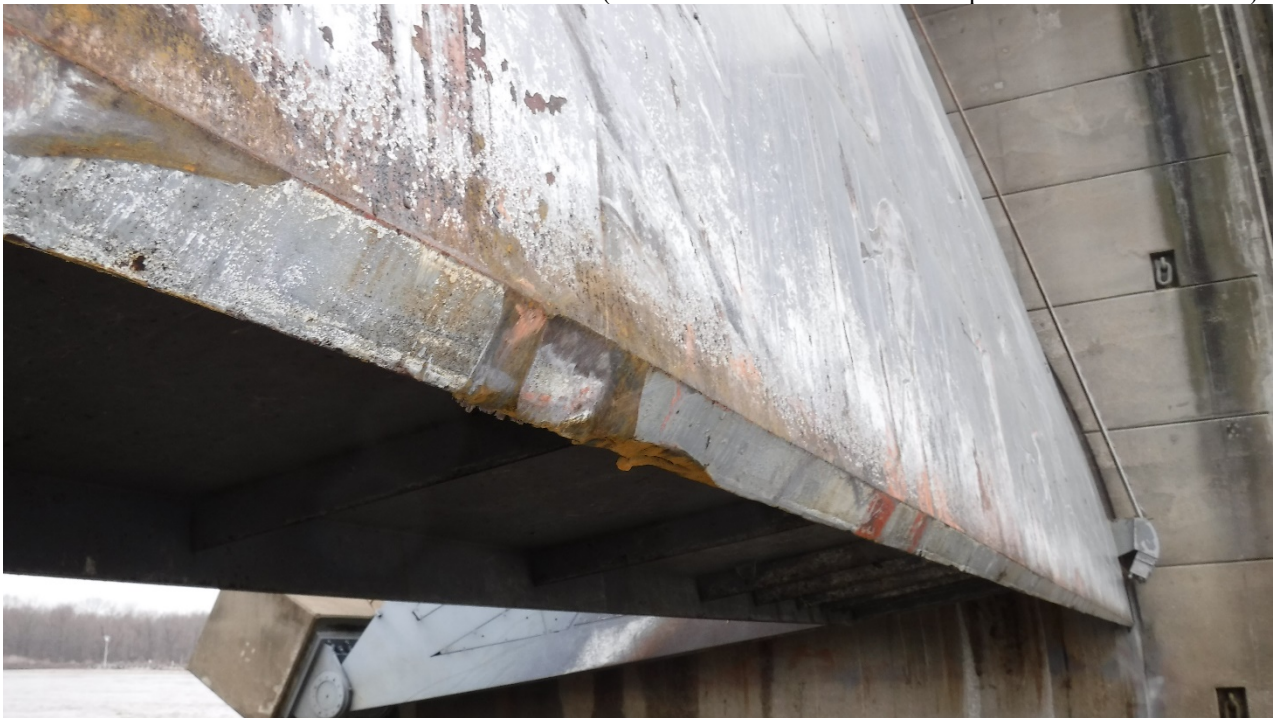
Photo 9 – Tainter Gate #7 – Gouge in Bottom Edge of Skin Plate
