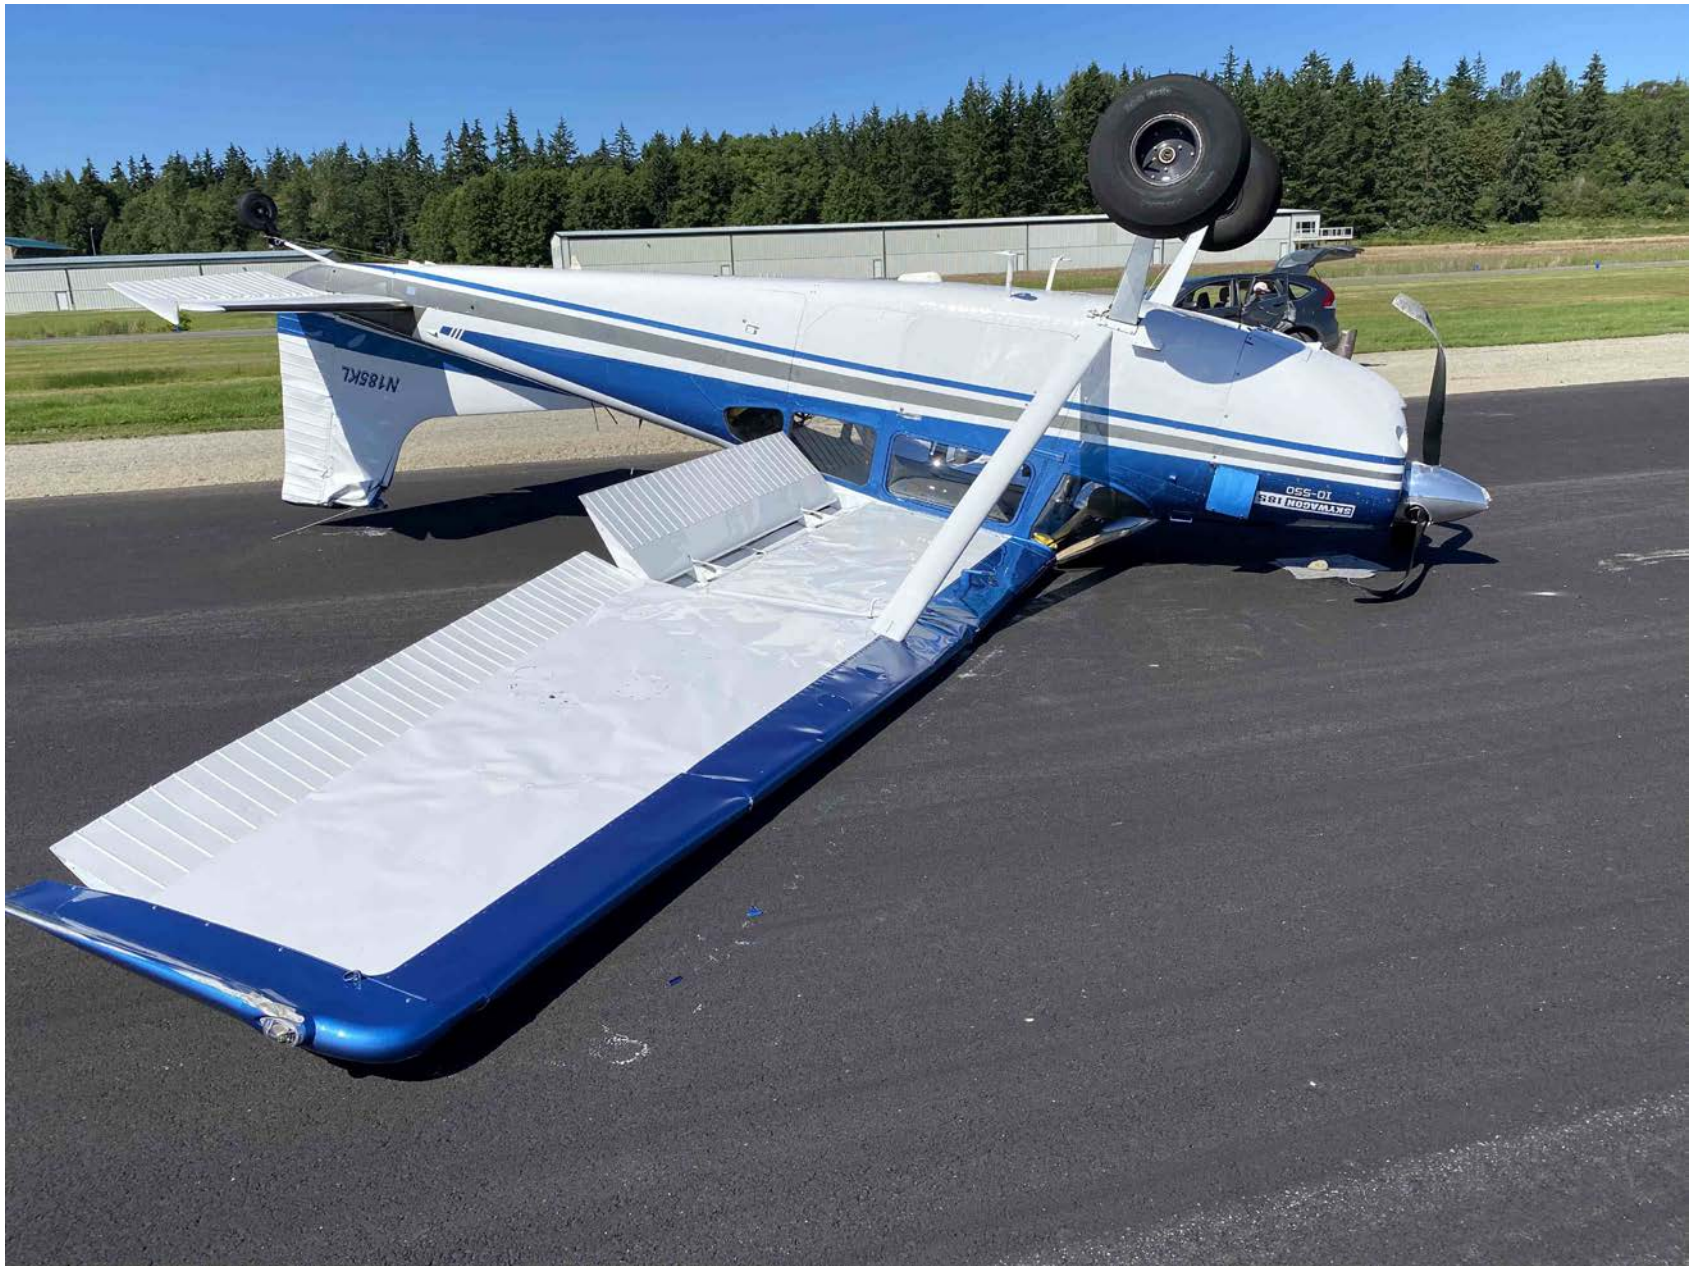
Photo 1 – View of left wing damage (photo courtesy of local law enforcement)

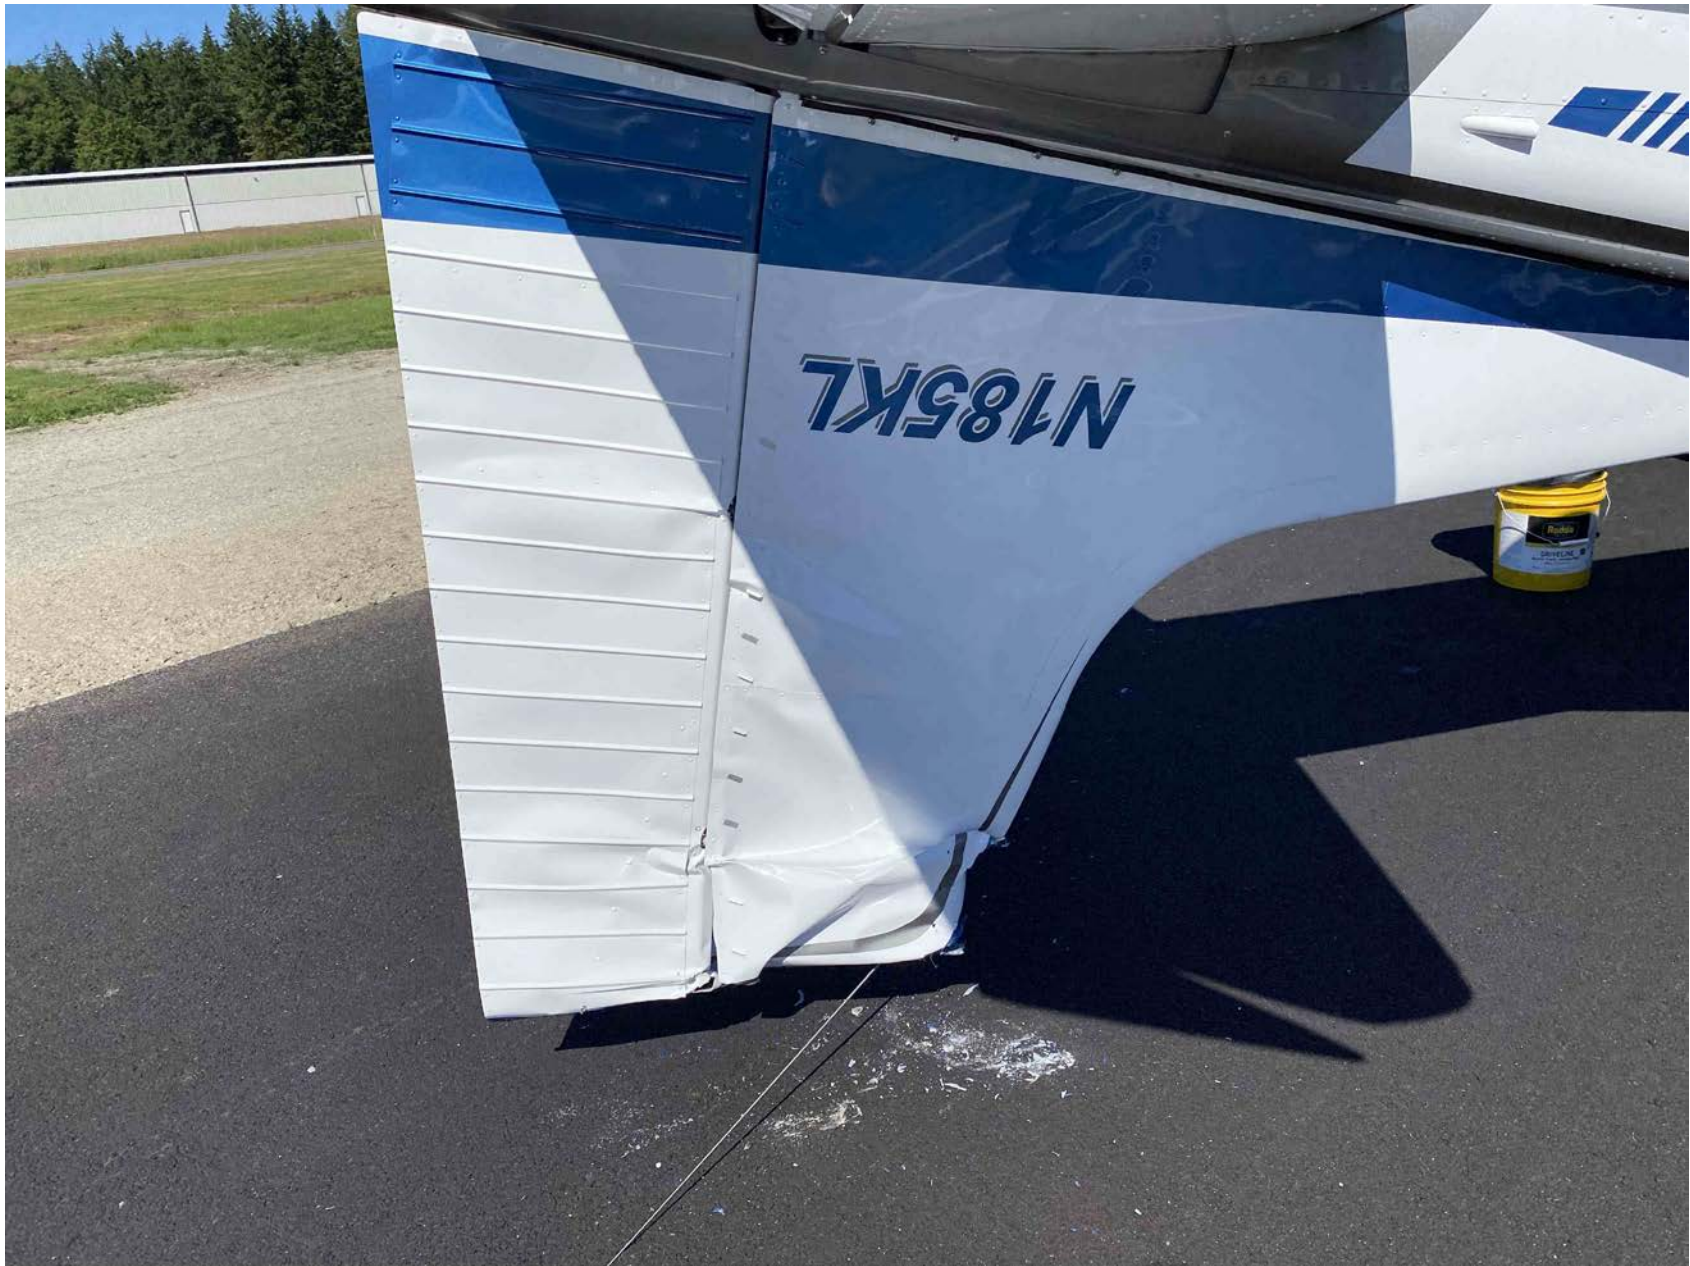
Photo 2 - View of vertical stabilizer and rudder damage (photo courtesy of local law enforcement)

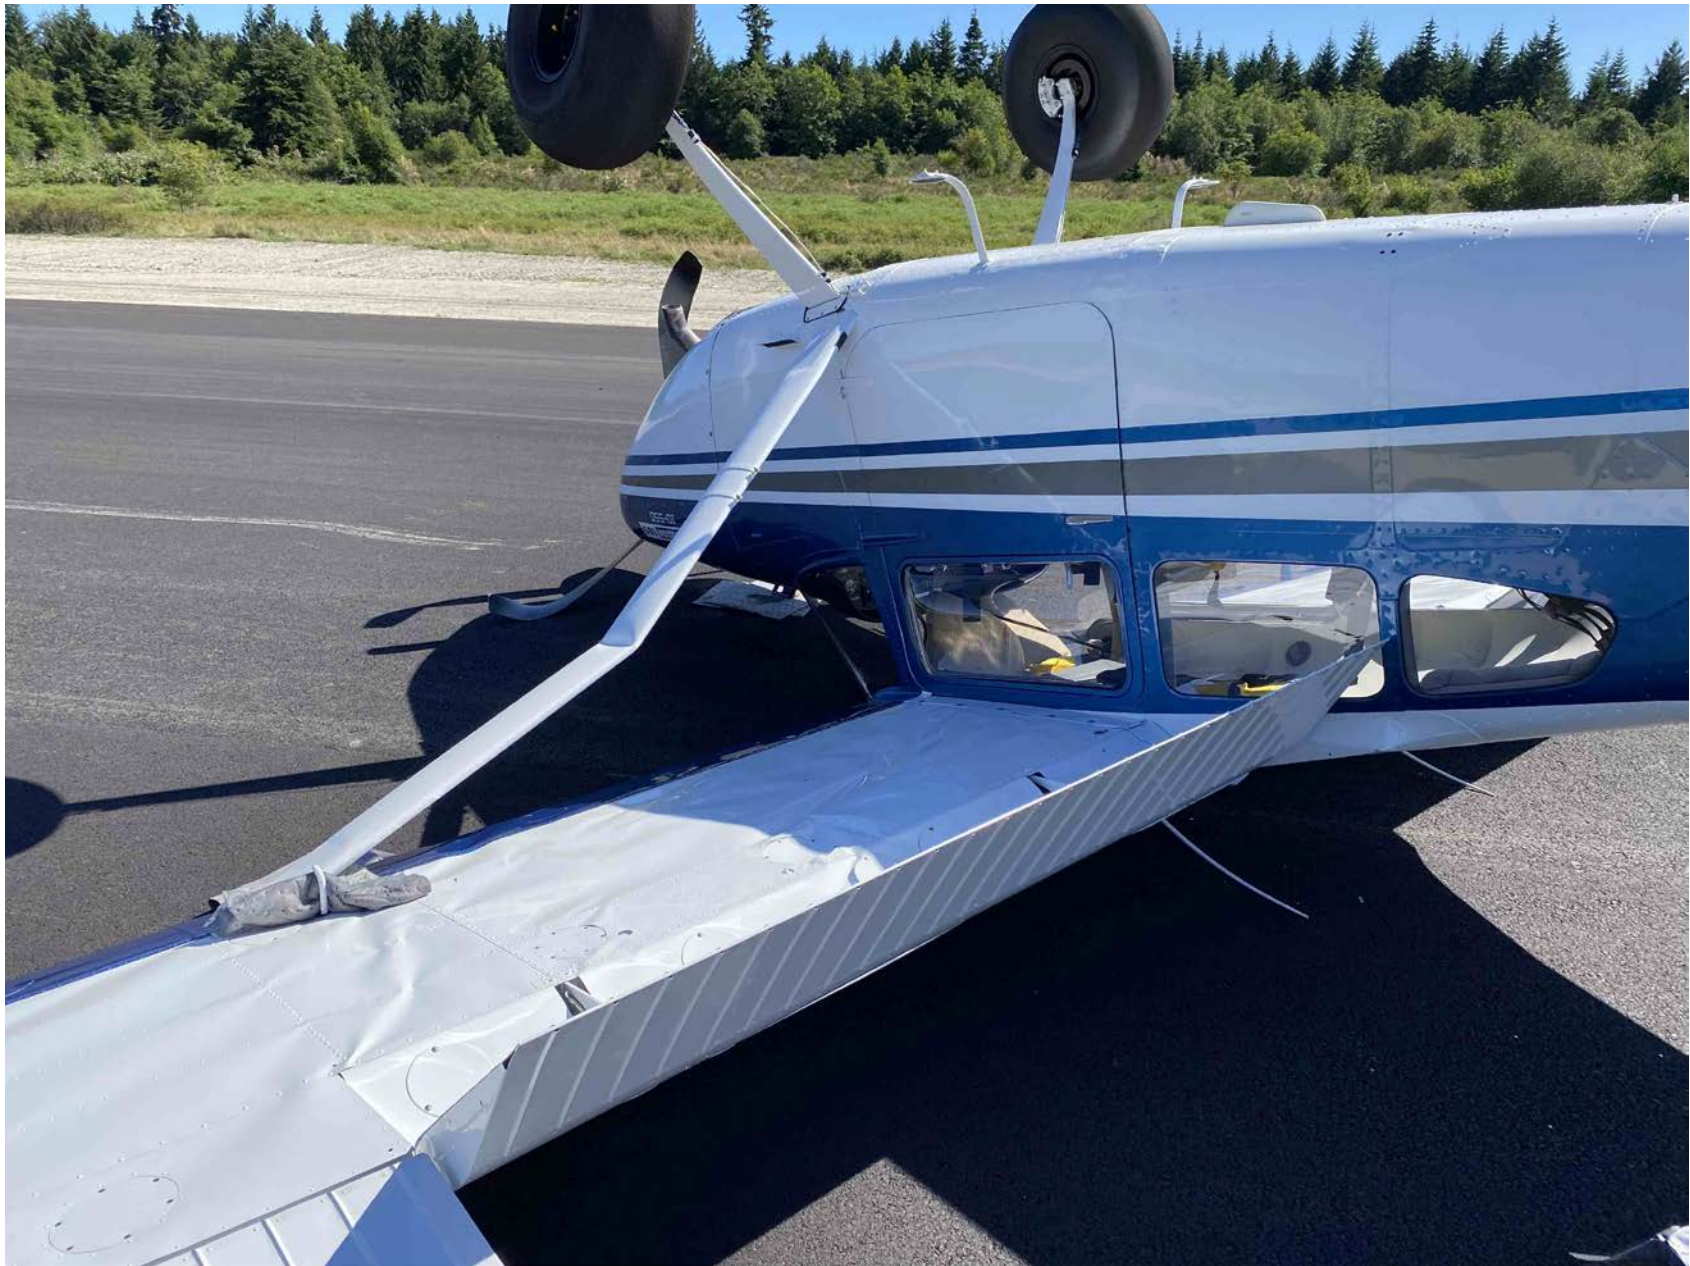
Photo 3 - View of right wing and lift strut damage (photo courtesy of local law enforcement)
