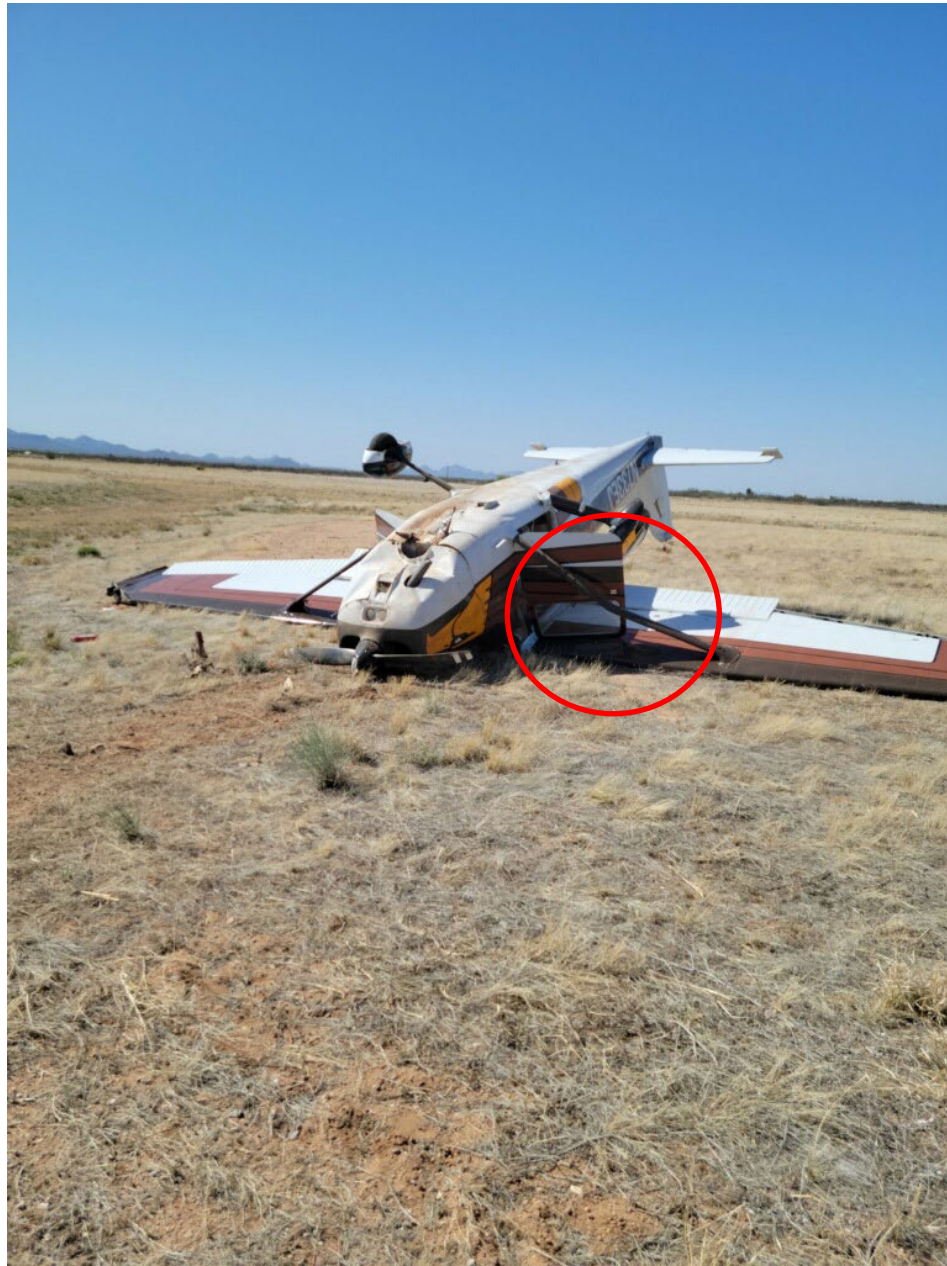
Photo 1 – View of the right-wing lift strut damage (photo courtesy of the pilot)

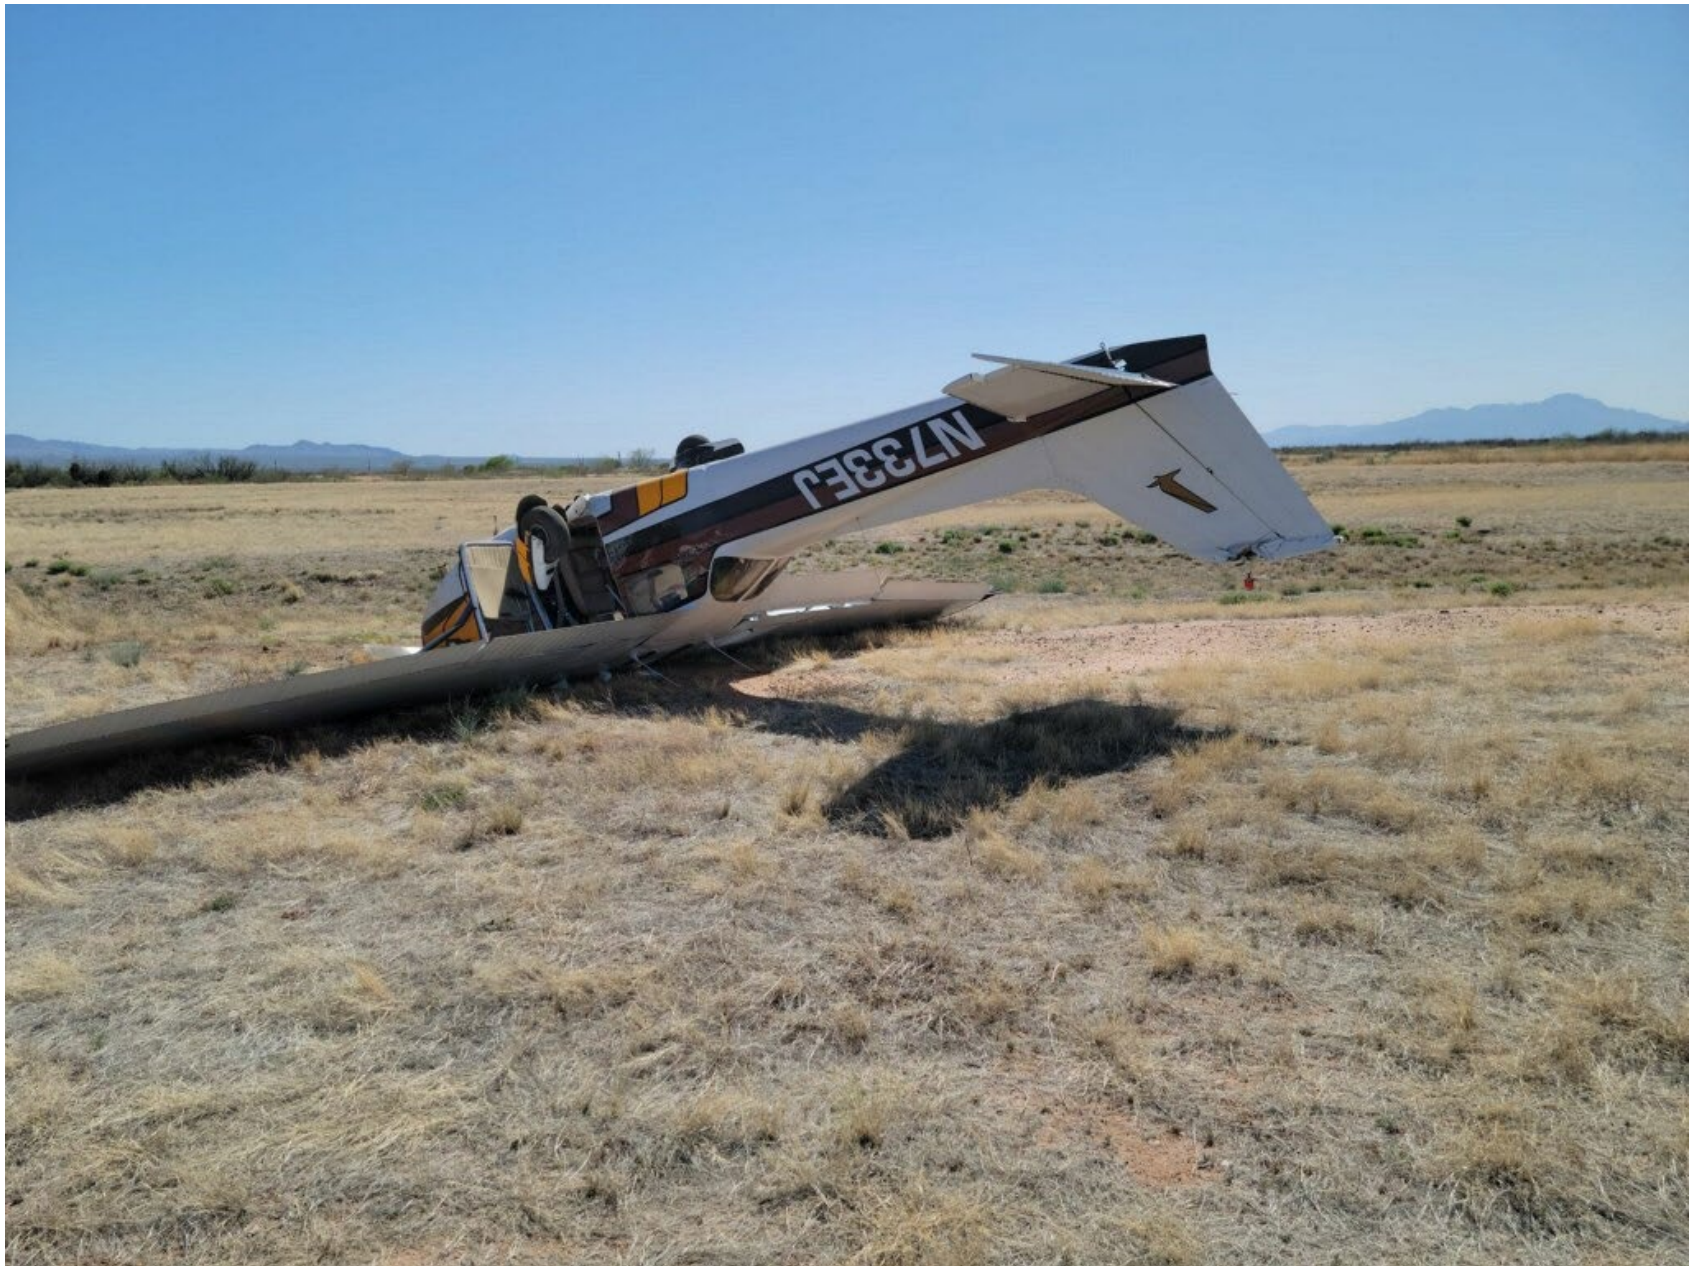
Photo 2 - View of the vertical stabilizer and rudder damage (photo courtesy of the pilot)
