RRD22LR004  
Accident  
Southeastern Pennsylvania Transportation Authority  
December 9, 2021  
Darby, PA

## **National Transportation Safety Board**

### **Operations Group – Factual**

June 6, 2022

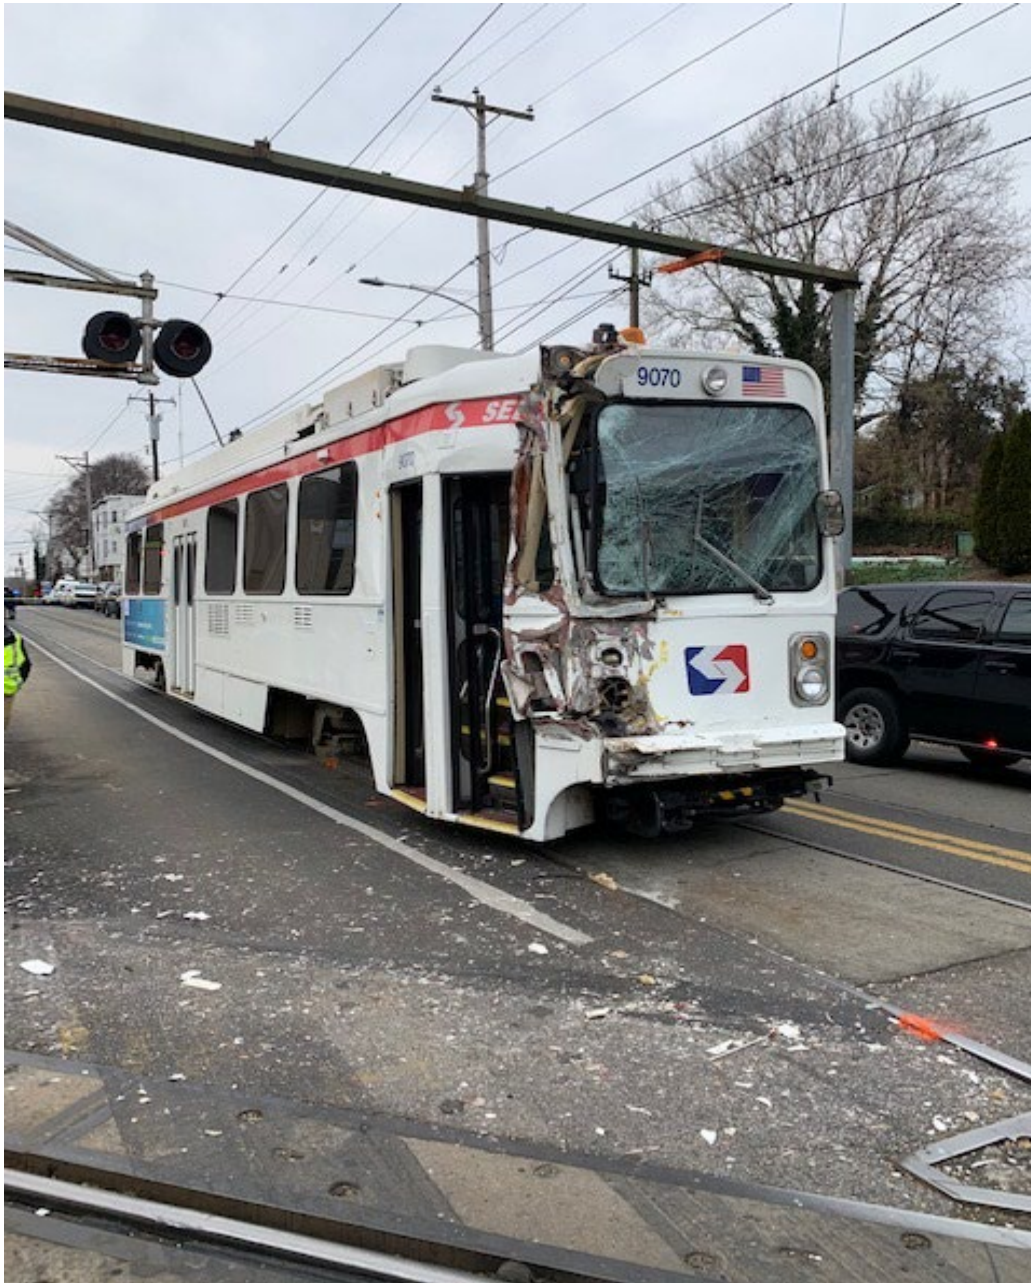
On Thursday December 9, 2021 at approximately 0825 CSXT freight train I03309 was traveling westbound at 25 miles per hour on the Philadelphia subdivision and struck the front of a SEPTA trolley at mile post BAK 4.97 at the main street crossing in Darby Borough. The SEPTA trolley was fouling the CSXT track, and the crossing gates were on top of the trolley car.

View of damaged trolley look south on Main Street, CSX Transportation track in foreground.
