Issued: March 24, 2022 NTSB No. RRD22FR006

## BNSF Railway Employee Fatality

Denver, CO February 9, 2022

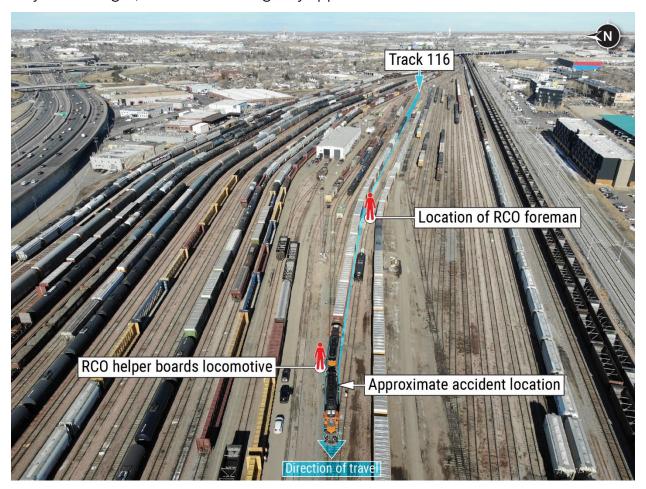
Figure. BNSF Globeville Yard in Denver with equipment in its postaccident position.
