RRD22FR006
BNSF Railway
February 9, 2022
Denver,
Colorado

National Transportation Safety Board

Operations and System Safety Factual Report

NTSB Accident Number:	RRD22FR006
Date of Accident:	February 9, 2022
Time of Accident:	10:57 a.m.
Type of Train and No:	Mixed Freight Train - YDEN1152-09i
Railroad Owner:	BNSF Railway
Train Operator:	BNSF Railway
Crew Members:	RCO Foreman, RCO Helper
Location of Accident:	Denver, Colorado

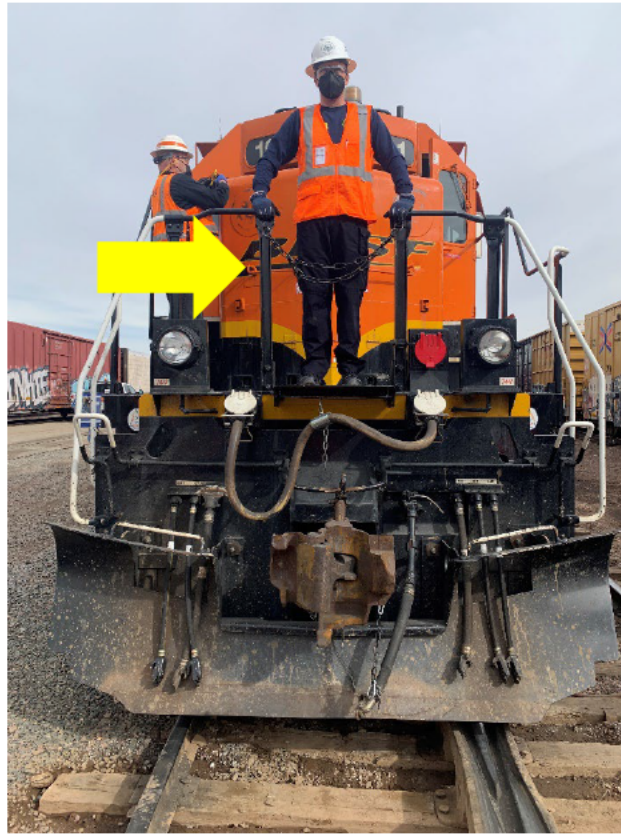
Figure 1: NTSB Investigator standing on the nose platform of the locomotive. The yellow arrow indicates the position of the continuous barrier chain. Source NTSB.

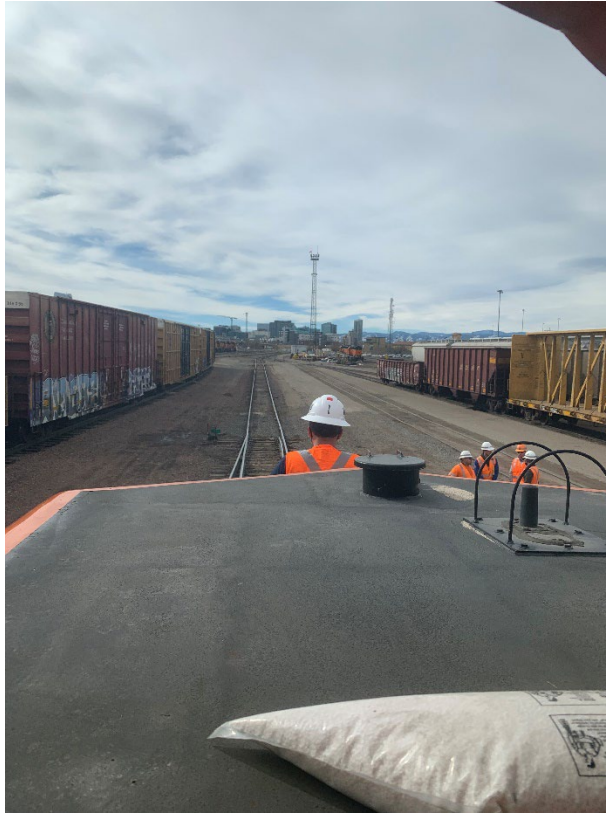
Figure 2: NTSB Investigator standing on the center of the nose platform of the locomotive facing forward. Source NTSB.
