NATIONAL TRANSPORTATION SAFETY BOARD

Digital Fuel Monitor

Specialist's Factual Report

Location: Chebanse, Illinois
Date: July 5, 2019
Aircraft: Beechcraft A36
Registration: N1809S
Operator: Private
NTSB Number: CEN19FA210

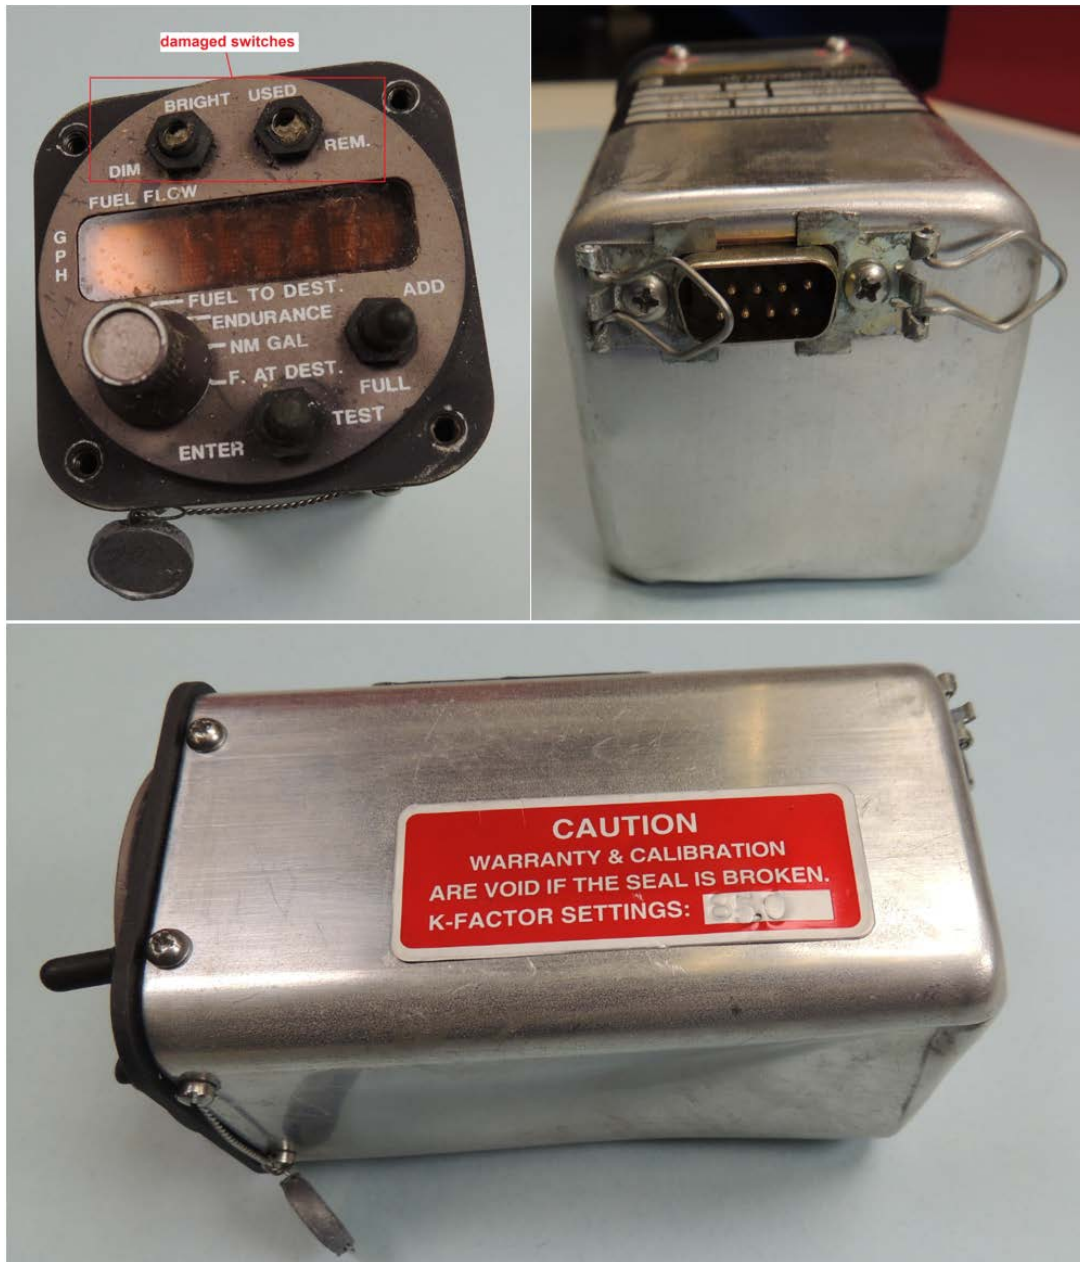
Upon arrival at the Vehicle Recorder Division, an exterior examination revealed the unit had impact damage on its front panel and metal outer case, as shown in Figure 1.

Figure 1: Shadin Microflo-L as received (front, back and side).

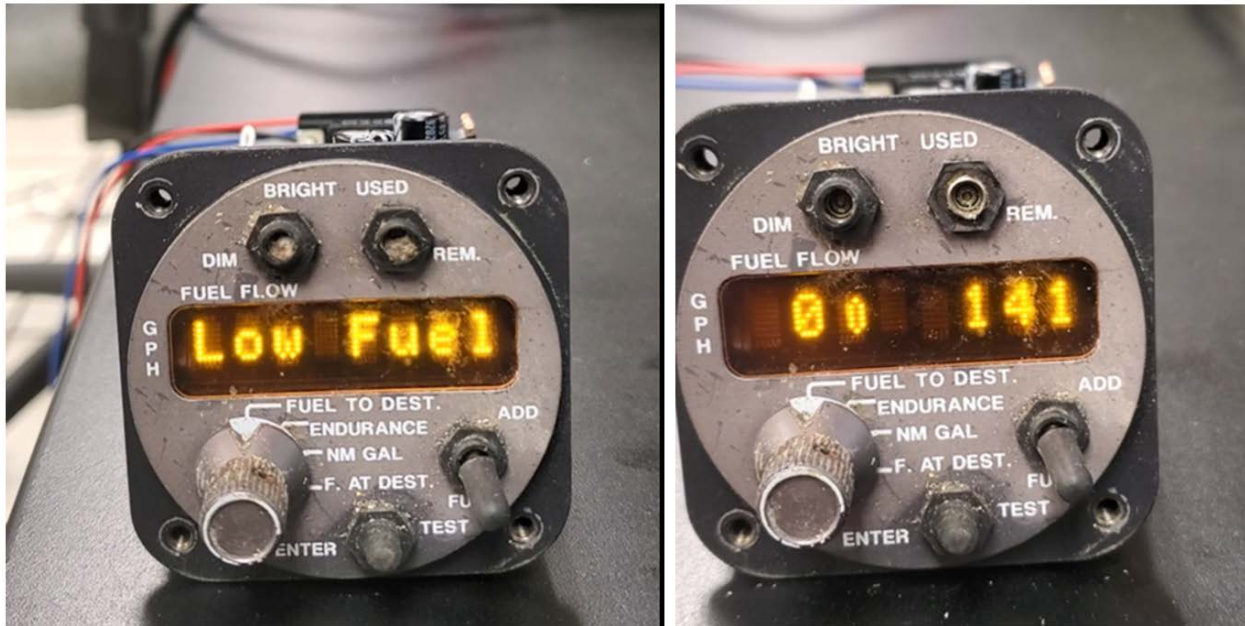
The Shadin Microflo-L was visually inspected internally, and no damage was found. When the unit powered up initially, it was continuously flashing “Low Fuel” warning on its display, as shown on the left side of Figure 2. The warning persisted until it was acknowledged by pressing the ENTER/TEST button¹. According to the manufacturer, this warning indicated that the fuel level on board was below a preset low fuel level before the power to the unit was cut off. After the low fuel warning was acknowledged, the device displayed fuel flow rate of 0.0 GPH on the left and maximum usable fuel of 141 gallons on the right, as shown on the right side of Figure 2. This display configuration was not expected according to the manufacturer.

Figure 2: Low Fuel warning when initially powered up (left), fuel flow rate and max usable fuel (right).

warning shown when the device was powered up is believed to have been valid at the end of the accident flight when power to the unit was cut off according to the manufacturer.

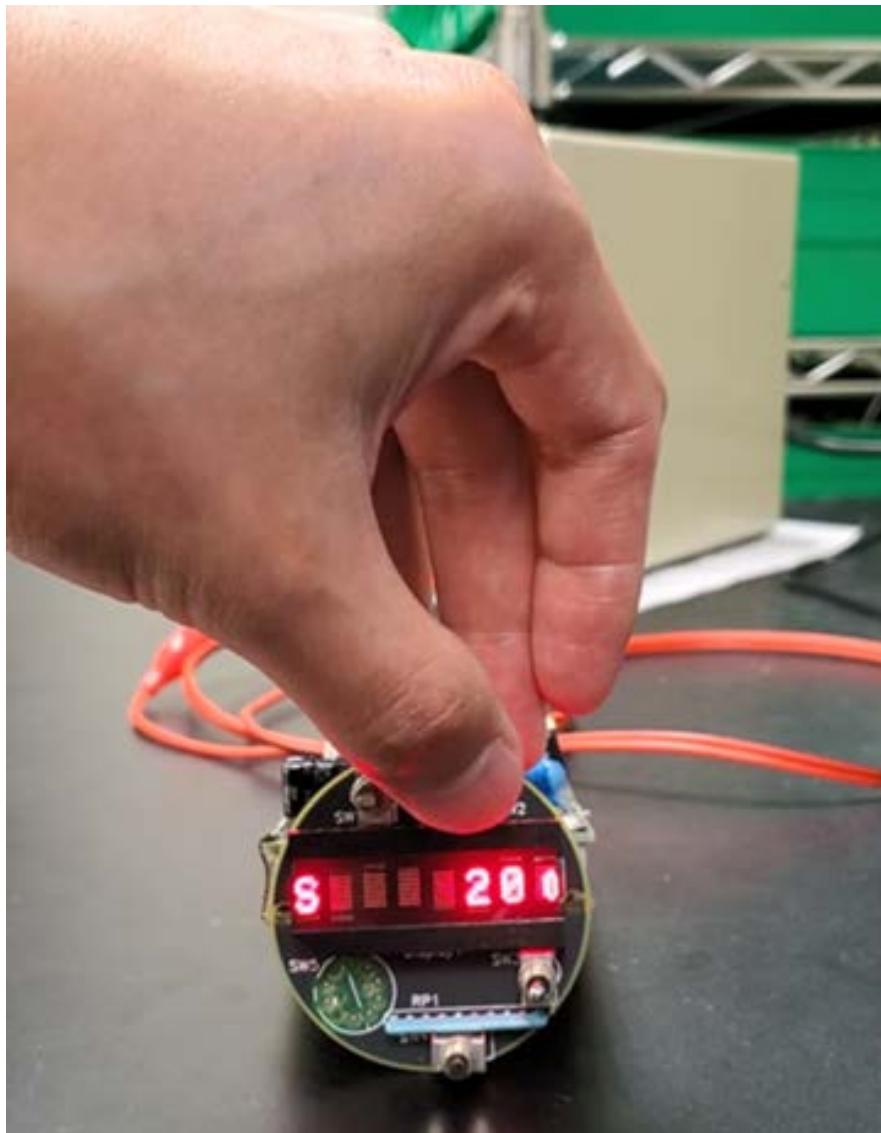
In order to retrieve the initial set-up values, the manufacturer provided a new display. The unit was powered up again with the new display. The stored Low Fuel Level was read to be 20.0 gallons, as shown in Figure 3. This indicates that the fuel remaining on the accident aircraft was lower than 20 gallons before the electrical power to the unit was cut off. All the stored configuration values retrieved from the unit are shown in Tables 1, 2 and 3. The Group 1 configuration is set up by the distributor and contains information defined by the part number of the unit, while the Group 2 configuration can be set up by programing the unit in Manual Entry Mode.

Figure 3: Low Fuel Level setting in device's Entry Mode.
