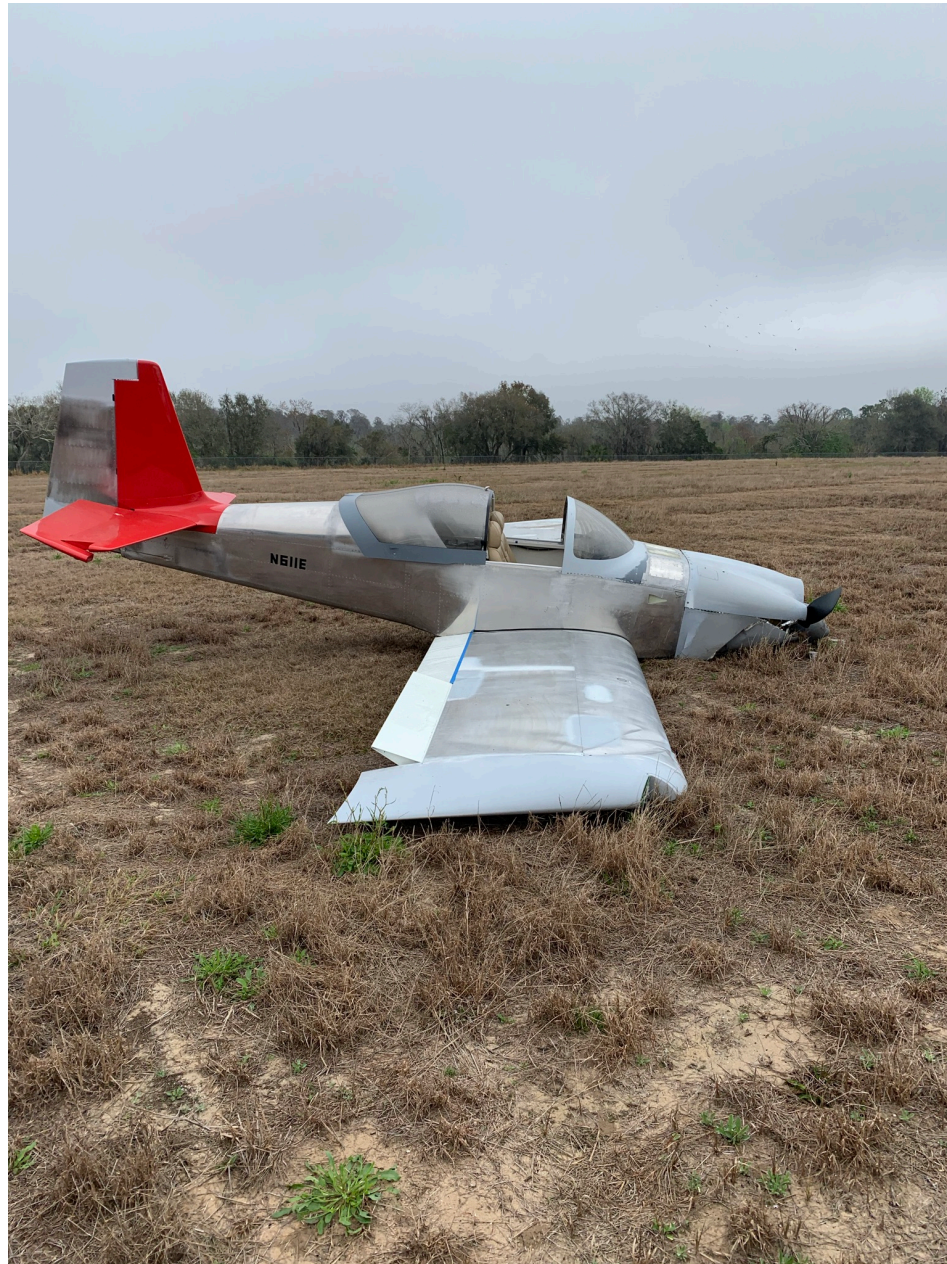
Photo 1 – View of Airplane as Found (FAA)

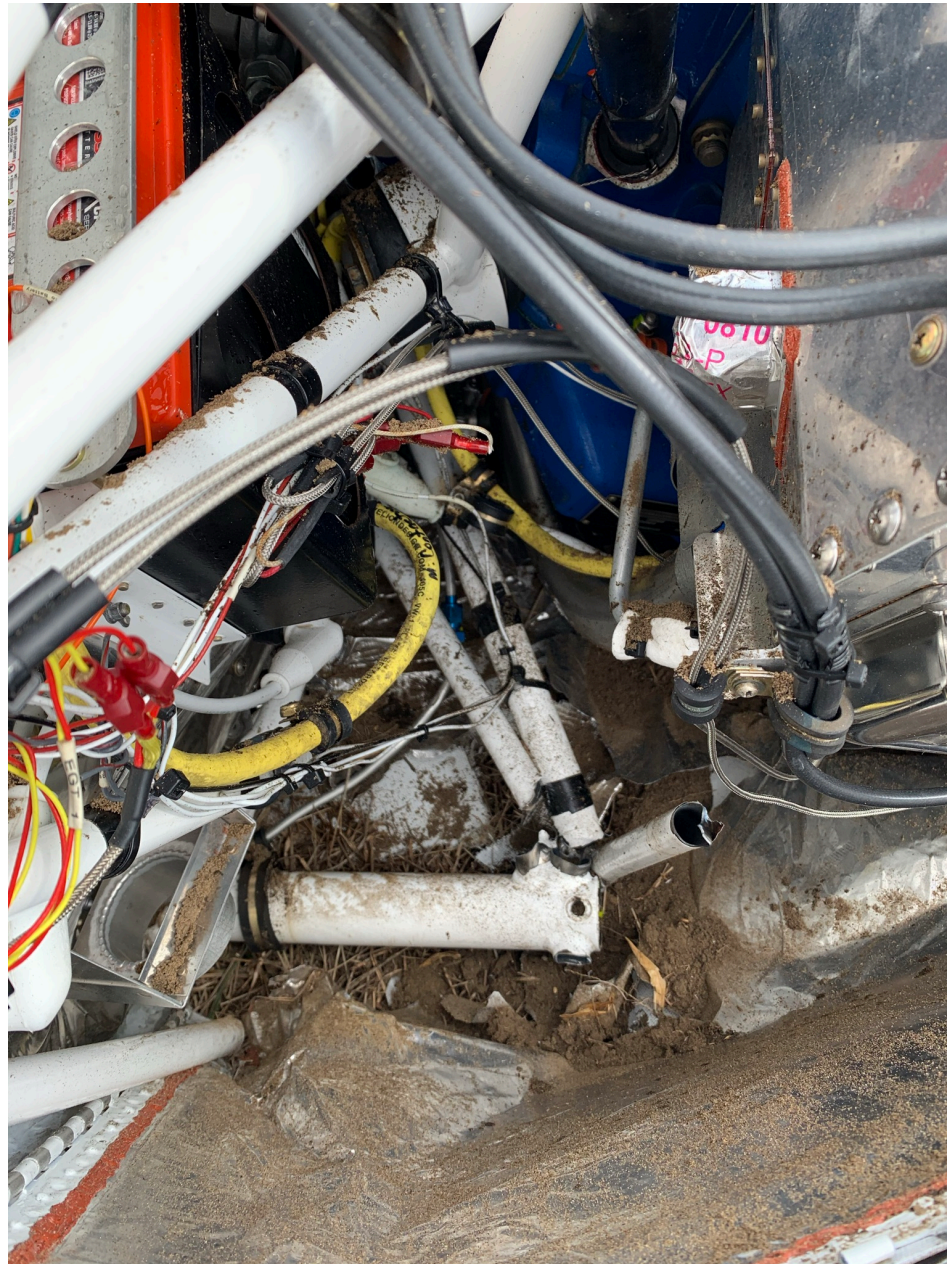
Photo 2 - View of Fractured Engine Mounts and Fuselage Damage (FAA)

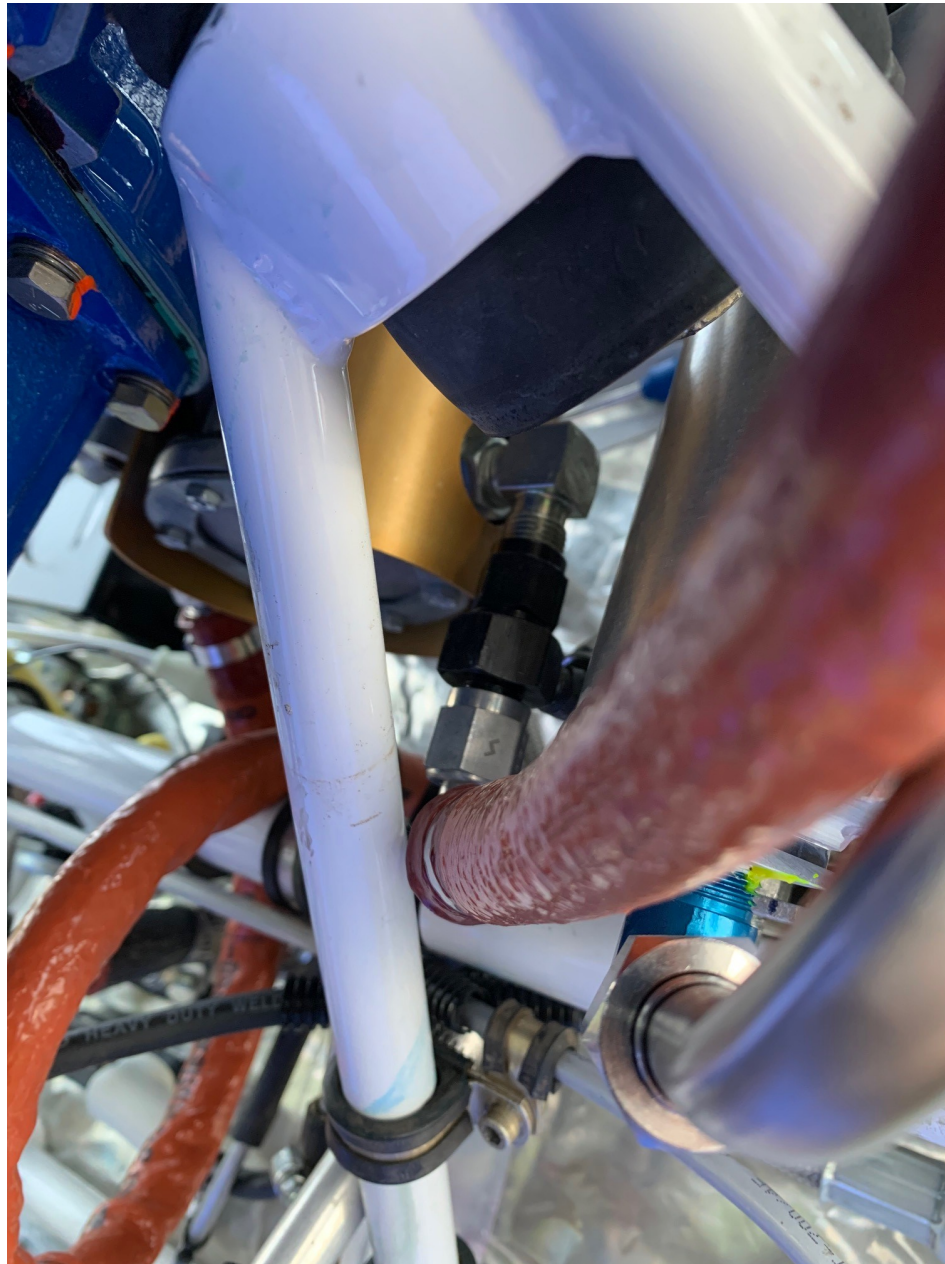
Photo 3 - View of Adapter Fitting as Installed (Owner)

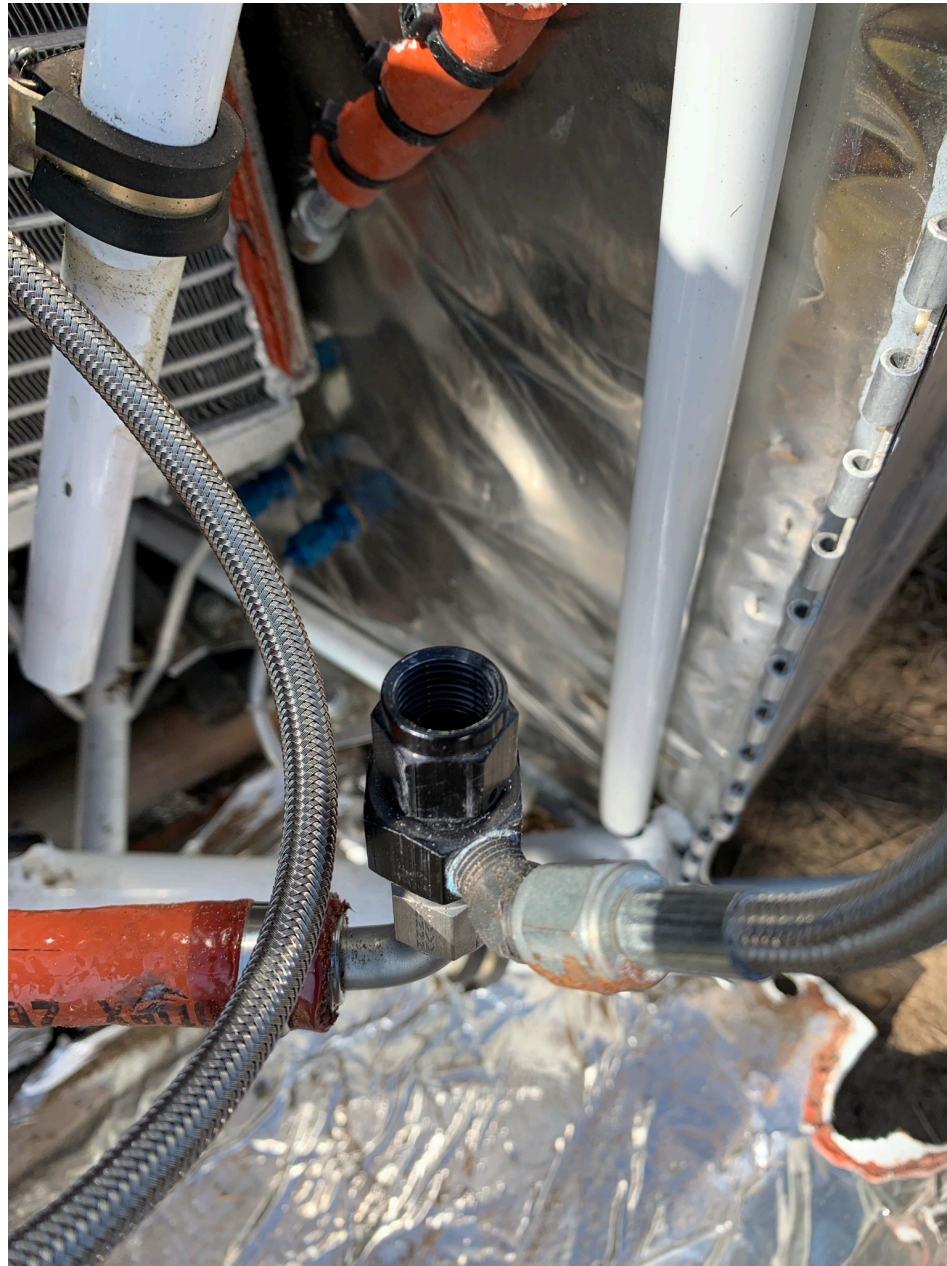
Photo 4 - View of Disconnected Adapter Fitting (FAA)

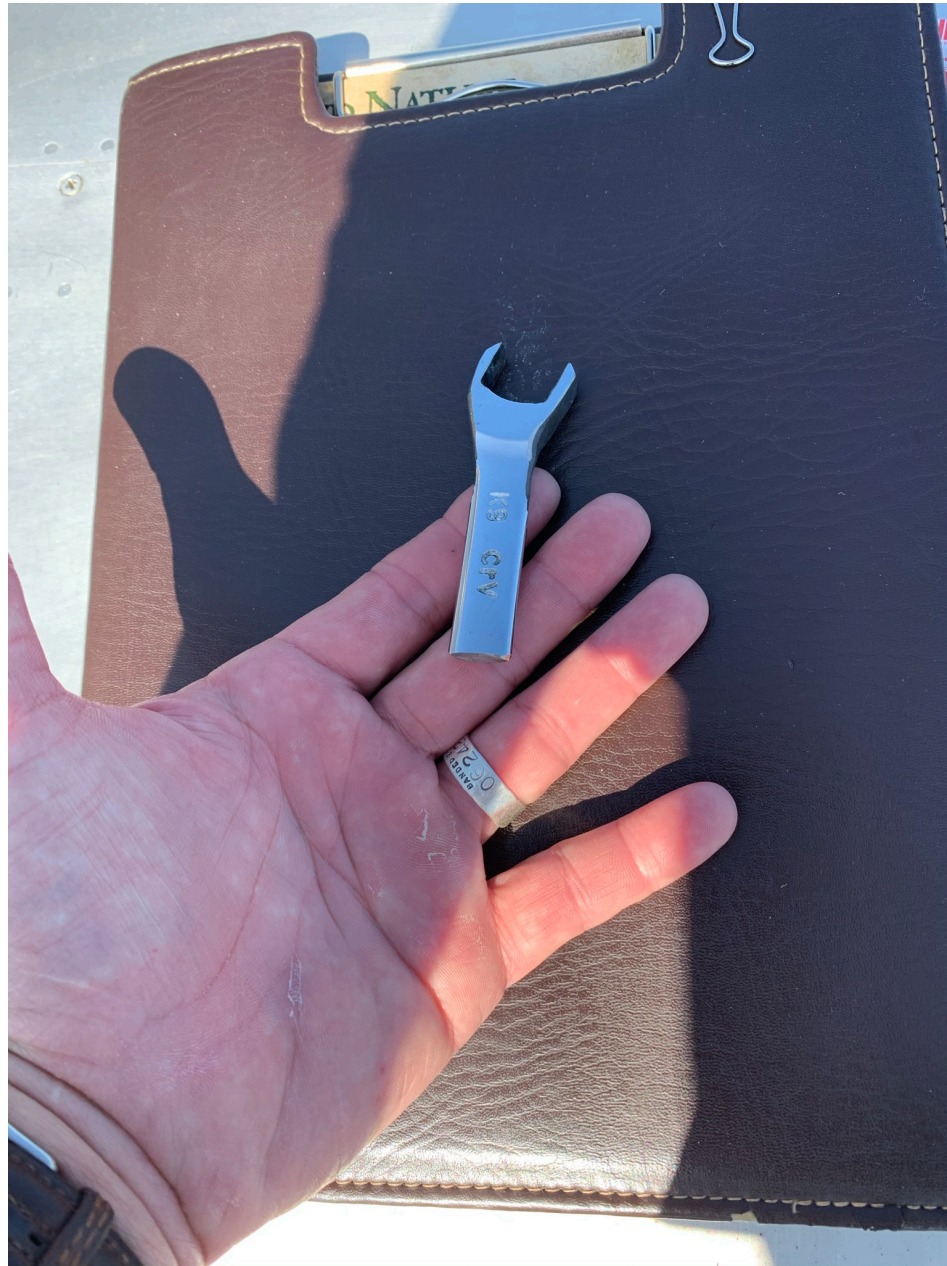
Photo 5 - View of Owner's Modified Spanner Wrench (FAA)
