**Survival Factors Attachment-
Investigation Photographs**

**Reed, PA
RRD22LR003**

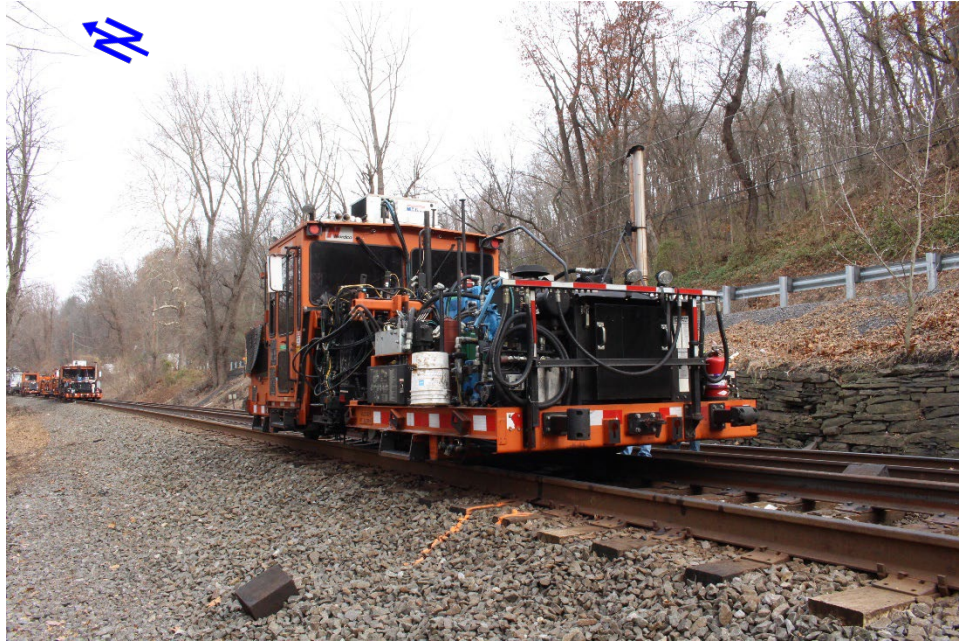
Figure 1 Photograph showing the front and right-side view of Spiker #2 at final rest. Spiker #3, located north of Spiker #2, is visible in the background.

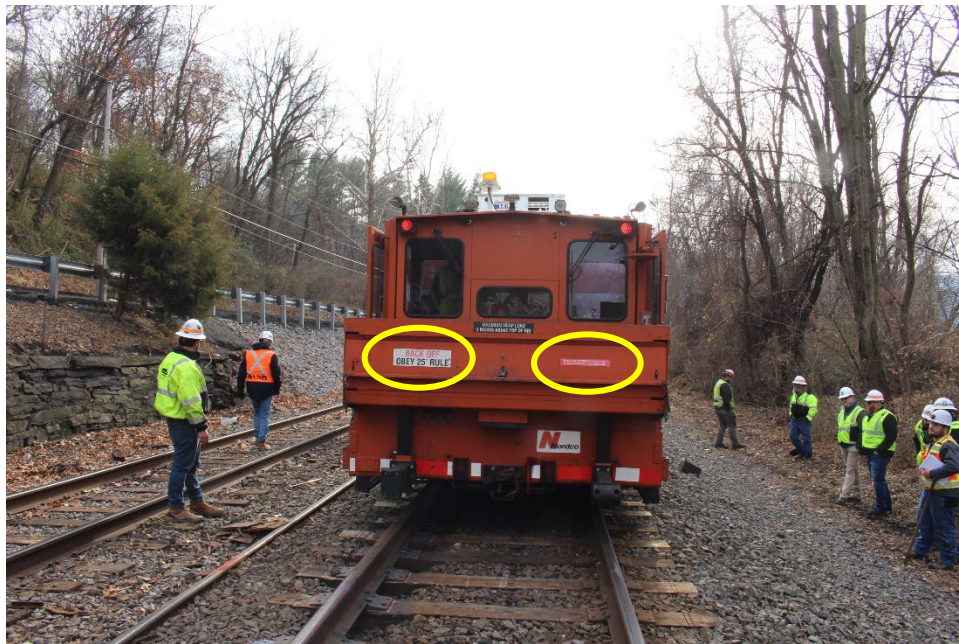
Figure 2 Photograph looking south at the rear of Spiker #2. Standoff warning notices to employees working to the rear of the equipment are highlighted by the yellow circles.

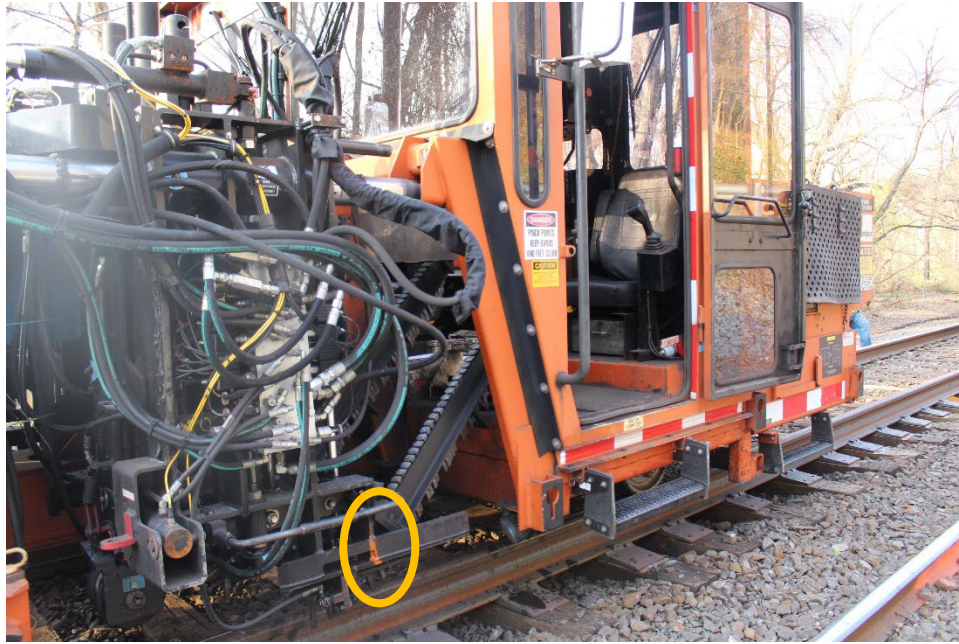
Figure 3 Photograph of the left (operator's) side of Spiker #2. The highlighted mark on the equipment indicates the location underneath the machine where the worker was found.

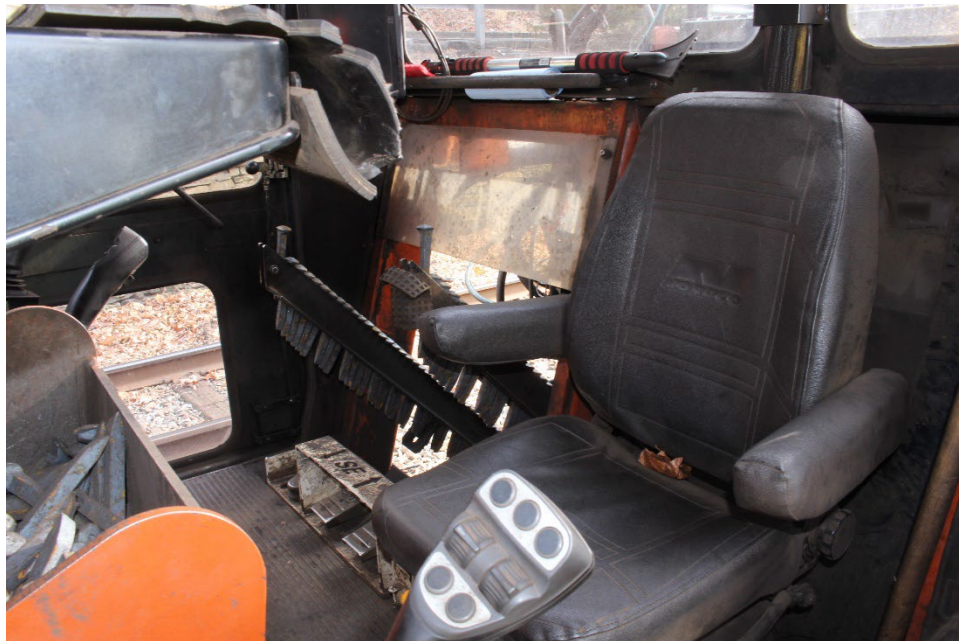
Figure 4 Photograph of the interior of the spike machine looking from the right side towards the left operator seat. The center seat, facing backwards, is for the spike feeder worker.

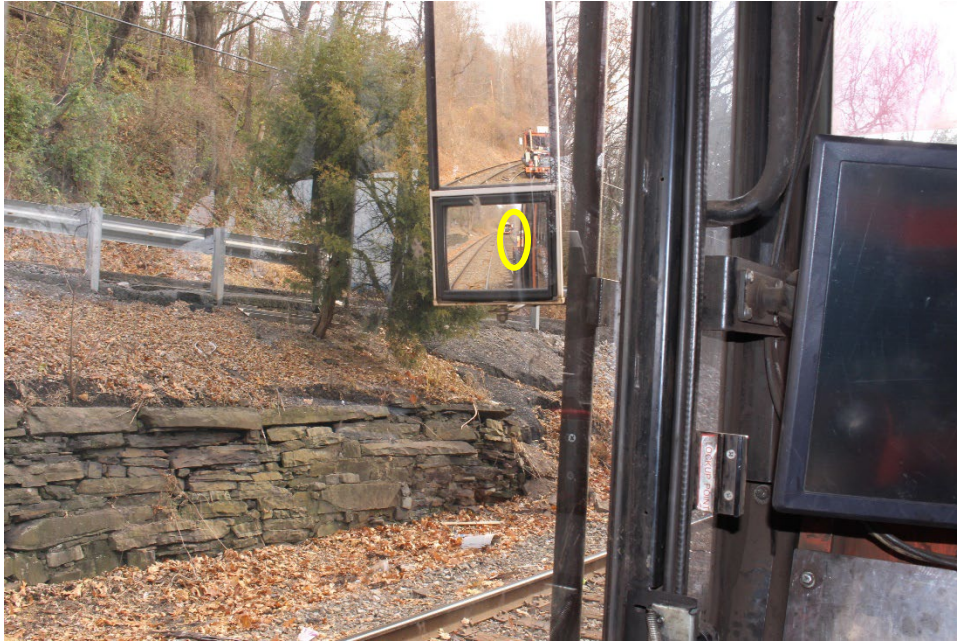
Figure 5 is the view from the left operator's seat of the track behind the spike machine. The yellow circle indicates the image of an individual standing in the center of the track.

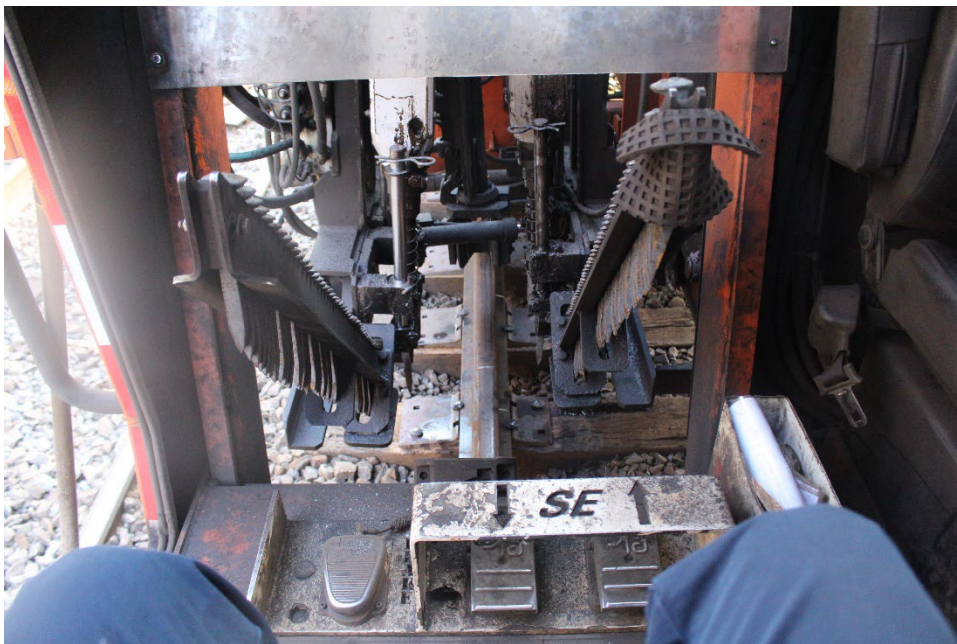
Figure 6 The view of the area underneath the equipment as seen by the operator in the left seat of the spike machine.

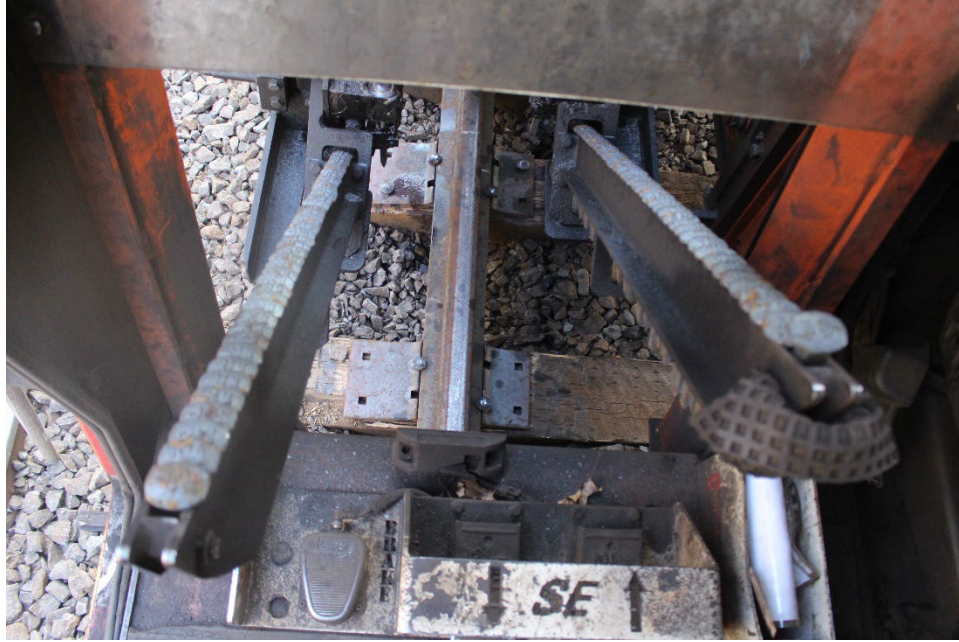
Figure 7 Shows the operator's view of the area underneath the spike machine and how the operator would have seen the worker once he had passed underneath the equipment.

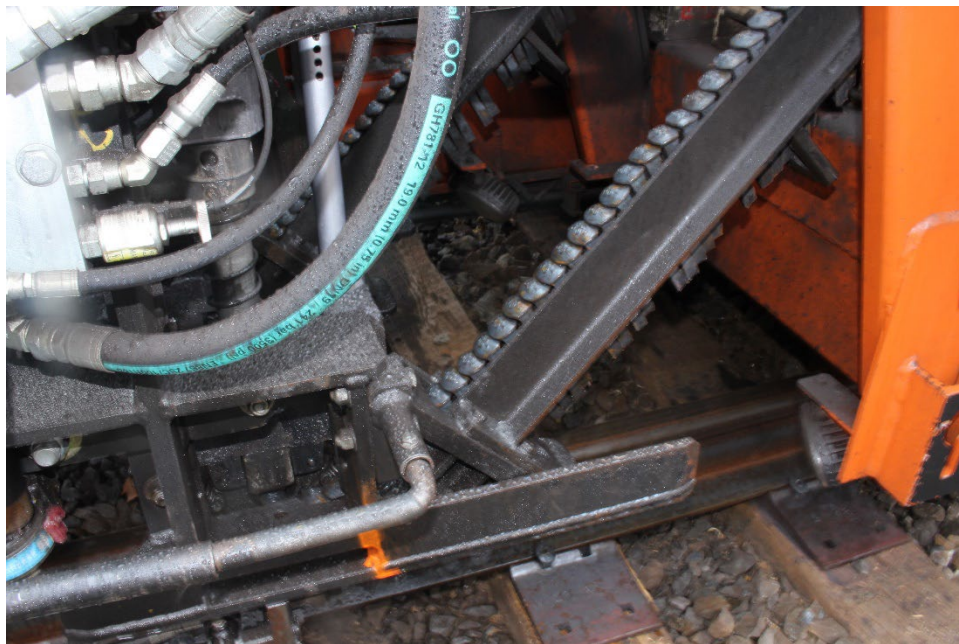
Figure 8 Photograph of the view of the area underneath the spike machine looking in from outside of the equipment.

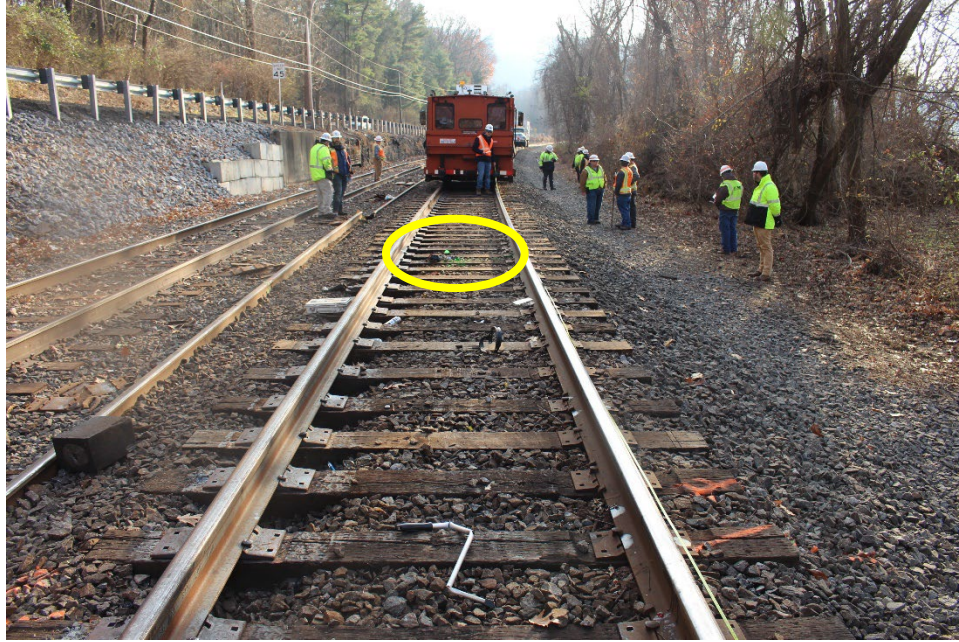
Figure 9 Looking southward down the track at Spiker #2. The final rest position of the worker underneath the equipment is indicated by the orange paint marks in the foreground. In the background, the green paint marks (circled in yellow) indicate the approximate point of contact between the equipment and the worker.

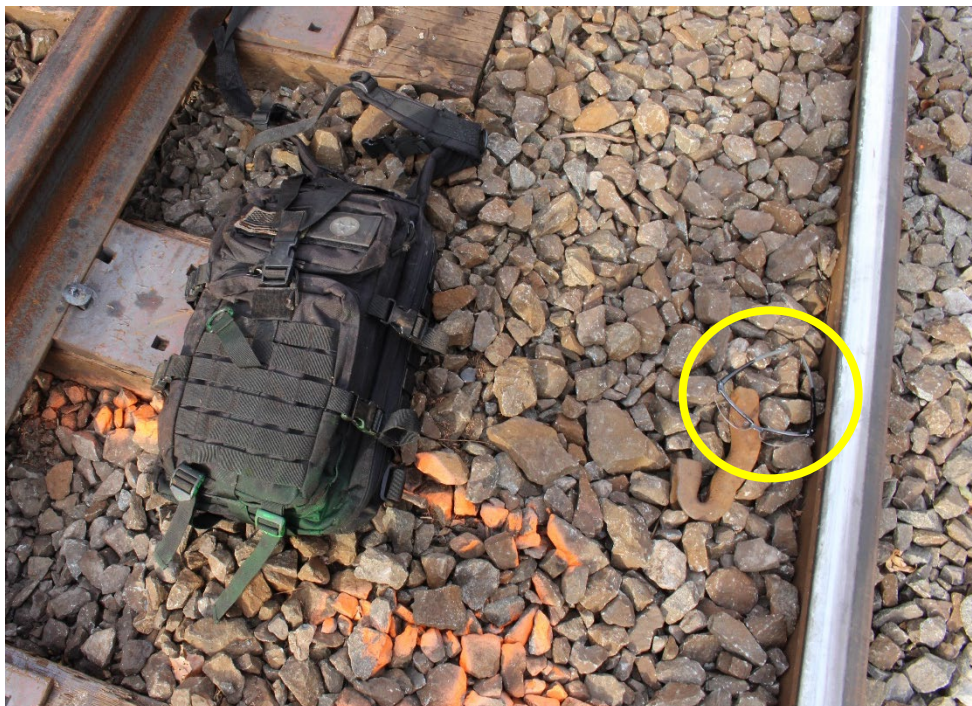
Figure 10 Photograph of the worker's personal effects found on the scene, to include the black backpack he was wearing at the time of the accident and a pair of safety glasses (highlighted by the yellow circle)

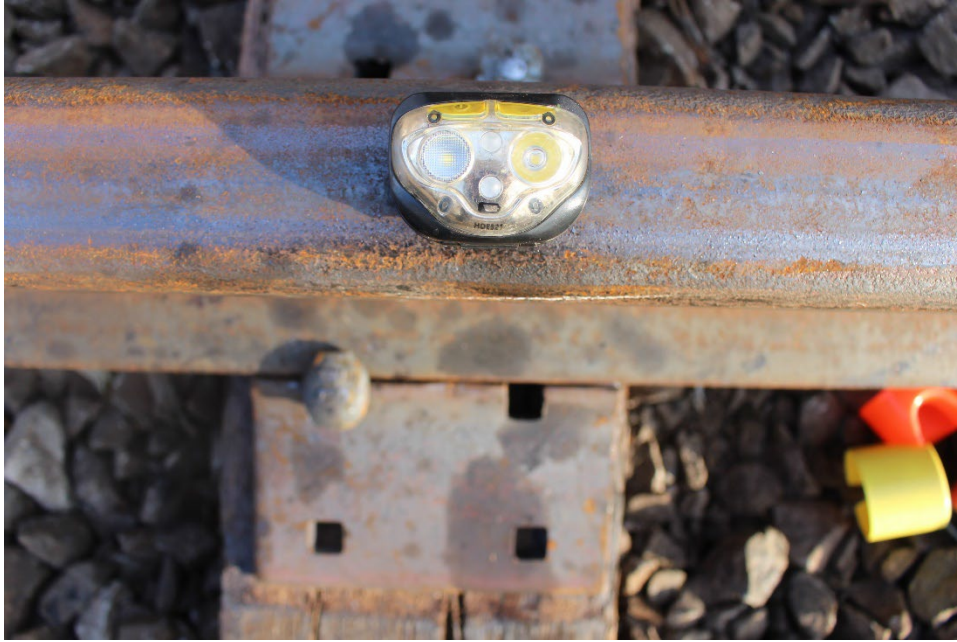
Figure 11 Closeup of the worker's hardhat light found on the scene. Post-accident, the light was still functional.

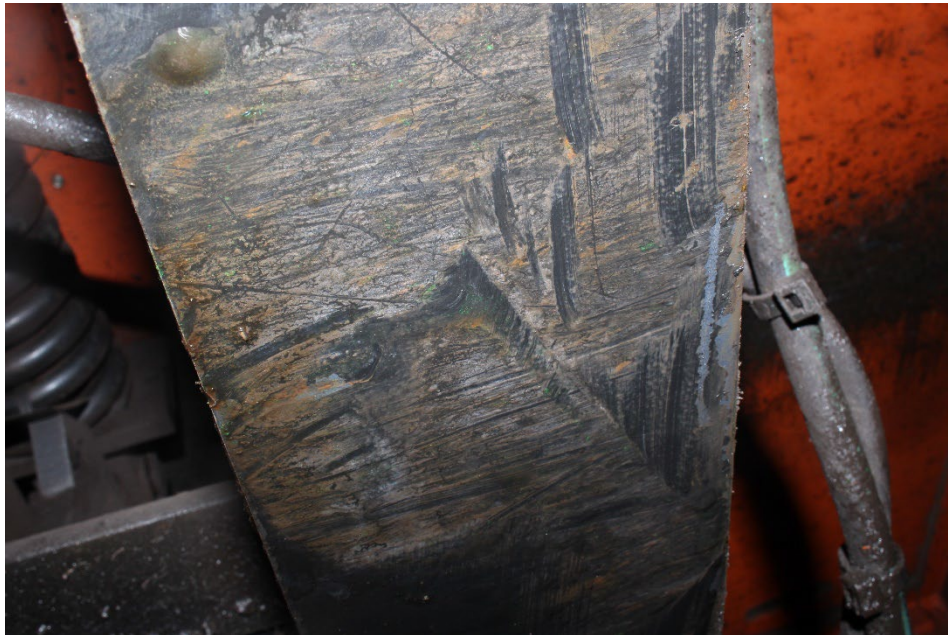
Figure 12 Photograph taken of the undercarriage of the spike machine showing the worker contact with the metal frame as he traveled underneath.

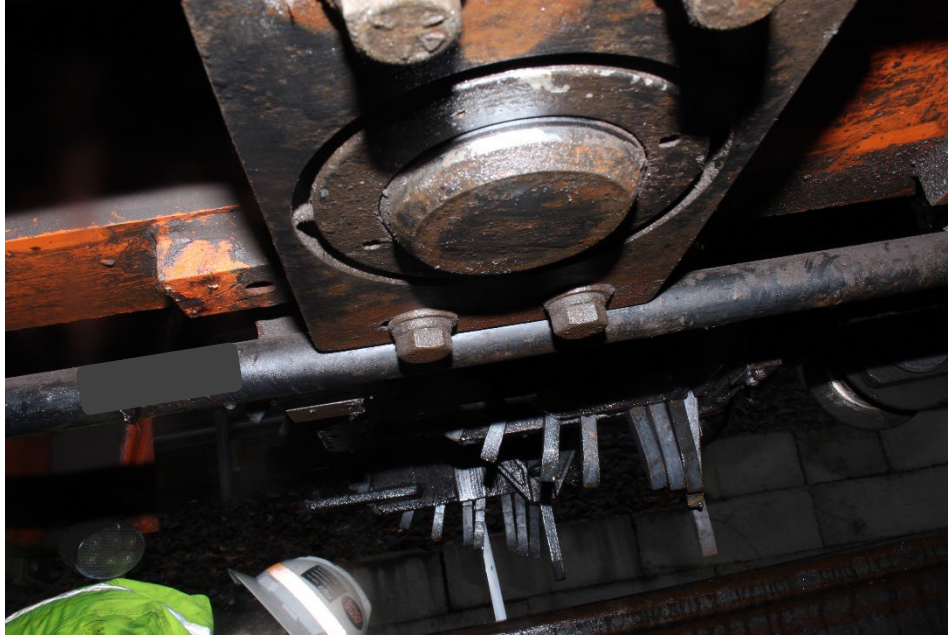
Figure 13 Photograph taken from underneath the spike machine, looking towards the left side of the equipment, showing the final rest position of the worker under the equipment. The spike feeder belt is visible in the background.

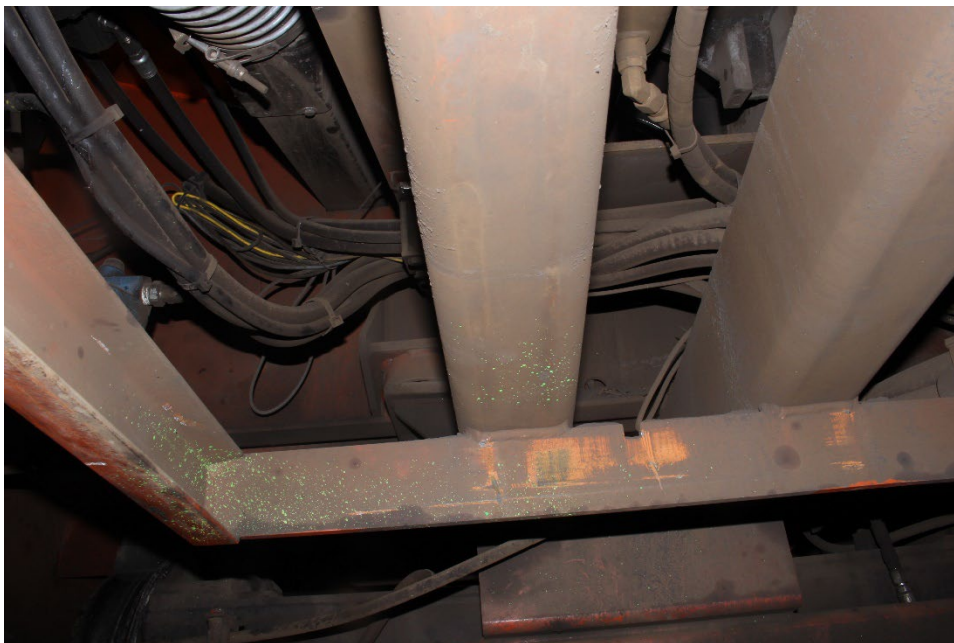
Figure 14 Photograph of the undercarriage of Spiker #2 showing the paint spray on the under frame caused by the exploding can of paint at the time of impact.

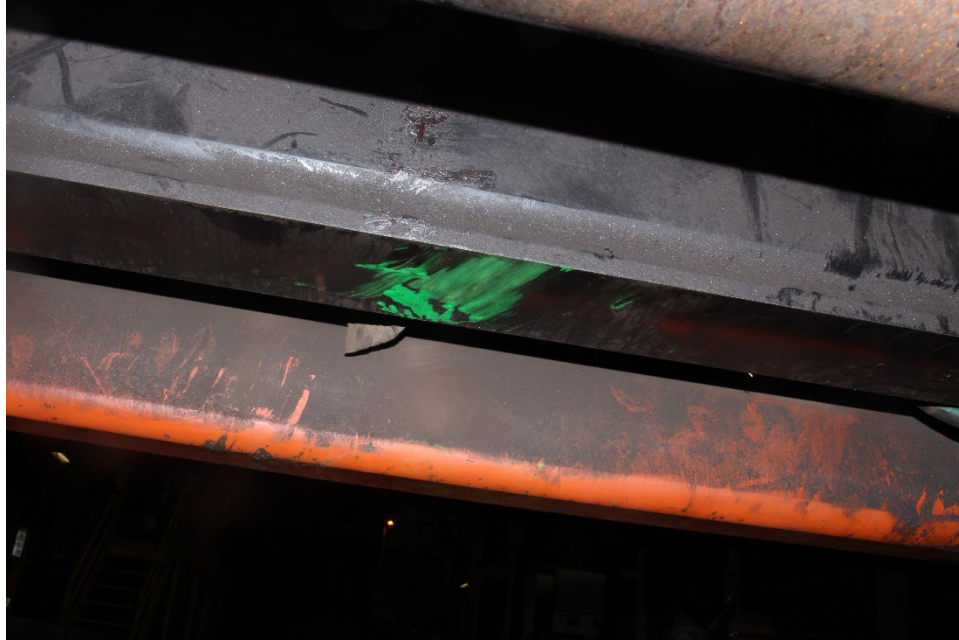
Figure 15 Photograph of the green paint smeared on the metal frame, transferred from the worker's paint covered backpack.

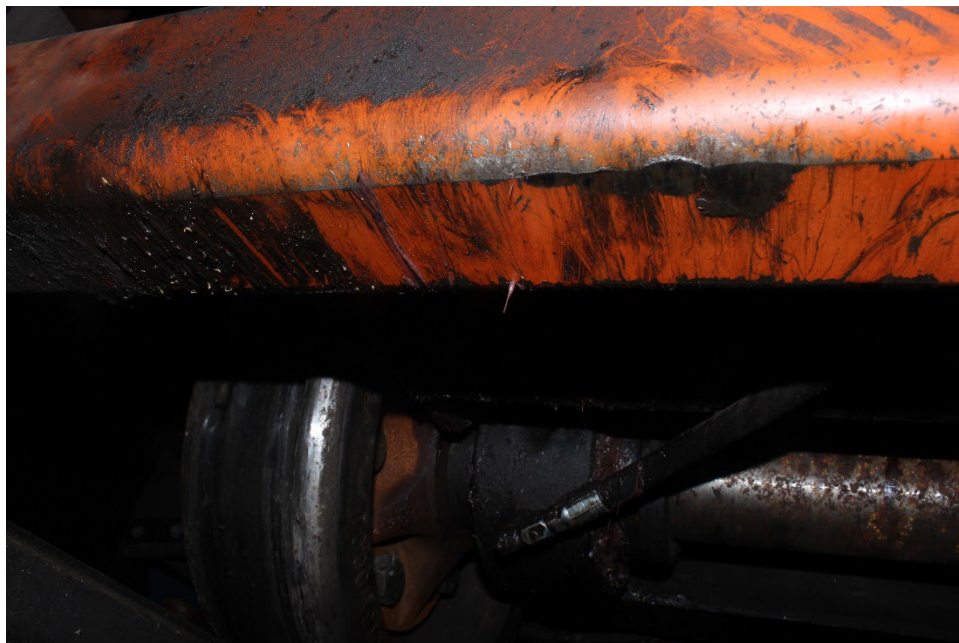
Figure 16 Evidence of the workers presence underneath the equipment which also shows directionality of the worker's body movements during the impact.

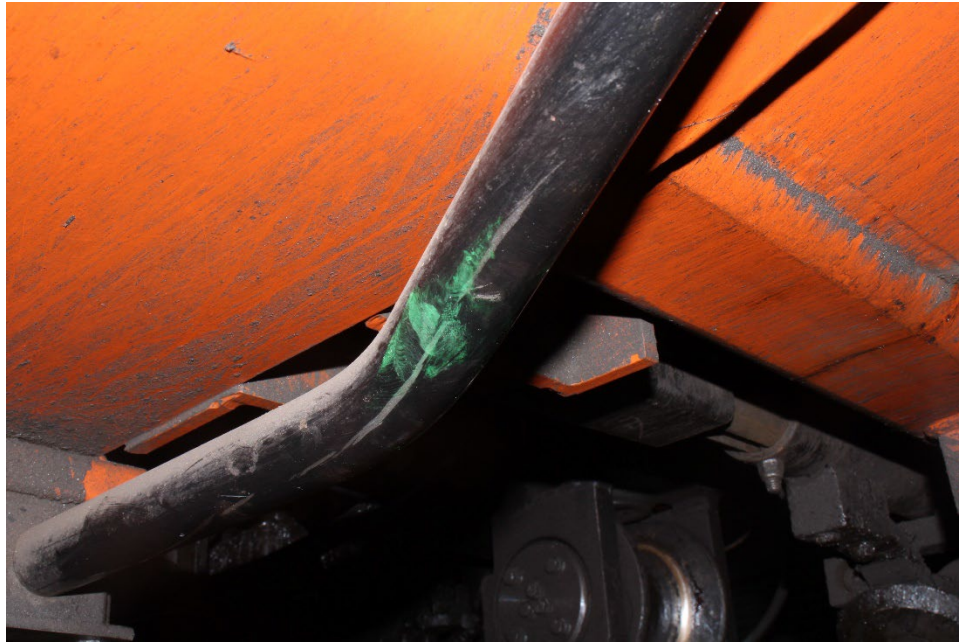
Figure 17 Photograph of more paint transfer from the worker's backpack to the undercarriage of the spike machine.

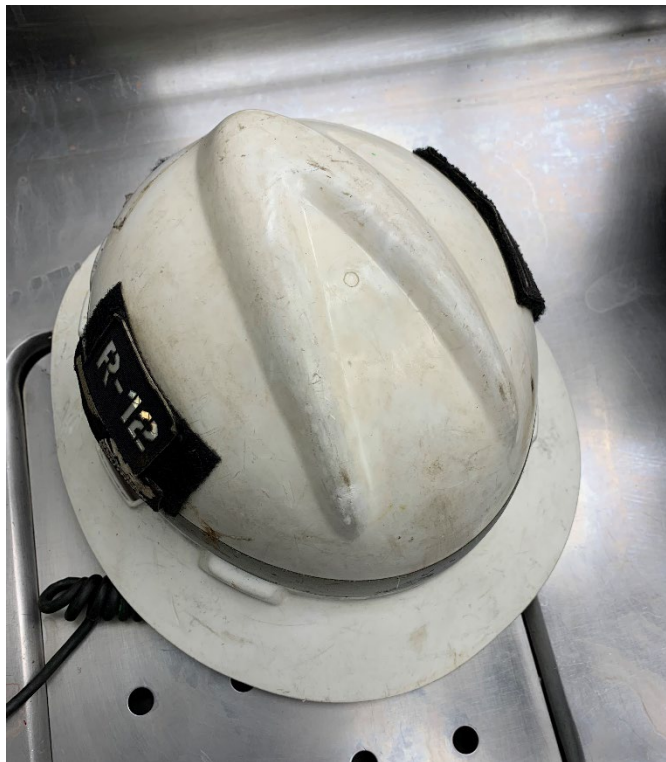
Figure 18 Photograph of the hardhat worn by the worker at the time of the accident. The hardhat was not issued equipment by National Salvage but still met regulatory requirements.

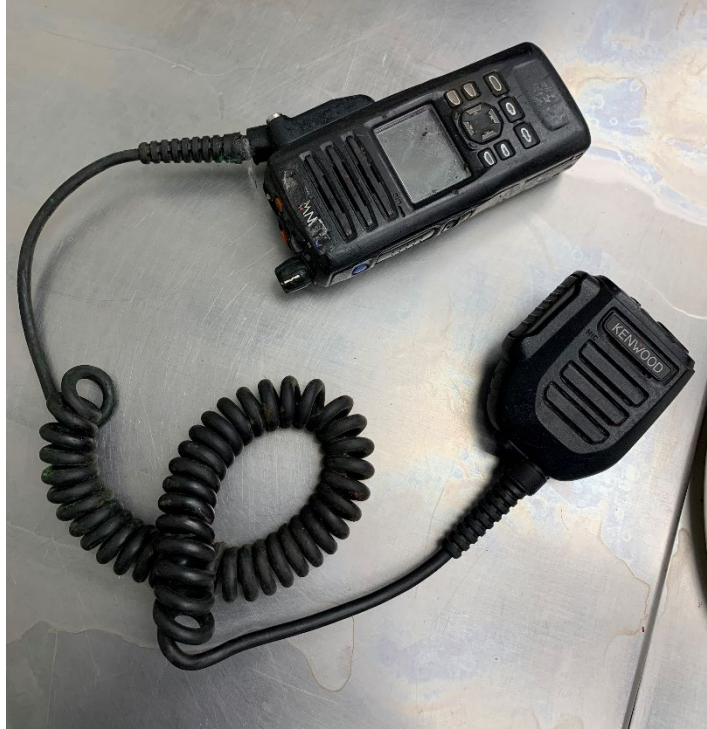
Figure 19 Photograph of radio worn by worker and recovered at the coroner's office.

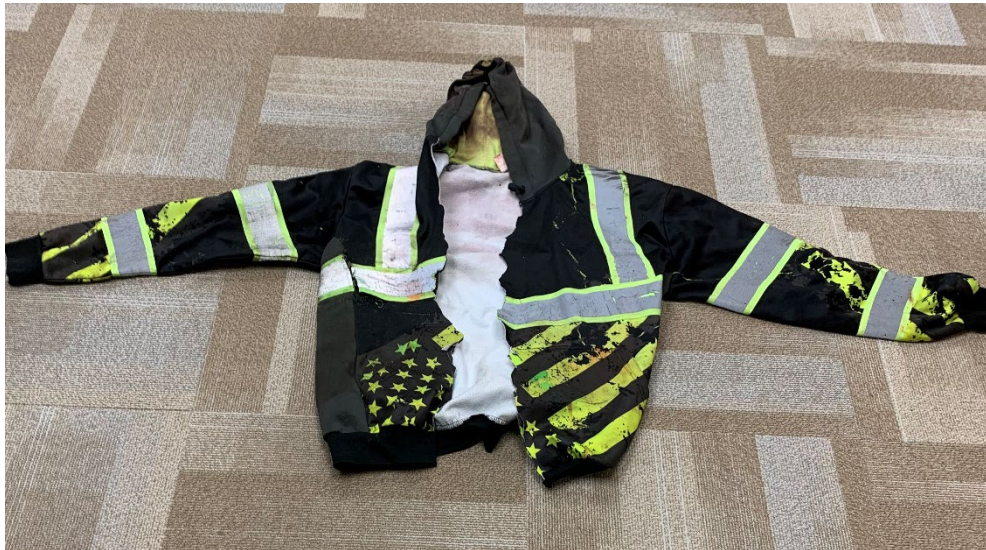
Figure 20 Photograph of the outer hooded jacket worn by the worker at the time of the accident.

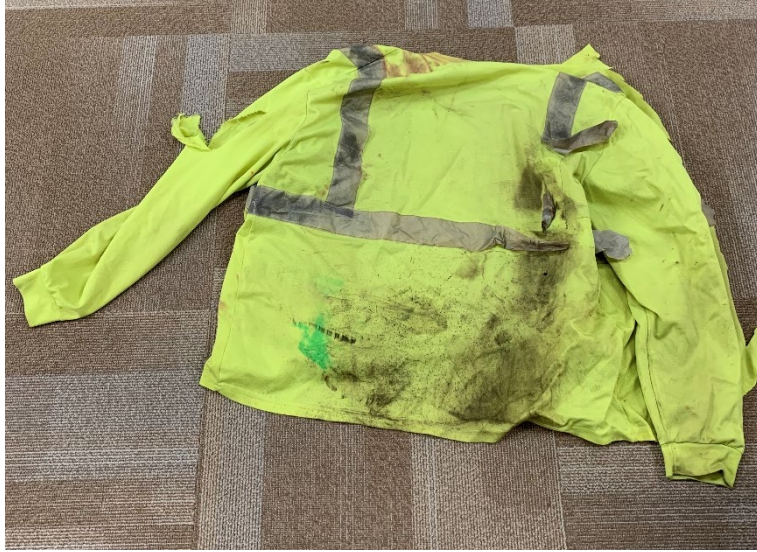
Figure 21 Photograph of the interior shirt worn by the worker. The shirt conforms to the ANSI Class 2 standard.

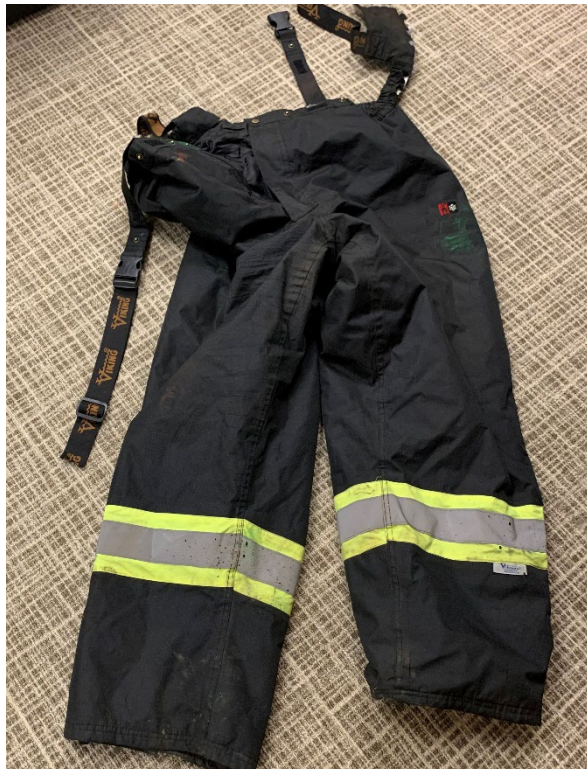
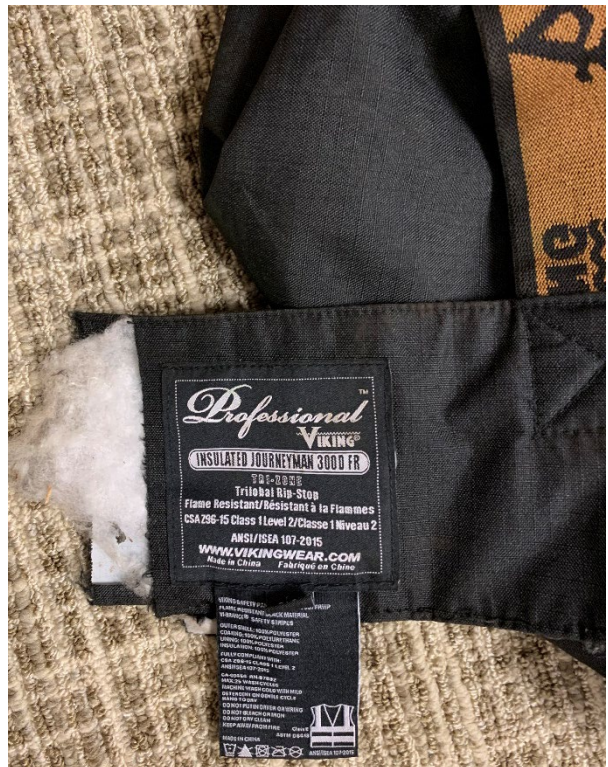
Figure 22 Photograph of insulated coveralls worn by worker at the time of the accident. **Figure 23** is a photograph of the manufacturer's label showing that the garment conforms to ANSI Class 1 standards.

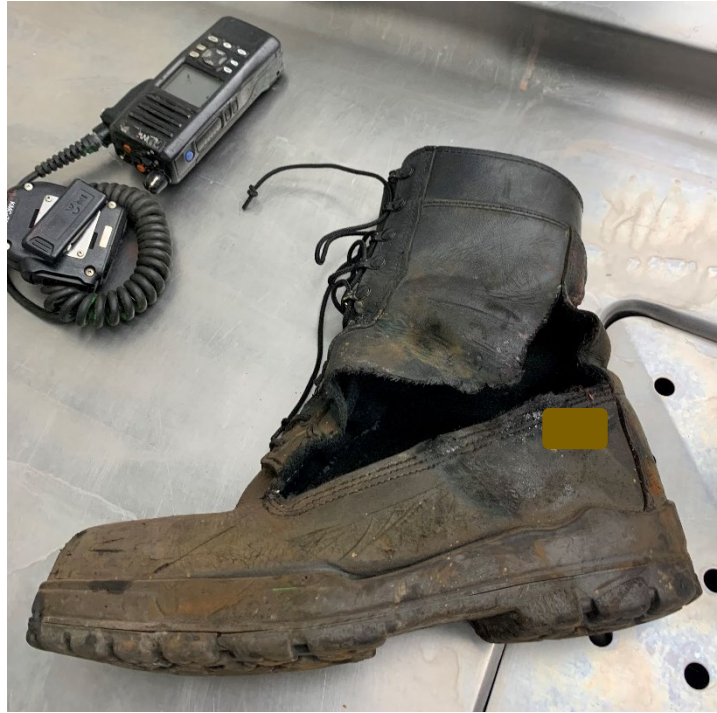
Figure 24 Photograph of left work boot recovered from the worker at the coroner's office.
