National Transportation Safety Board

ERA22LA145

LANDING DOLLY FACTUAL REPORT

Location: Abingdon, Virginia
Date: March 6, 2022
Time: 2359 local
Airplane: Eurocopter Deutschland GMBH MBB-BK-117 C-2 (N29VA)

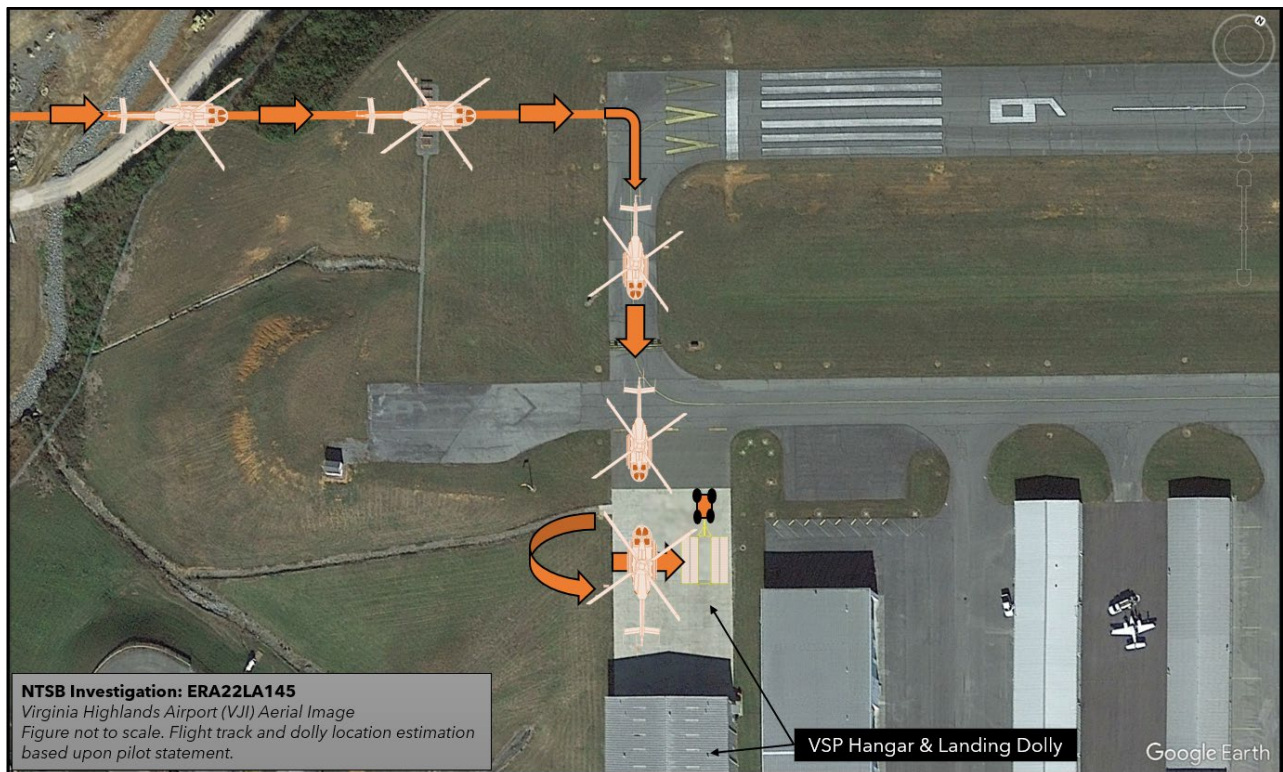
Figure 1: Flight track to landing recreated based upon pilot statement.

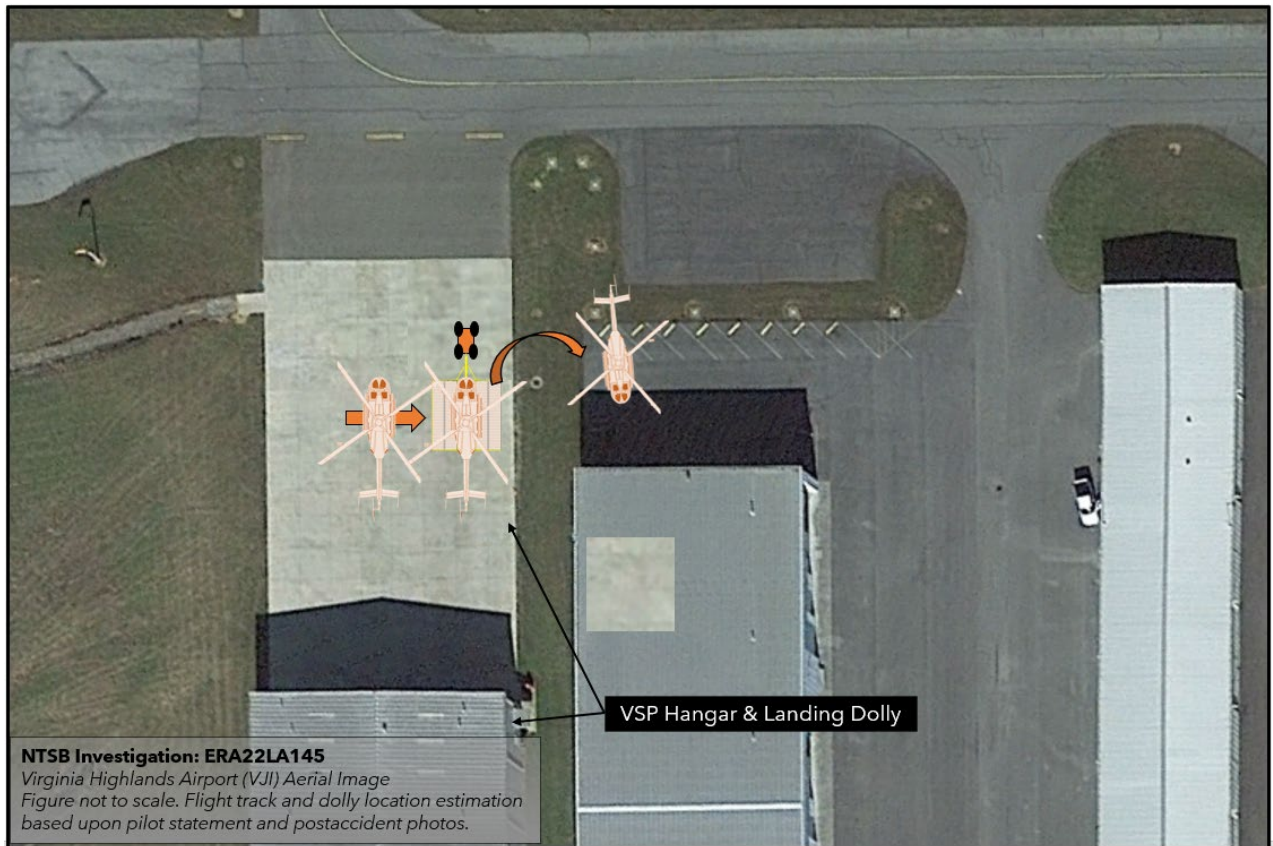
Figure 2: Estimated flight path over the dolly and final resting location of the helicopter based upon the pilot's statement.

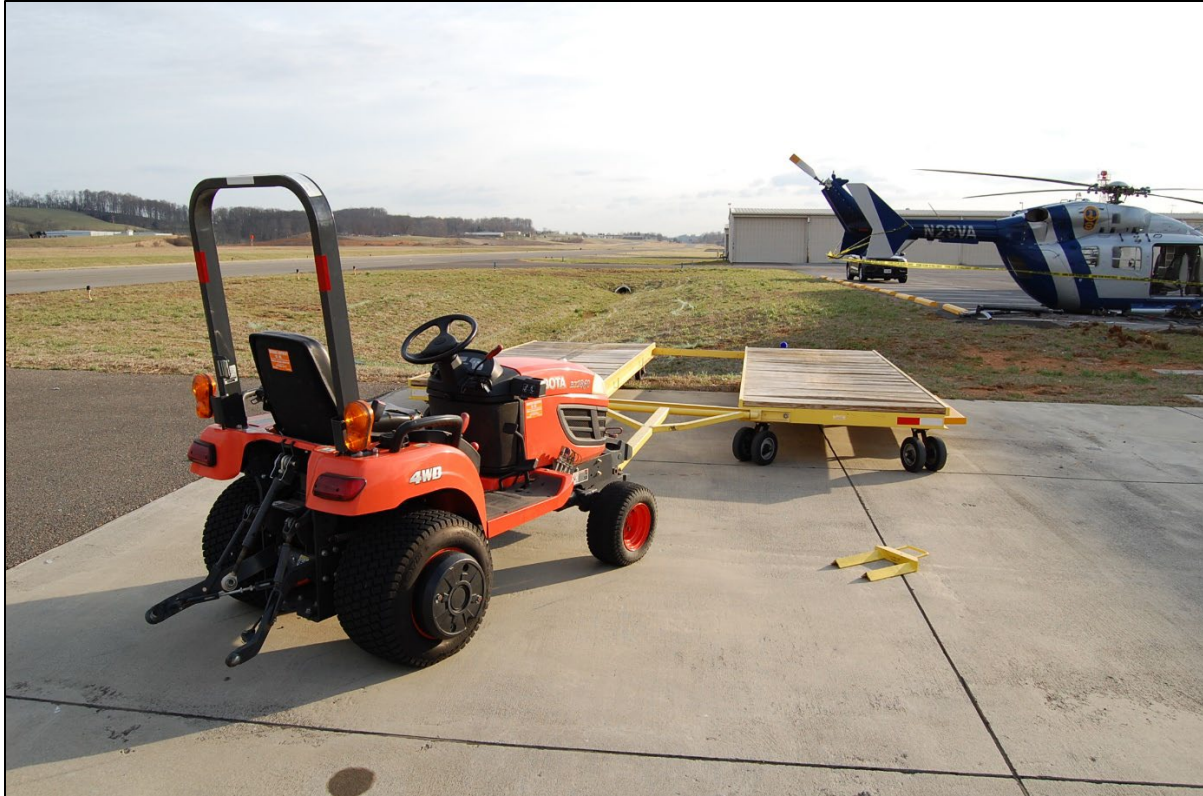
Photographs taken the morning after the accident showed that the helicopter had come to rest in the parking lot to the east of the VSP ramp. The dolly and tractor, which had been oriented on a general north-south direction aligned with the ramp pavement, was dragged by the helicopter partially off the ramp and reoriented facing northeast/ southeast. Figures 5 and 6 show where the helicopter came to rest and the location of where the dolly had been dragged and reoriented to.

Figure 5: View of the helicopter and dolly the morning after the accident (Photo Courtesy Virginia State Police)

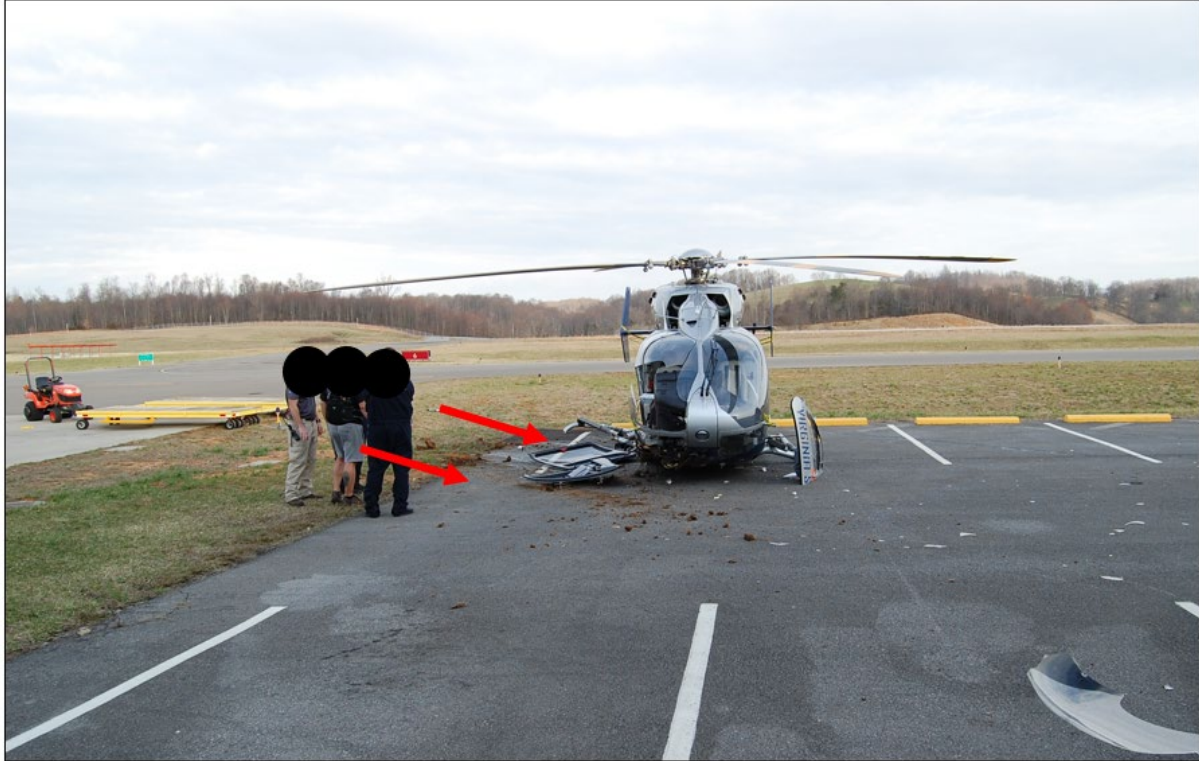
Figure 6: View of the helicopter and dolly the morning after the accident (Photo Courtesy Virginia State Police)

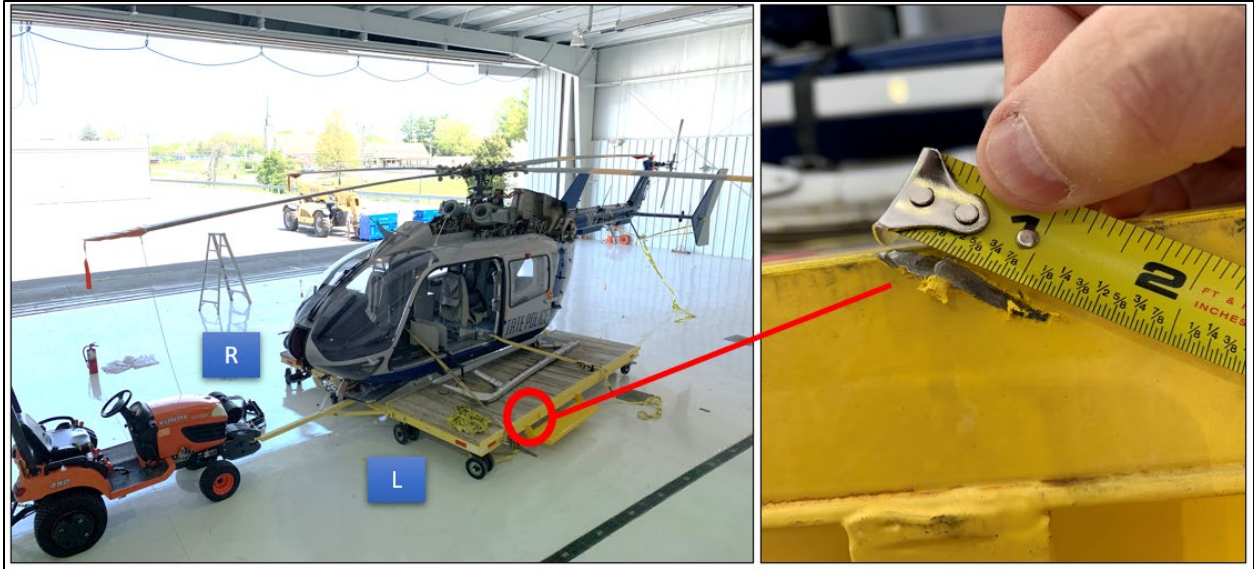
Figure 7: Overview of dolly damage and witness marks.

As shown in Figure 7, a witness mark was observed 48 inches from the front of the dolly platform. The mark was measured to be about 1 and ¼ inches at a 32° angle.

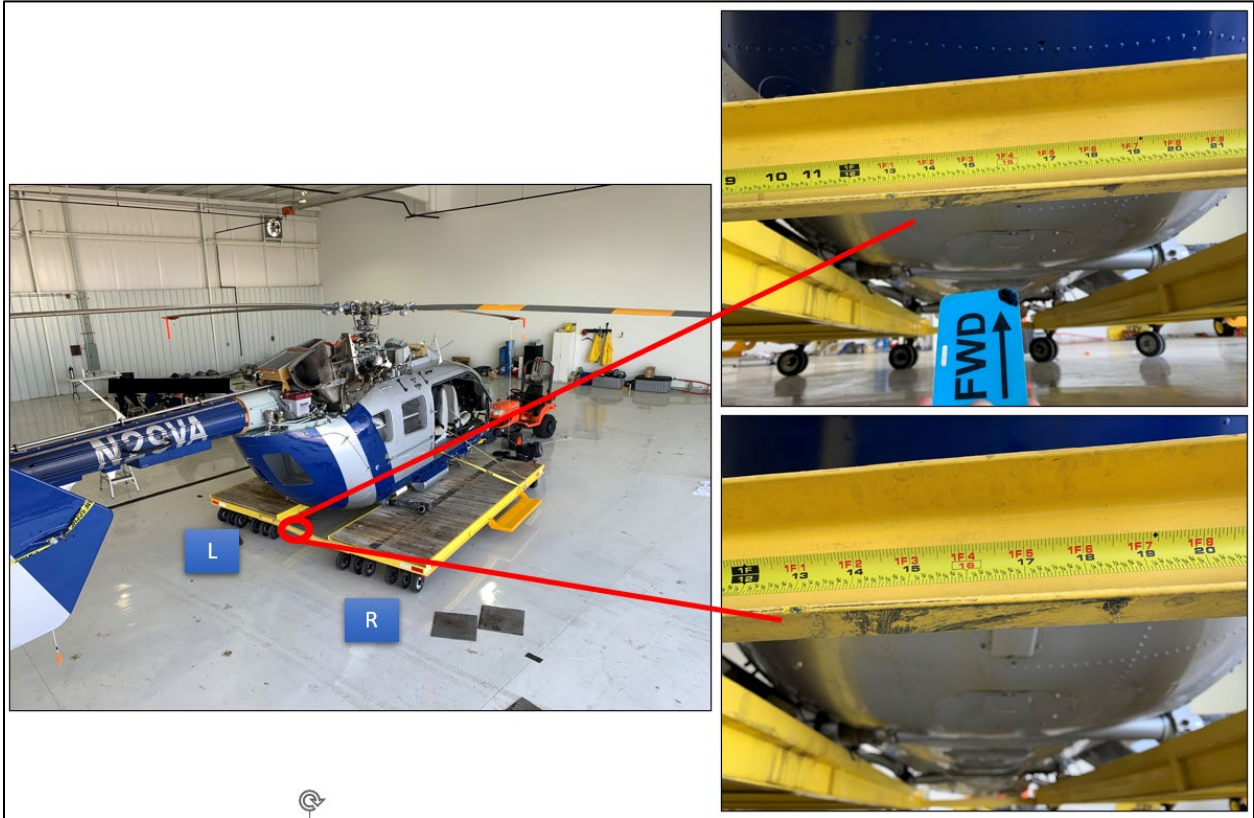
Figure 8: Overview of dolly damage and witness marks.

As shown in Figure 8, on the rear center crossbar underside, black scuffing and scars were observed. The crossbar also exhibited bending and deformation.

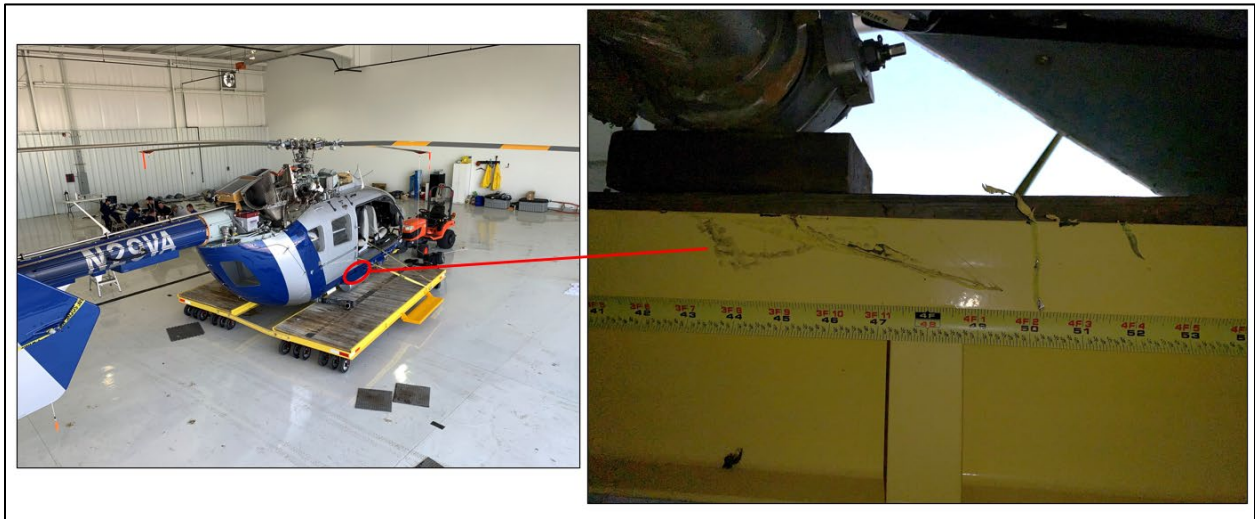
Figure 9: Overview of dolly damage and witness marks.

As viewed in Figure 9, the right inboard section of the dolly, 43-52 inches rearward from the front of the dolly exhibited black scuffing and witness marks.

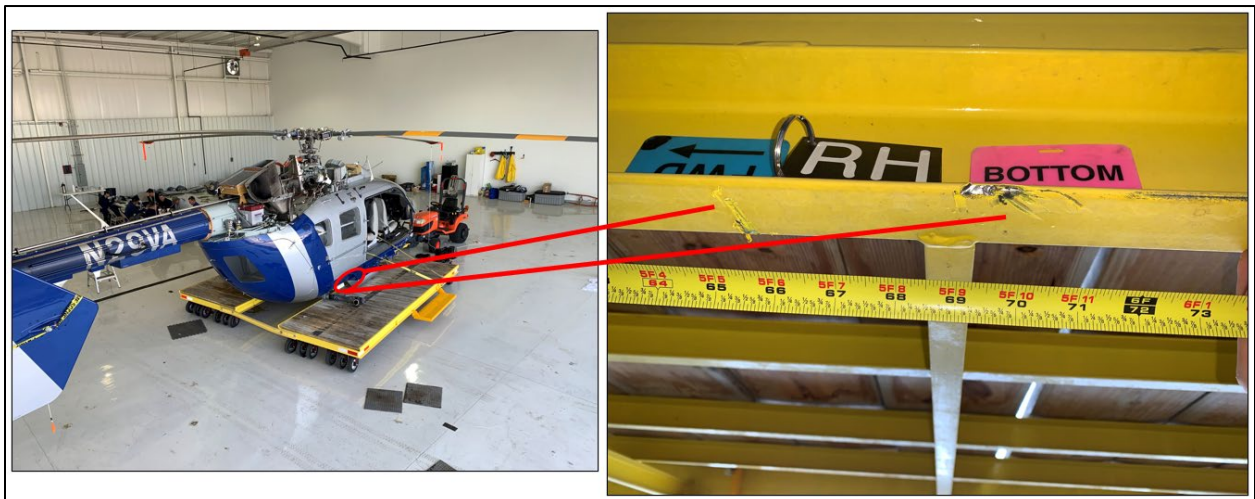
Figure 10: Overview of dolly damage and witness marks.

As viewed in Figure 10, on the right inboard bottom section of the dolly, from the front of the dolly 65-71 inches rearward, witness marks, gouging, and paint transfer was observed. Additional areas of yellow paint peeling were observed on this inboard right side of the dolly.

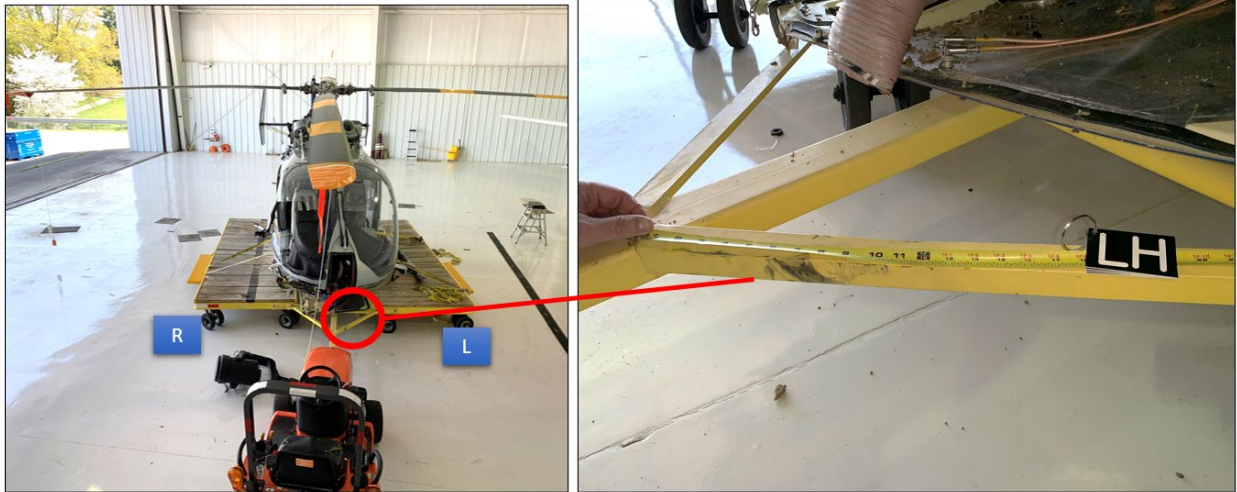
Figure 11: Overview of dolly damage and witness marks.

As viewed in Figure 11, on the forward left brace of the dolly, an area of black scuffing and gouging was observed.

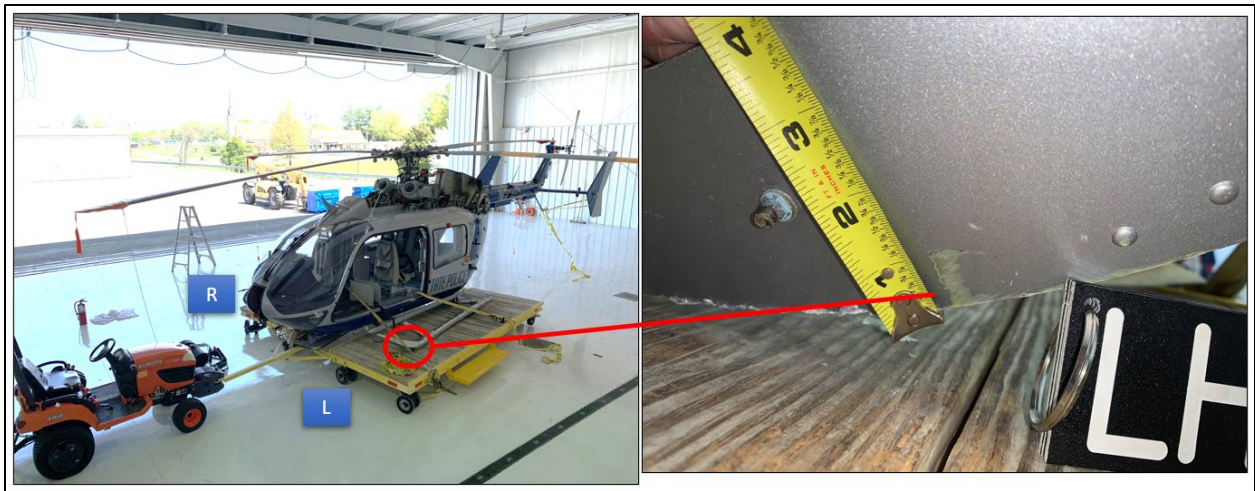
Figure 12: Overview of helicopter skid and dolly related witness marks.

As viewed in Figure 12, a 1-inch yellow paint transfer witness mark and additional yellow paint transfer was observed 22 inches from the tip of the left skid on its inboard and bottom areas.

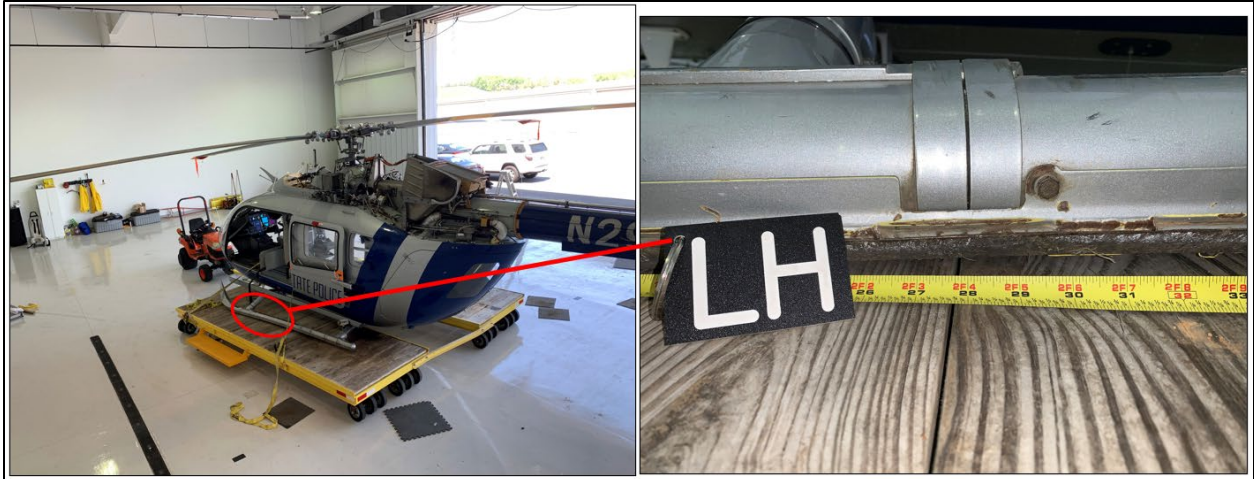
Figure 13: Overview of helicopter skid and dolly related witness marks.

As viewed in Figure 13, circled in red on the helicopter’s bottom left skid, yellow stripping of paint remnants was observed.

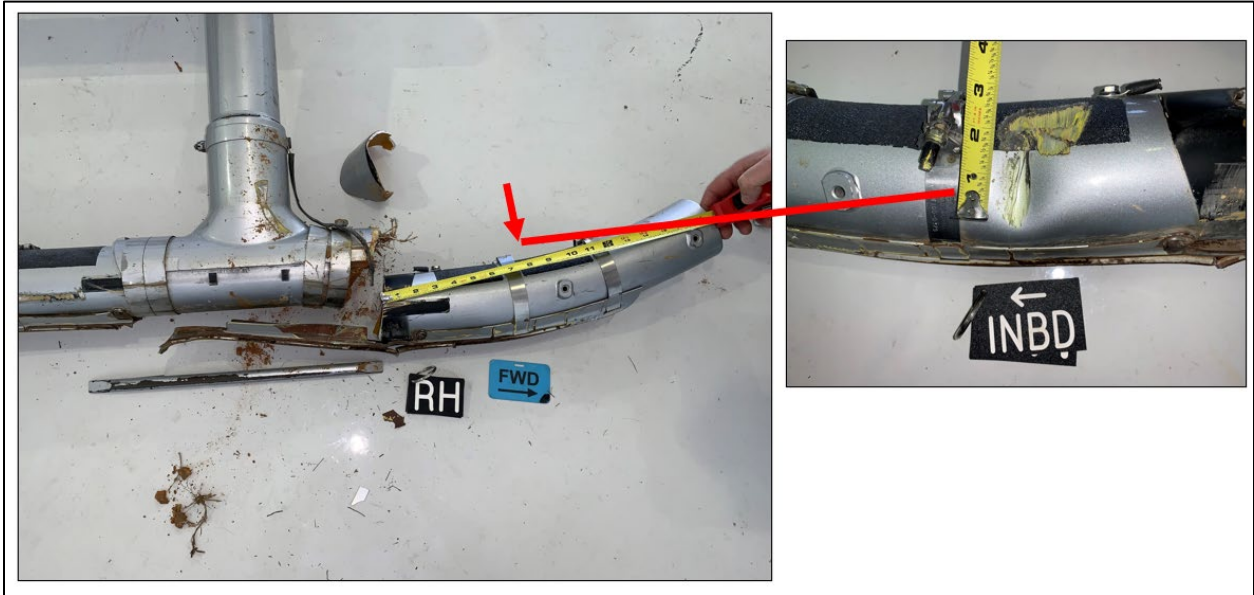
Figure 14: Overview of helicopter skid and dolly related witness marks.

As viewed in Figure 14, an 18-inch forward section of the right skid tubing had separated and peeled from the rest of the skid. The inboard section of the separated portion displayed denting deformation and yellow paint transfer. The clamps in this area exhibited paint transfer as well.

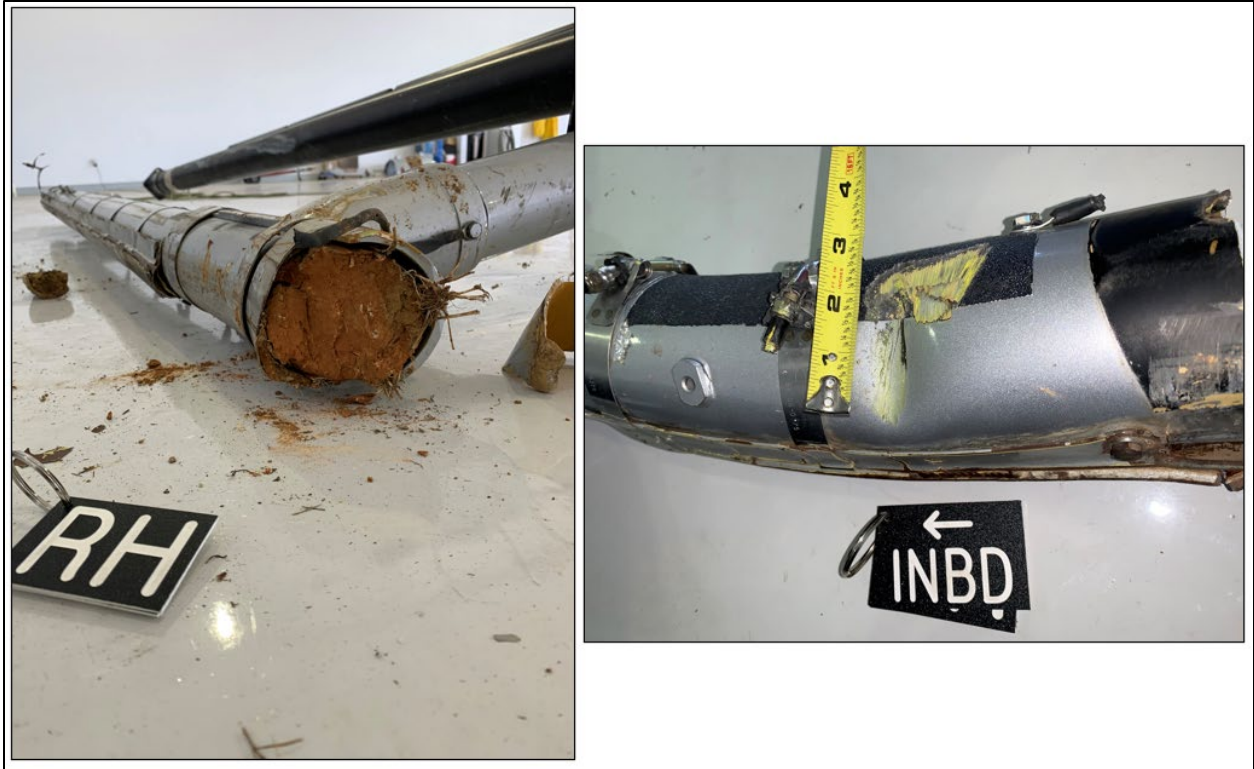
Figure 15: Overview of helicopter skid and dolly related witness marks.

As viewed in Figure 15, the forward area of the right skid exhibited caked/packed mudding. The separated piece was largely free of mud. The figure also provides an additional view of the inboard right skid area exhibiting denting and yellow paint transfer.

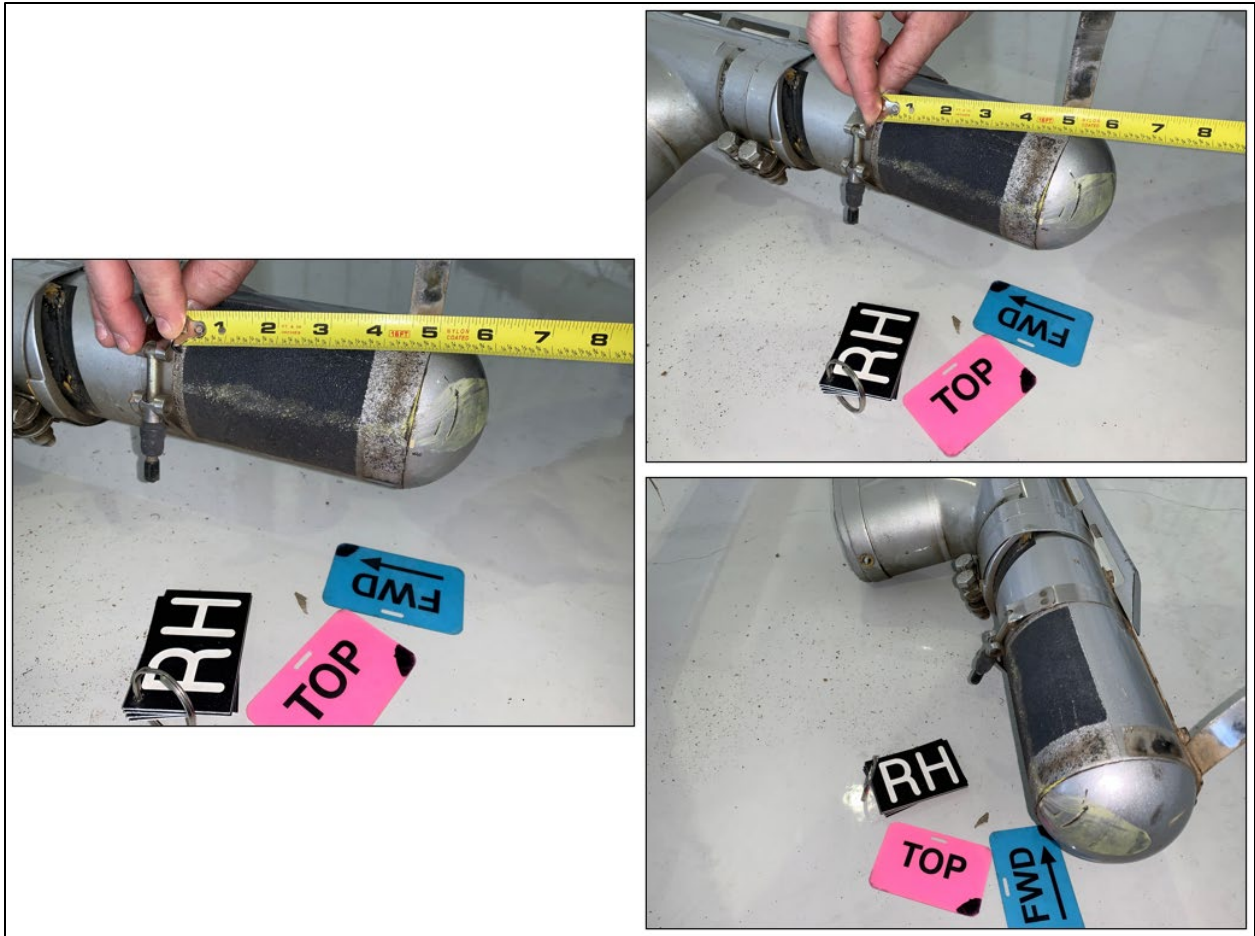
Figure 16: Overview of helicopter skid and dolly related witness marks.

As viewed in Figure 16, the most rearward portion of the right skid exhibited yellow paint transfer and scuffing on the top of the skid and its end cap area.

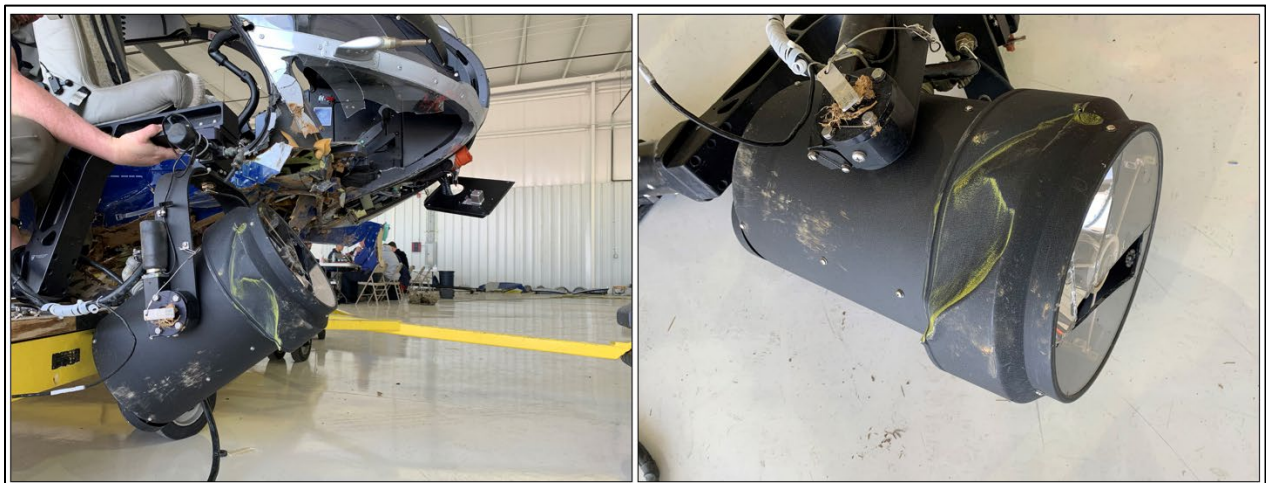
Figure 17: Overview of helicopter's police spotlight and dolly related witness marks.

As viewed in Figure 17, the spotlight exhibited denting and yellow paint transfer on the right outboard forward area casing.

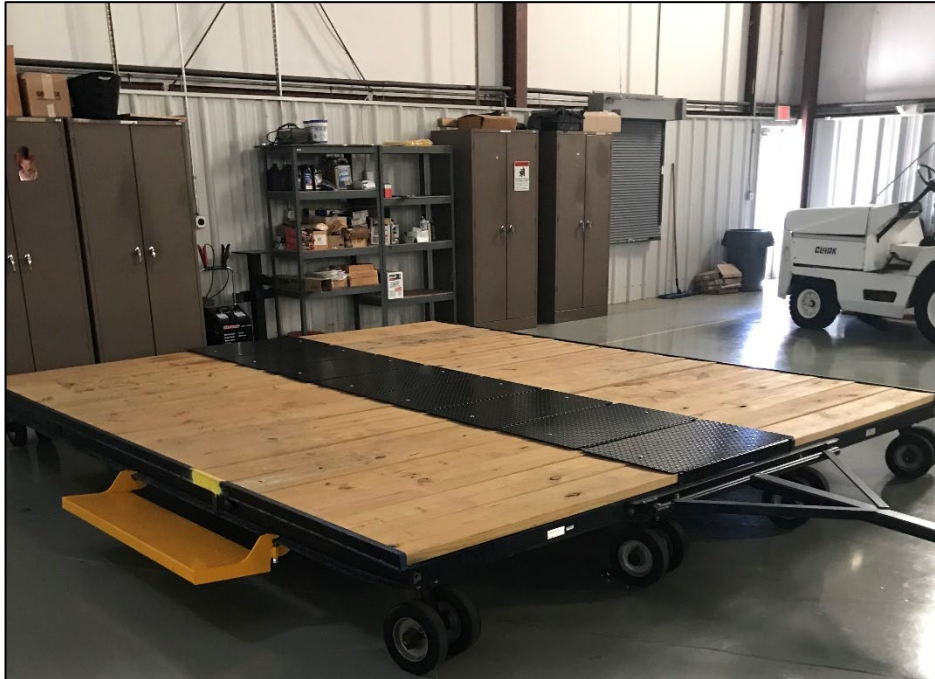
Figure 18: View of the replacement dolly utilized by Virginia State Police

Following the accident, the VSP provided photographs of the landing dolly that had replaced the accident landing dolly. The new dolly was similar in size to the accident dolly; however, the new dolly contained a metal center plate.
