**Group Chairman Factual Report**

**NATIONAL TRANSPORTATION SAFETY BOARD**

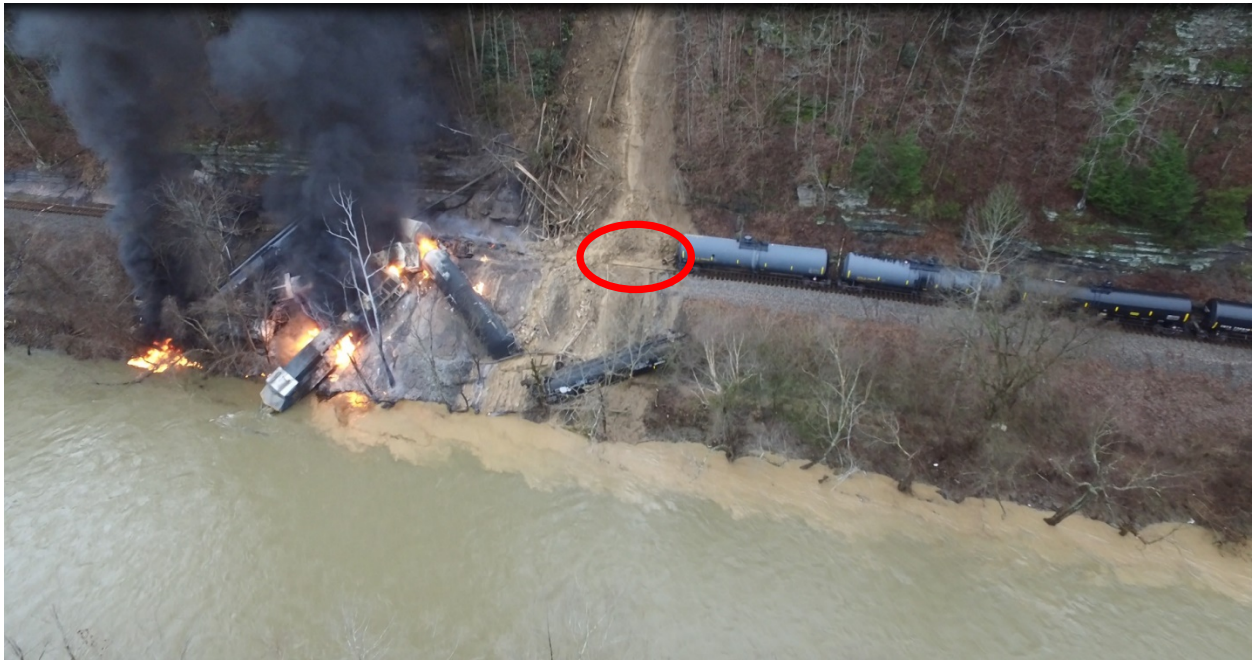
Figure 3. This is view looking at the mud slide and resting position of the equipment about one hour after the event. Notice the red circle outlining the depression in the slide portion covering the track.

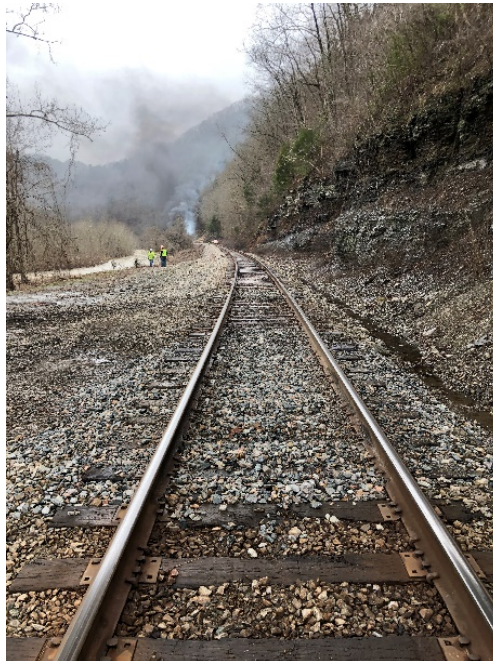
Figure 4. View looking at track structure and approach the accident train traverse prior to collision with the obstruction. (source: FRA Inspector—taken on 2/13/20)
