Accident Investigation
Aero Commander 500B
National Transportation Safety Board

This document provides the investigation report for Tank Unit Part Number EA515B-1404M, being returned to Collins Aerospace as part of an accident investigation. This Tank Unit was equipped on the Aero Commander 500B which had a flight accident on January 28, 2023.

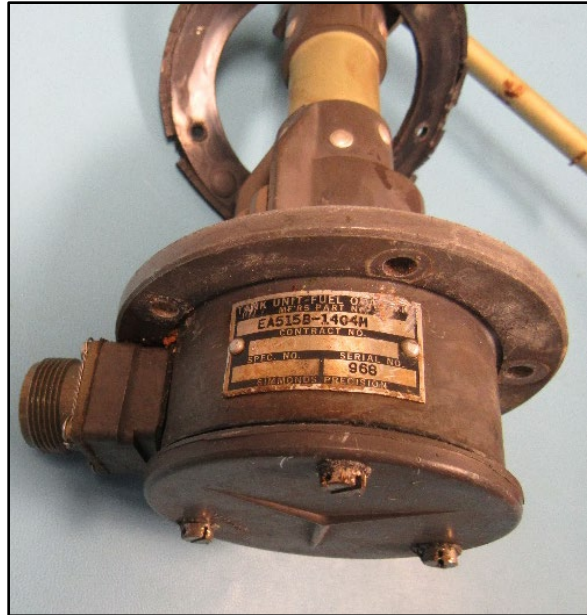
Figure 1: Nameplate

The nameplate is attached and legible however does exhibit some scratch marks. See Figure 1.

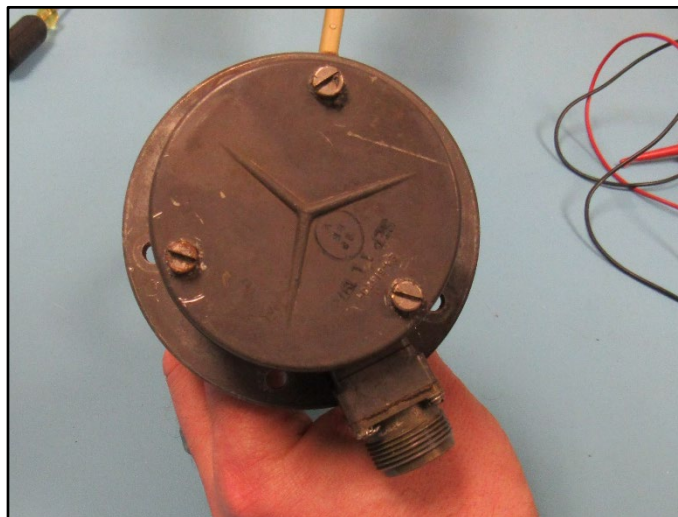
Figure 2: Housing Cover

Several small scratches on the housing cover. See Figure 2.

Lock wire on top of the housing had been removed. Lock wire screws do appear to be original and secure. See Figure 2. The lock wire used to secure the connector screws is intact and secure. See Figure 3.

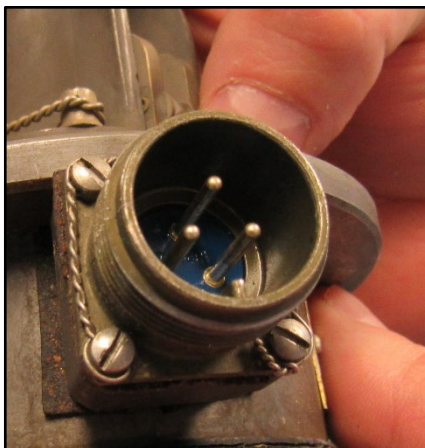
Figure 3: Connector

- Test equipment used was a Fluke Model 179 Digital Multimeter, calibrated on 6/17/2022.
- Float arm assembly moved throughout its range freely without any binding. There was a small amount of drag consistent with the wiper dragging on the resistive element inside the housing.
- Pins A and B are the ends of the resistor element inside the housing. The result of the resistance test is acceptable at 195.6 Ohms.
- When monitoring the resistance value along the sweep of the wiper, the resistance measurement started at 196.7 Ohms (full) and ended at 23.4 Ohms (empty). These values align with what is expected of a functioning fuel transmitter.
- The wiper maintained contact with the resistive element throughout the sweep and did not exhibit any voids or null spots throughout the sweep.
- There are no signs of damage to the connector or pins. See Figure 3.

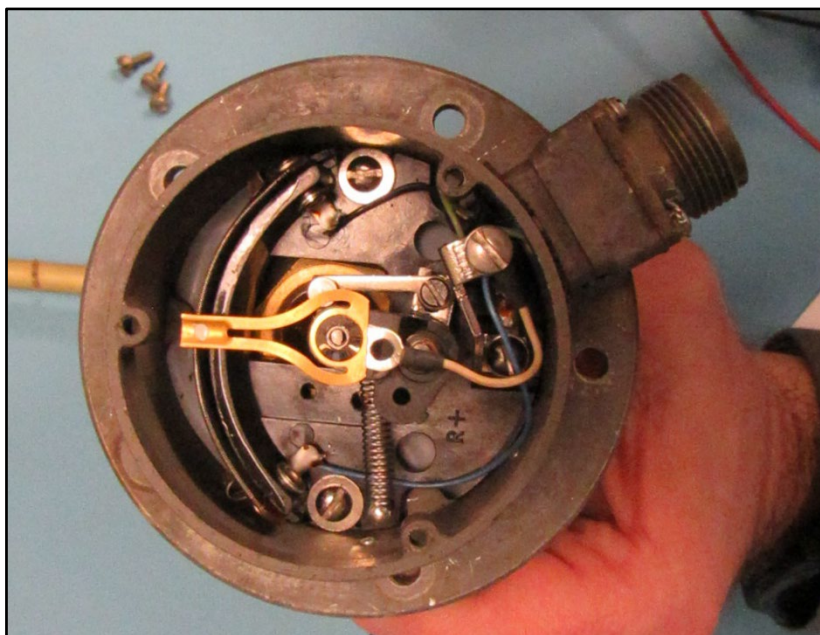
Figure 4: Wiper Assembly

- **Cover:** The 3 screws securing the cover were tight and no damage to screw heads or threads was observed.
- **Inspect housing cover seal:** Seal around the inside of the cover is intact with no signs of damage or leaking.
- **Structural damage to electrical component:** No visual signs of structural damage to the wires or resistor element inside the housing. See Figure 4.
- **Structural damage to mechanical components:** No visual signs of damage to the wiper or any other mechanical components inside the housing. See Figure 4.

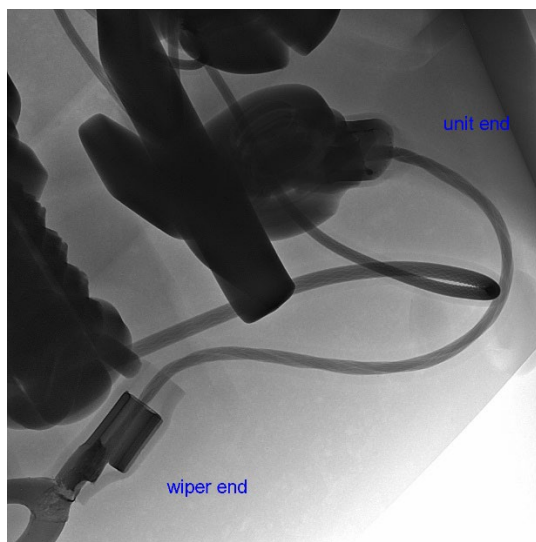
Figure 5: Wiper Wire

- The unit was X-rayed in the Collins Failure Analysis Lab using a Nikon XT V 160 with maximum voltage of 160 kV at 20 W.
- The X ray images showed that there are no broken wires or other anomalies that would cause an intermittent or complete loss of electrical connectivity. See figure 5 for X-ray of the wiper wire.

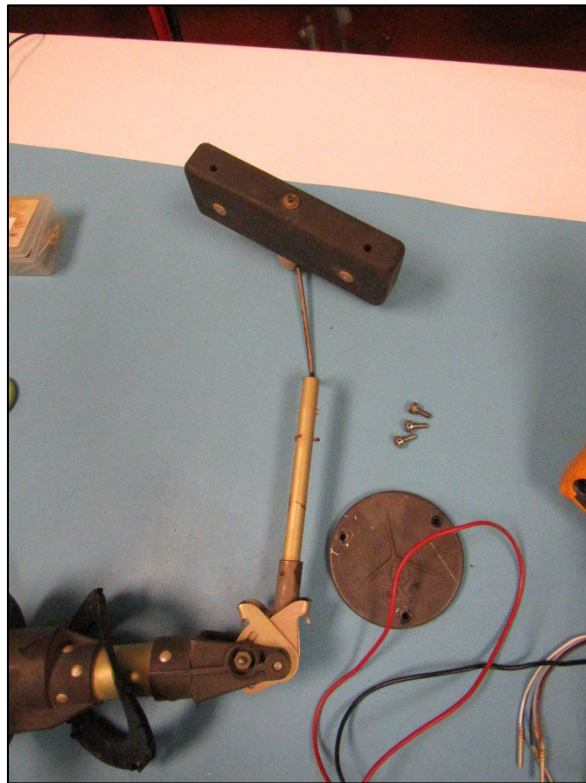
- **Float arm assembly**

No physical damage to the tank unit or connector seals. The tank unit float arm does appear to be slightly bent between the mid-point and float assembly.
