NATIONAL TRANSPORTATION SAFETY BOARD
Office of Aviation Safety
Washington, D.C. 20594

POWERPLANT GROUP CHAIRMAN'S FACTUAL REPORT

NTSB No. ENG18IA003

Location: Seattle, Washington
Date: November 7, 2017
Time: Approximately 2102 Pacific Daylight Time
Aircraft: Airbus A330-200, Registration N375HA
Operator: Hawaiian Airlines

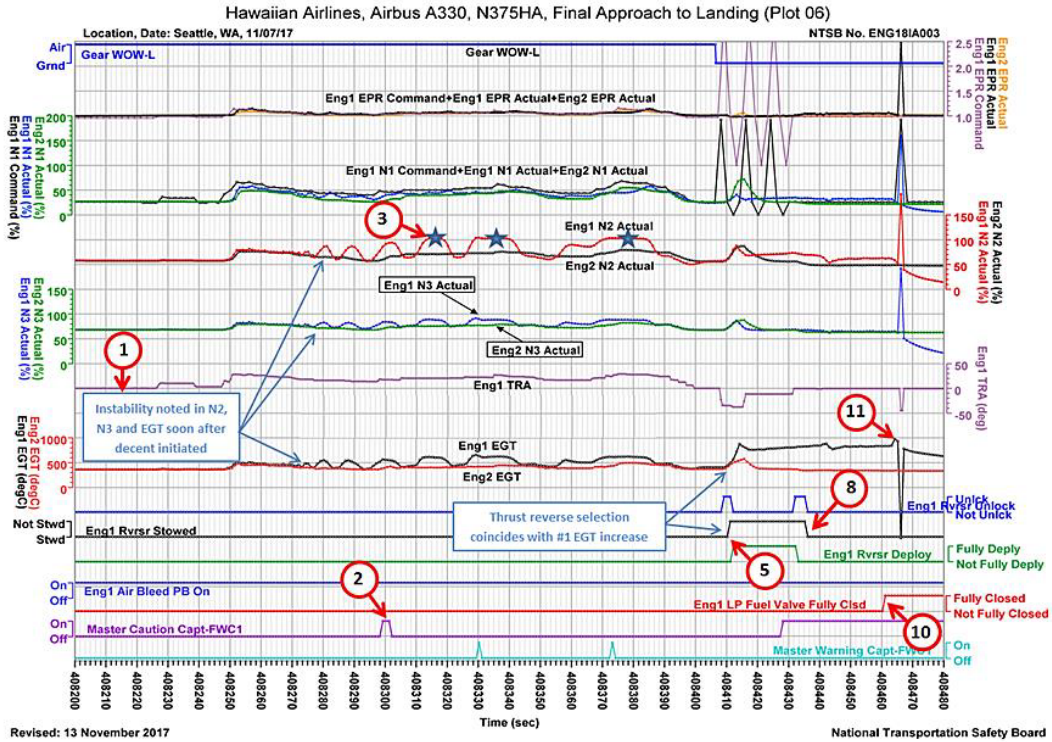
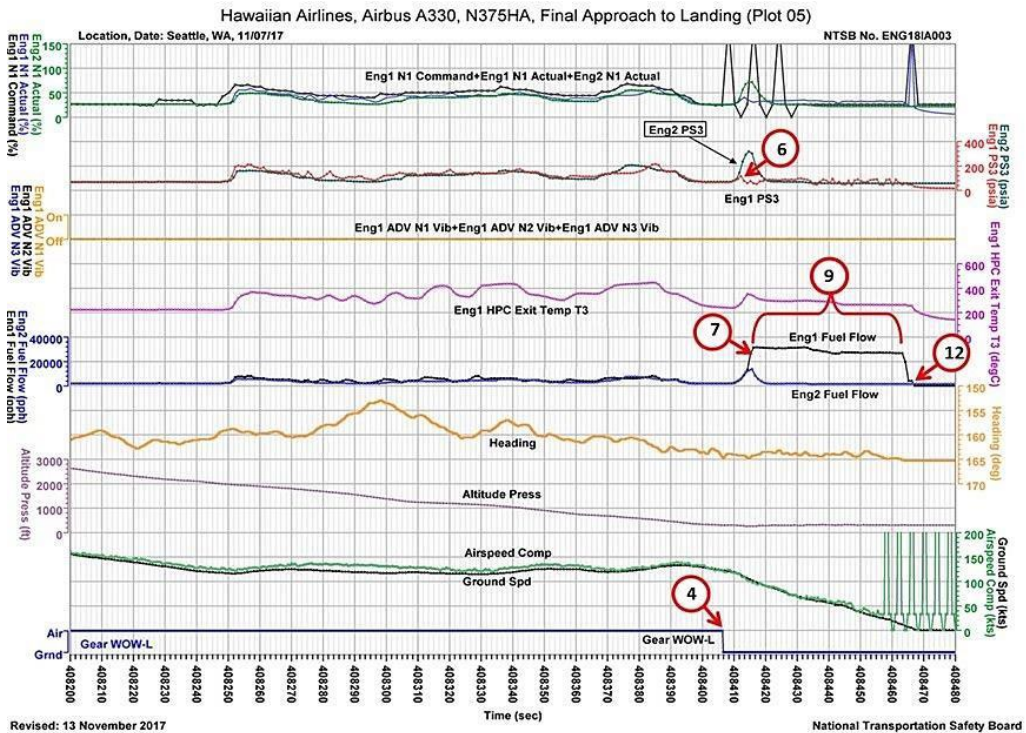
Figure 2 - DFDR Engine Parameter Plot of Event

The DFDR was sent to the NTSB recorder laboratory where it was downloaded and the plot on [Figure 2](#) & [Figure 3](#) prepared. A review of the significant occurrences was noted and highlighted on the plot and descriptions of the occurrences were made on [Figure 2](#) & [Figure 3](#).

Reference No. on Figure 2 & Figure 3	Condition	Comment	Time
1	Engine instability evident in N2, N3 and EGT	Instability appears to be cyclic	
2	ENG CTL SYS FAULT with VSV SYSTEM / VSV CONTROL UNIT messages set	VSV position difficult to achieve, aircraft ECAM message inhibited on final approach	
3	VSV actual and demanded positions disagree during descent	3 times N2 overspeed alerts with VSV becoming increasingly sluggish	05:01:15
4	Aircraft landed	Engine power to idle	05:01:48
5	Full reverse thrust selected; Engine EEC controlling in N1 mode, VSV's no response	Fuel flow rises to approx. 32K pounds per hour (pph) (maximum) in an attempt to achieve demanded N1	05:01:51
6	N3/P30 mismatch due to high fuel flow and slow N3 speed	P30 pipe failure set – Surge detection function inhibited	05:01:56
7	Core engine surges	P30 drops	
8	Reverse thrust cancelled. Engine EEC transfers control from N1 to N3 mode	N3 actual 67% and within EEC expected levels, therefore high fuel flow maintained	05:02:14

9	Taxi. FWD idle, high TGT and FF	Repeated surges, ignition of unburnt fuel exhausted from jet pipe. ATC notifies crew	
10	TGT exceeds 900 °C	EEC reduces FF	05:02:43
11	Pilot operates fire handle	Airplane LP fuel (spar) valve closes although engine continues to burn downstream fuel	05:02:46
12	Pilot selects engine master lever to off	Shut down - HP fuel valve closes	05:02:47

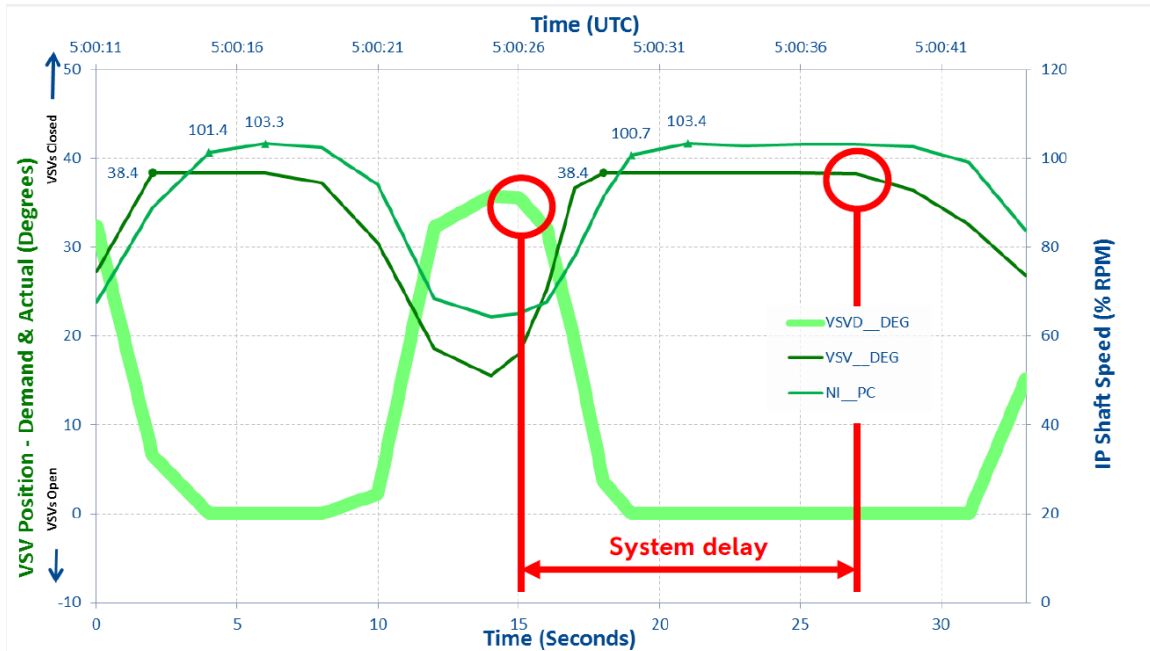
Figure 5 – Plot Showing VSV Demand and Actual Position – Note Delay (Courtesy R-R)

Additionally, a review of the data that was obtained from the N2 exceedances on the R-R reports and plotted (Figure 5) revealing that during descent:

- N2 exceedance #1 occurrence at 05:00:17 UTC; 6 seconds to respond
- N2 exceedance #2 occurrence at 05:00:32 UTC; 10 seconds to respond
- N2 exceedance #3 occurrence at 05:01:15 UTC; >12 seconds to respond

Analysis of the VSV positional data taken from the N2 exceedance reports observed a disagreement between the demanded and actual position of the VSVs, to a point where control was lost. Further assessment noted the VSV response time had become increasingly sluggish for each N2 exceedance (see [Figure 5](#)).

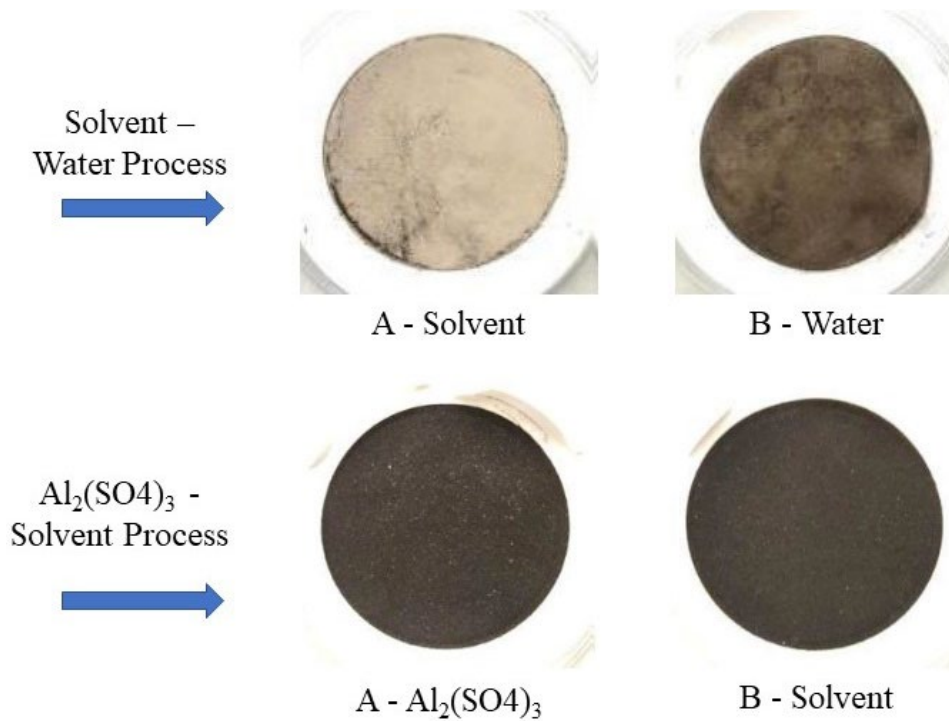
Figure 13 – Debris Captured from MIF After Immersions

Images of the captured debris from the MIF is shown on [Figure 13](#).

After the filter tests, the water-soluble residue was extracted from the debris in the laboratory filters. After the water was evaporated, the quantity of the debris was measured. Those filters that were water soaked had between 11 and 18 mg of residue while those soaked in the $\text{Al}_2(\text{SO}_4)_3$ (alum) solution had between 76 and 83 mg of residue.

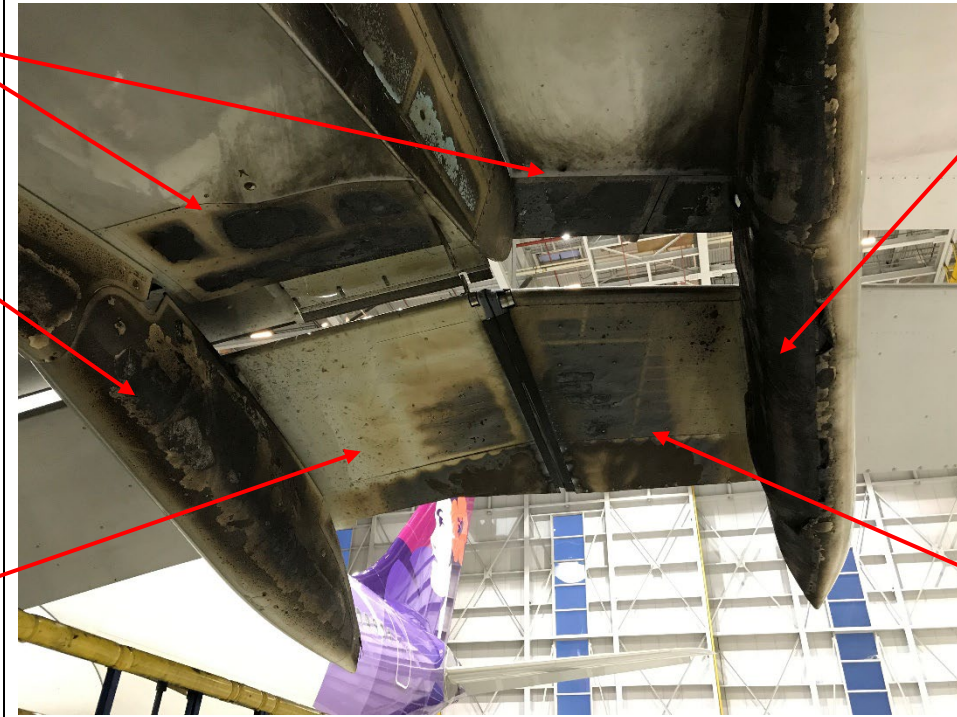
Photo 2 – Left Wing Damage

During an initial inspection, the maintenance staff discovered fire distress on the engine common nozzle assembly, underside of the wing, pylon, flap track fairings, spoilers, and flaps.

Initial examination of the event airplane and engine occurred from November 9 - 12, 2017 at the SEATAC. Investigation team members including the NTSB, FAA, Hawaiian Airlines, UK AAIB, R-R, and ALPA were in attendance. The left-wing external composite panels on the common nozzle assembly, lower panels of the flaps, and flap track covers had evidence of burn patterns and blistered paint consistent with unburnt fuel vapors igniting towards the back of the engine ([Photo 1](#) & [Photo 2](#)).

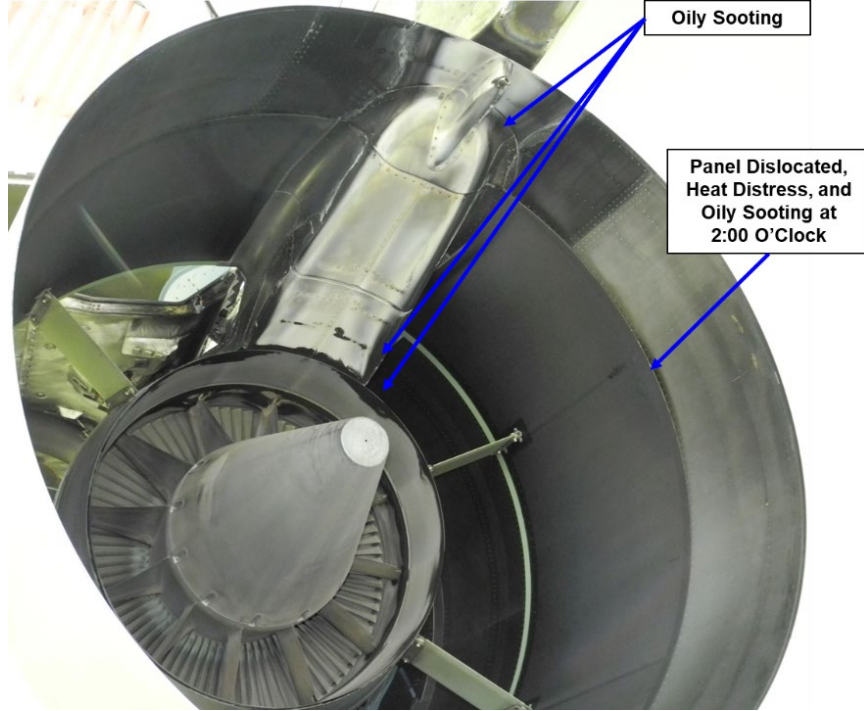
Photo 6 – VSV Actuator Ram Measurement

The static positions of the rams were measured ([Photo 6](#)). On the LH (event) engine the distance measured between the inboard ram collar flange and the ram housing was 45.5 millimeters (mm) for both actuators. As a comparison, the RH engine static actuator locations were measured to be 58 mm. According to the Goodrich Engine Control Systems Component Maintenance Manual, the piston travel is 58.51 mm. The actuator on the LH engine was more extended than on the RH engine, which corresponds to a higher power condition.

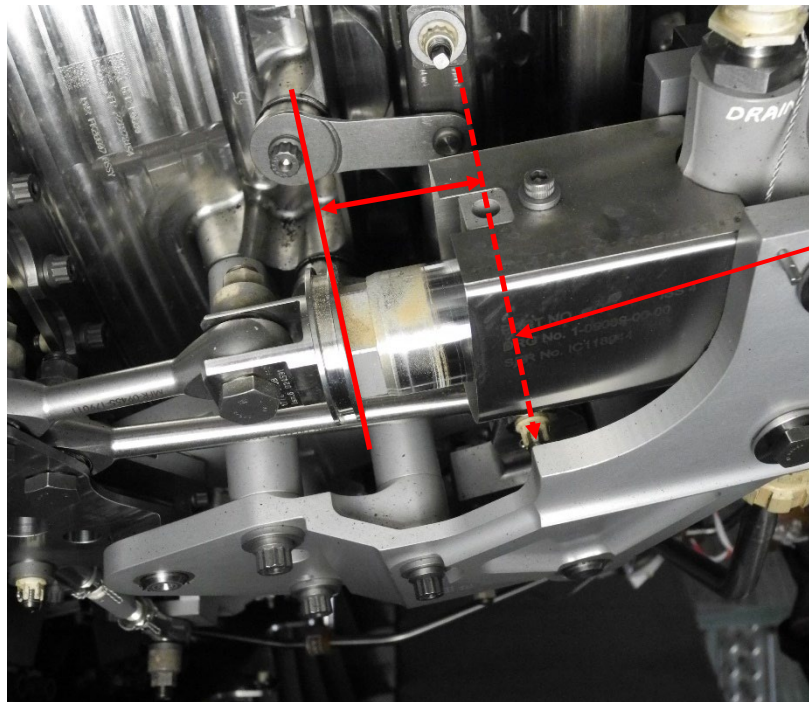
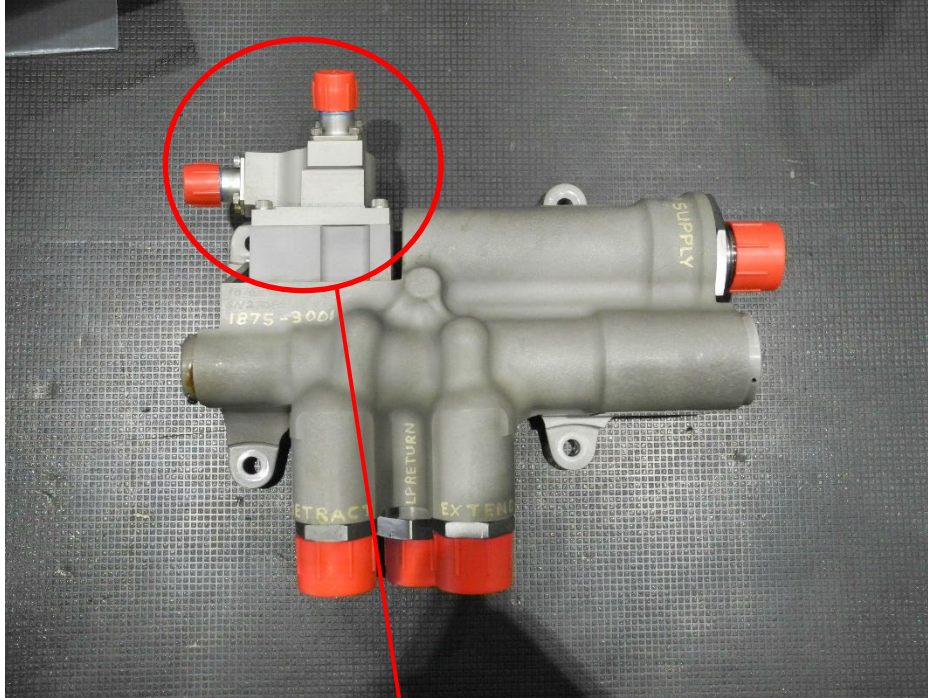
The VSV controller (Photo 7 & Photo 8) and VSV actuators (Photo 9 & Photo 10) were removed from the engine with no difficulties. The VSV controller, VSV actuators and FMU were sent to R-R Bristol for CT scanning, after which they were transferred to the manufacturer, UTAS, in Marston Green, Birmingham England for teardown and examination. The CT scan of the VSV controller and actuators revealed no evidence of internal damage or anomalous features, so they were forwarded to the manufacturer, UTAS at the Marston Green facilities, England for a teardown and examination without functional testing.

Photo 7 - Variable Stator Vane (VSV) Controller

Photo 8 - Variable Stator Vane (VSV) Controller Torque Motor

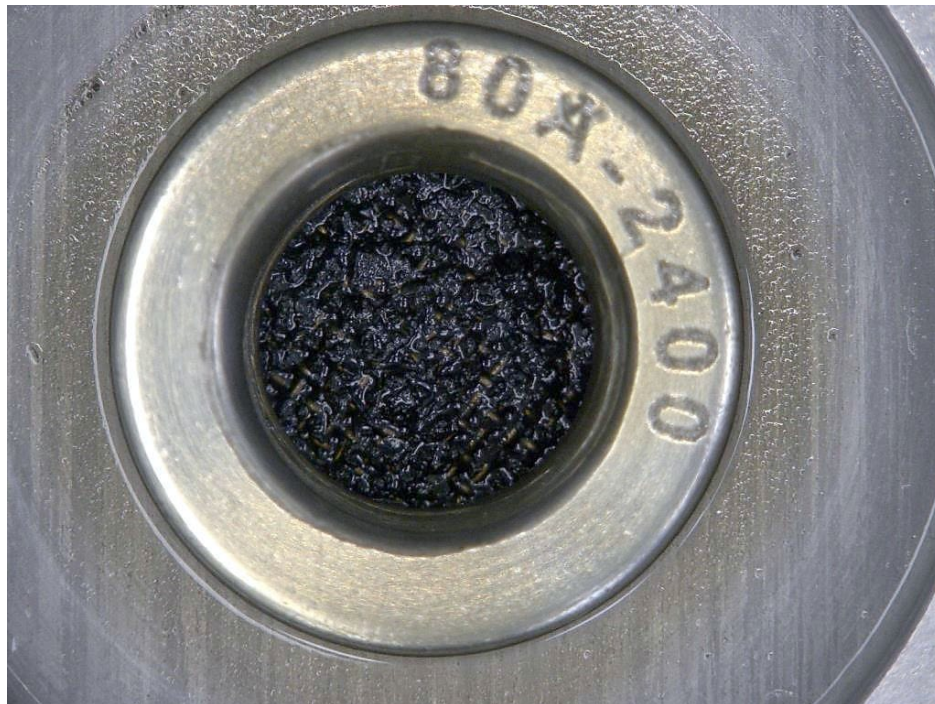
A detailed visual inspection found the TM supply port filter had significant accumulation of debris that was adhered on the supporting mesh and filter element of the VSVC supply port filter (Photo 15). Backlight assessment of the filters visually confirmed both the supply and return port filters were 95% blocked with contamination. It was noted that the debris accumulation was adhered to the supporting mesh and element rather than being settled on the upstream side. A scanning electron microscope (SEM) energy dispersive x-ray (EDX) material analysis found its composition to include metallic elements (Cu, Fe, Ni and Cr) combined with fuel breakdown products (C, O, S and N). According to UTAS and MOOG, filter blockage with operational age is a known phenomenon.

Photo 15 – ESN 42543 TM Supply Port Filter (dry) – Lab Photos

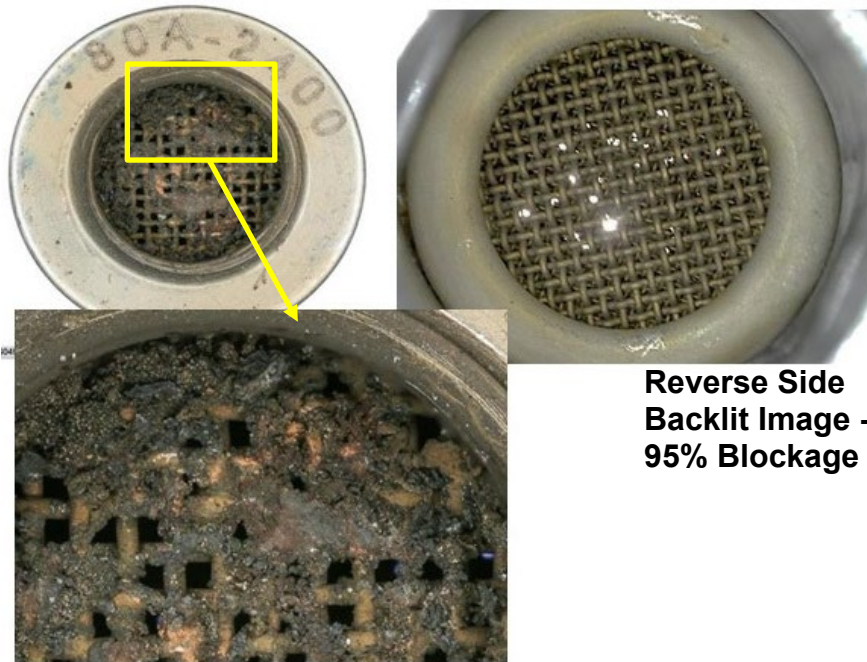
The VSVC TM supply port filters of the sister engine, ESN 42544 were also removed, inspected, and compared to the event engine, revealing a similar filter blockage of 95%; however, the captured debris was not adhered to filter support mesh as observed on the event engine but rather the debris was mostly settled on the element itself (Photo 16).

Photo 16 - ESN 42544 TM Supply Port Filter (dry) – Lab Photos

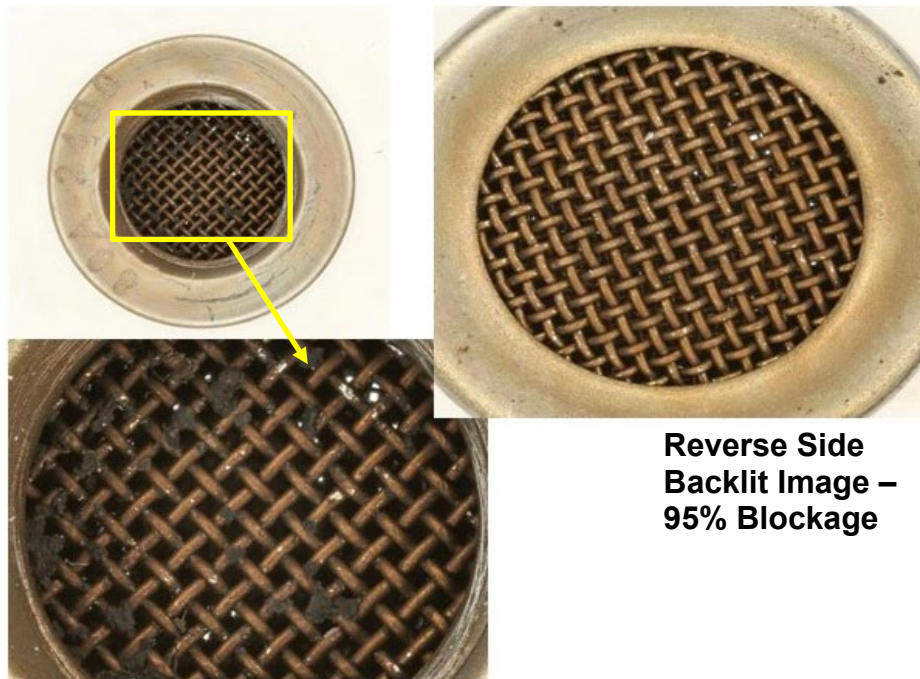
The FMU FMV TM supply filter was approximately 95% blocked (Photo 17). An SEM EDX material analysis found a similar elemental composition of the debris as in the VSVC supply port filter.

Photo 17 – ESN 42543 FMU FMV TM Supply Port Filter (dry)

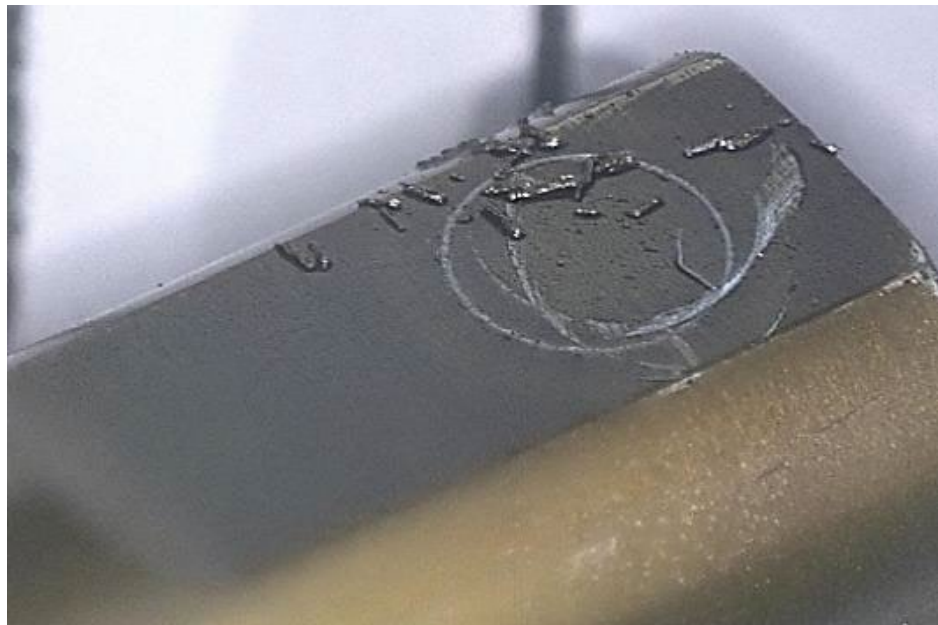
Photo 19 – Flapper Valve ‘Sun Ray’ Contact Marks with Nozzle

Sun Ray Pattern is Indicative of Contamination in Nozzle for Extended Time

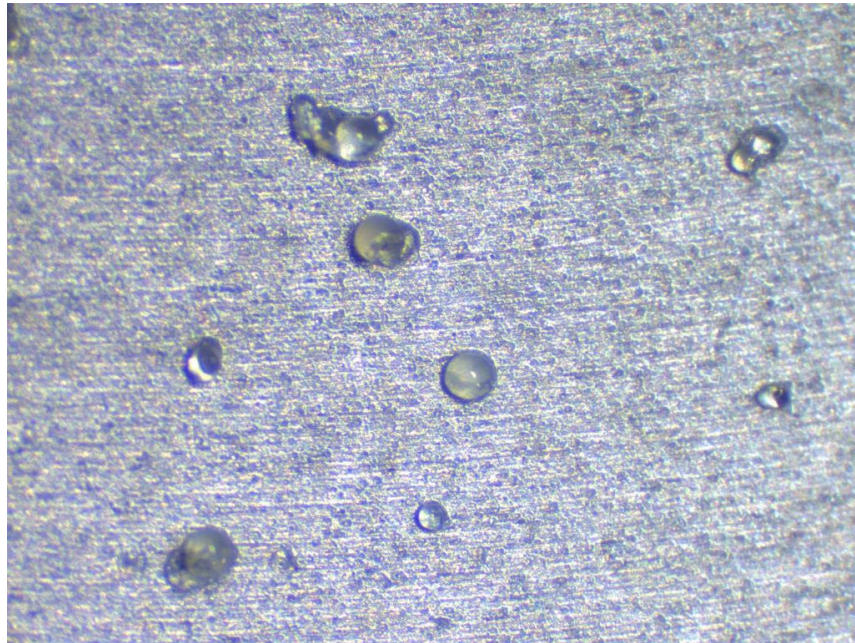
Photo 22 – Translucent Globular Deposits found on Internal Surfaces of LVDT Housing

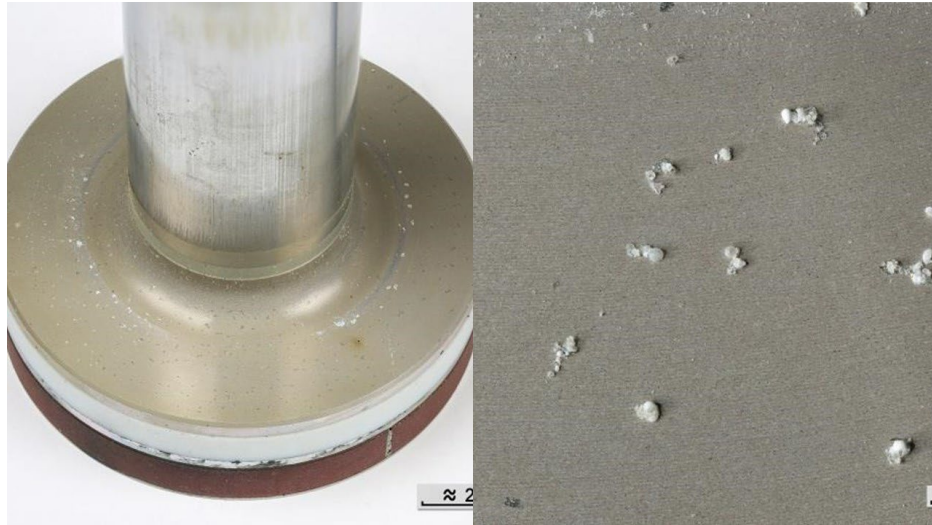
Photo 23 – VSV Actuator Piston - White, Dried Deposits

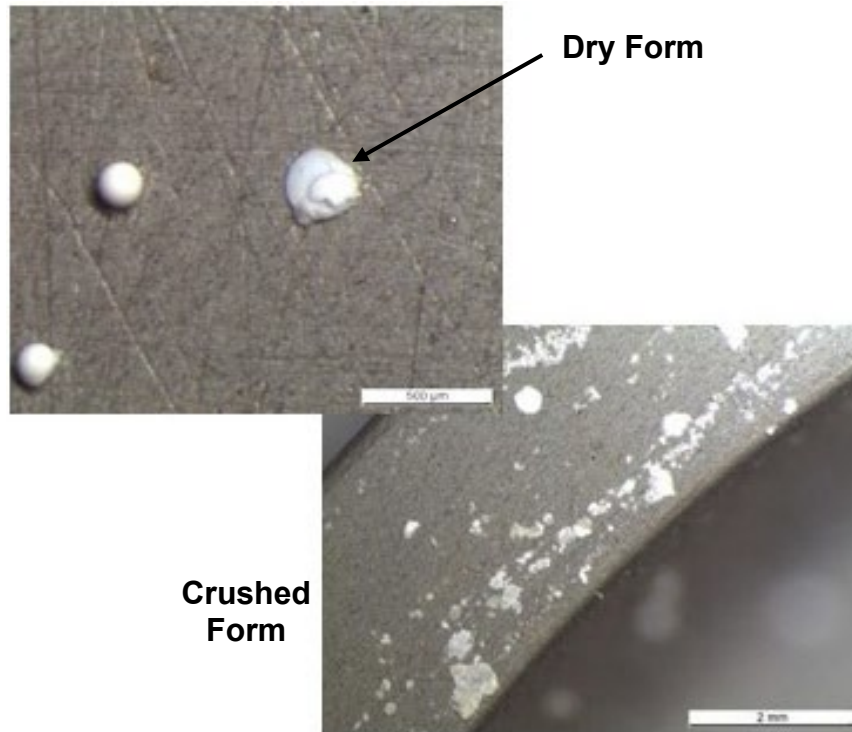
Photo 24 – VSV Actuator Piston - Aluminum Sulfate (Alum) Deposit

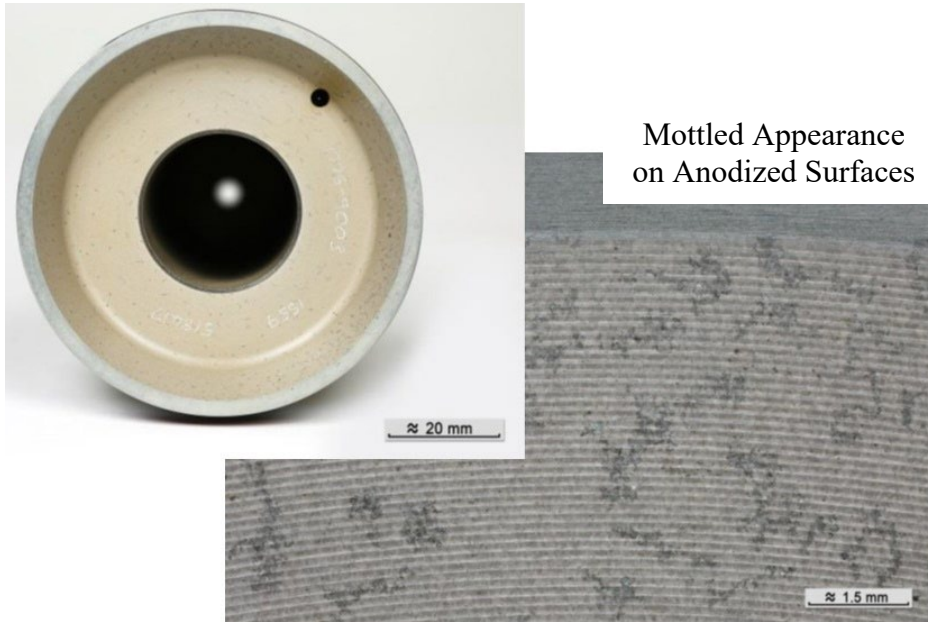
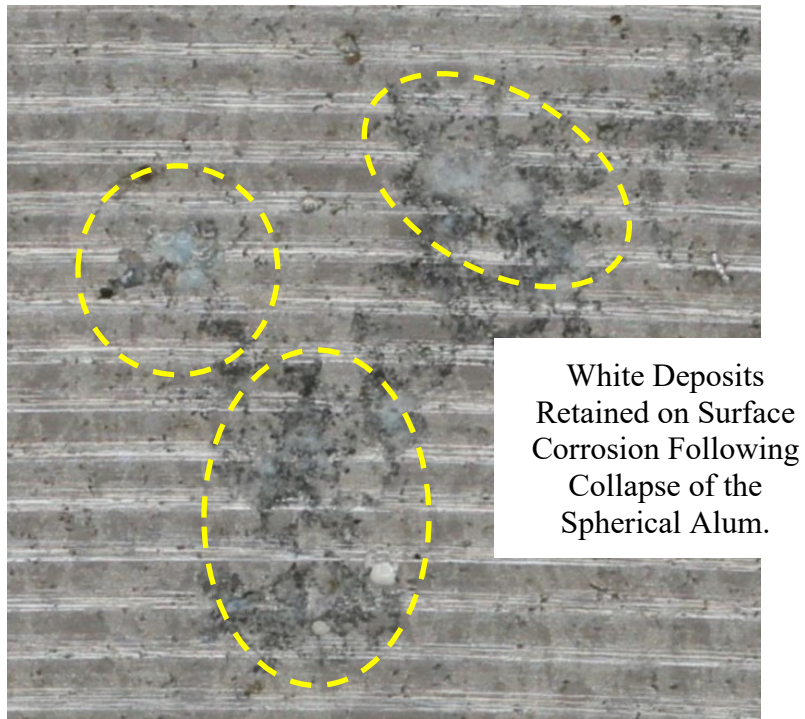
Photo 25 – VSV Actuator Piston Surface Corrosion

Photo 26 – VSV Actuator Piston Surface Corrosion

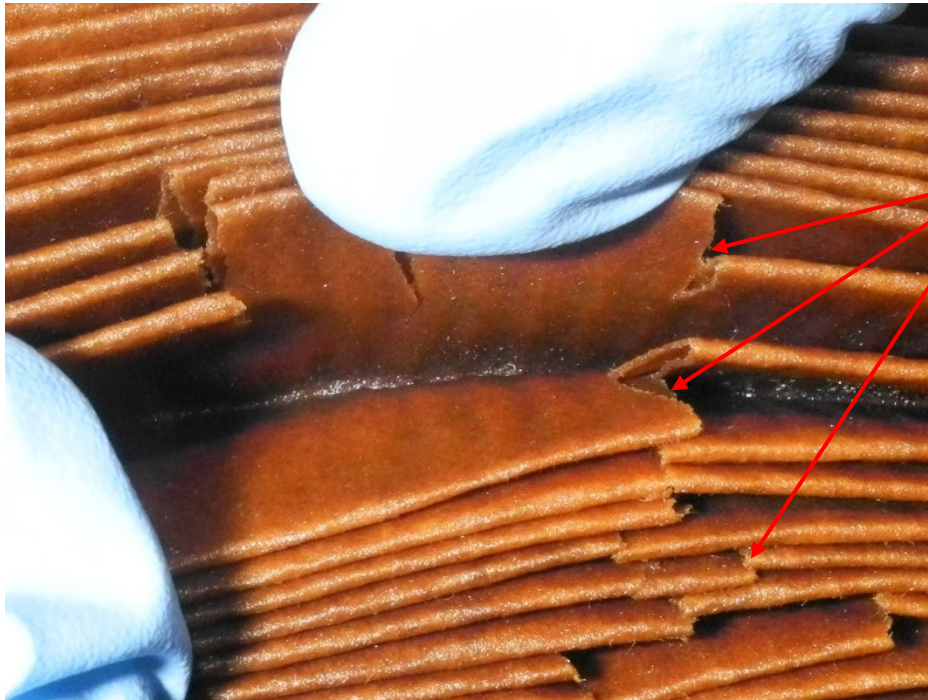
Photo 28 - LP Fuel Filter Element – Fine Metallic Debris in Pleats

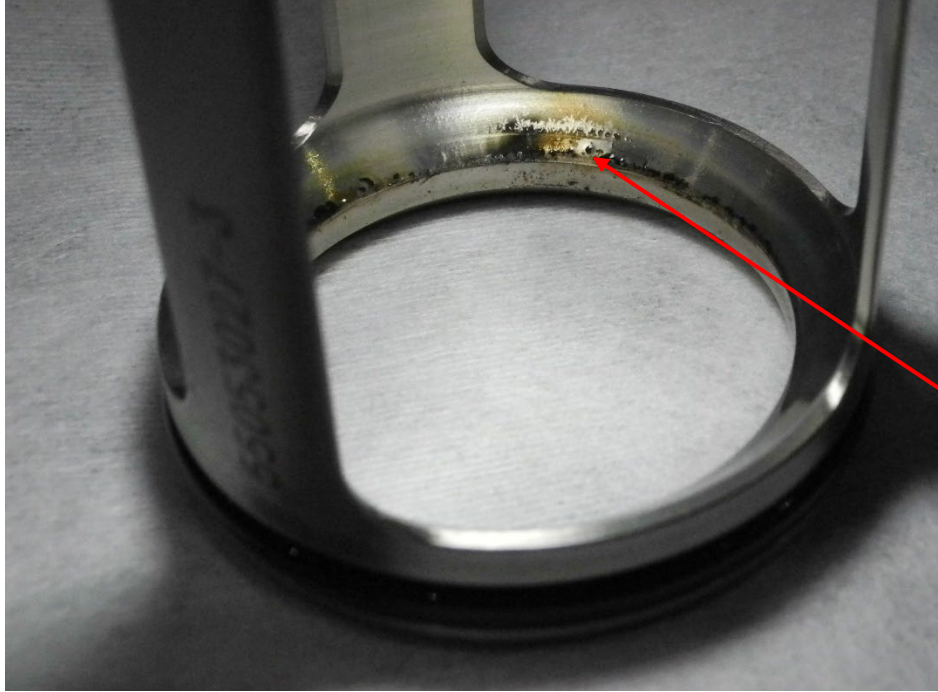
Wear,
Discoloration and
Leakage Evidence

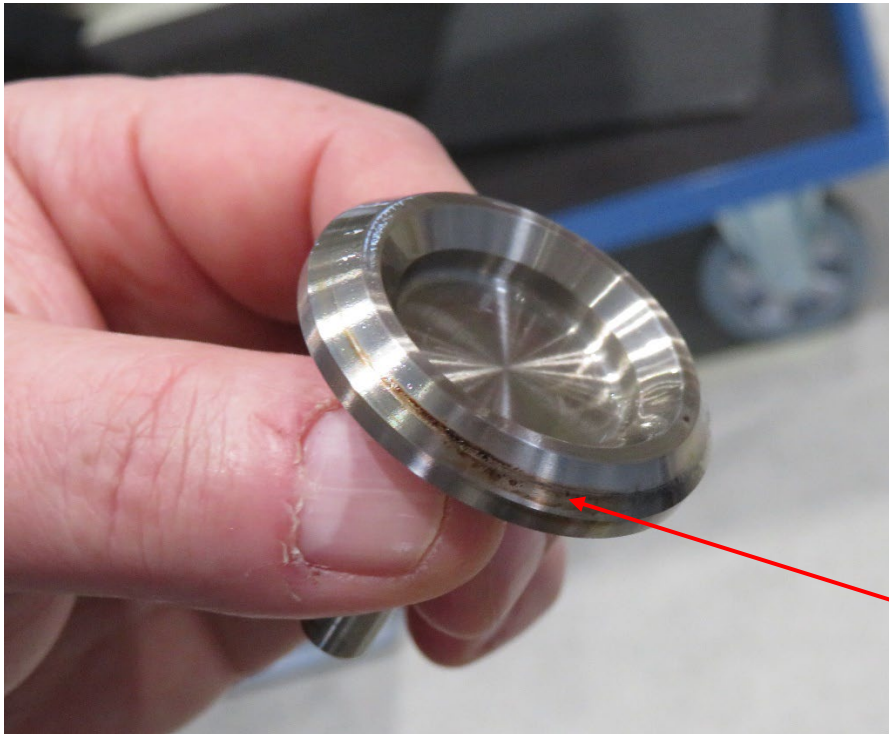
Wear and
Discoloration

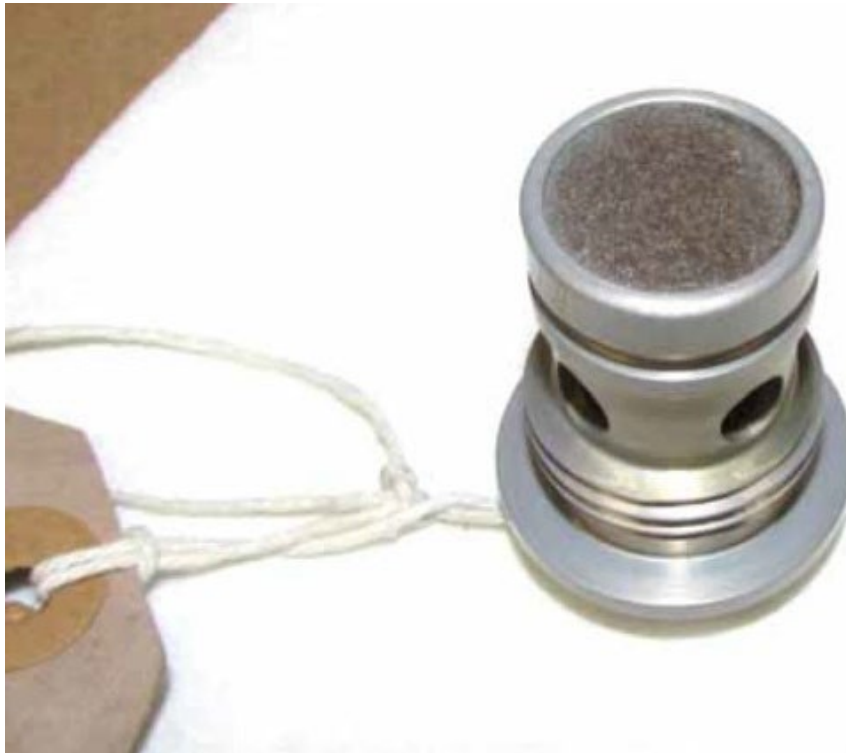
Photo 34 – Fuel Pump Lube Flow Screen – Partially Blocked

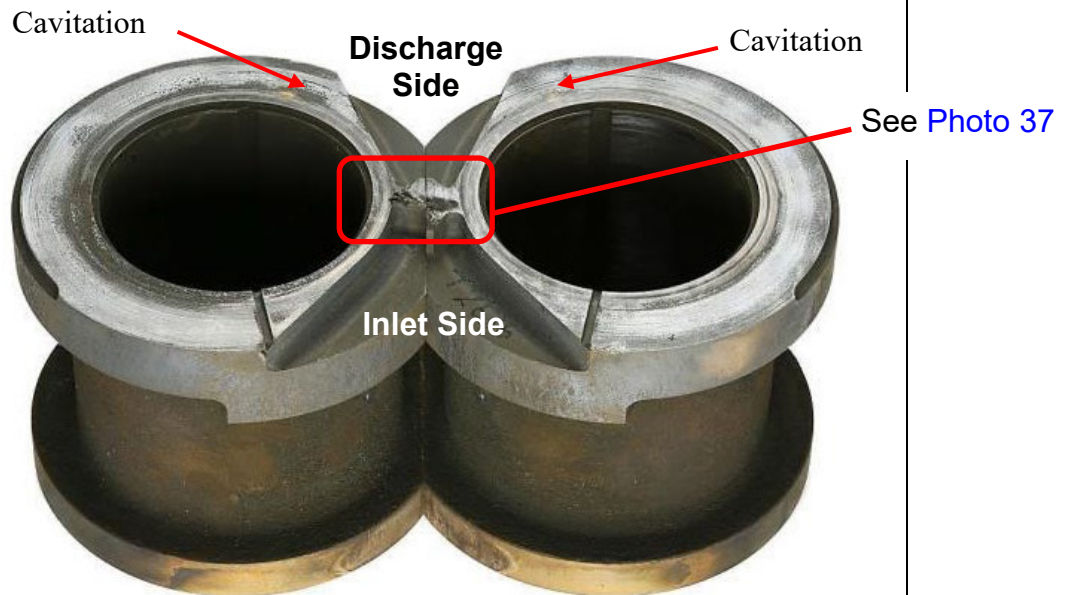
Photo 36 – Cavitation Erosion on Discharge Side of Fixed Bearing Face – Abnormal Wear

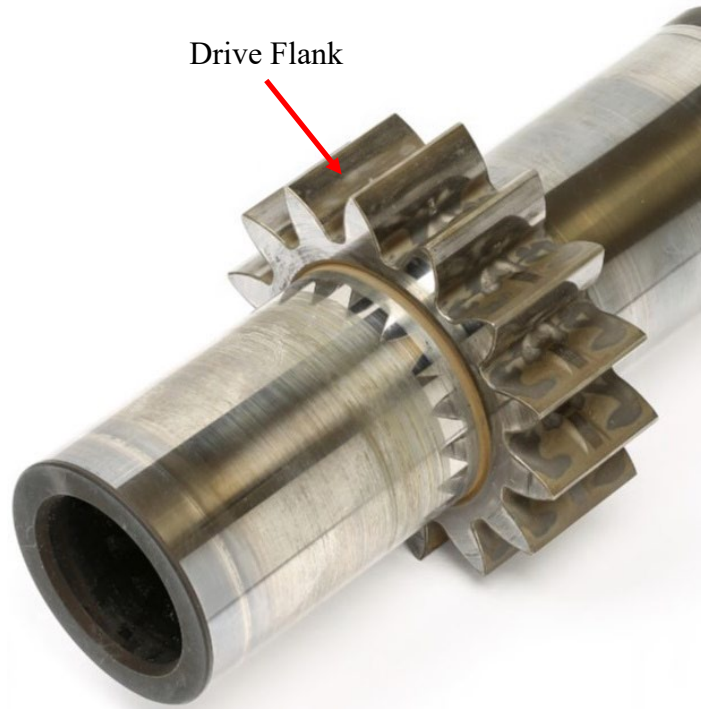
Photo 39 – HP Fuel Pump Drive Gear – Cavitation Erosion

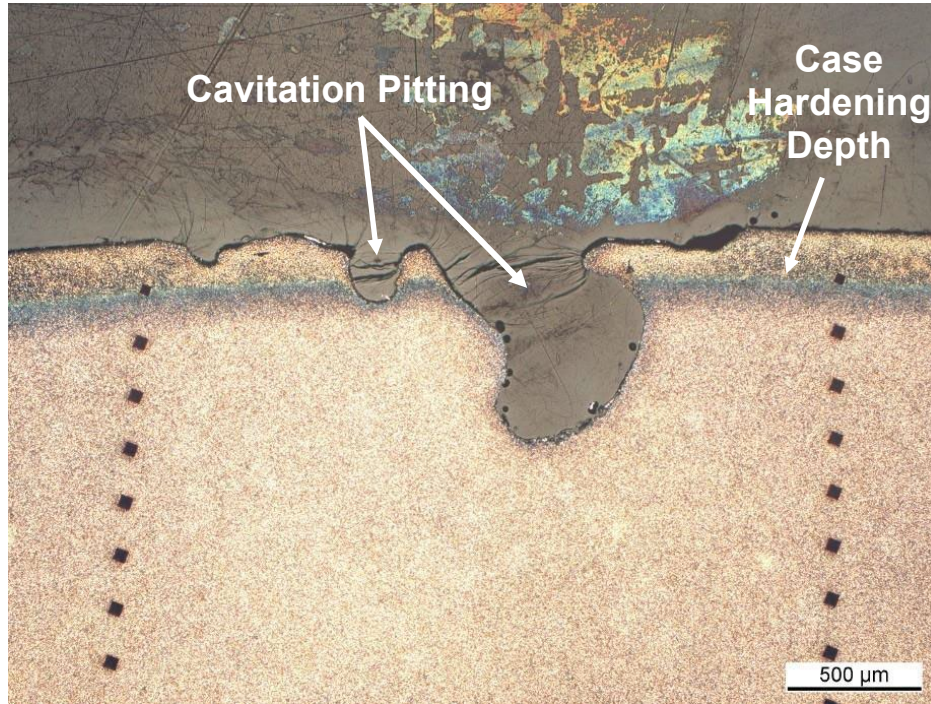
Photo 41 – Section Through Cavitation in Drive Gear Tooth
