National Transportation Safety Board

ENG22LA004

AIRCRAFT SYSTEMS

Group Chair's Factual Report

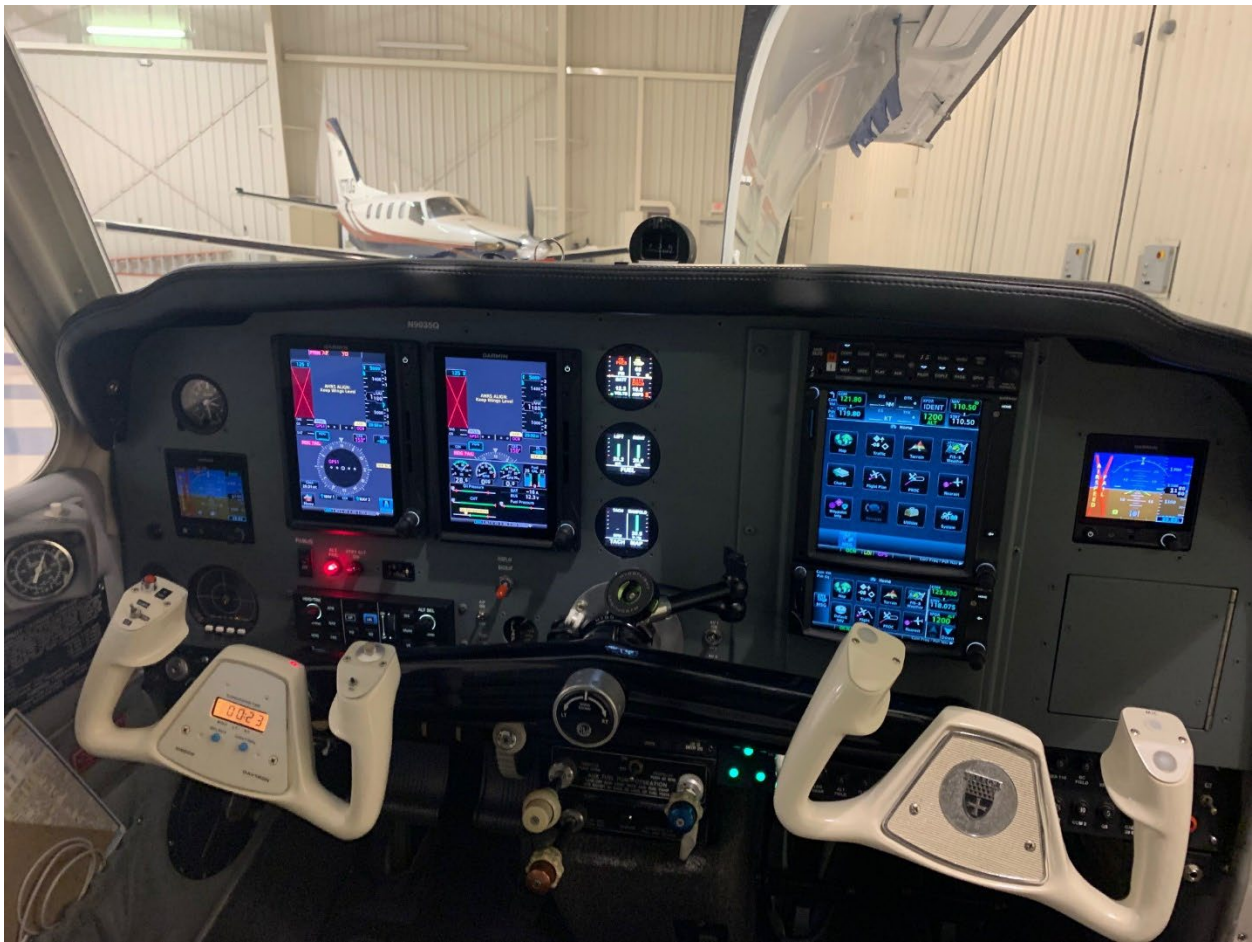
Figure 2. The airplane's flight deck and autopilot installation.

Prior to and during the testing, the Garmin GSA 28 servo actuator in the pitch position was annunciating an intermittent fault. The fault annunciating was "Monitor Pitch Torque Voltage." Garmin indicated that the fault, which indicates a tripping of the pitch

While connected to the air data test set and simulating 130 knots and 4,000 feet altitude, the autopilot was engaged. In response, the autopilot immediately commanded nose down pitch trim to the stop limits. This was repeated several times with the same, full nose down trim result.

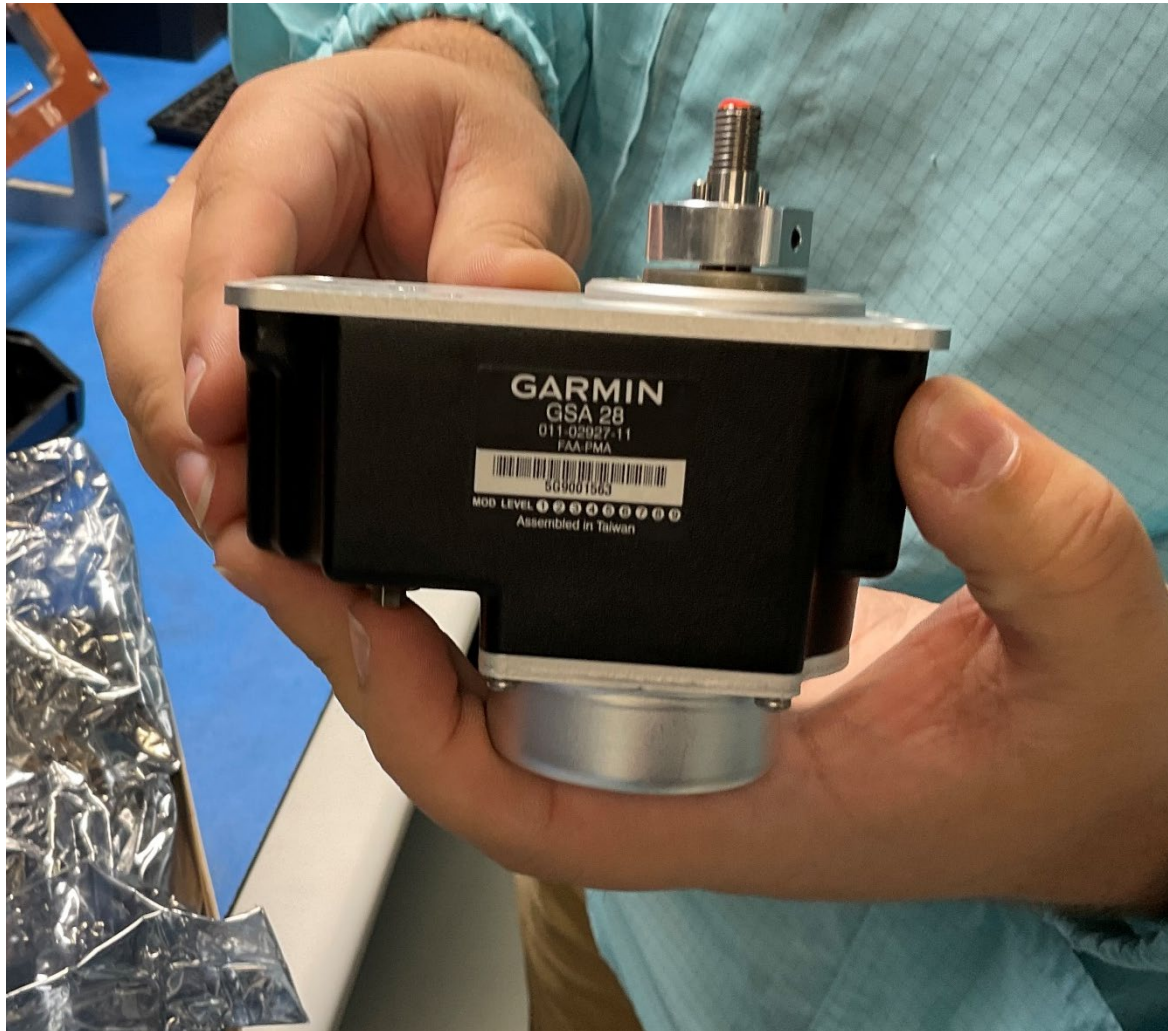
Upon arrival, the group removed the unit from its packaging and visually examined the servo's exterior. No anomalies were noted. The servo's part and serial number were confirmed. See Figure 3.

Figure 3. The GSA 28 Servo, as received at Garmin for examination.

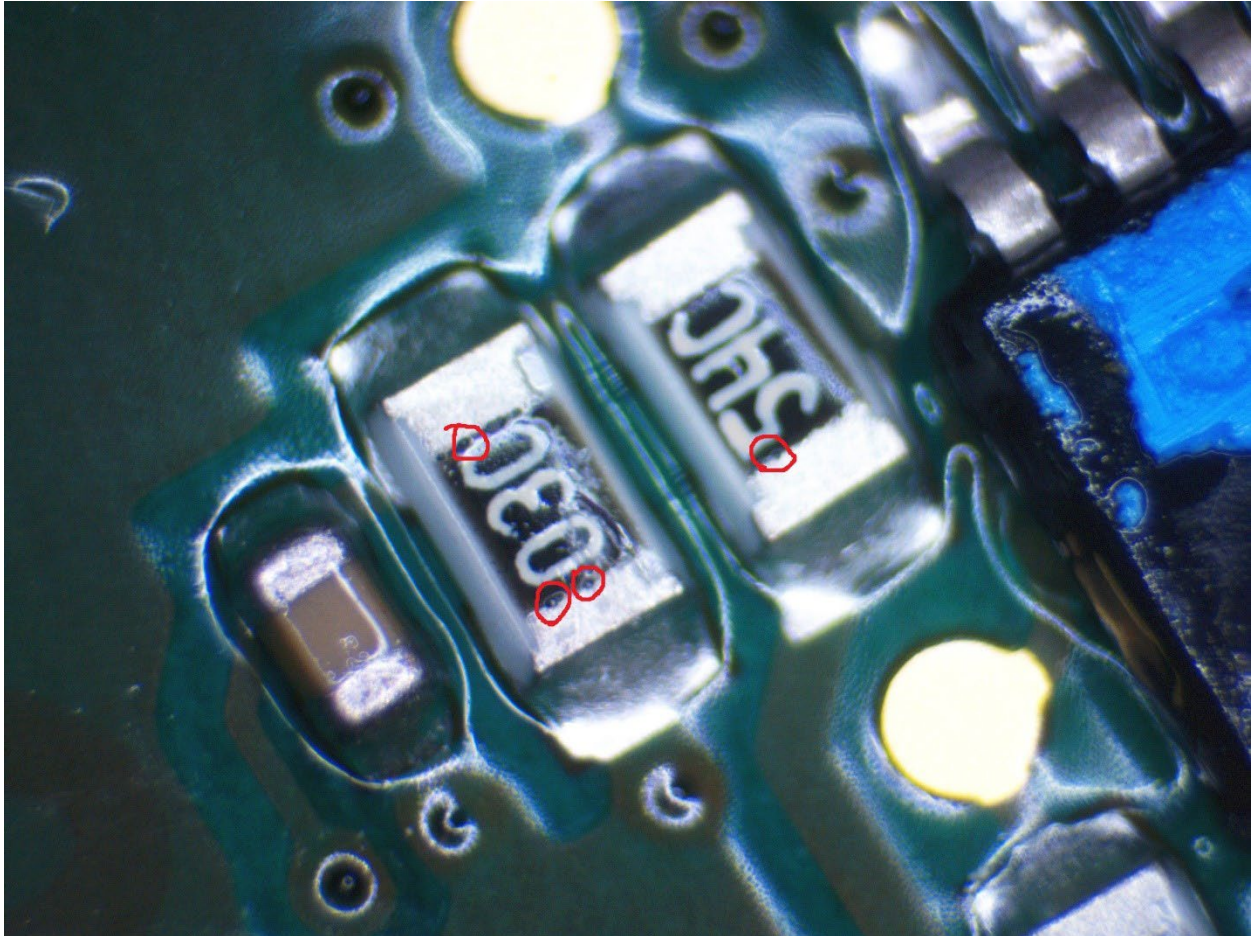
Following completion of the ATE Minimum Performance Specification Test, the unit was dis-assembled to access the servo's circuit board. The purpose of the visual examination was to look for evidence of sulphuration on the circuit board. Garmin indicated that sulphuration of components on the circuit board was the root cause of the failed servos identified in Service Bulletin 2063.

The circuit board was removed from the servo and the padding protecting the reverse/bottom side of the board was removed. The components on the board were examined under magnification. Garmin identified that at least two resistors (R540 and R536, parts of the torque monitoring circuitry) exhibited damage or evidence of sulphuration. See Figure 4.

Figure 4. Servo circuit board viewed under magnification with areas of sulphuration circled in red. Photo courtesy of Garmin.

Action: Before further flight either disable the GFC 500 by pulling the AUTOPILOT circuit breaker and placard "Inoperative" or contact a Garmin dealer to disable the pitch trim.

The AD would require updating the applicable Garmin GFC 500 Autopilot System software and prohibit installing earlier versions of the software.
