NATIONAL TRANSPORTATION SAFETY BOARD

Helicopter Terrain Awareness System (HTAWS)

Specialist's Factual Report

Location: Hertford, North Carolina
Date: September 8, 2017
Aircraft: Eurocopter MBB BK-177 C2
Registration: N146DU
Operator: Air Methods Corporation
NTSB Number: ERA17FA316

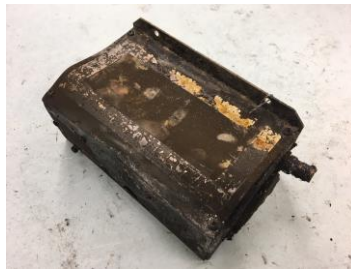
Upon arrival at the Vehicle Recorder Laboratory, an examination revealed the unit had sustained significant fire and impact damage. The outer case of the unit was charred and bent. Figure 1 shows the unit's condition upon arrival.

Figure 1. Photo of damaged unit

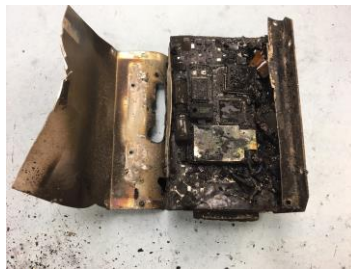
The unit was opened mechanically and the internal components, including any non-volatile memory (NVM) were found to be heavily fire damaged. Figure 2 shows the condition of the internal components after the device was opened with a shear.

Figure 2. Photo of the device after being mechanically opened.

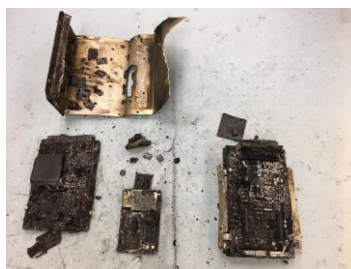
A review of the internal components revealed obvious heat damage.

Figure 3. Photo of the device's internal components partially disassembled and laid out.

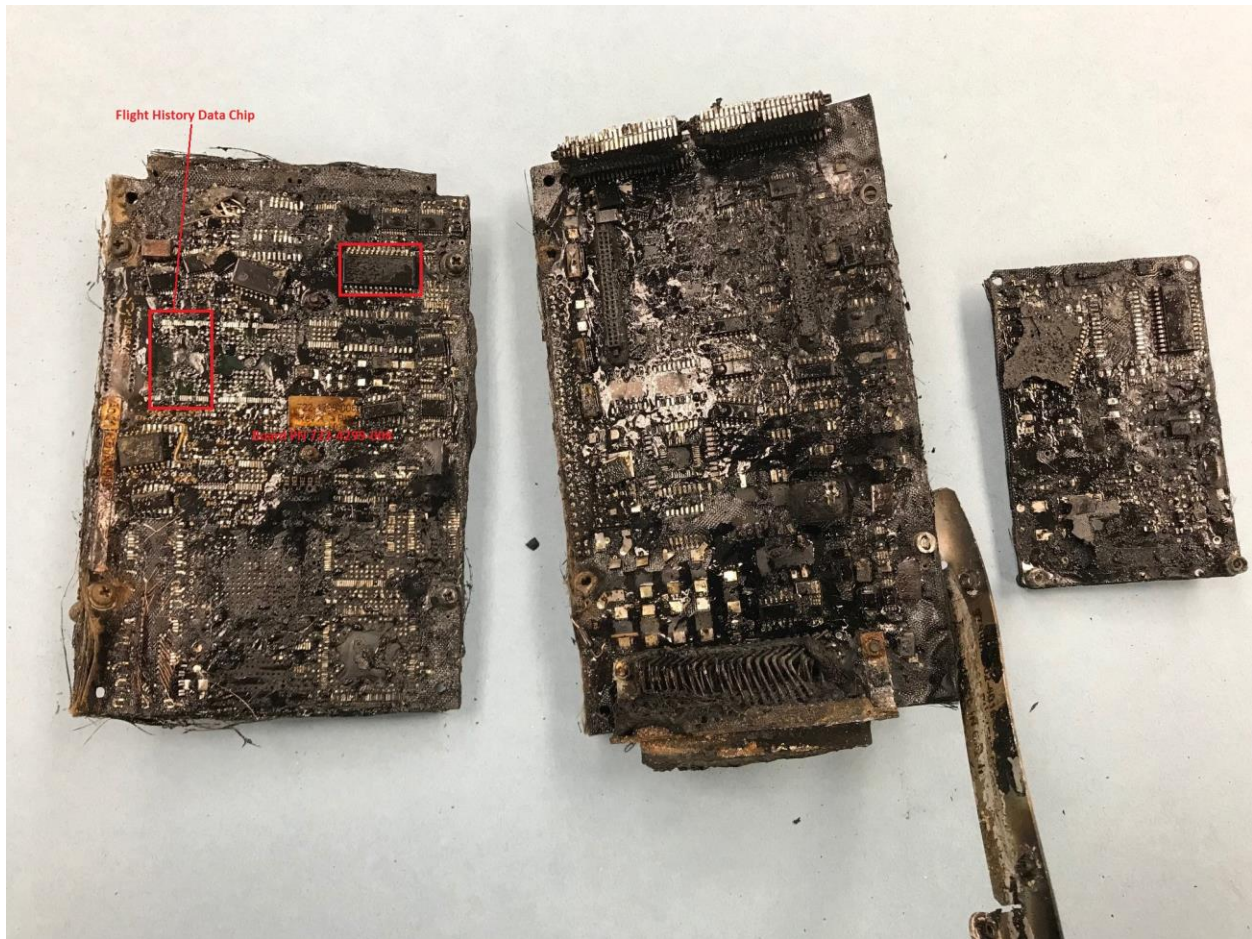
In collaboration with the manufacturer, Honeywell, individual NVM chips that would have potentially contained data were identified. The chips are Intel branded E28F320 J3A110 chips. Figure 4 shows the location of the flight history data chip, as identified by Honeywell. As evident in figure 4, the flight history data chip was missing.

Figure 4. The location of the flight history data chip. The chip was missing from the board. The second marked box is the location of another NVM chip that is helpful in decoding the flight history data chip, but not required.

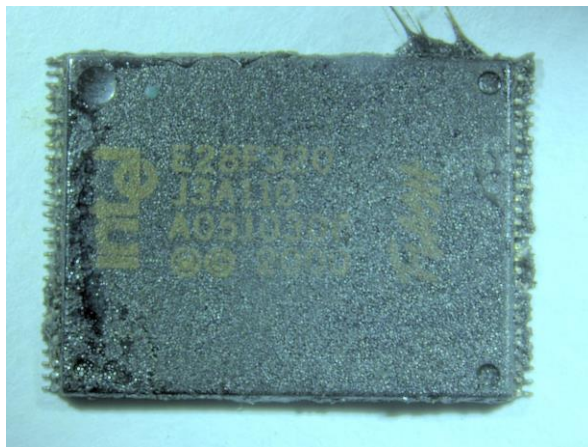
Figure 5. Stereoscopic microscopy photo of chip “A.”

Chips A, B, and C were then read using the appropriate socket type adapter via a Xeltek 6100 and a PC. Multiple reads for each chip were taken and compared. Chip A read out with only a pin error on pin 48. Chip B read out with a pin error on pins 18 and 48. Chip C read out with pin errors on pins 19, 22, 31 and 48.

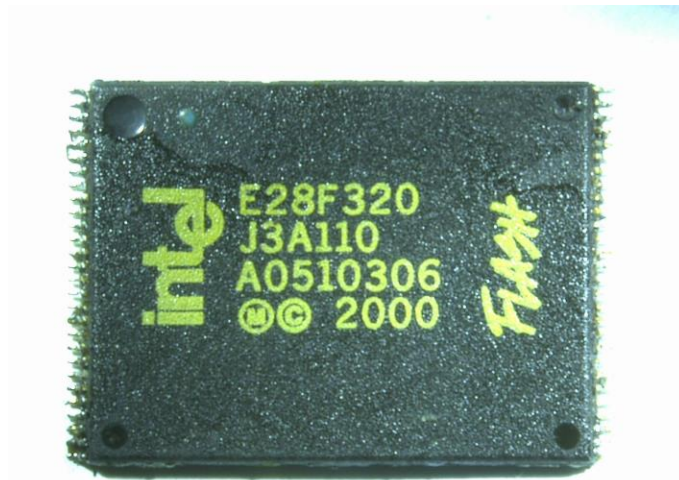
Figure 6. Stereoscopic microscopy photo of chip “B.”

It is likely the pin error on pins 18 and 48 affected the read of the chip's memory, however, enough decoded data existed such that Honeywell was able to determine that no latitude and longitude records near the location of the accident were recorded. This could indicate that the device did not trigger near the accident site.

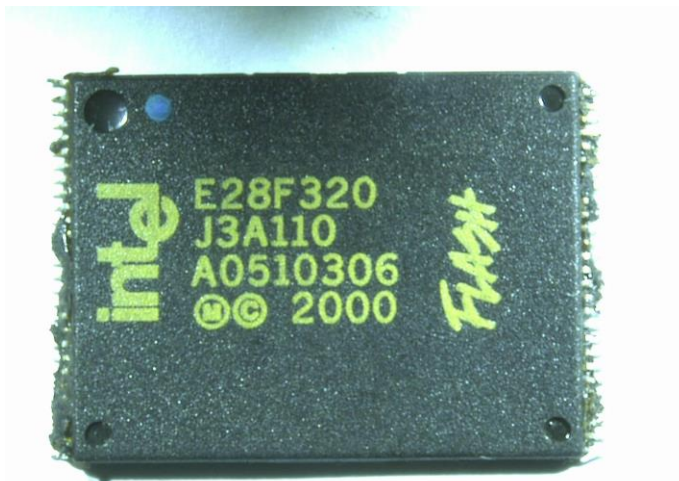
Figure 7. Stereoscopic microscopy photo of chip “C.”

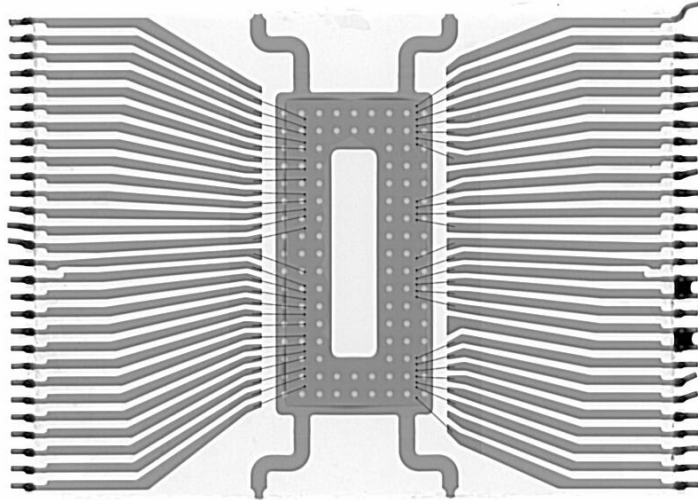
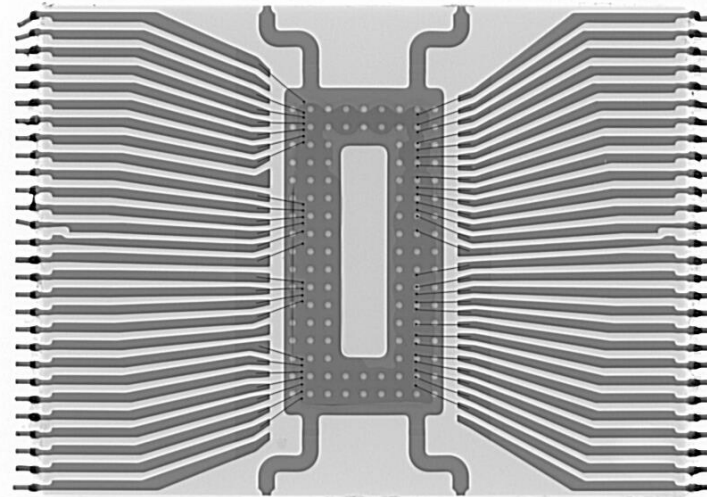
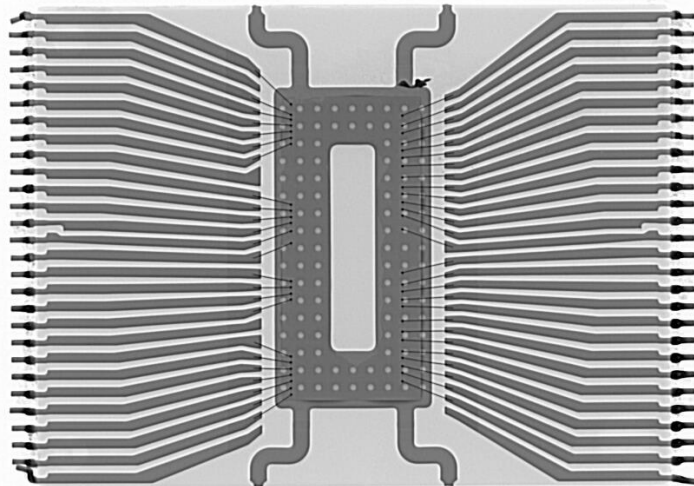
Figure 8. X-ray microscopy for chip "A"

Figure 9. X-ray microscopy for chip "B"

Figure 10. X-ray microscopy for chip “C”

The x-ray examination revealed no obvious defects in the bond wires or lead-frame packaging for each chip. The die condition could not be conclusively determined using an x-ray examination.
