# NATIONAL TRANSPORTATION SAFETY BOARD

## UAS Aerial Imagery Report

### A. ACCIDENT ERA18FA120

Location: Daytona Beach, Florida

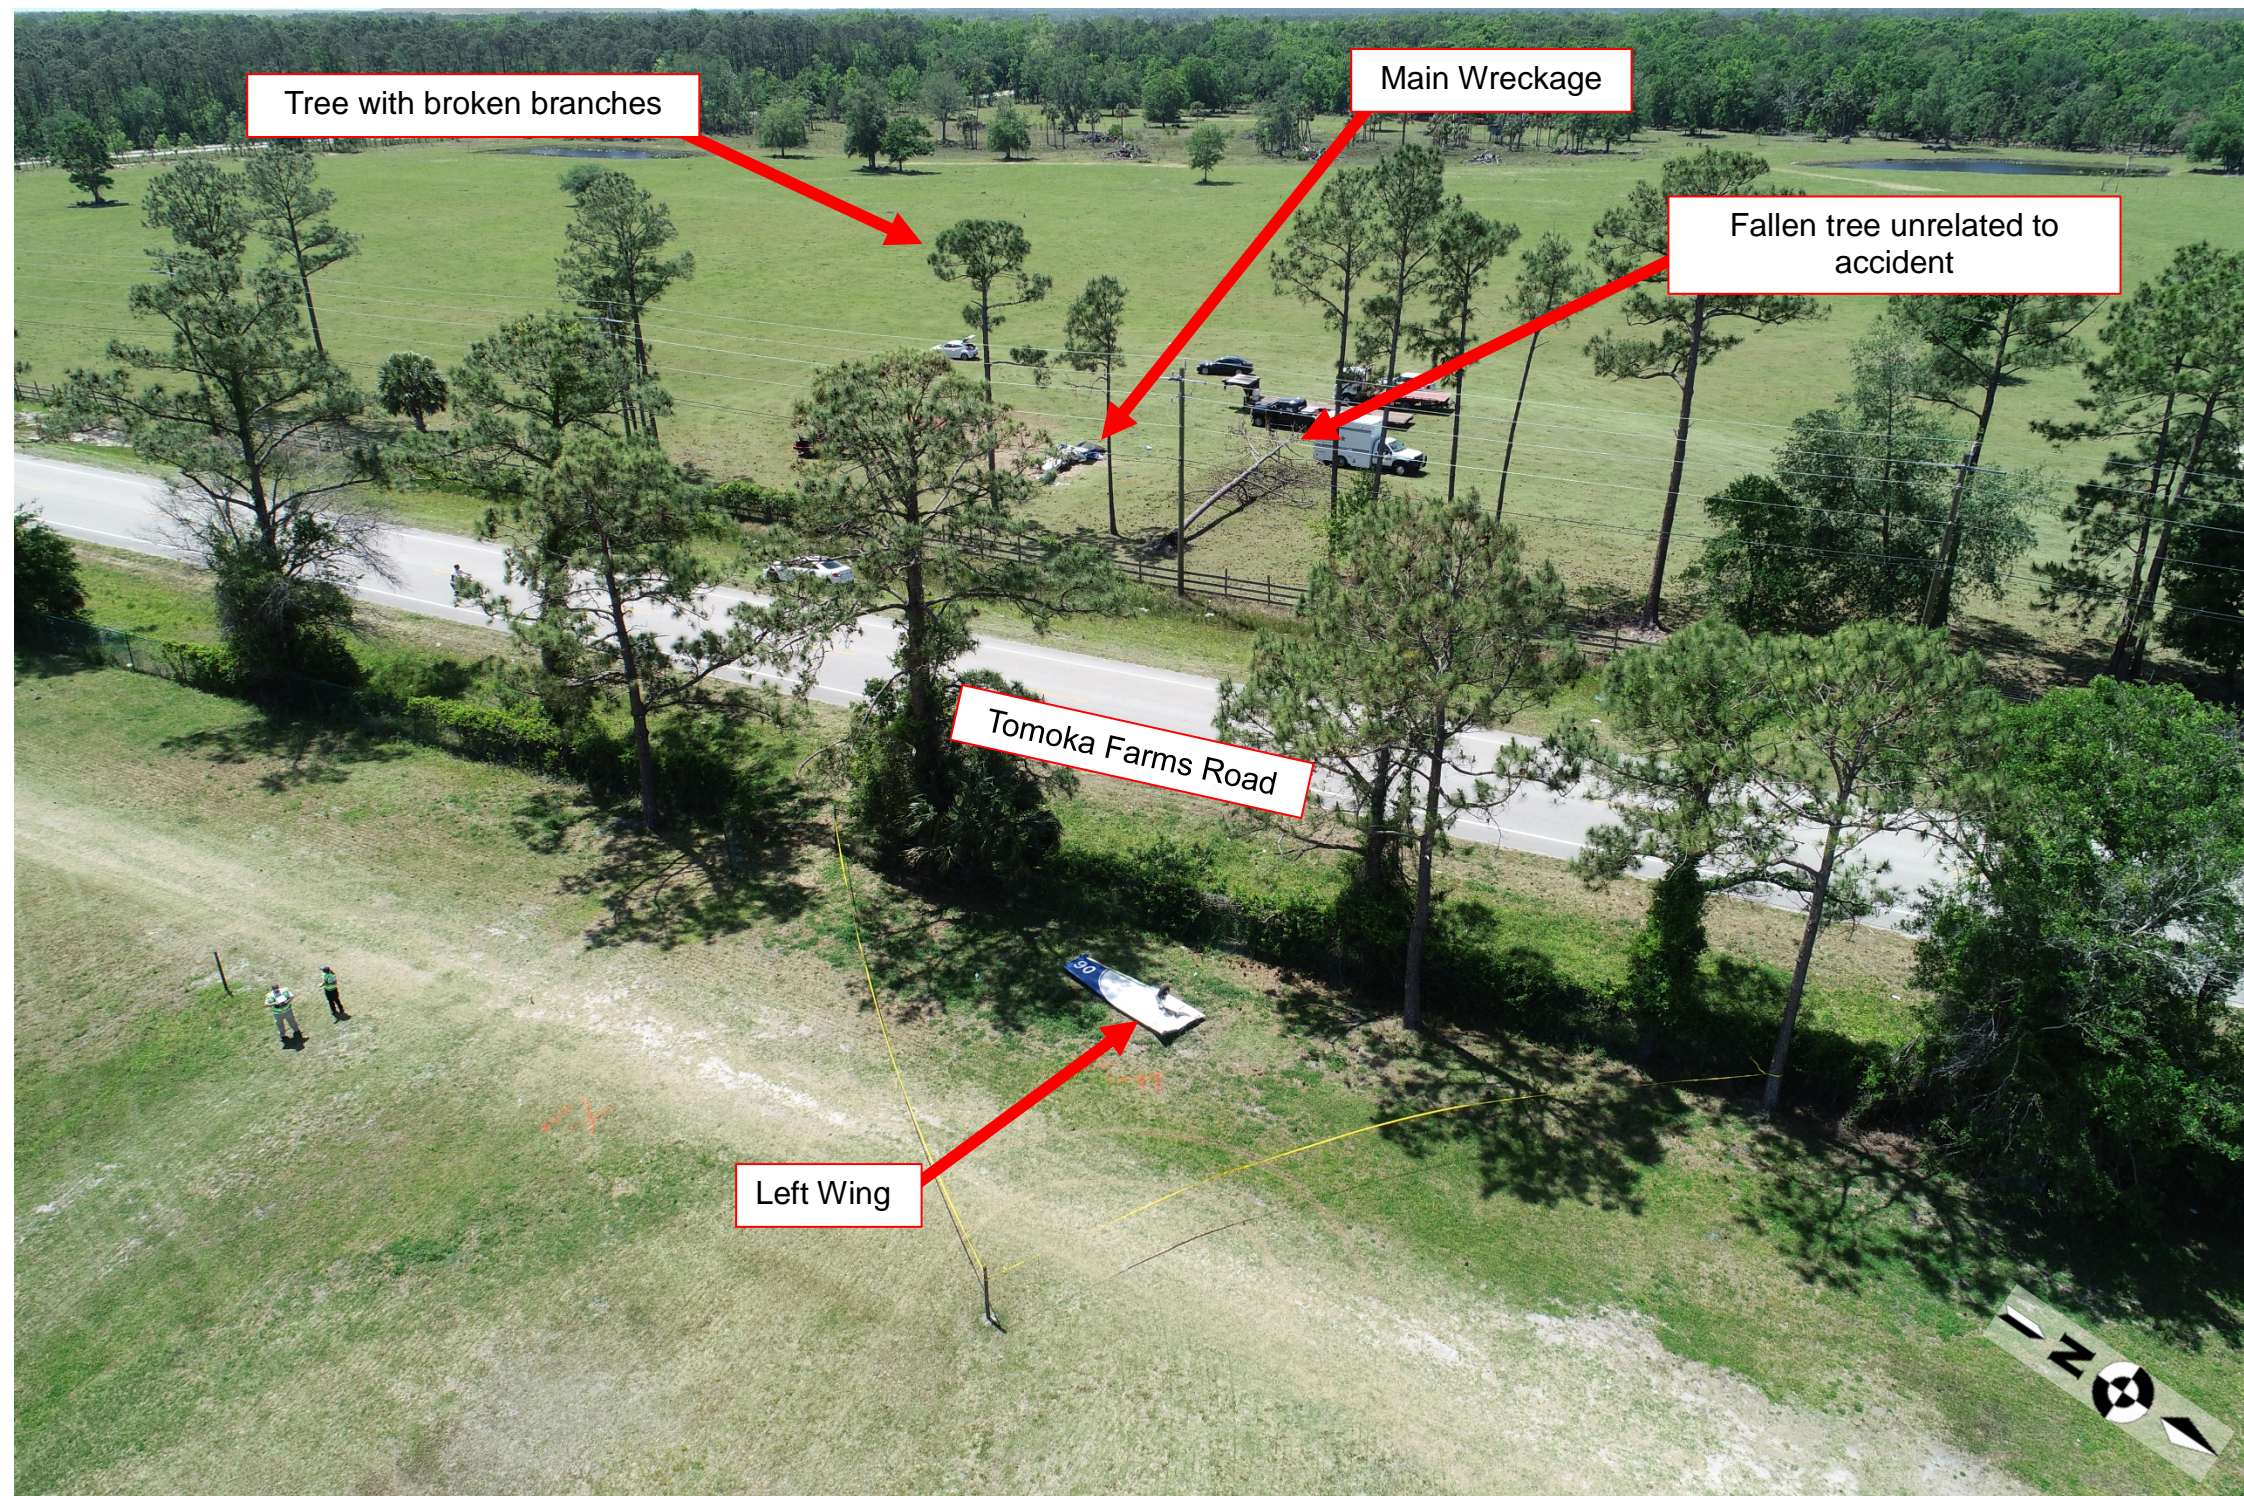
Figure 1 is a still image showing a general overview of the accident scene. The left wing is in the foreground and the main wreckage is in the background past Tomoka Farms Road. The distance between the main wreckage and left wing was measured to be approximately

200 ft, using data from the point cloud. One tree is highlighted to show its location due to the multiple branches that were severed during the aircraft wreckage's descent.

Figure 1 – Photo – Scene Overview (directional arrow approximated)

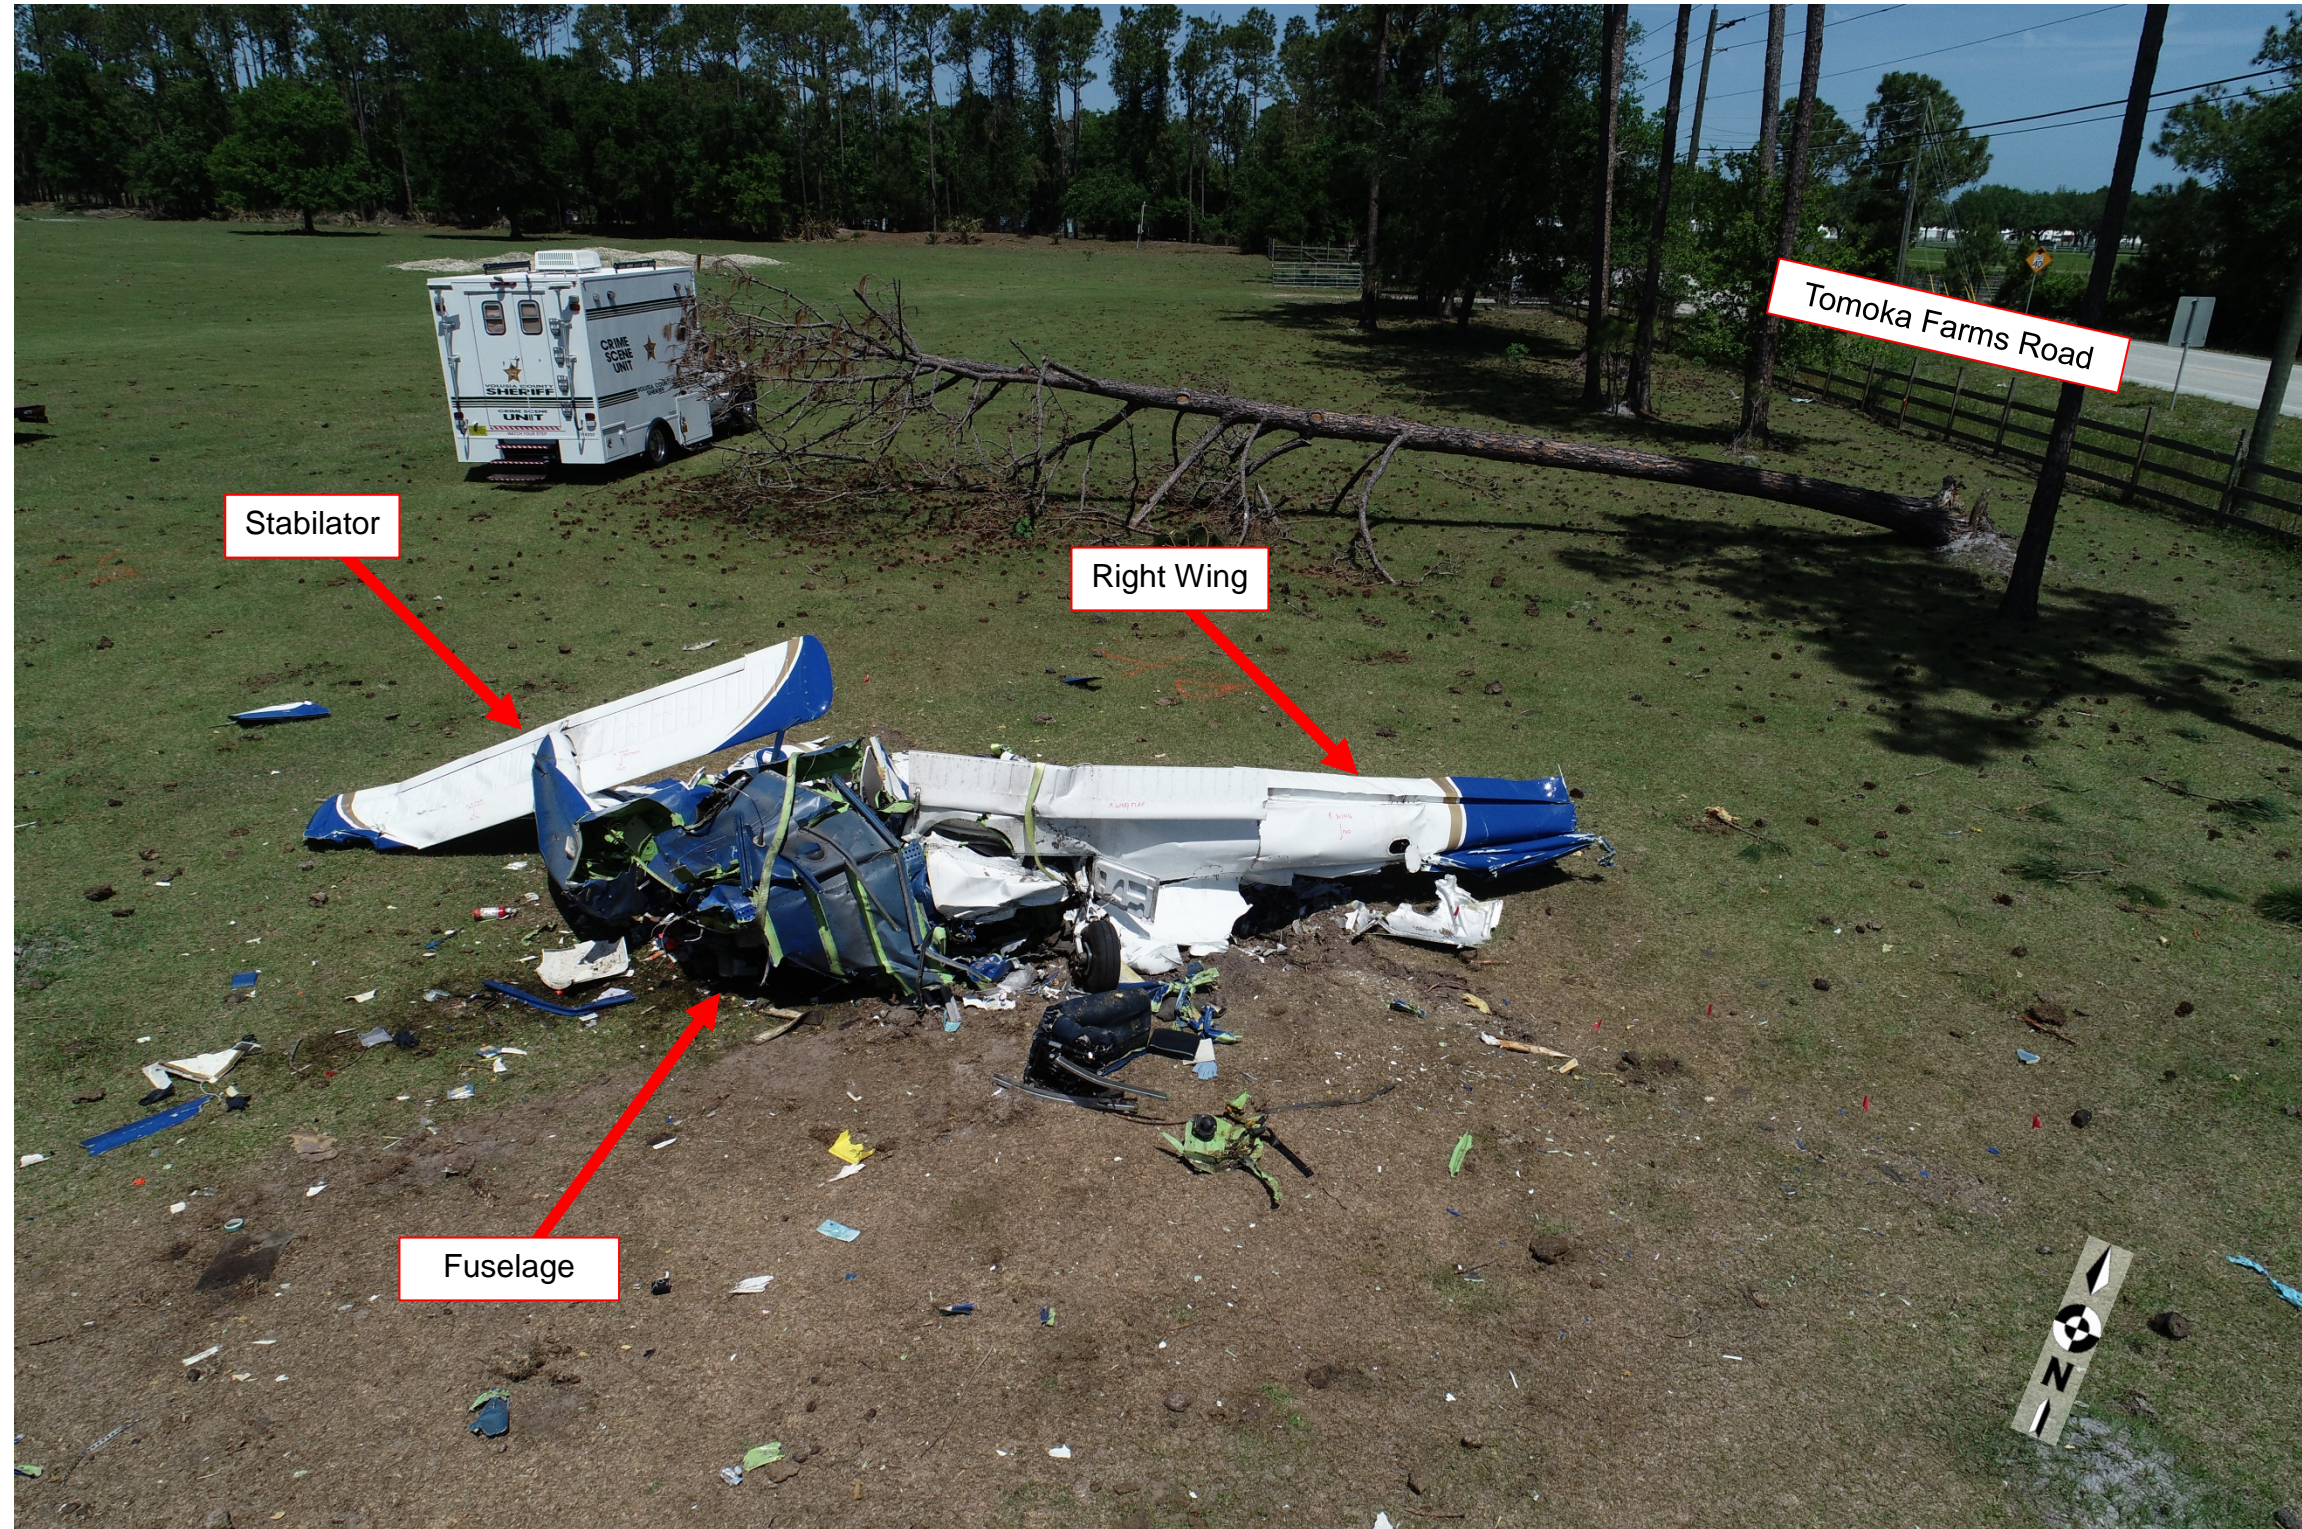
Figure 2 is a still image showing the main wreckage at the accident scene. The fuselage, right wing and bottom surface of the stabilator is visible in the image.

Figure 2 – Photo, Main Wreckage Site (directional arrow approximated)

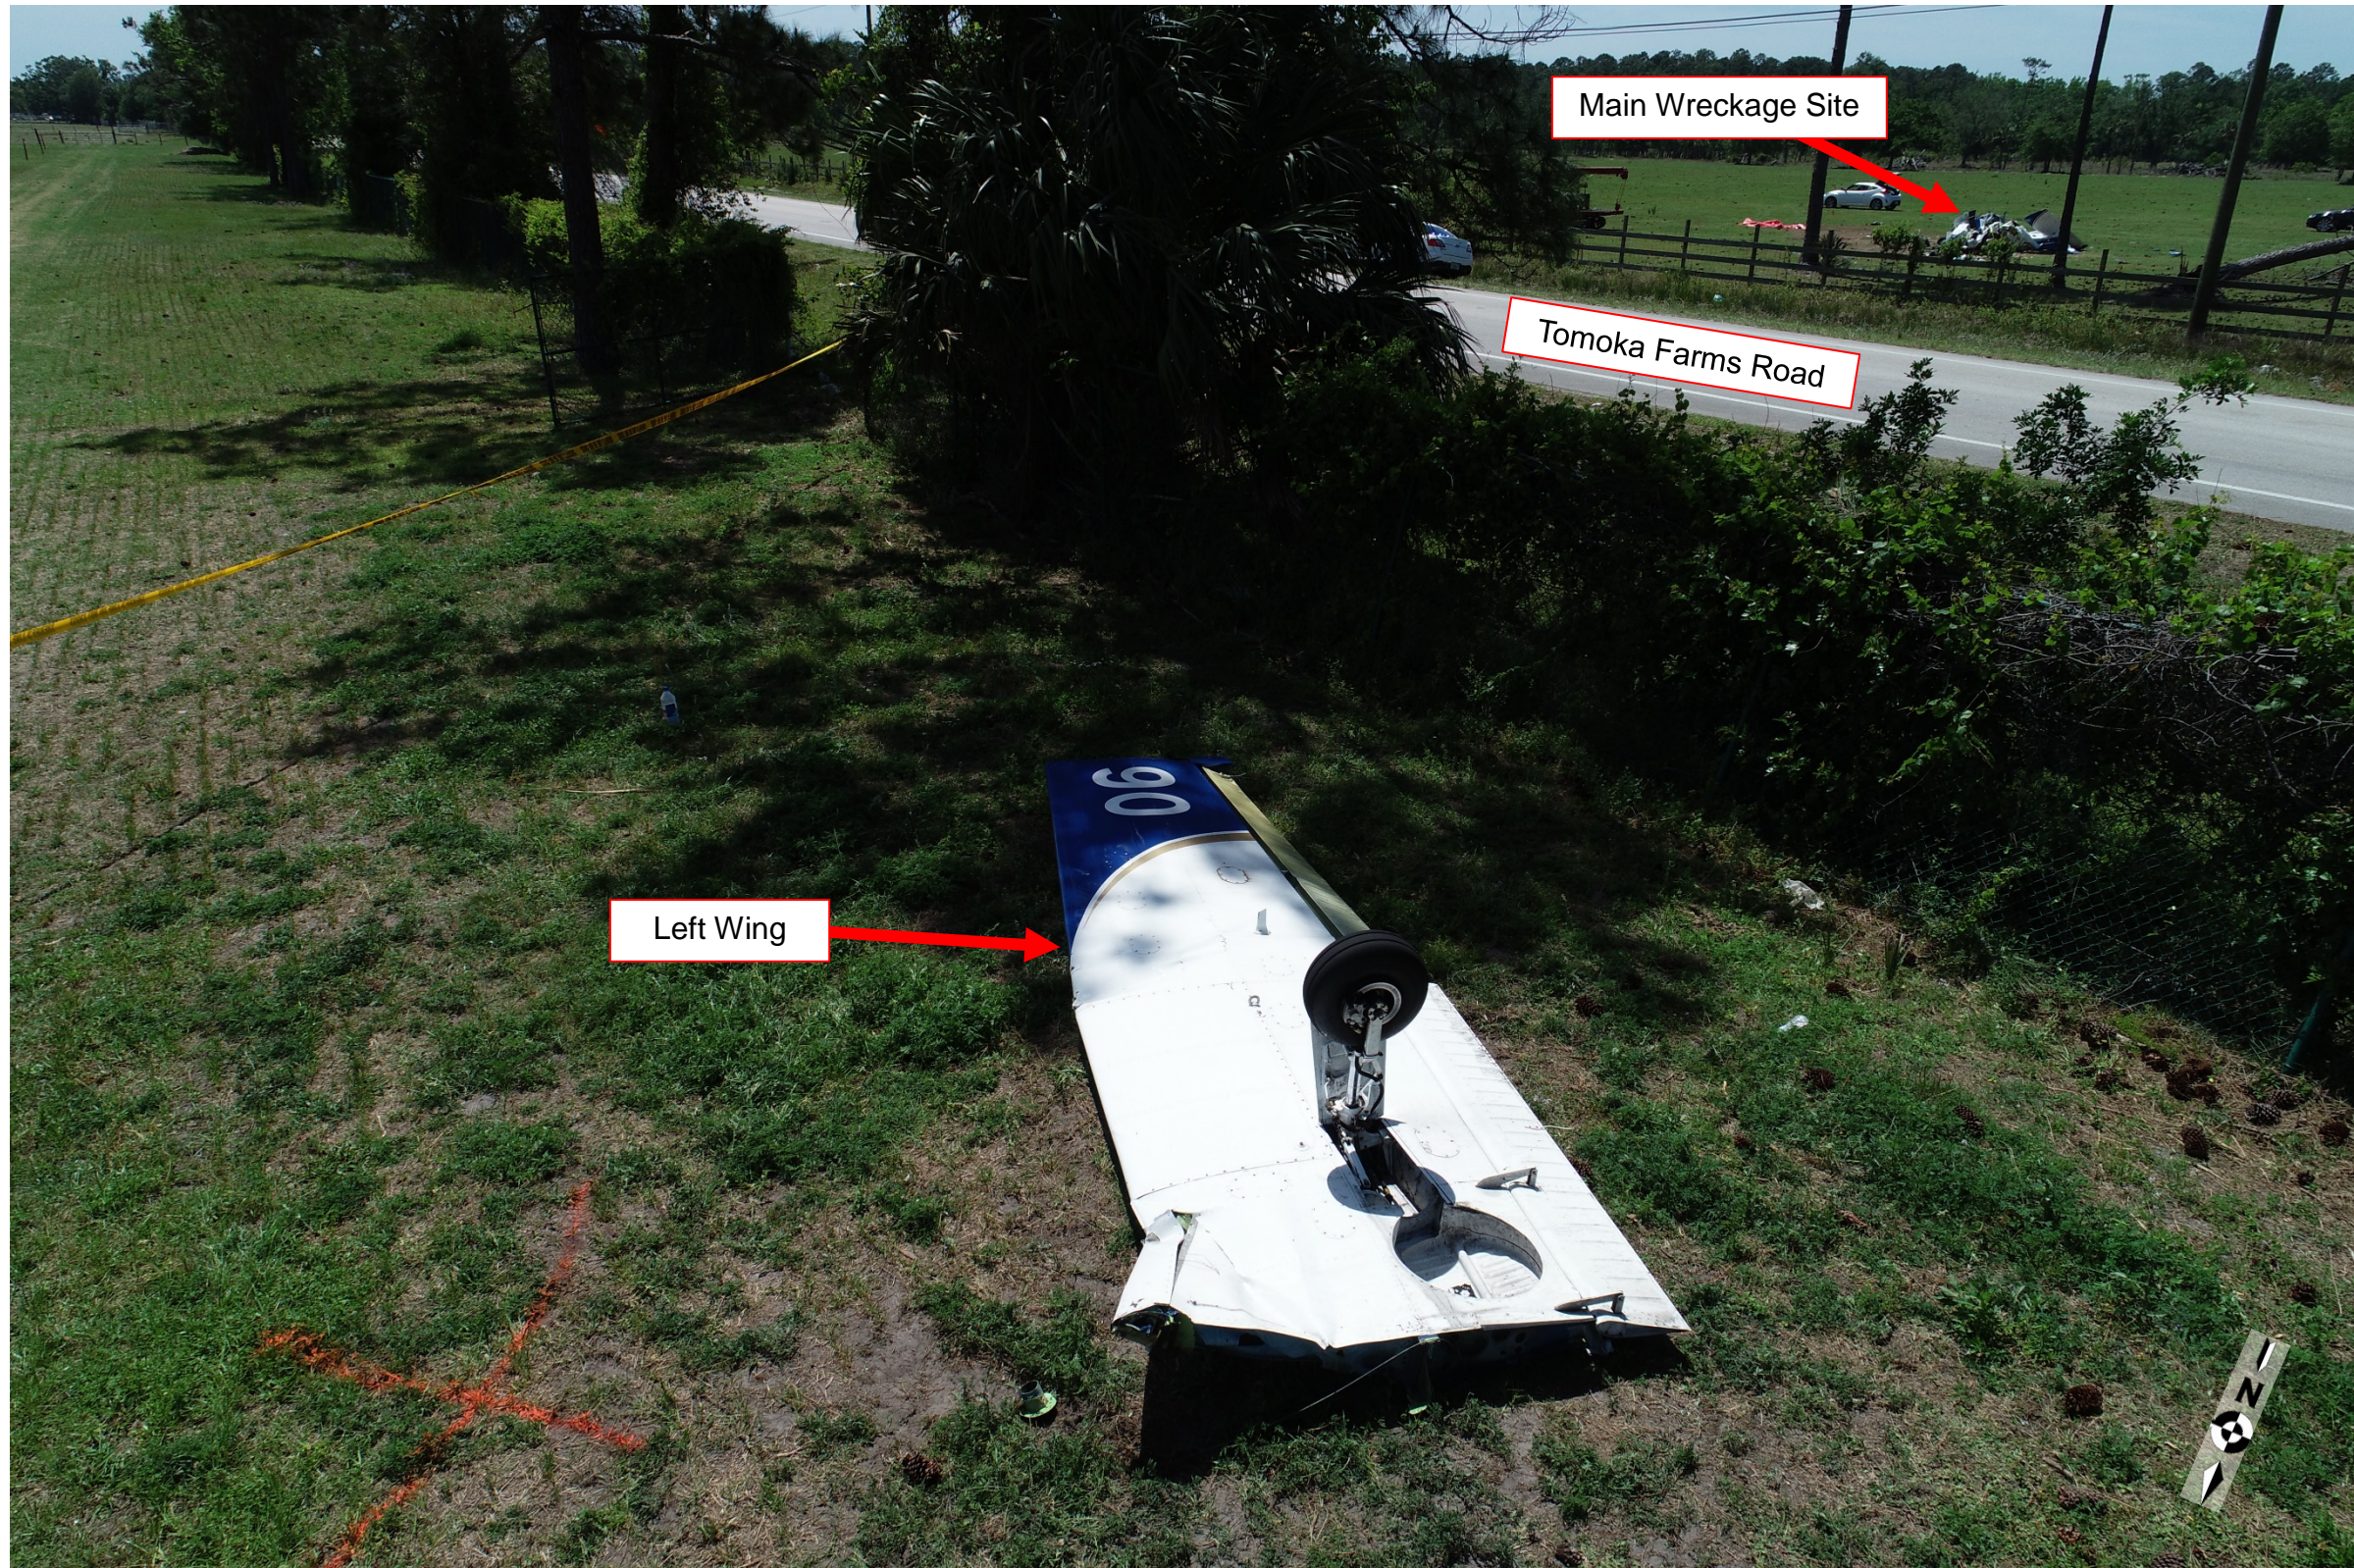
Figure 3 is a still image showing the left wing at the accident scene. Left main landing gear can be seen in an extended position.

Figure 3 – Photo – Left Wing (directional arrow approximated)

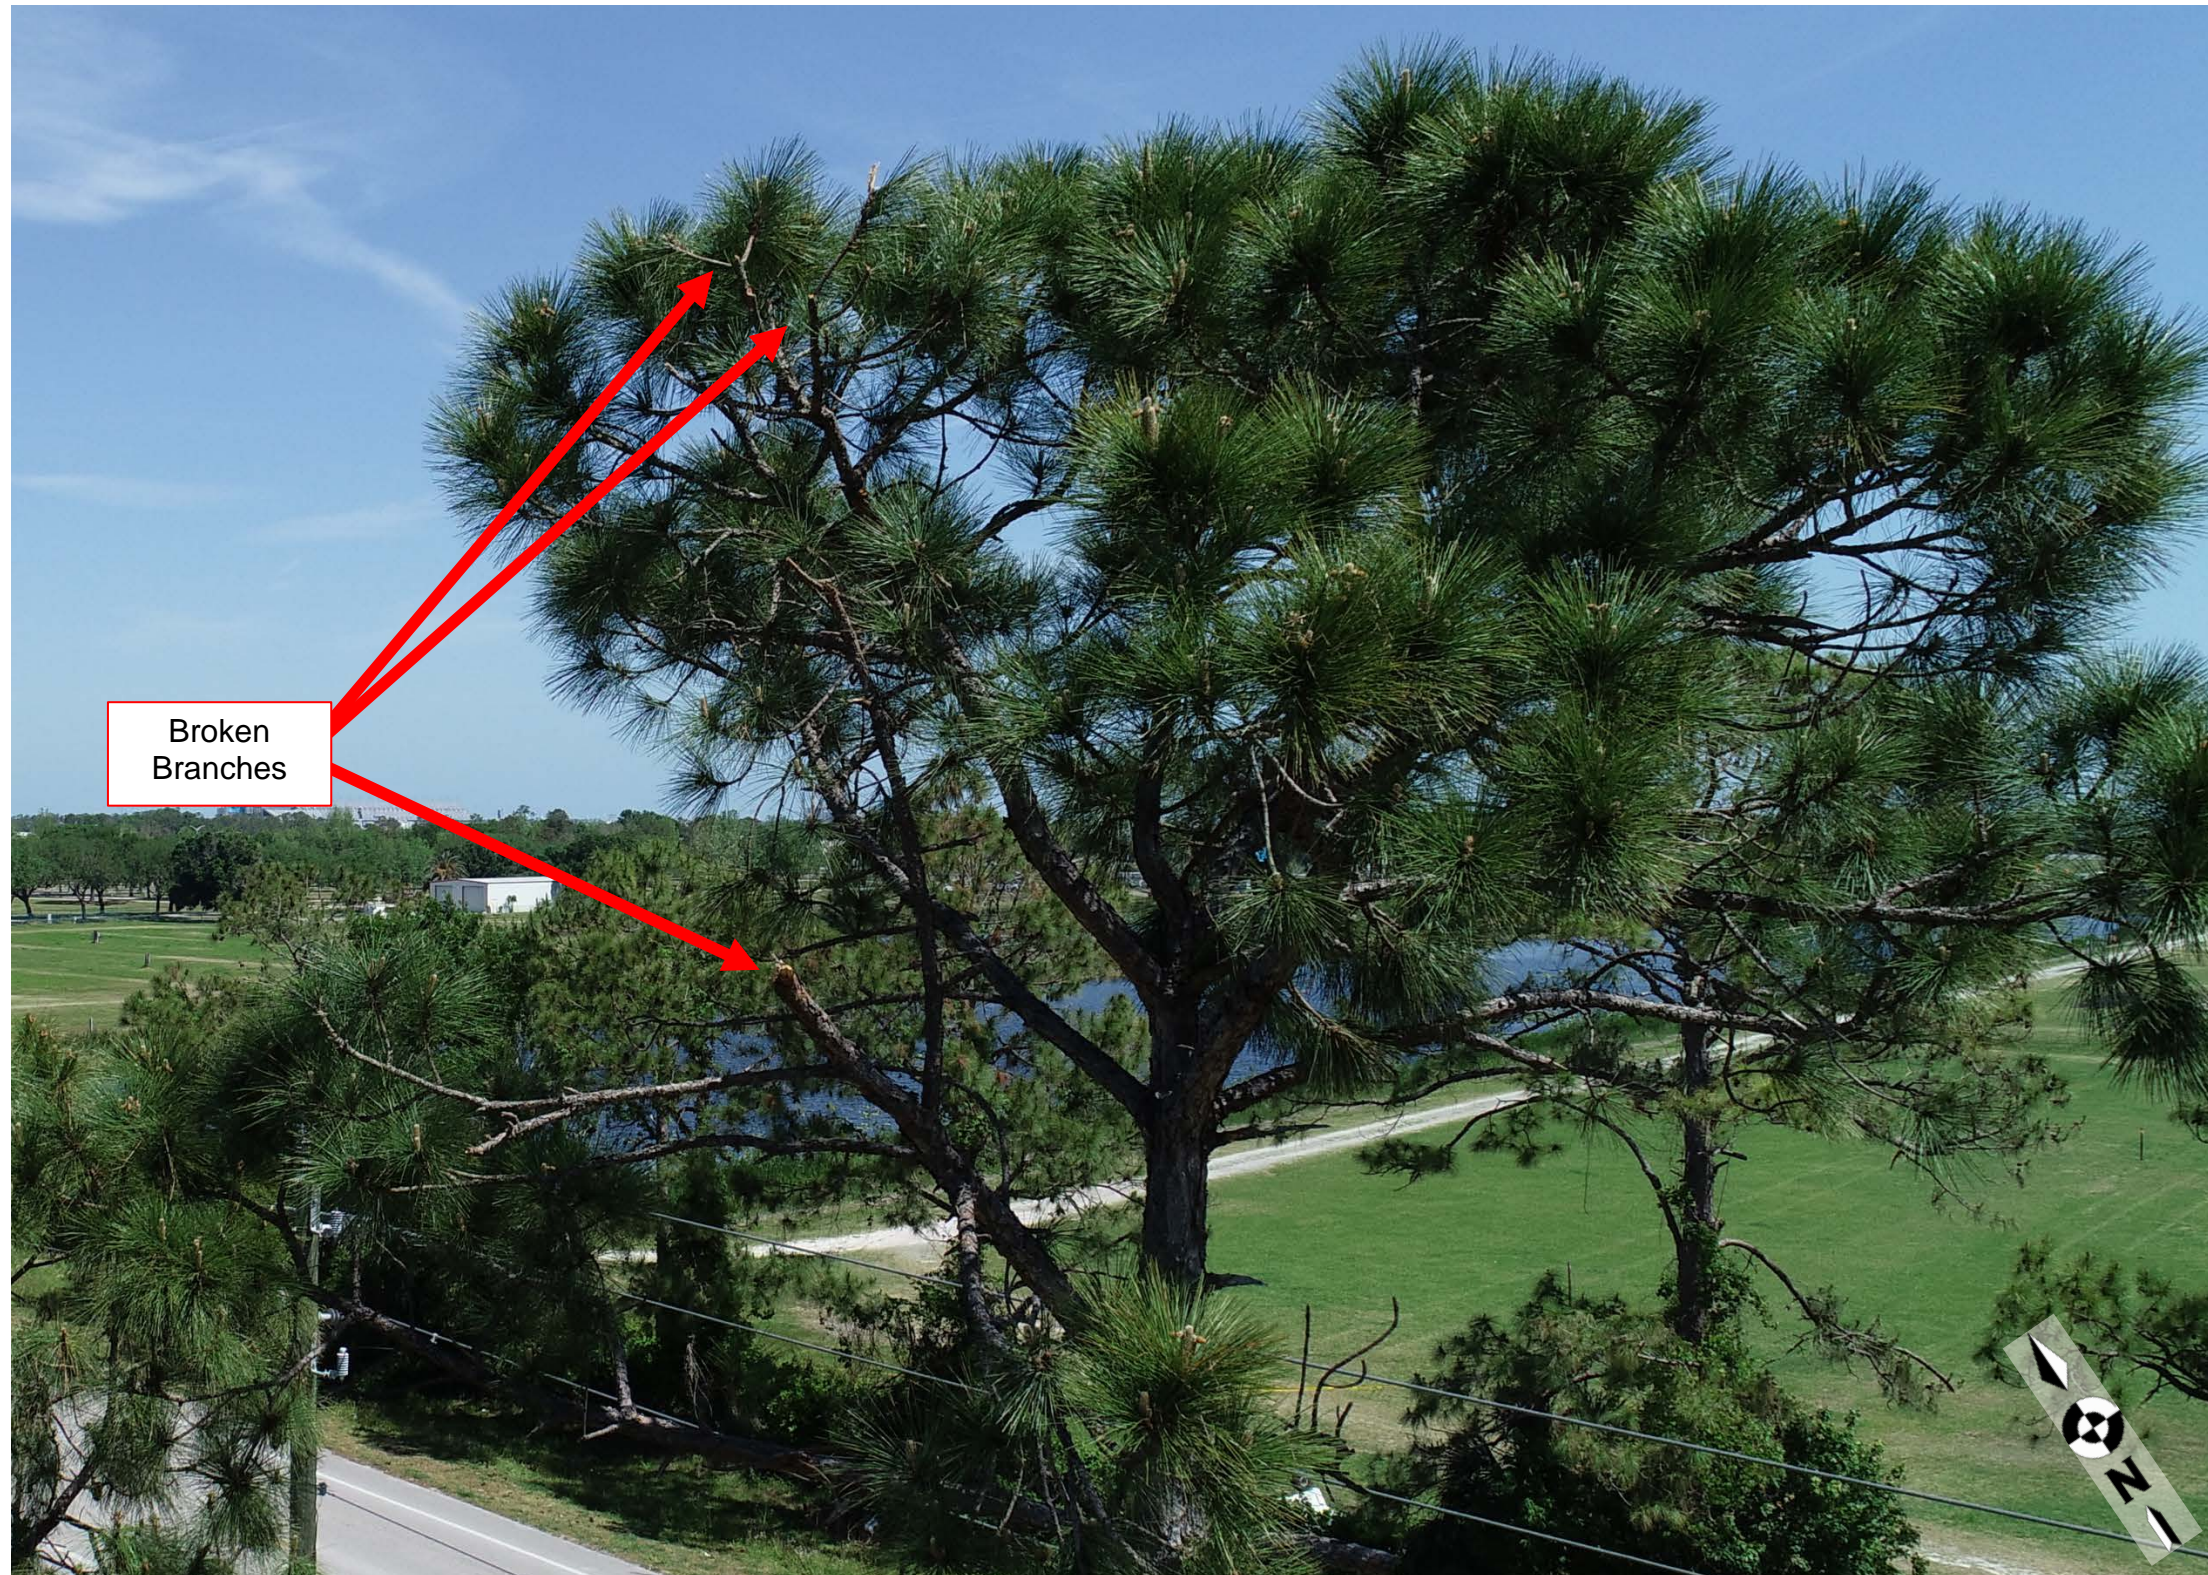
Figure 4 is a closeup, cropped, still image showing the tree that had branches separated during the aircraft's descent. Multiple severed branch locations are noted. Utilizing data from the point cloud, the aircraft's angle of descent was approximately 71 degrees relative to the horizon.

Figure 4 – Photo (Cropped) showing a closeup of tree in flight path with broken branches (directional arrow approximated)

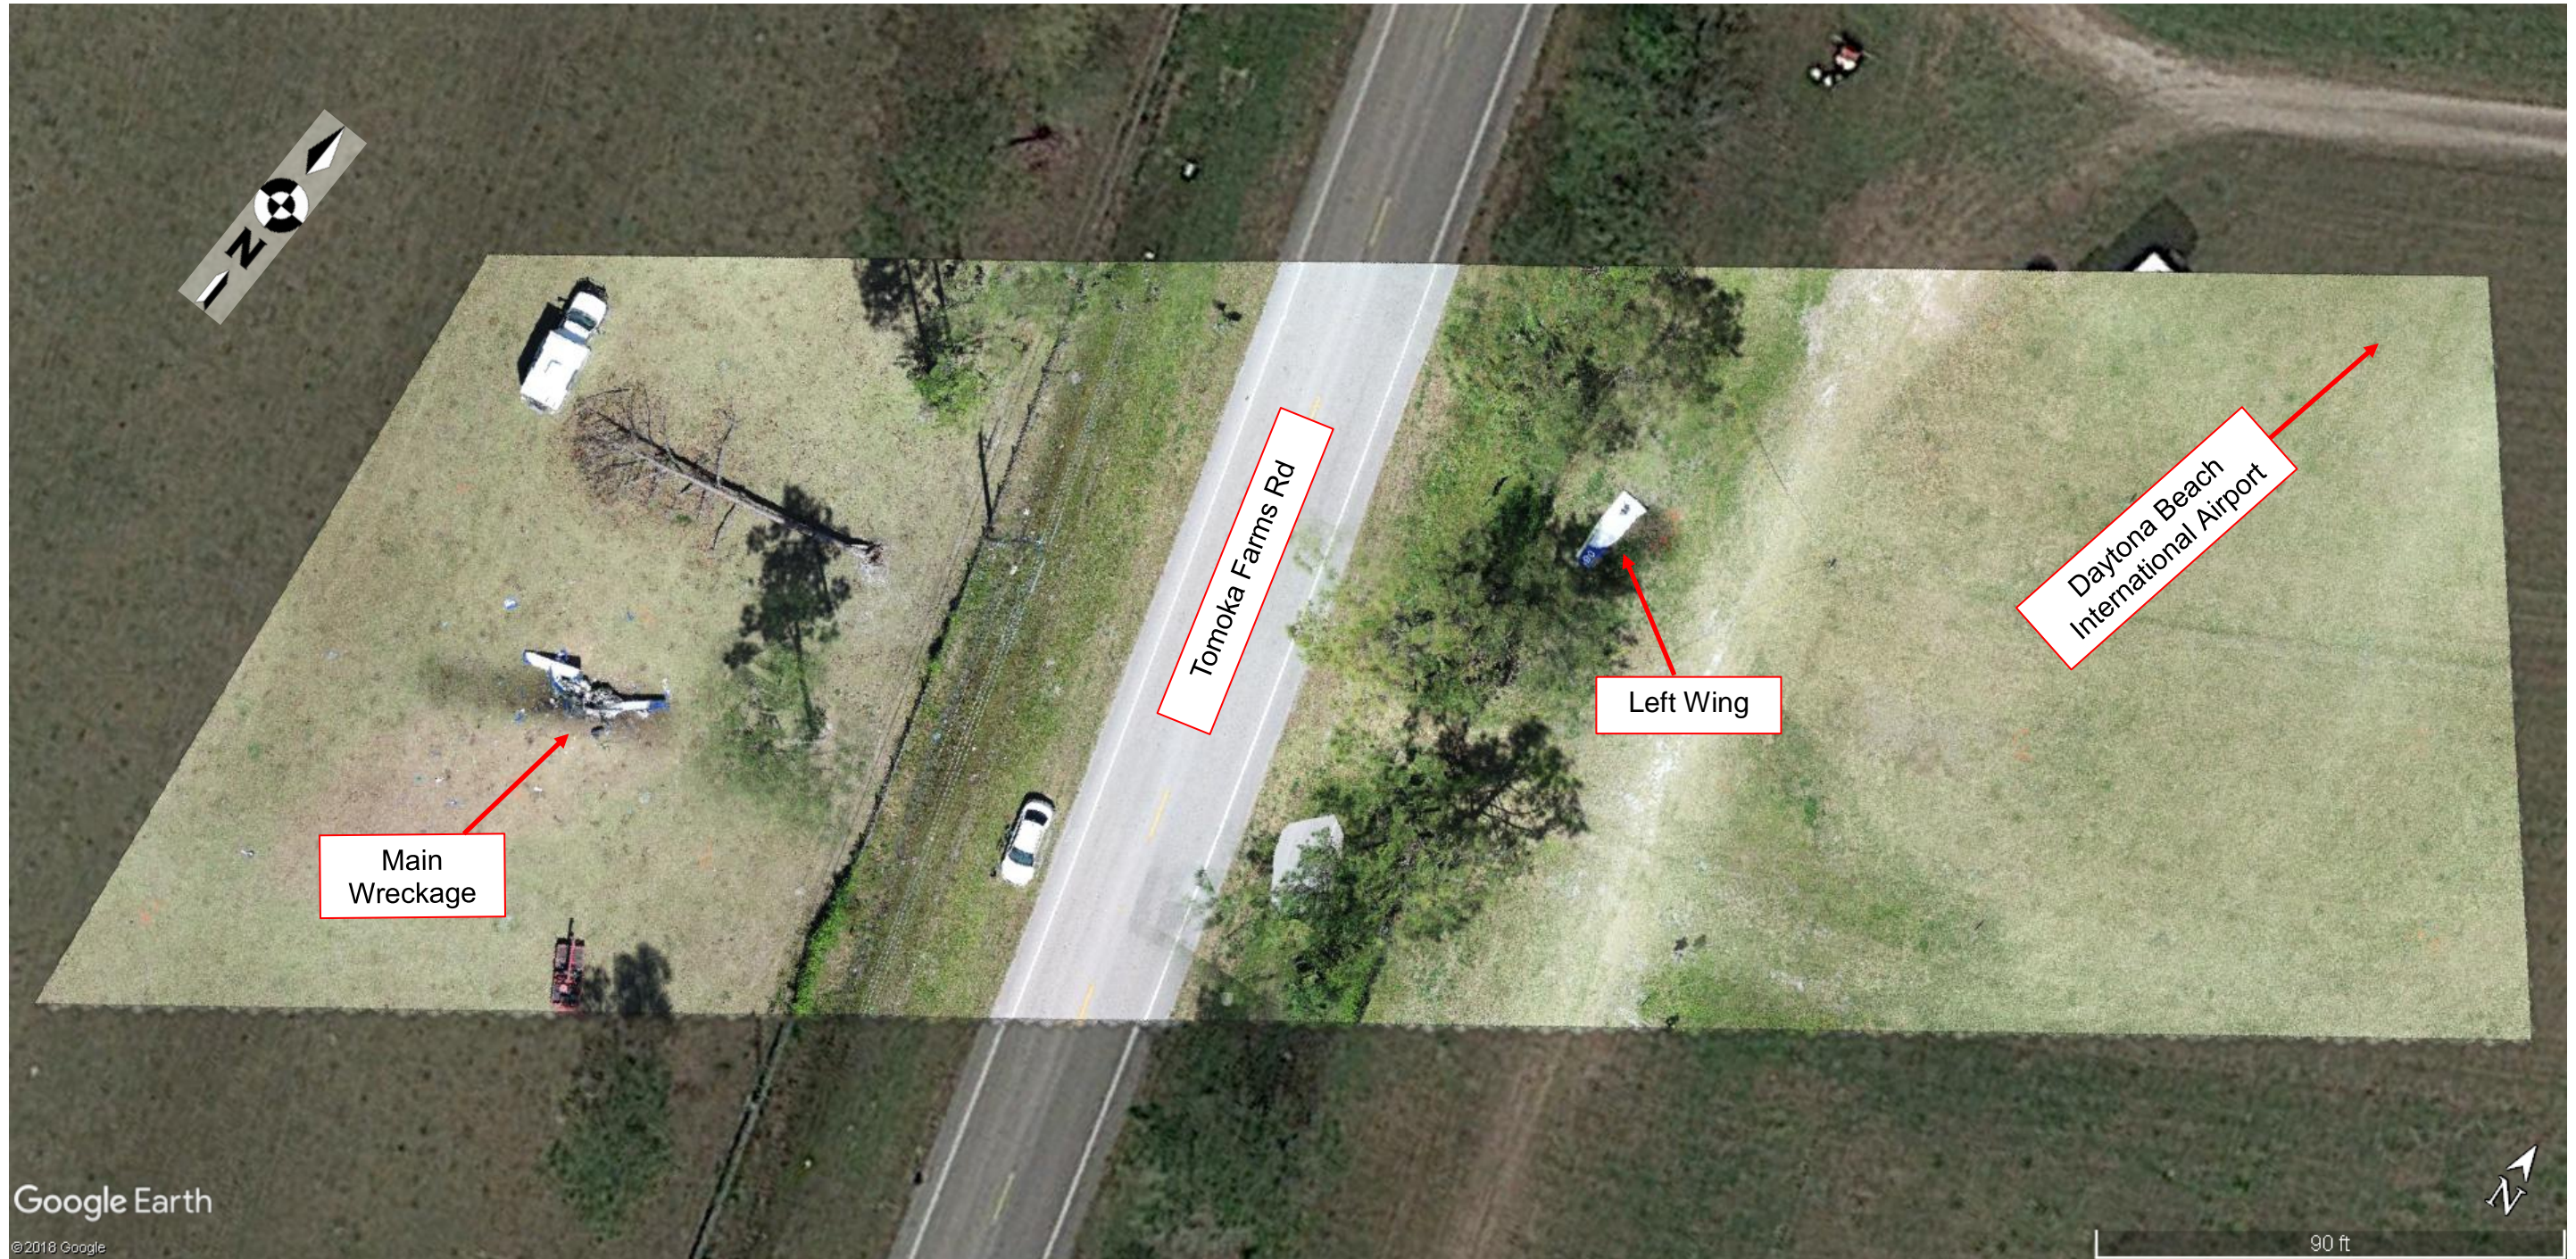
Figure 5 contains a screenshot of the orthomosaic map in Google Earth .kmz format.

Figure 5 - Orthomosaic of accident site overlaid on Google Earth.

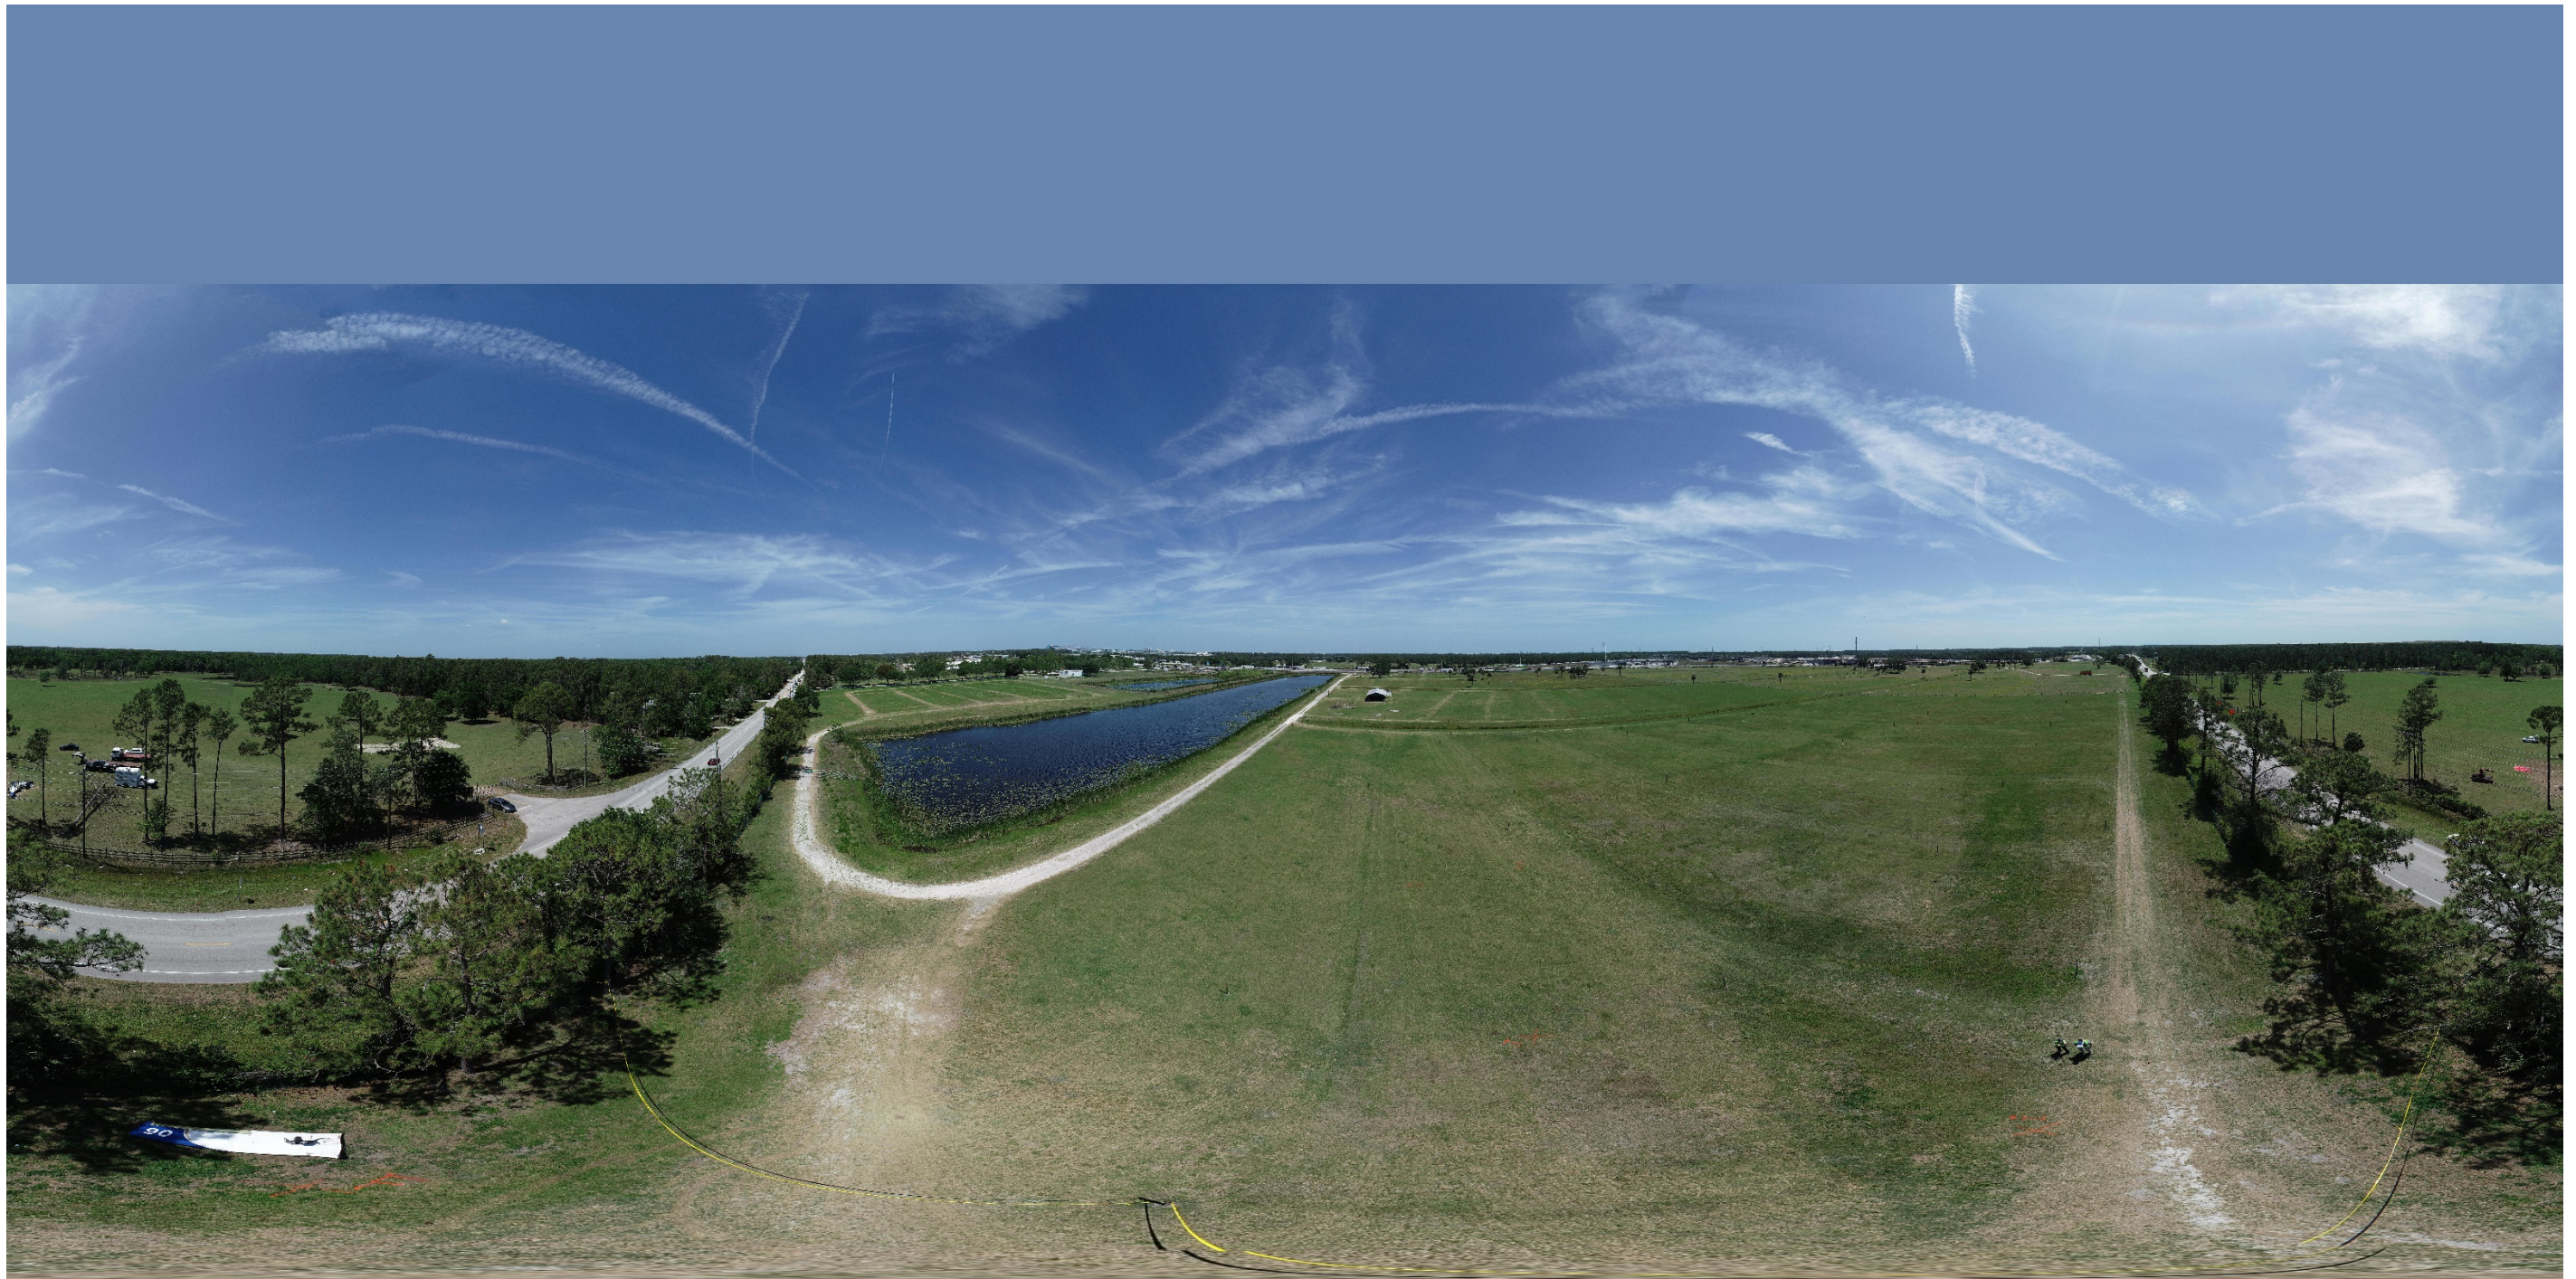
Figure 6 is a sample of the panoramic view of the overall accident scene. The image was created using commercially available software which stitched together 34 individual images taken using a programmed sequence from the drone control software. The product is intended to be used with a 360 Panoramic viewer software and it is projected onto 2D for this report, creating various distortions. The original panoramic image is an attachment to this report and located in the accident docket.

Figure 6 - Panoramic image of wreckage scene (Image contains distortions)<sup>3</sup>.
