NATIONAL TRANSPORTATION SAFETY BOARD

Group Chairman's Factual Report

ERA18FA120

Attachment 3 – USAF Wing Spar Analysis Results (38 pages)

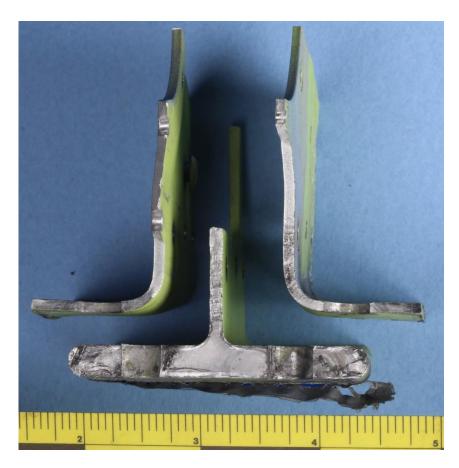
Crack on sister aircraft

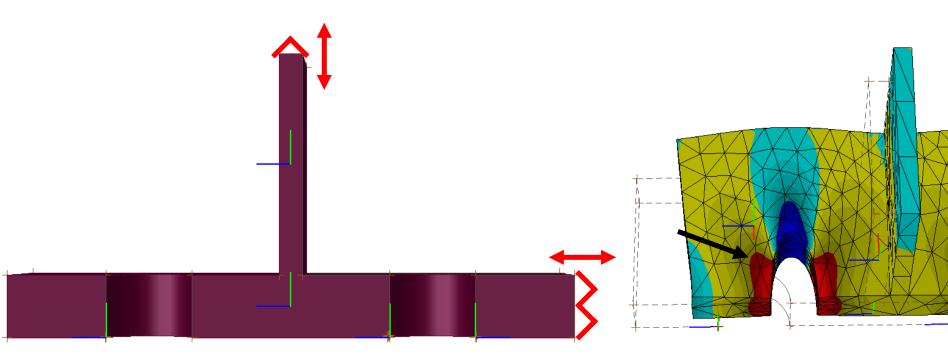
Initial constraint approach

Slight unintended bending caused higher stresses on left side hole. The difference caused cracks to not grow analytically on the side closest to the constraint.

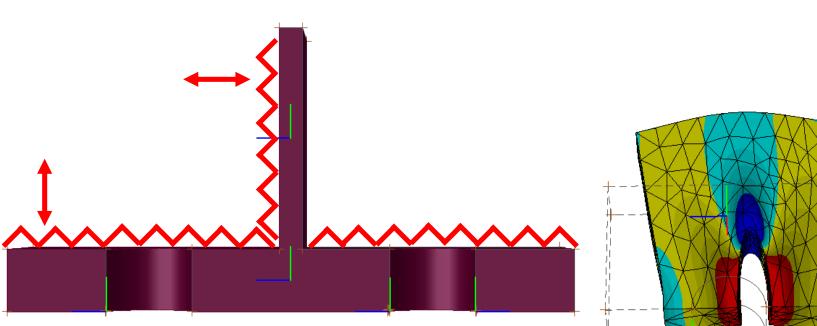
Final constraint approach

No noticeable bending is induced and

Take away: apply constraints near the neutral axis

stress/deformation around holes are symmetric.

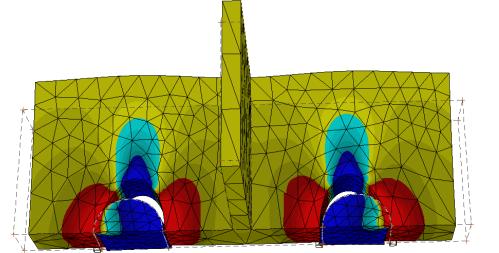
This was the first analysis attempted using fastener contact in BAMF
 Initial pin constraint restricted translation on the upper face of the pin in two directions, up-down and fore-aft

Constraining the pins laterally caused the spar to deform around the pins creating peak stresses on the outer sides and minimal contact on the inner. Furthermore, pin bending caused high stresses at the top of the pin with minimal contact at the bottom

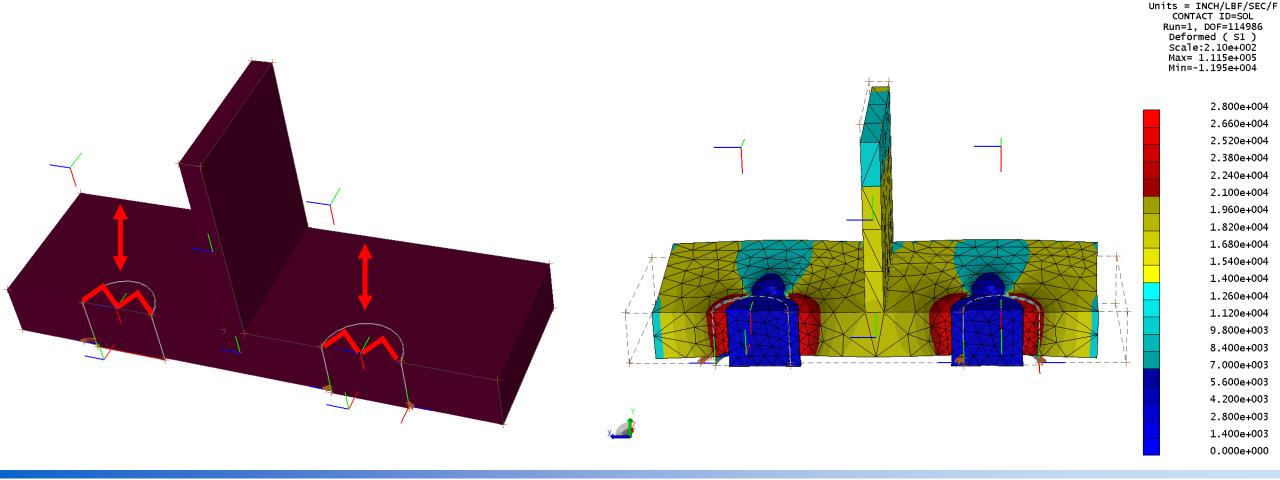
Permitting the pin to translate laterally with spar deflection created the expected, uniform stresses through thickness at the fastener holes stresscheck VID.3

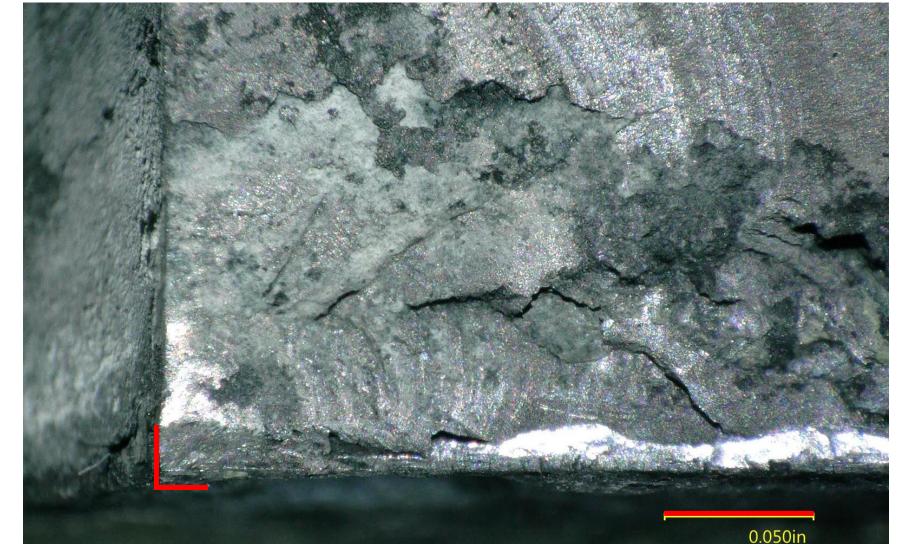
Surface length line: 0.75 Reference line: 1.73 Surface/Ref erence=x/0. 05 a=0.75*0.05 /1.73=**.022**"

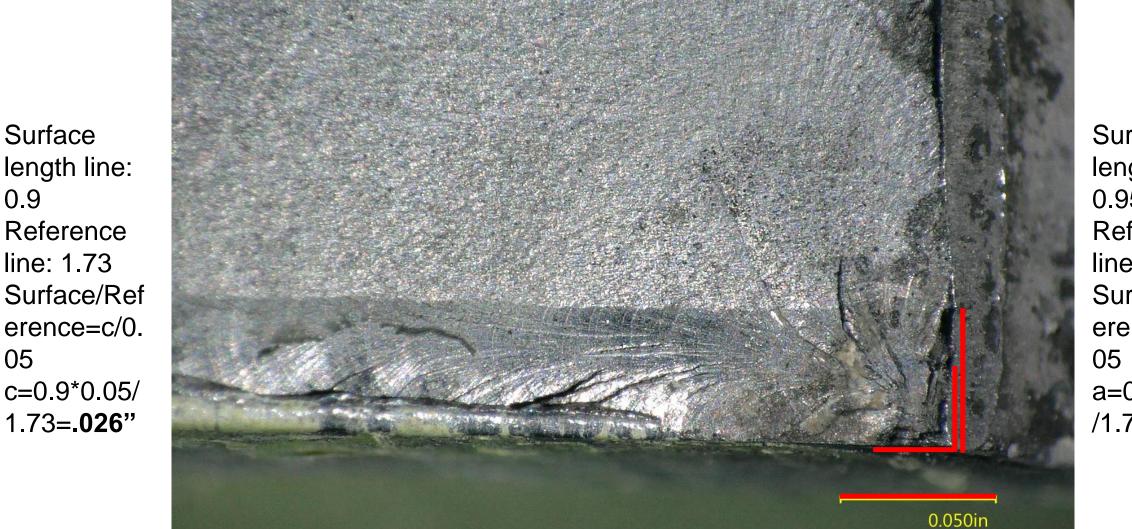
Surface length line: 0.95 Reference line: 1.73 Surface/Ref erence=a/0. a=0.95*0.05 /1.73=.027"

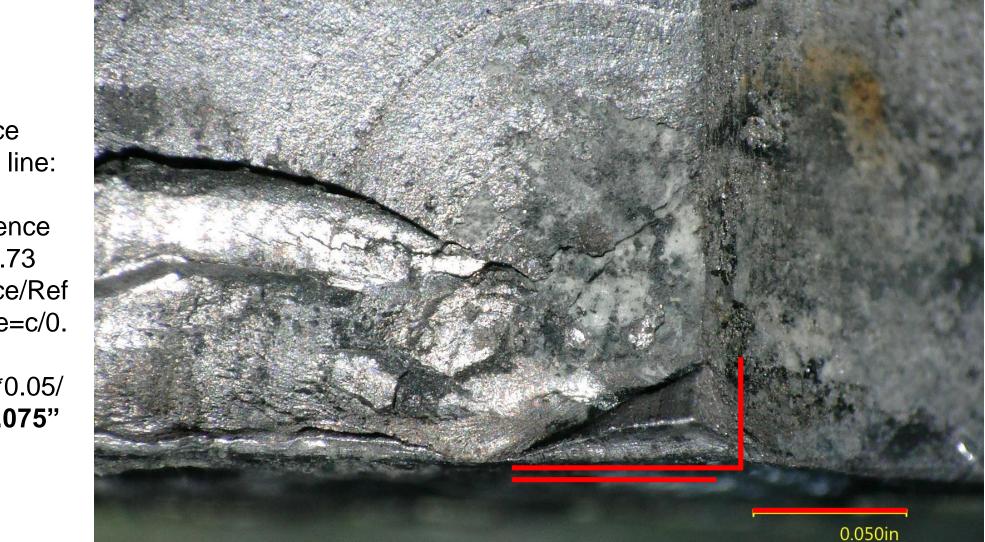
Surface length line: 1.25 Reference line: 1.73 Surface/Ref erence=a/0. 05 a=1.25*0.05 /1.73=**.036**"

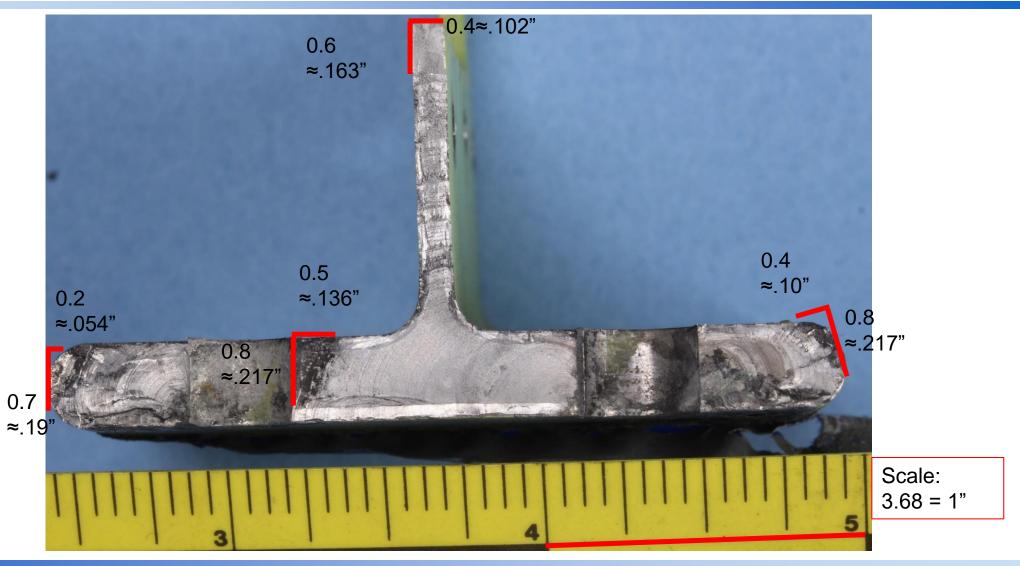
Remaining Area: .102" x .163" + .054" x 0.19" + .108" x .217" + .136" x .217"/2 = .065 in^2

Remaining load capability: A=1.907 in^2 P=Sigma*A = 44 ksi*.065in^2= **2.86 kip**

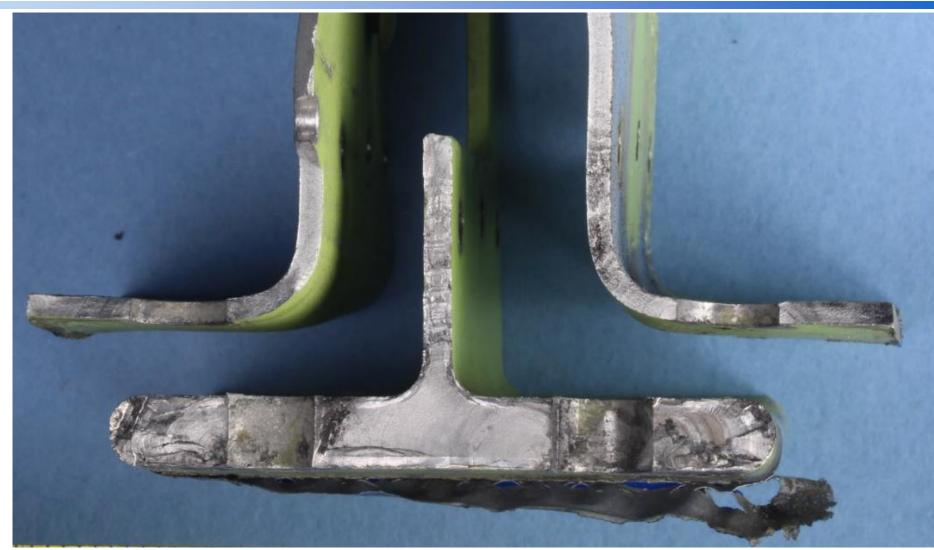
Remaining load capability of only 2.86 kip implies load redistributed to other structure.

Image of angles confirms load did redistribute and grow cracks in secondary structure
