----- SYSTEMS GROUP CHAIRMAN'S FACTUAL REPORT -----

Location: Greenville, South Carolina  
Date: September 27, 2018  
Time: About 1840 GMT (1340 LCL)  
Aircraft: Dassault Falcon 50  
Serial Number: 17  
Registration: N114TD

#### **3.2 Systems Group Summary**

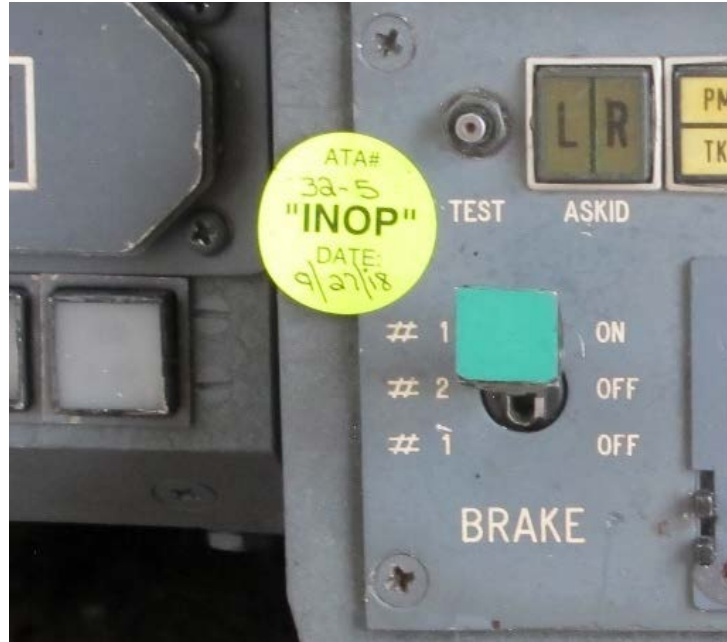
Figure 7 – Brake switch showing “INOP” sticker closeup

The “Brake” switch was found in the “#1-ON” position. Next to the switch, a green sticker was affixed to the panel with the label “ATA # 32-5 “INOP” DATE: 9/27/18”, ref Figure 7.

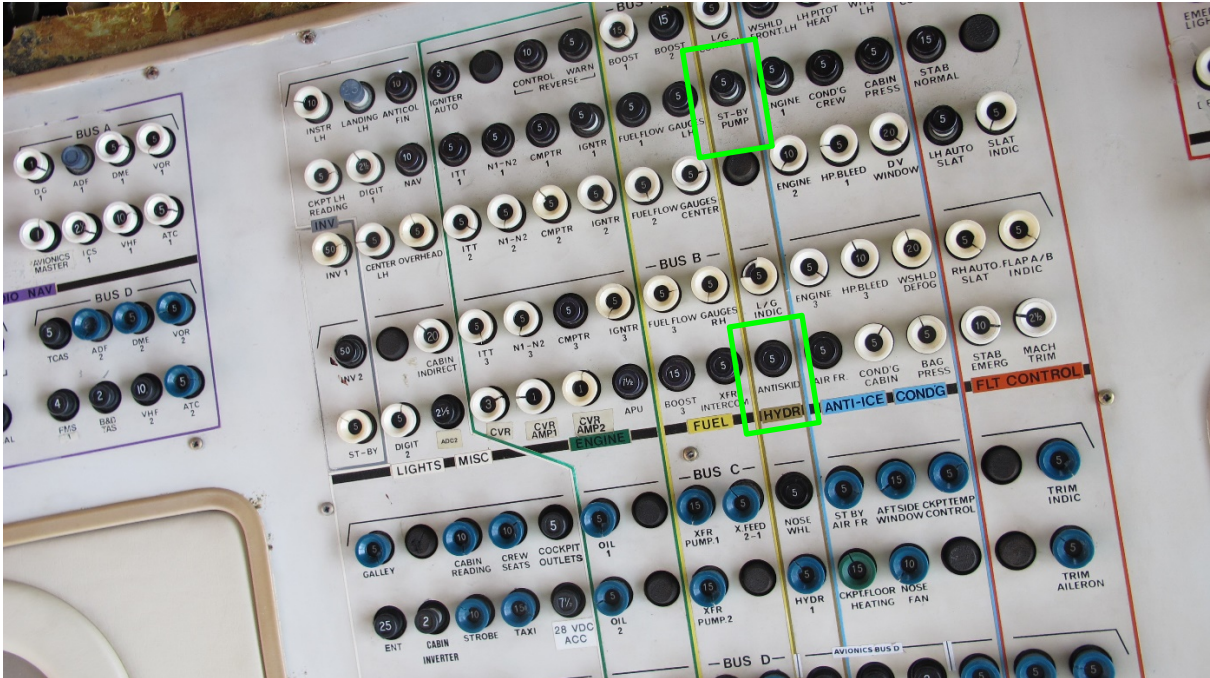
Figure 8 – Overhead C/B Panel with antiskid and standby pump breaker highlighted

The overhead circuit breaker panels were inspected for any circuit breakers in a tripped/open/collared state. Relevant circuit breakers for the hydraulic, “HYDR”, were noted in the following positions as stated in Table 1 and a portion of the panel is shown in Figure 8.

Name	Panel Ref.	Condition
HYDR 1	HYDR	Closed
HYDR 2	HYDR	Closed
NOSE WHL	HYDR	Closed
ANTISKID	HYDR	Closed
L/G INDIC	HYDR	Closed
L/G CONTROL	HYDR	Closed
ST-BY PUMP	HYDR	Open/Trip

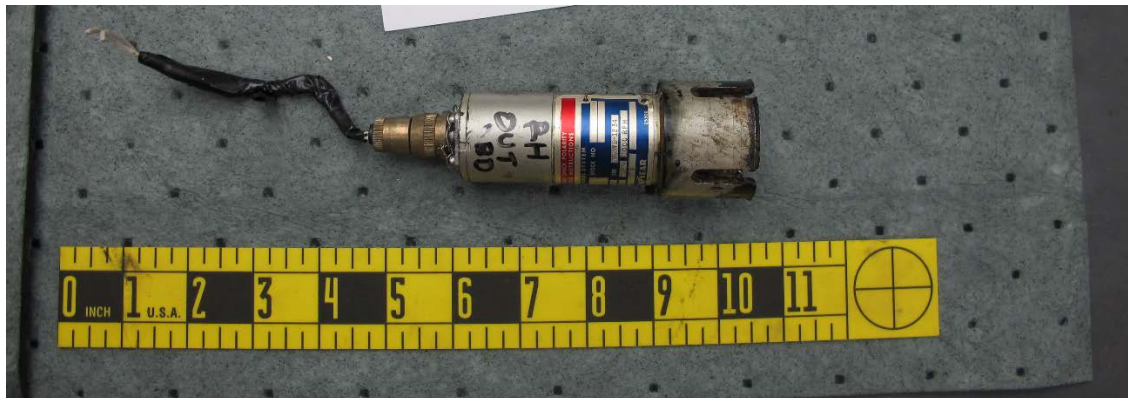
Figure 13 - RH Outboard transducer wiring

No notable signs of visible damage were noted, ref Figure 13. The aircraft wiring harness had indications of a field splice on the wiring which was covered using vinyl electrical tape. The electrical tape was not removed and remained in place for the CT scans.

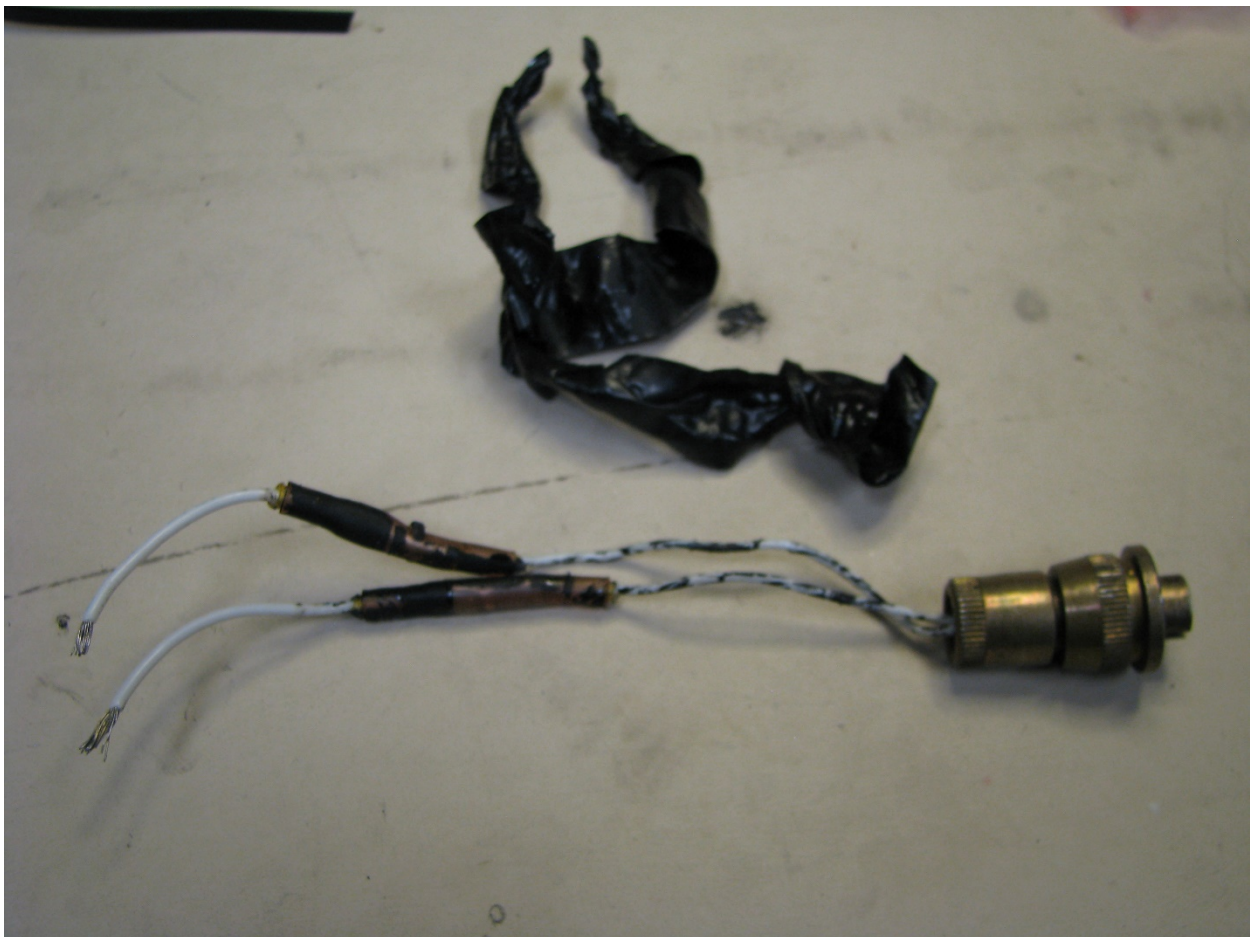
**Figure 14 - RH outboard transducer wiring with electrical tape removed.**

After the testing the electrical tape was removed to inspect the wire splices, ref Figure 14. It was noted that the wiring between the aircraft and the connector were of two different wire gages. Dassault informed the group that the use of splices in the wiring is not a recommended practice. The removal and replacement of the electrical connectors of the wheel speed transducers is specified in AMM Task 32-61-01-900-801 "Removal/Installation of the MLG Harness." This task also includes electrical tests after reinstallation of the electrical connectors.

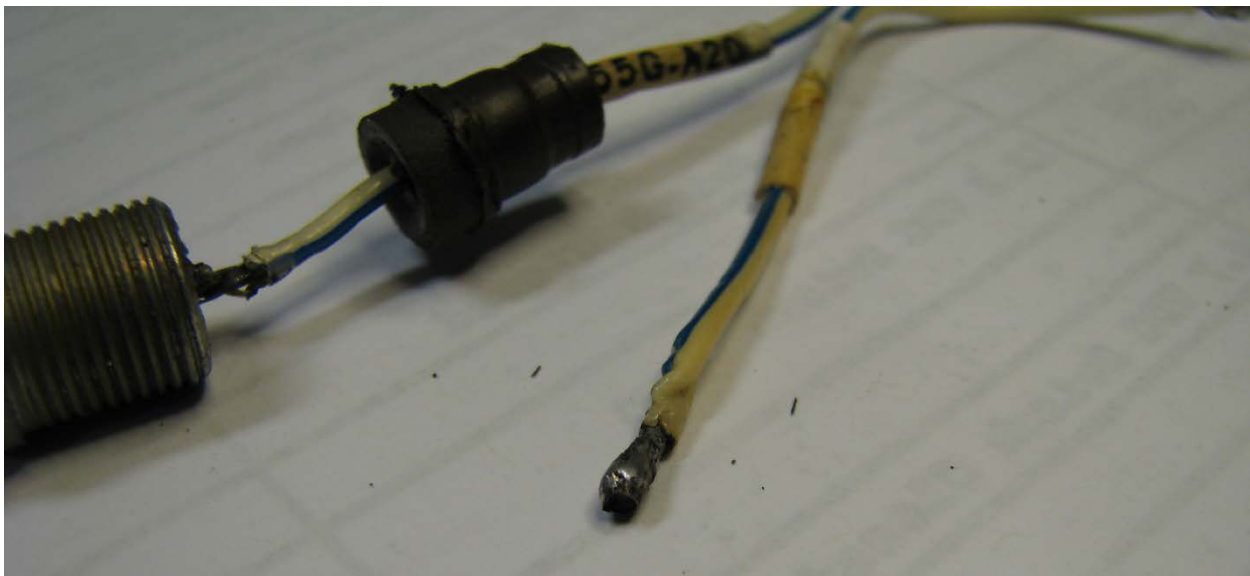
**Figure 18 - Broken wire to pin on wheel speed transducer connector**

With the aircraft harness installed, the unit passed the insulation resistance and dielectric test points. All remaining tests failed. If the harness was lightly moved, an intermittent voltage could be read from the device, but could not be sustained and resulted in a failed test.

After the testing the insulation was removed from the wiring harness, ref Figure 18. The solder connection at Pin B was found to be fractured and not making solid contact with the pin.

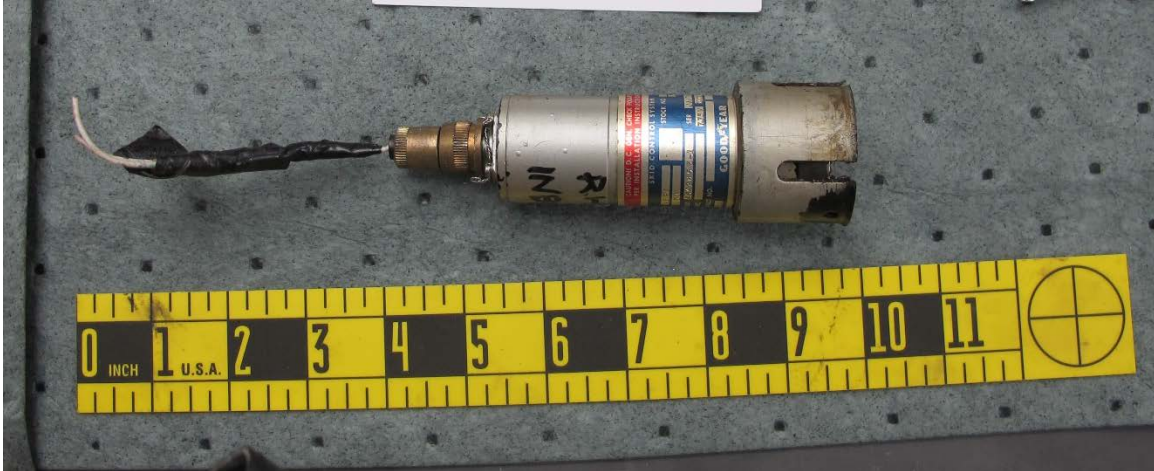
**Figure 19 – RH inboard transducer**

No notable signs of visible damage were noted, ref Figure 19. The aircraft wiring harness had indications of a field splice on the wiring and was covered using vinyl electrical tape. The electrical tape was not removed and remained in place for the CT scans.

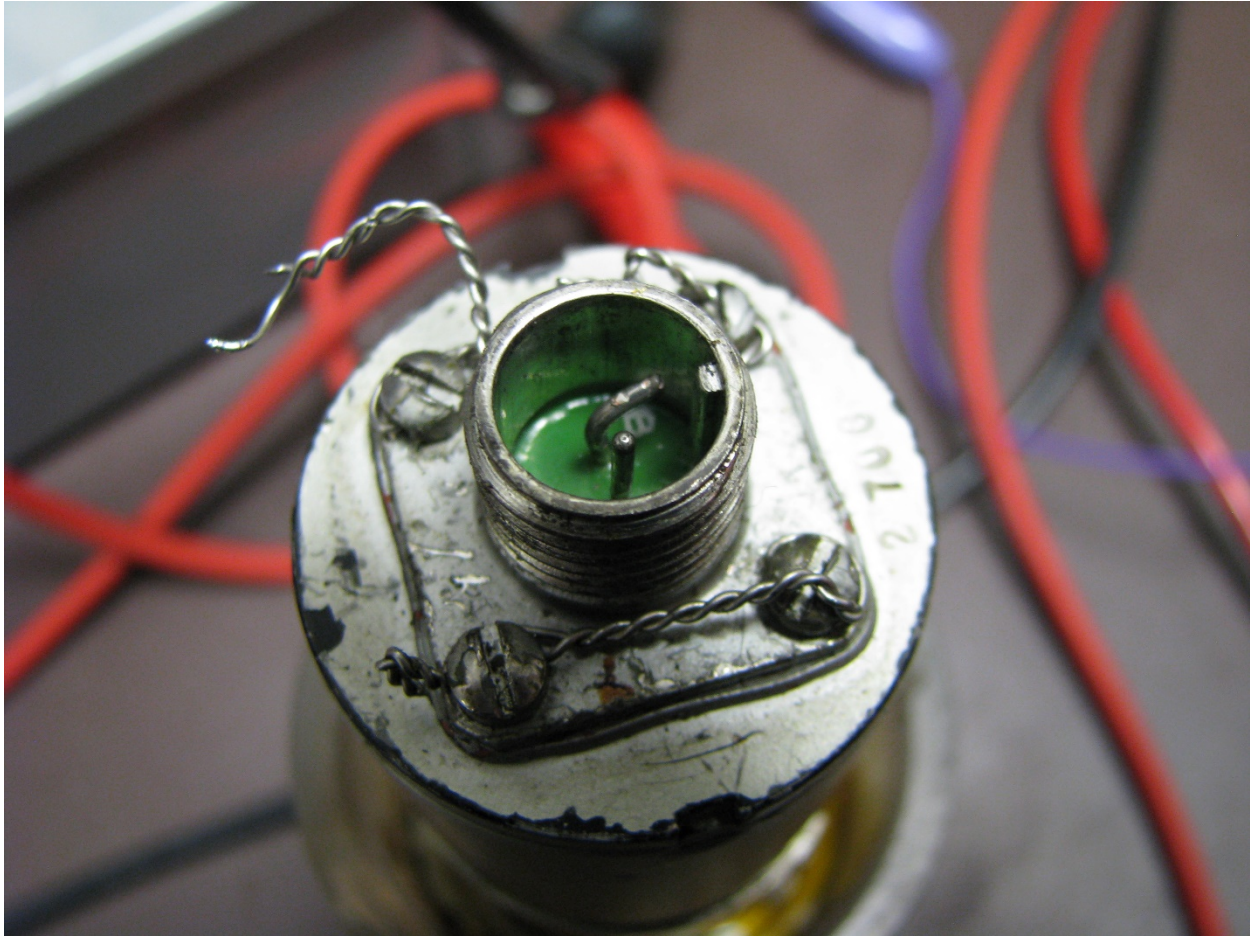
**Figure 20 - RH inboard transducer bent pin B after connector removal**

During the CT scans, Pin B on the transducer was found to be bent and appeared to be in contact with the side of the connector insulator (Refer to CT factual report for images of fouling condition). Prior to removing the aircraft harness, the insulation resistance and dielectric testing was repeated, but a portion of the paint on the wheel adapter was removed to provide a metal to metal contact. Both tests failed. In order to replicate an aircraft installation and possible grounding path, the probe lead was connected to the locking bolt hole. Both the IR and dielectric tests failed at voltages exceeding 350 V (the test required 500 V). The test was repeated using an exemplar unit and the unit passed the testing.

The harness was removed, and the bent pin examined, ref Figure 20. When the connector was removed, no obvious signs of the pin contacting the connector side were visible. The insulation resistance and dielectric testing was repeated, and the unit passed per the FTI requirements.

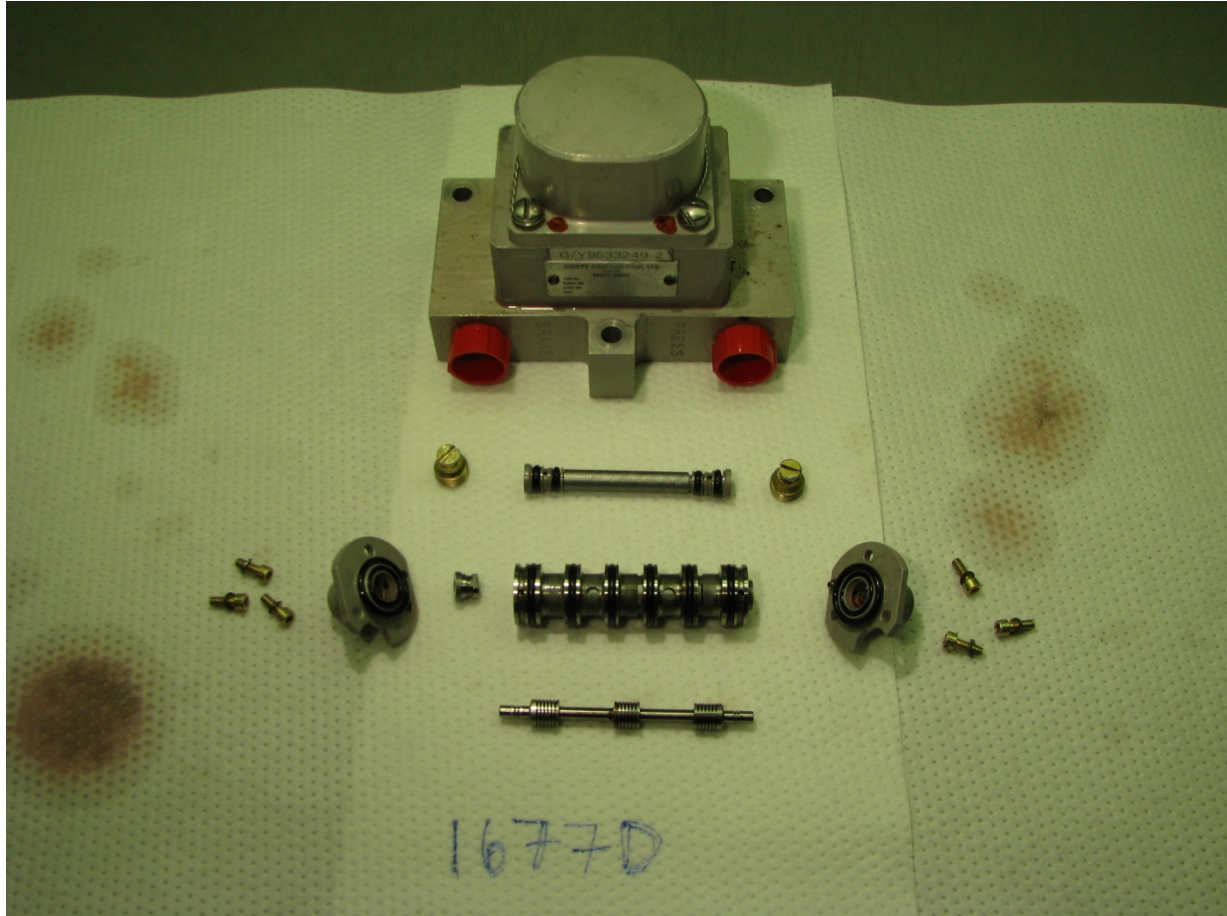
**Figure 23 - LH disassembled control valve**

The valve passed the coil resistance and insulation resistance, leakage and proof pressure tests. The valve failed the pressure control checks and the pressure drop tests.

The spool and sleeve were removed. The sleeve and packing material were inspected under a microscope. The seals visually appeared to be intact and installed correctly. Areas of discoloration and corrosion were noted on some of the spool surfaces. The spool would move freely in the spool when acted upon by gravity. No obvious signs of friction were noted.

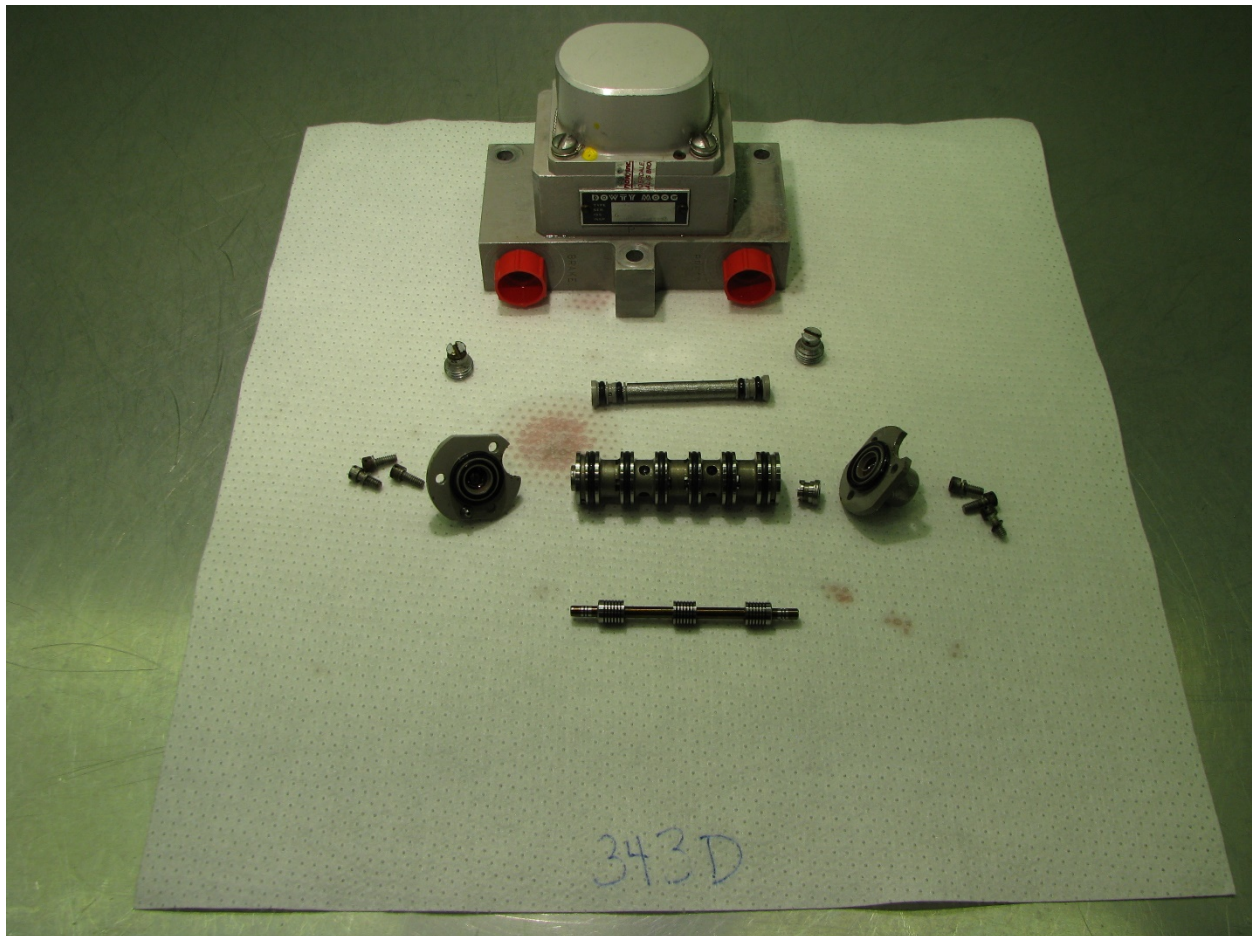
Figure 24 - RH disassembled control valve

The valve passed the coil resistance and insulation resistance, leakage and proof pressure tests. The valve failed the pressure control checks and the pressure drop tests.

The spool and sleeve were removed. The sleeve and packing material were inspected under a microscope. The seals visually appeared to be intact and installed correctly. Areas of discoloration and corrosion were noted on some of the spool surfaces. The spool would move freely in the spool when acted upon by gravity. No obvious signs of friction were noted.

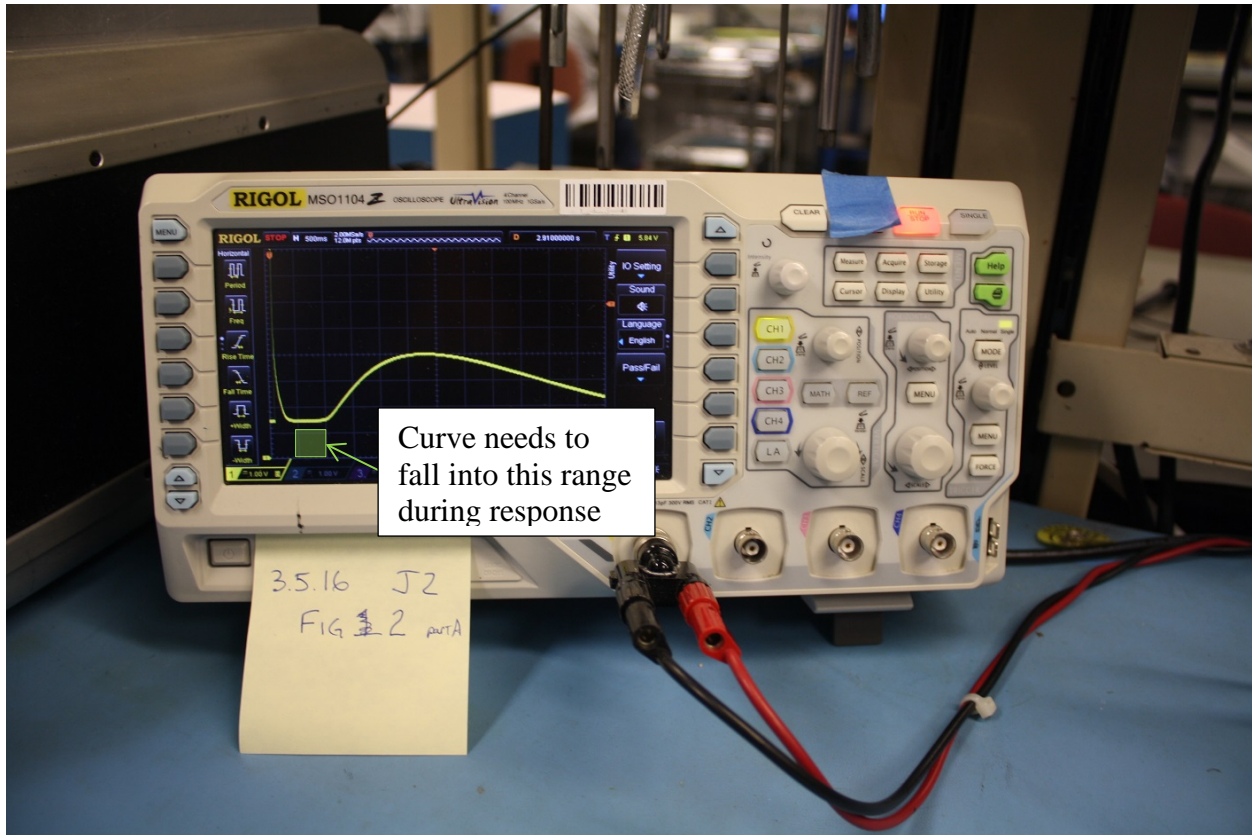
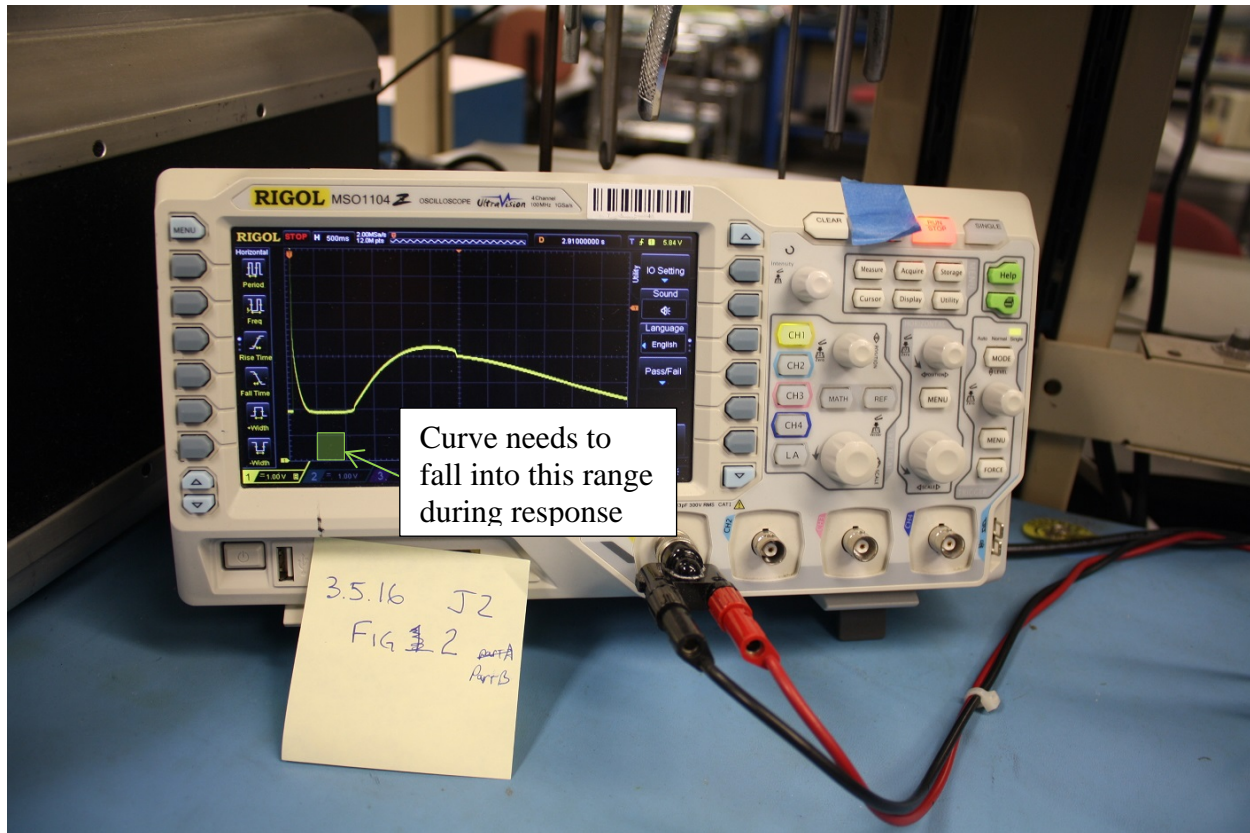
During the valve control signal validation test, both parts A and B the voltage response did not fall within the acceptable range. Figure 26 and Figure 27 highlight the voltage response from the unit during the test and shows the area that that voltage response is expected to fall into during an acceptable test.

Figure 26 - Voltage Response for valve control signal validation test part A

**Figure 27 - Voltage response for valve control signal validation test part B**

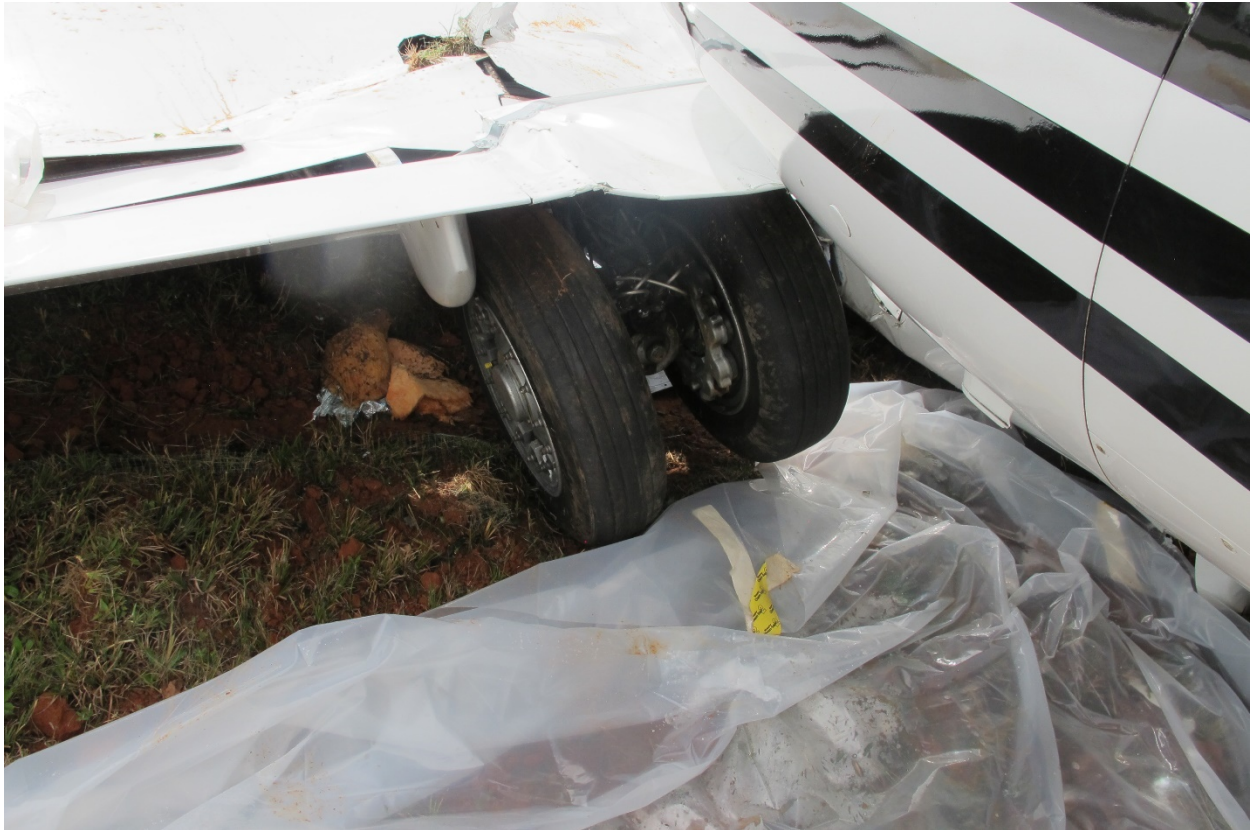
**Figure 30 - LH Main gear as found**

The main landing gear on each side was detached from the trunnion mounts and found folded under the aircraft wing, ref Figure 30 and Figure 31. The inspection of the tires and brakes were conducted after the aircraft was relocated to the secured facility.

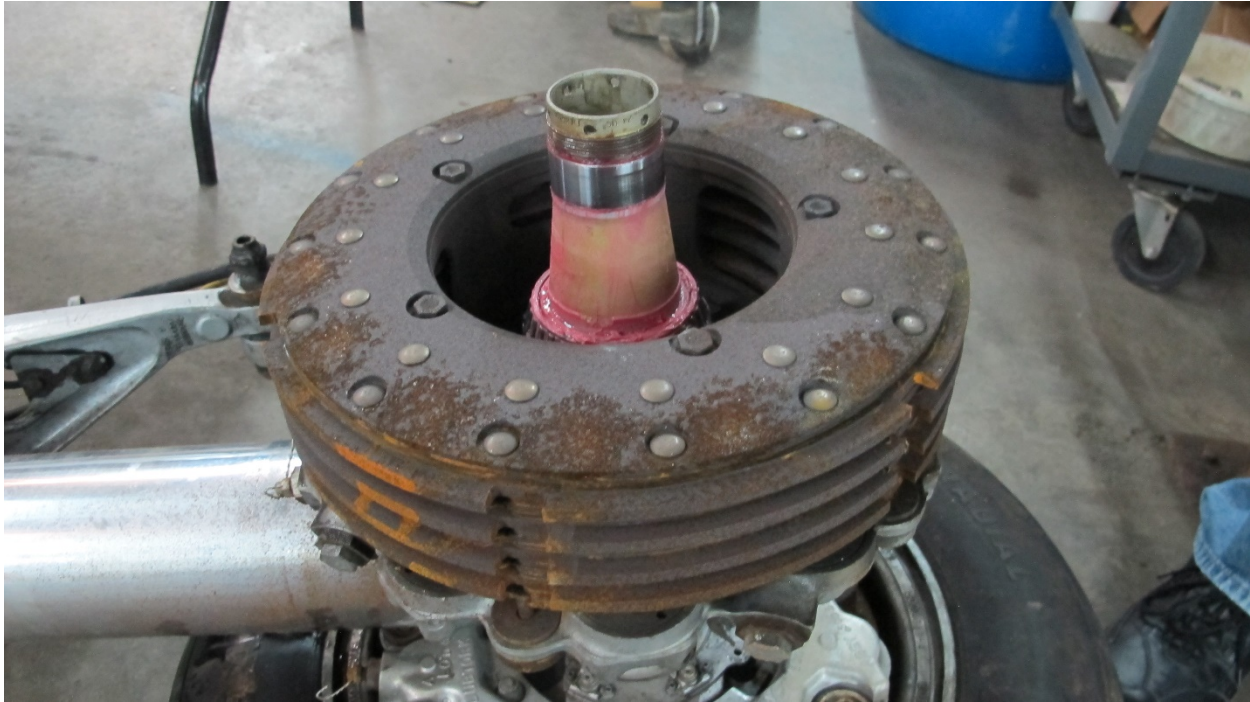
**Figure 33 - RH Inboard brake assembly, wheel removed**

The group performed an additional visual inspection of the RH inboard brake assembly with the wheel removed, ref. Figure 33. The brake disk surface contained areas of visible rust. The brake rotors freely rotated by hand. Normal wear pattern of the stator pads was also noted (visual from the

outside diameter). Measurements of the individual rotor and stators were taken and were consistent with a brake assembly within normal serviceable limits.

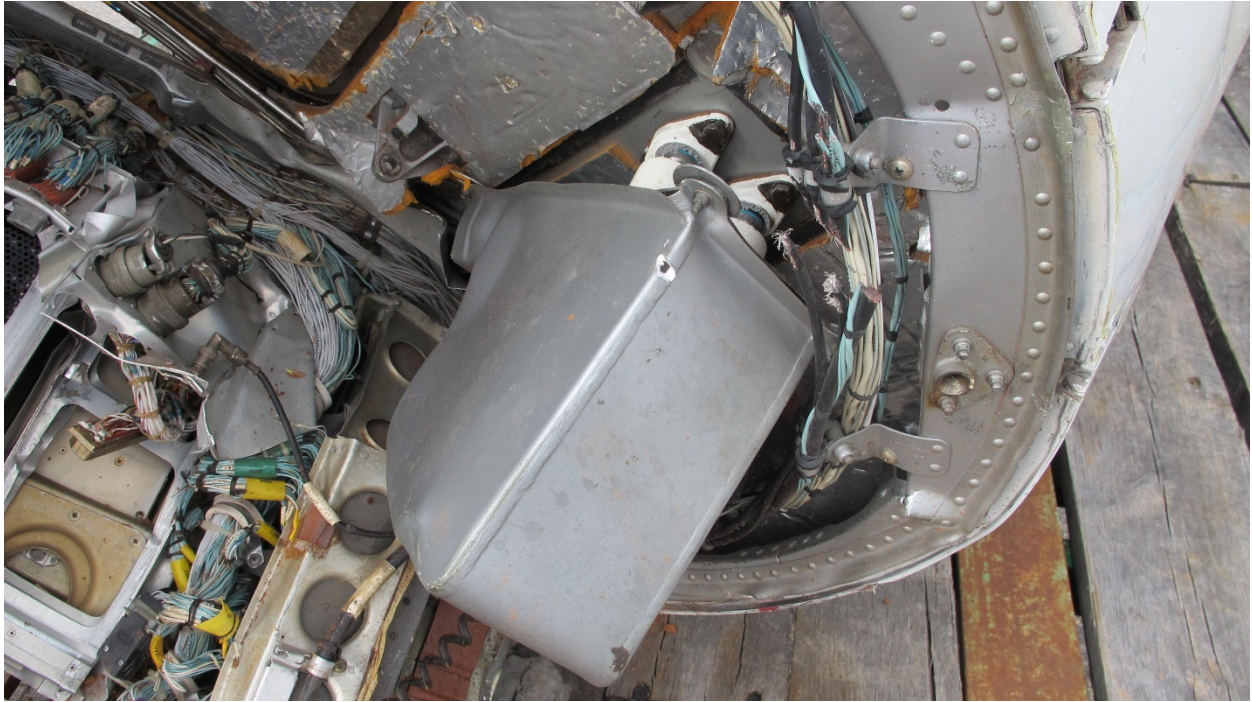
**Figure 36 - Normal/Emergency Brake Selector Valve with damage to the cover.**

The normal/emergency brake selector valve which is mounted to the forward pressure bulkhead was visually inspected, ref Figure 36. The cover was separated from the pressure bulkhead and the selector valve was fractured just forward of the mounting flange, ref Figure 37. The fracture was

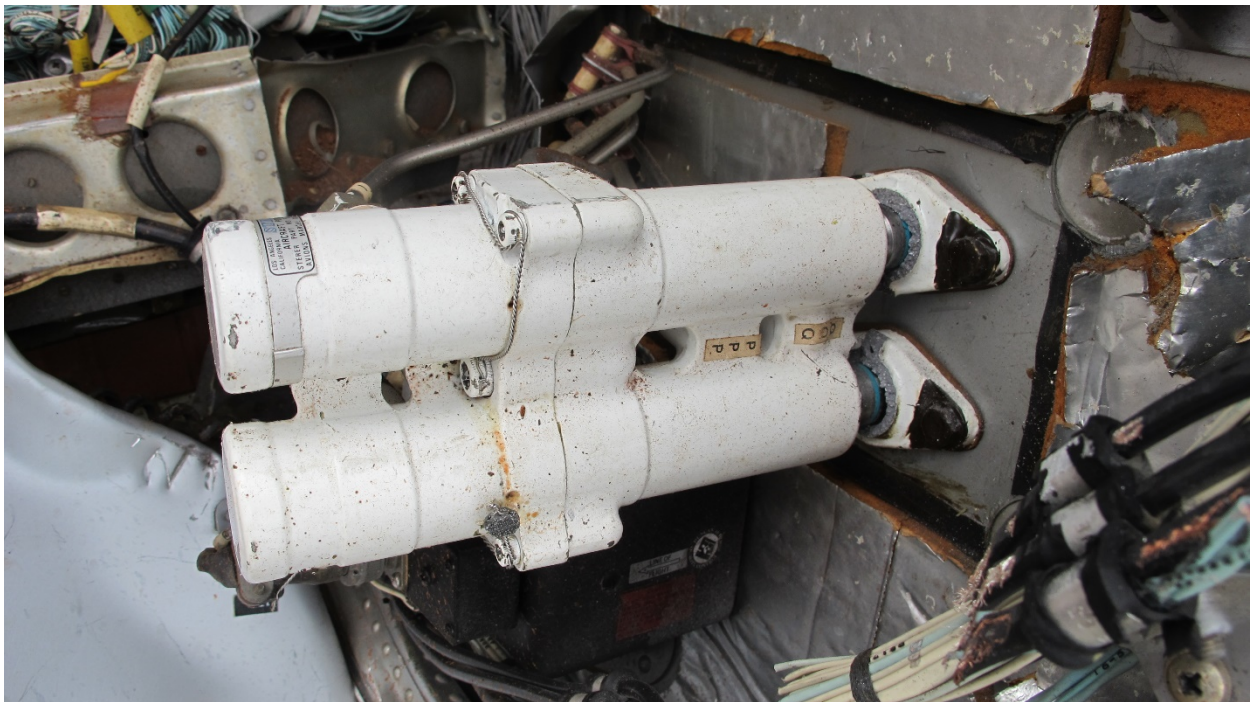
**Figure 37 - Normal/Emergency Brake Selector Valve with fractures at the pressure bulkhead**

consistent with overload. There were no visible signs of hydraulic fluid leakage around the hydraulic fittings, ref Figure 38.

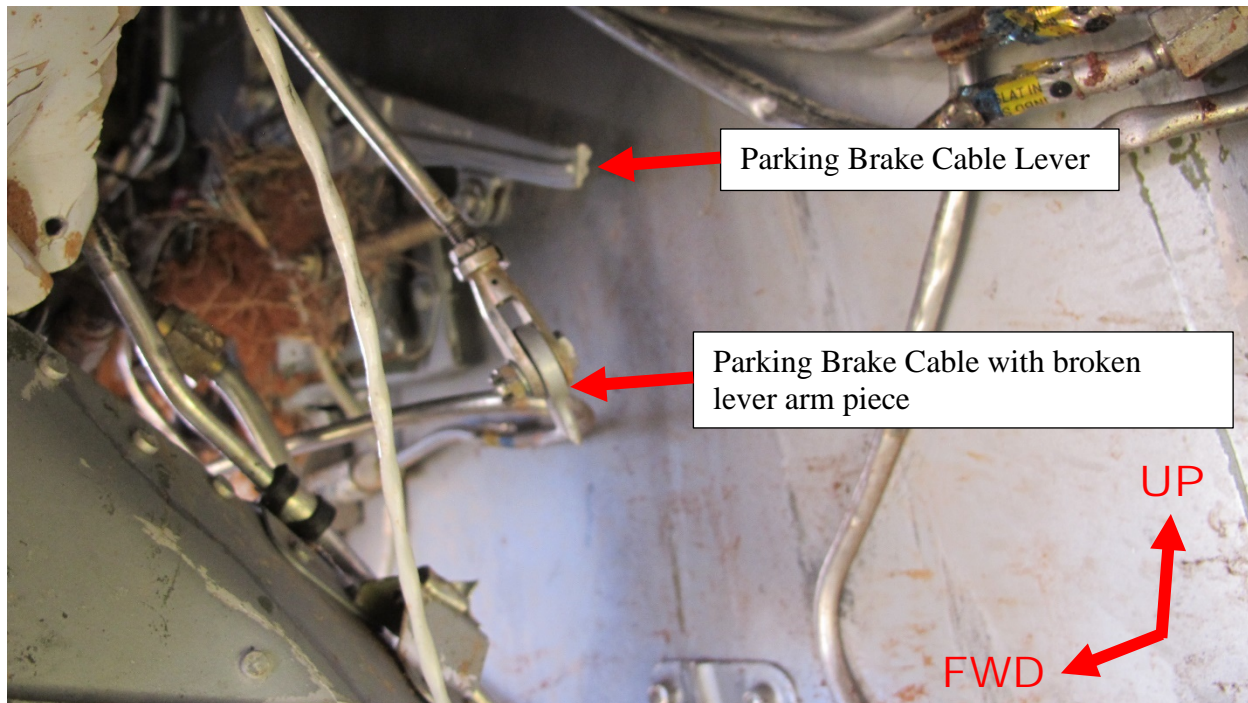
**Figure 41 - Parking brake cable and selector valve severed connection**

The cable end in the fuselage section was also located and it was attempted to be moved. The lower fuselage area where the control cable ran had areas of crushing damage and required portions of the skin and structural frames to be pried away from each other to gain access to the area. Due to the crushing damage of the fuselage, the control cable would not move and additionally, the control cable end at the parking brake selector valve was broken at the lever arm.

The hardware to attach the parking brake control cable to the selector valve lever arm were present and secure, except for the cotter pin. The fracture surface on the lever arm was consistent with an overload failure. The parking brake selector valve was also displaced from its normal mounting location and rotated by approximately 90 degrees and impacted against the frame assembly. Figure 39 contains an image of the parking brake selector valve installed in an exemplar aircraft. Figure 40 and Figure 41 show the parking brake selector valve as found in the accident aircraft and includes the fractured end of the selector valve lever arm. The hydraulic lines in the area had multiple areas of crushing damage and breaches in the line runs.
