NATIONAL TRANSPORTATION SAFETY BOARD
Vehicle Recorder Division
Washington, DC 20594

Specialist's Factual Report
By Nick Swann

Location:	Oliver Springs, TN
Date:	July 13, 2019
Aircraft:	Quicksilver MXII, N3889Z
Operator:	Private
NTSB Number:	ERA19FA225

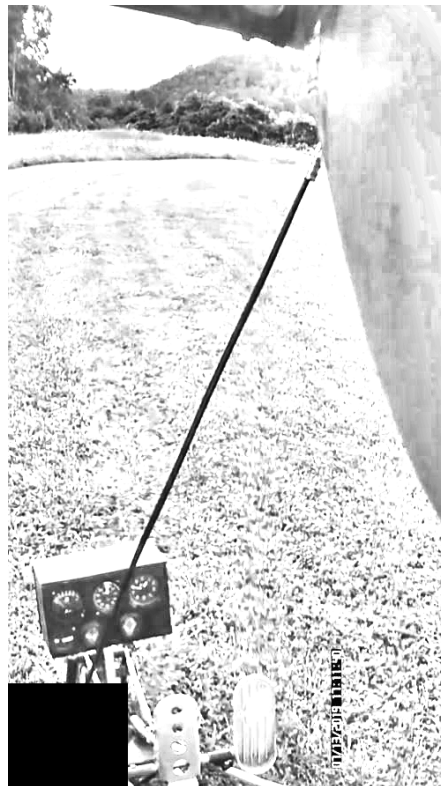
Figure 1. Digital Illustration of Camera View

The accident recording was made at a resolution of 720x480 pixels at a frame rate of 30 frames per second (fps). An associated audio track was also recorded from the camera's internal microphone. The camera was mounted to the frame of the aircraft and was oriented to show a forward-facing field of view that included a view of the instrument panel and rudder pedals. The field of view of the accident recording is digitally illustrated in figure 1 below.

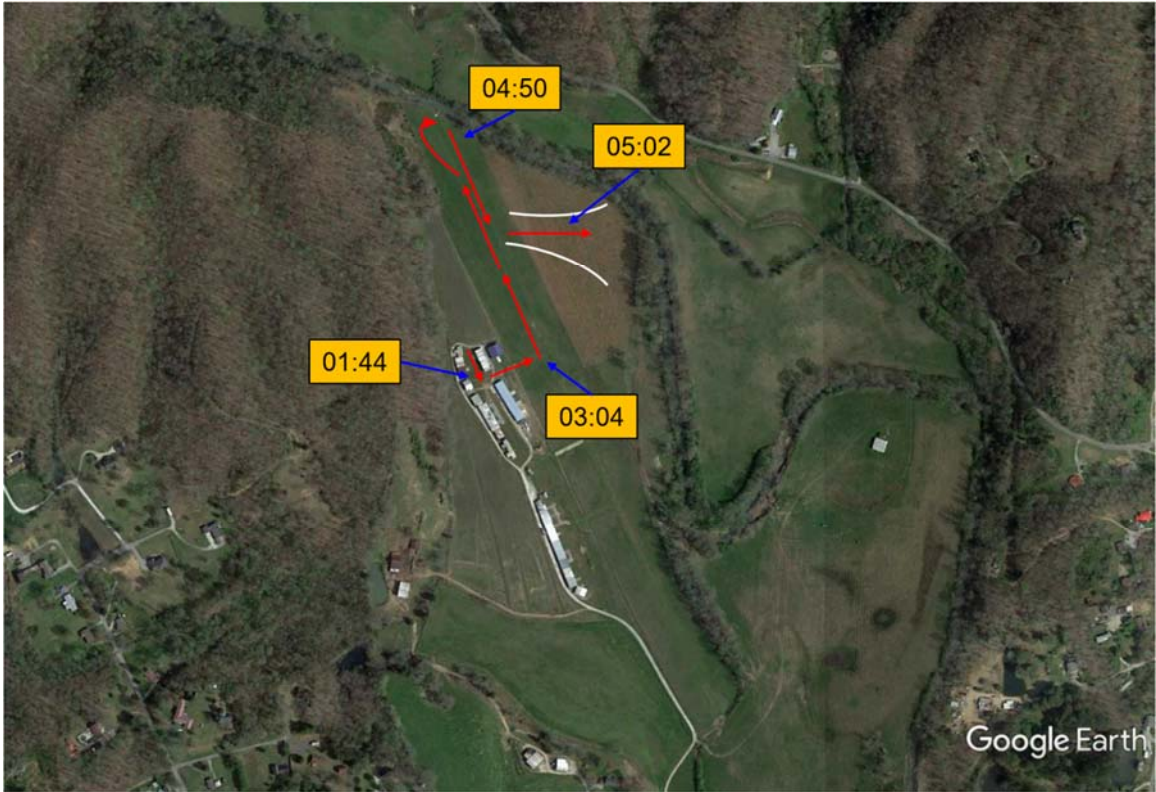
Figure 2. Approximate Visualization of Flight Path.

An approximate visualization of the flight path of the aircraft and the location at corresponding video time stamps is shown below in figure 2. The position information is based on simple visual references from the recorded video, not GPS data.
