# **WRECKAGE EXAMINATION**

NTSB ACCIDENT NUMBER: ERA20FA031

AIRCRAFT REGISTRATION: N714LK

ACCIDENT LOCATION: New Bedford, MA

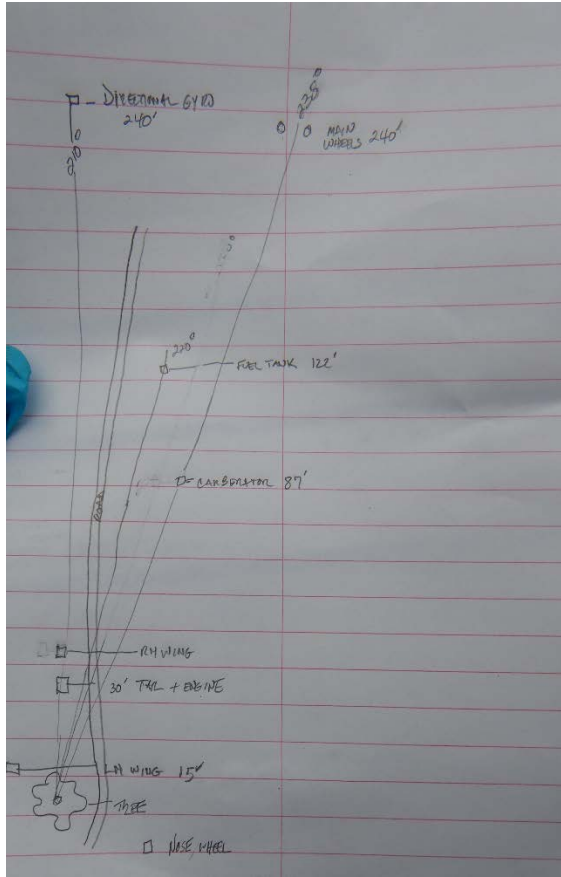
Figure 1: Wreckage Diagram

The airplane descended into a large tree before impacting terrain in a cemetery about 3.5 nautical miles south (164°) of the EWB airport. The wreckage path was oriented on a true heading of 220°. The left wing was located about 10 ft from the tree, followed by the tail and engine at 30 ft, the right wing at 40 ft, the carburetor at 87 ft, the fuel tank at 122 ft, and the main wheels and directional gyro at 240 ft. The nose wheel was located 30 ft at 330° from the tree. The accident site elevation was about 83 ft mean sea level. The left wing, with the strut attached, was the closest piece to the tree. The empennage, engine, right wing (with cabin overhead attached), and cabin floor were near each other but were separate pieces. Both wings exhibited leading edge damage similar to impact with large tree branches.

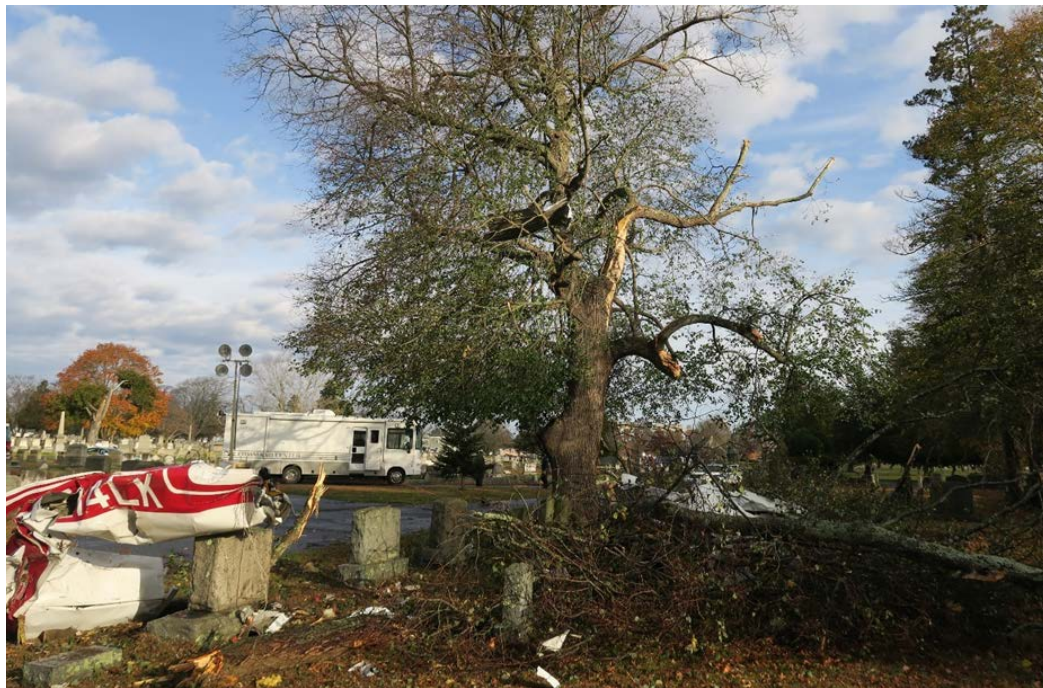
Photo 1: Main wreckage and tree damage

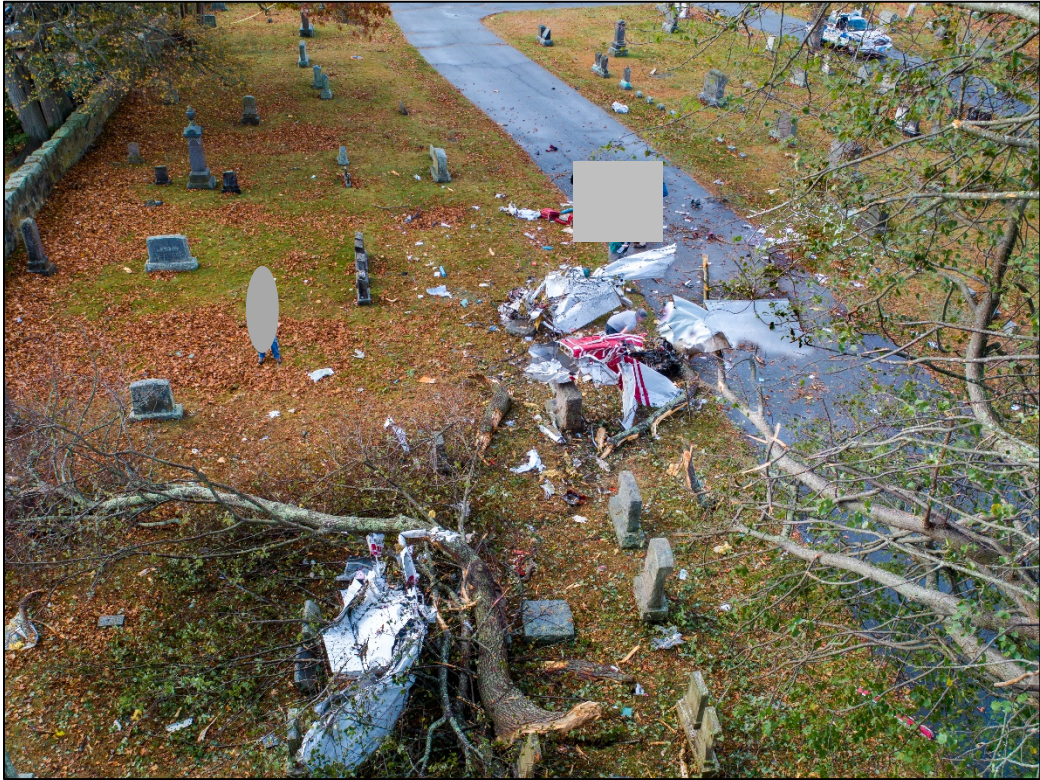
Photo 2: Wreckage from above

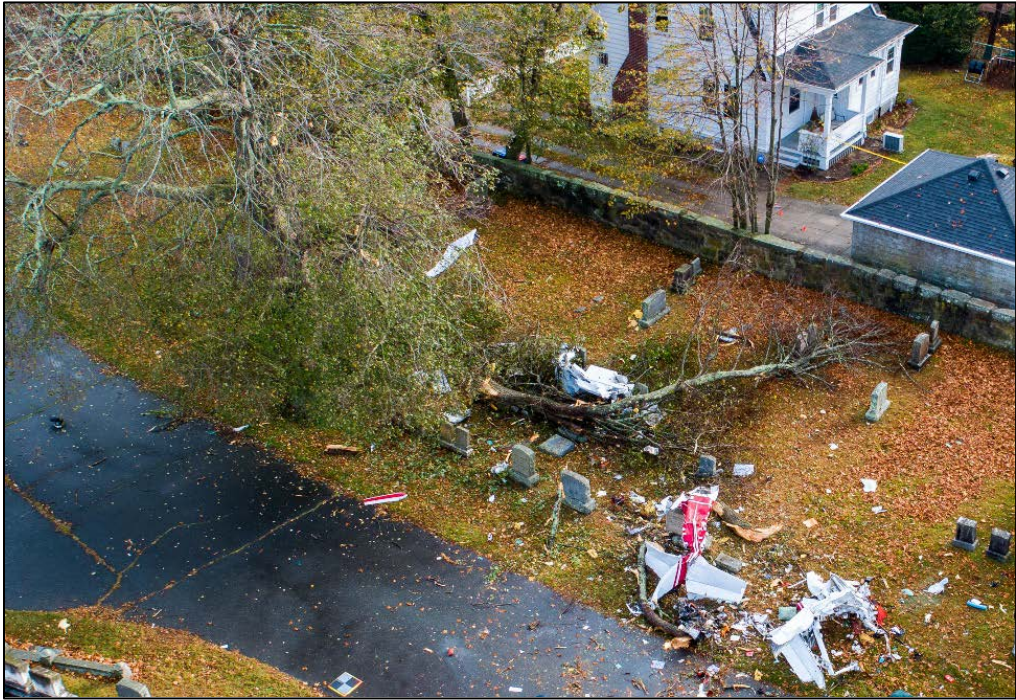
Photo 3: Wreckage from above

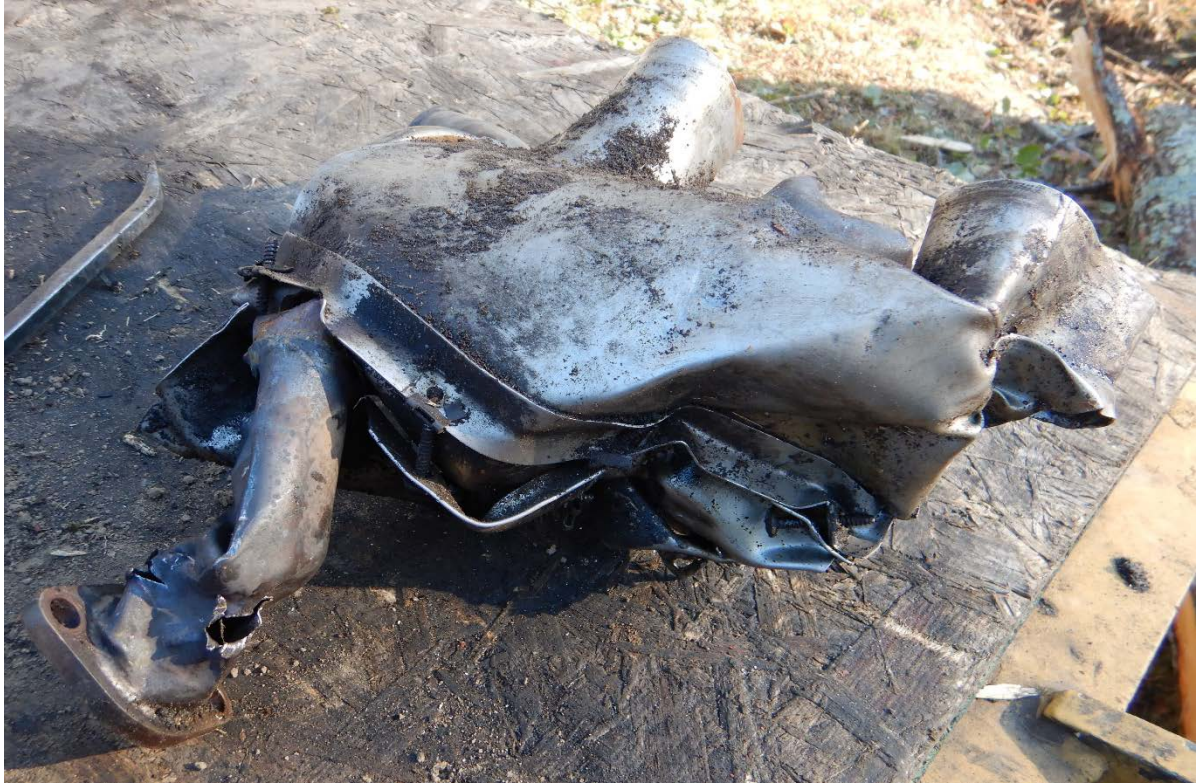
The right muffler separated from the airplane and was found crushed and compacted. The shroud (which provides heated air to the carburetor heat control) was intact around the muffler.

The front of the left muffler was partially separated. The cylinder 4 exhaust tube flange was cracked at the front of the muffler. The aft end cap of the left muffler was found separated from the muffler. The end cap had a hole in center of it and exhibited pin holes in the middle. The muffler metal was corroded and thin. The cabin heat shroud was removed from the muffler and pin holes were observed on the sides of the muffler.

*Photo 4: Muffler assembly*

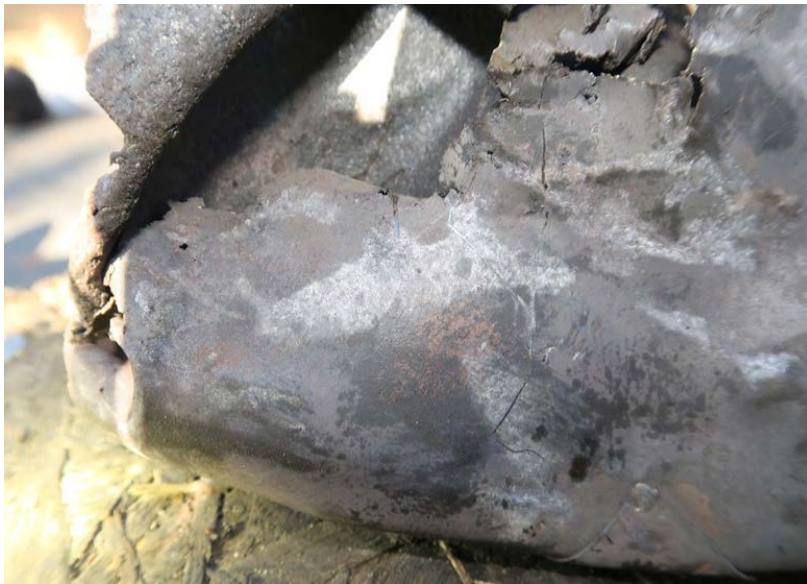
*Photo 5: Muffler corrosion after muffler shroud removed*

The right exhaust muffler from cylinders one and three separated and was discovered approximately 50 feet forward in the debris field. The grass and tree leaves under the separated muffler was scorched indicating that the muffler was hot when it came to rest after impact. The left muffler remained partially attached to cylinders two and four. The muffler outer casing was impact crushed exposing the end plate which exhibited an erosion hole with several other small pin holes visible. The heat shroud was removed, and additional evidence of internal deterioration was present.

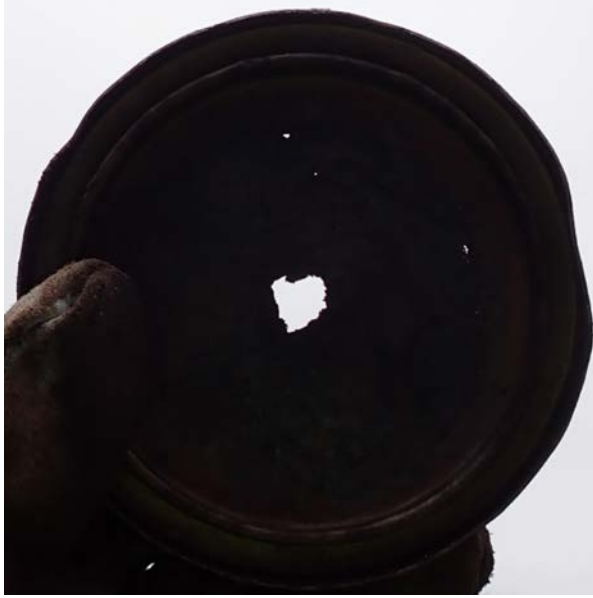
*Photo 6: Muffler end plate showing corrosion*

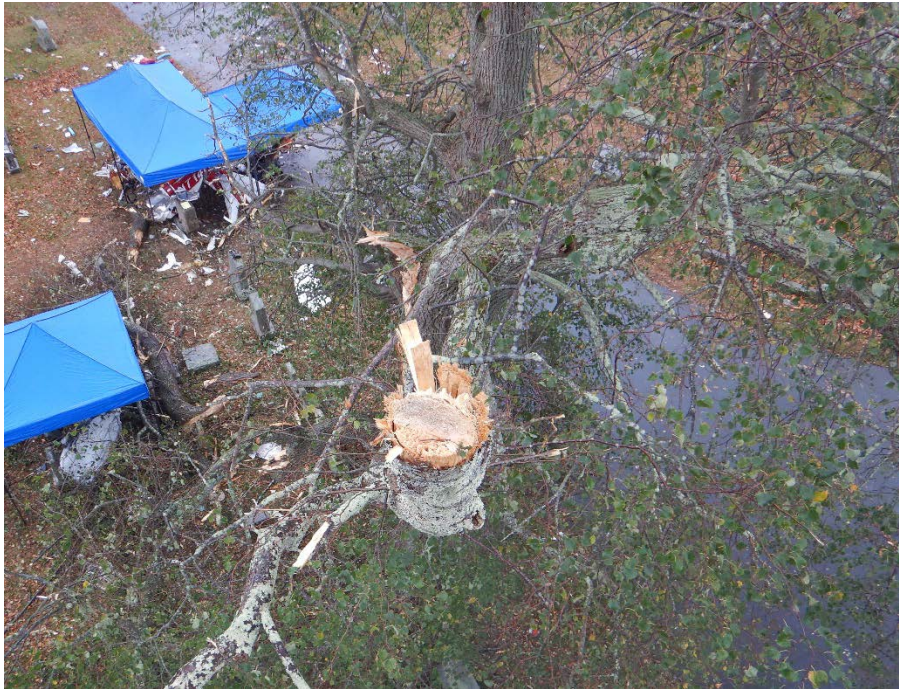
A tree branch, approximately five inches in diameter, exhibited evidence of being cut by a propeller blade. Both propeller blades were bent aft and were wavy with polishing on the cambered side of the blade.

*Photo 7: Tree damage consistent with propeller strike*

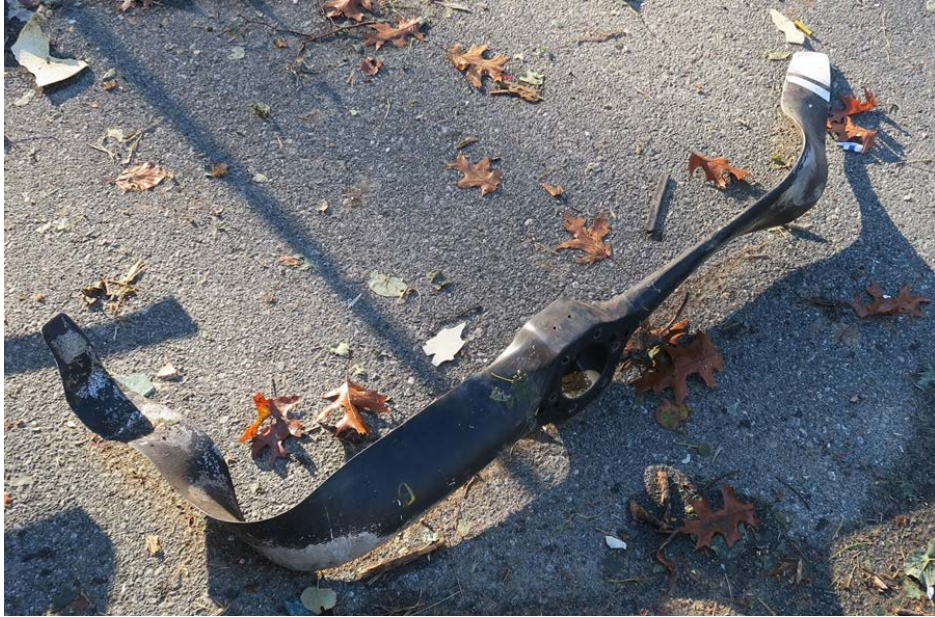
*Photo 8: Propeller*

The engine data plate was missing but was recovered from the wreckage. An impact damaged McCauley two-blade fix pitched propeller remained attached to the engine crankshaft propeller flange. The propeller exhibited chordwise twisting and bending along the length of both blades with paint transfer and leading-edge gouging.

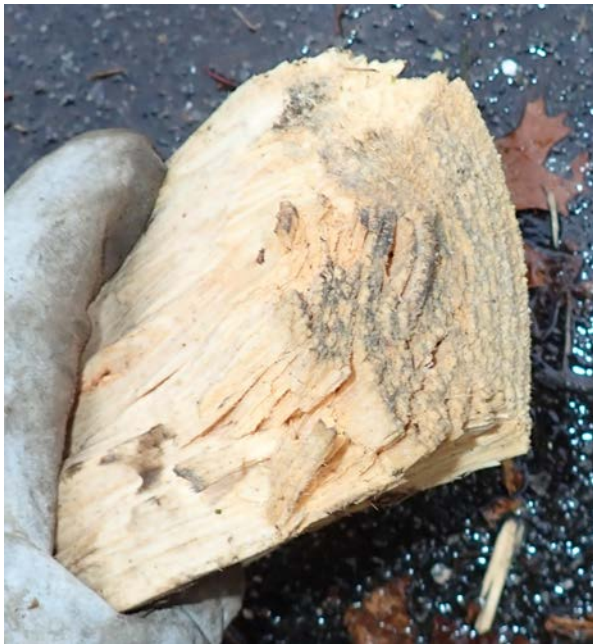
*Photo 9: Tree limb damage consistent with propeller strike*

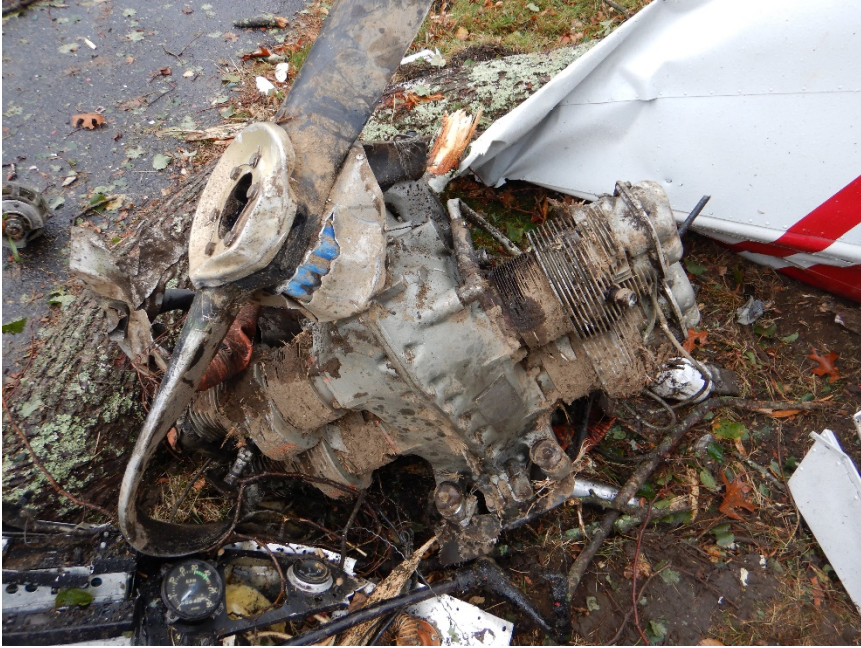
*Photo 10: Propeller and engine*
