**NATIONAL TRANSPORTATION SAFETY BOARD
OFFICE OF AVIATION SAFETY
WASHINGTON, D.C. 20594**

Airworthiness Group Chairman's Factual Report

ERA20MA001

Operator: Collings Foundation
Aircraft: B-17G, N93012
Location: Windsor Locks, CT
Date: October 2, 2019
Time: 0953 EST

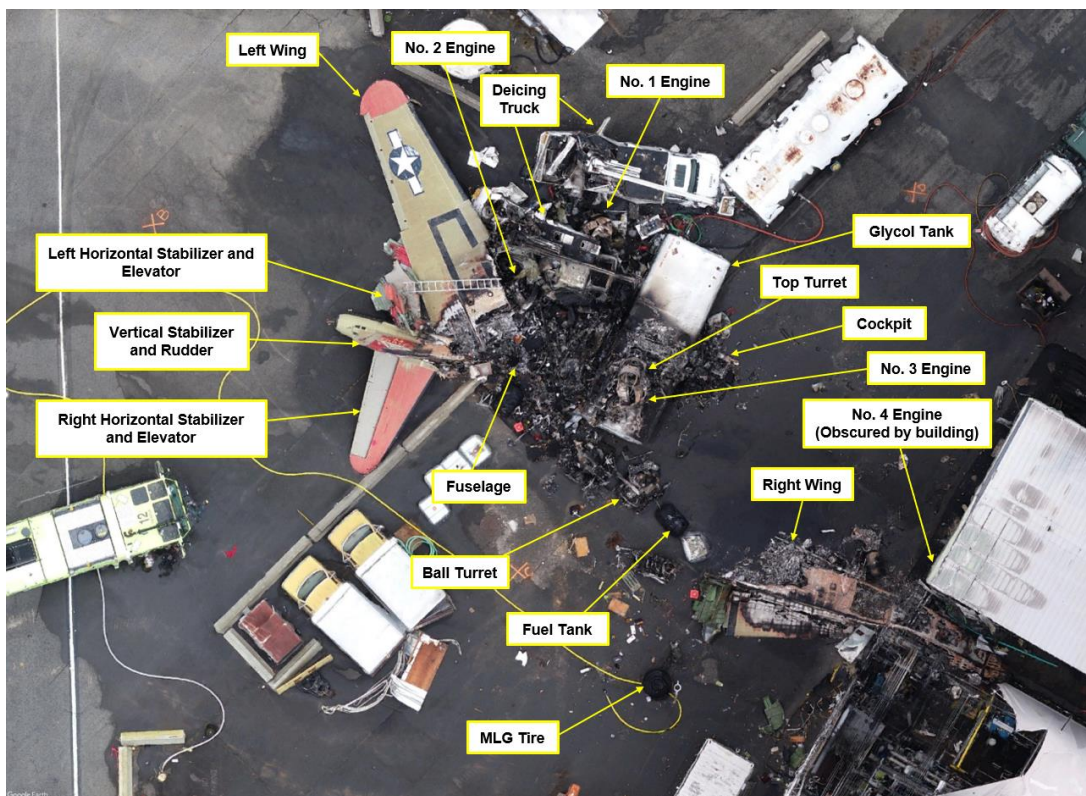
The airplane exited to the right of runway 6, impacted jersey barriers, two deicing vehicles, and a glycol storage tank. Most of the cockpit, fuselage, and right wing were consumed by post impact fire. An overview image of the accident site (Figure 1), was reproduced here from the UAS Aerial Imagery factual report, Figure 19.

Figure 1 Aerial View of Accident Site

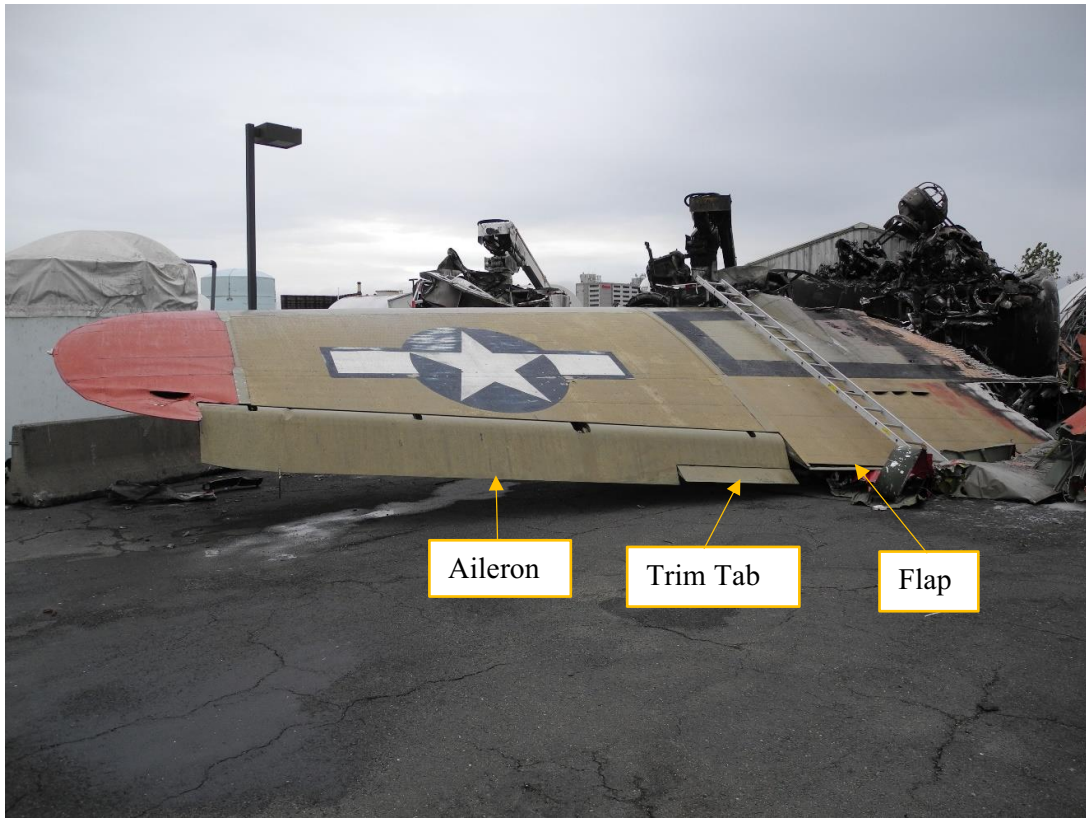
The left wing was mostly intact from the wingtip to outboard of the #2 engine (Figure 2). The aileron was intact, but the pushrod and most hinges were fractured. The trim tab was intact, the hinges were intact but the rod from the spool to the tab was bent (Figure 3). Rotation of the shaft moved the tab. The wing was placed upside down, the flap appeared to be retracted and there was 16 feet of the outboard portion intact (Figure 4). There was a small area of impact damage on the bottom of the flap. The access panels on the bottom side of the inner wing panel were opened to view the flap jackscrews. The cover was detached to show the threaded region and it was observed that there were no threads showing, indicating it was in full retracted position (Figure 5).

Figure 2 Left Wing

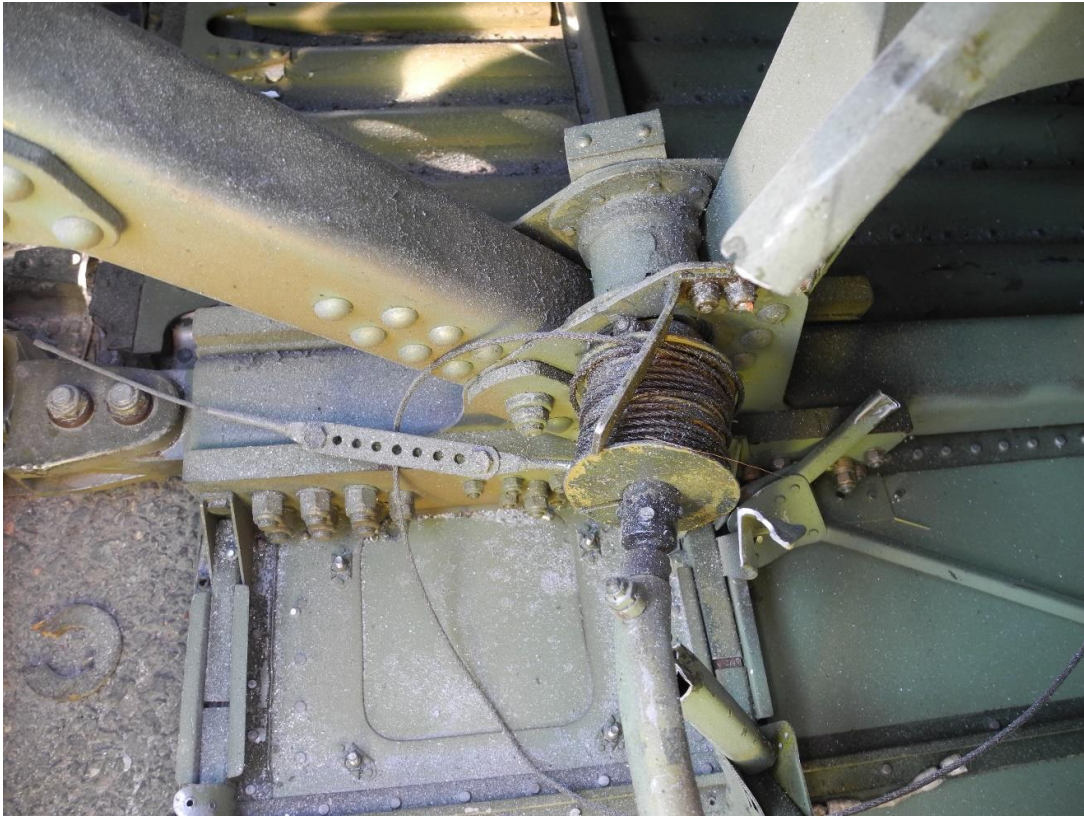
Figure 3 Trim tab cable drum

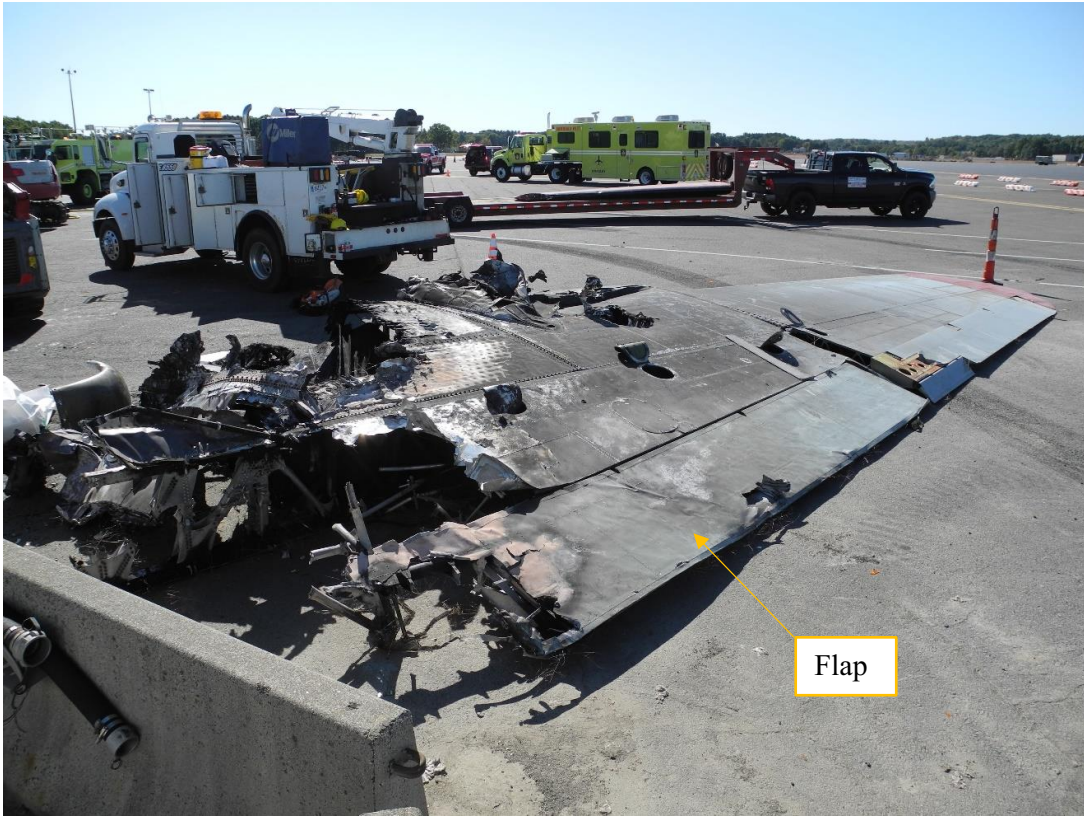
Figure 4 Left wing upside-down to show flap

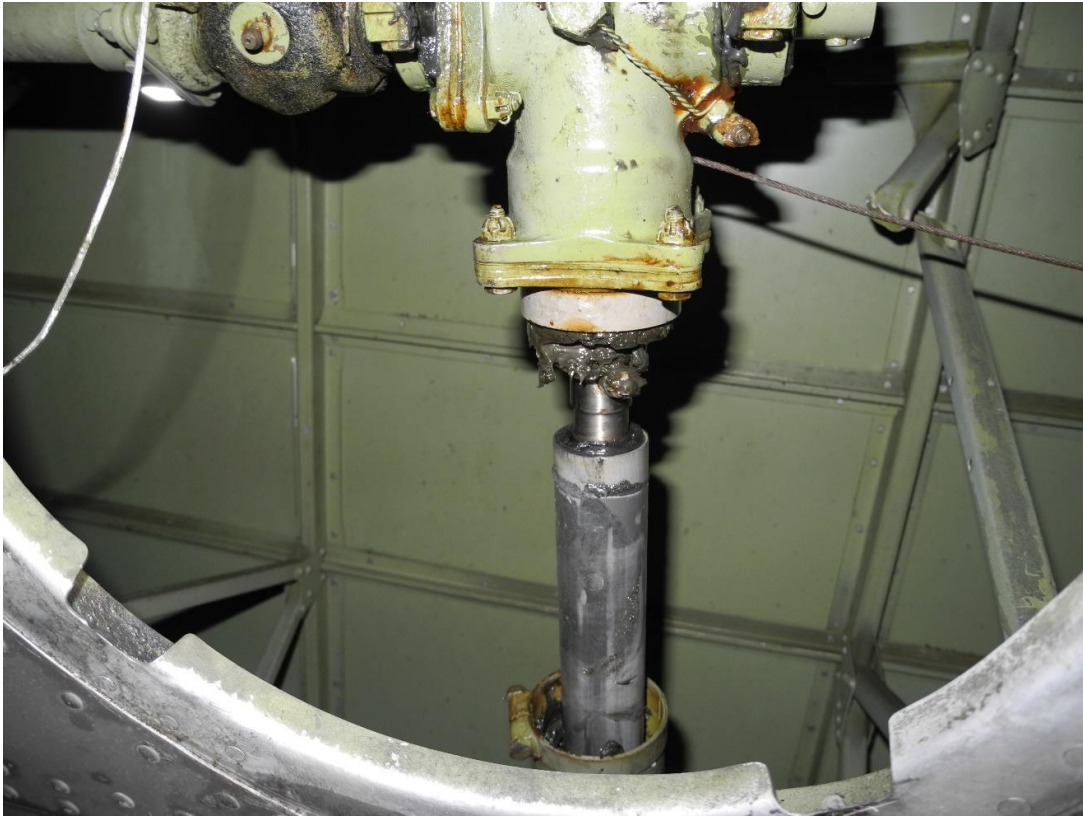
Figure 5 Flap drive and jackscrew

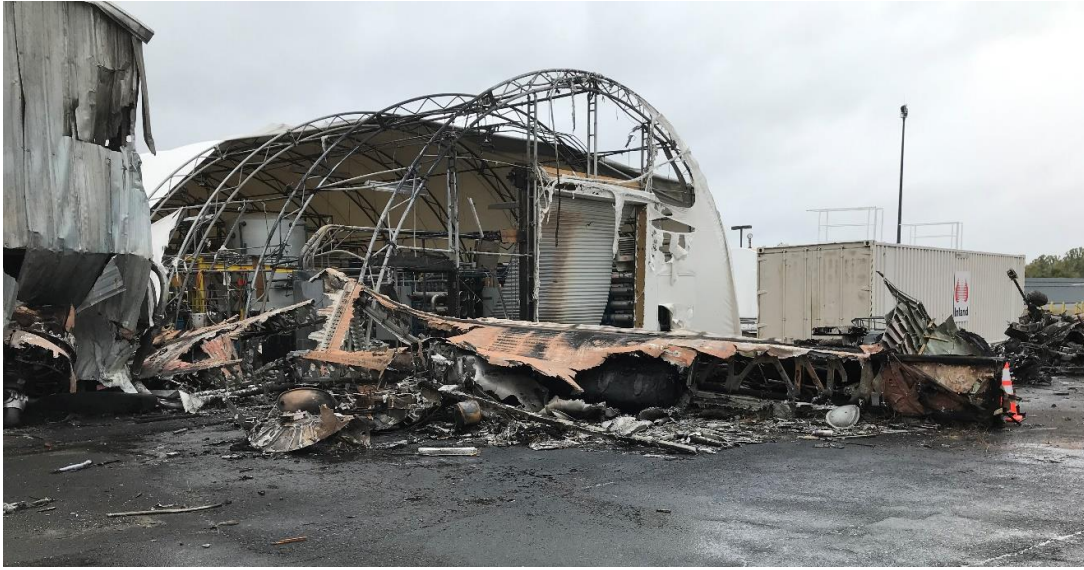
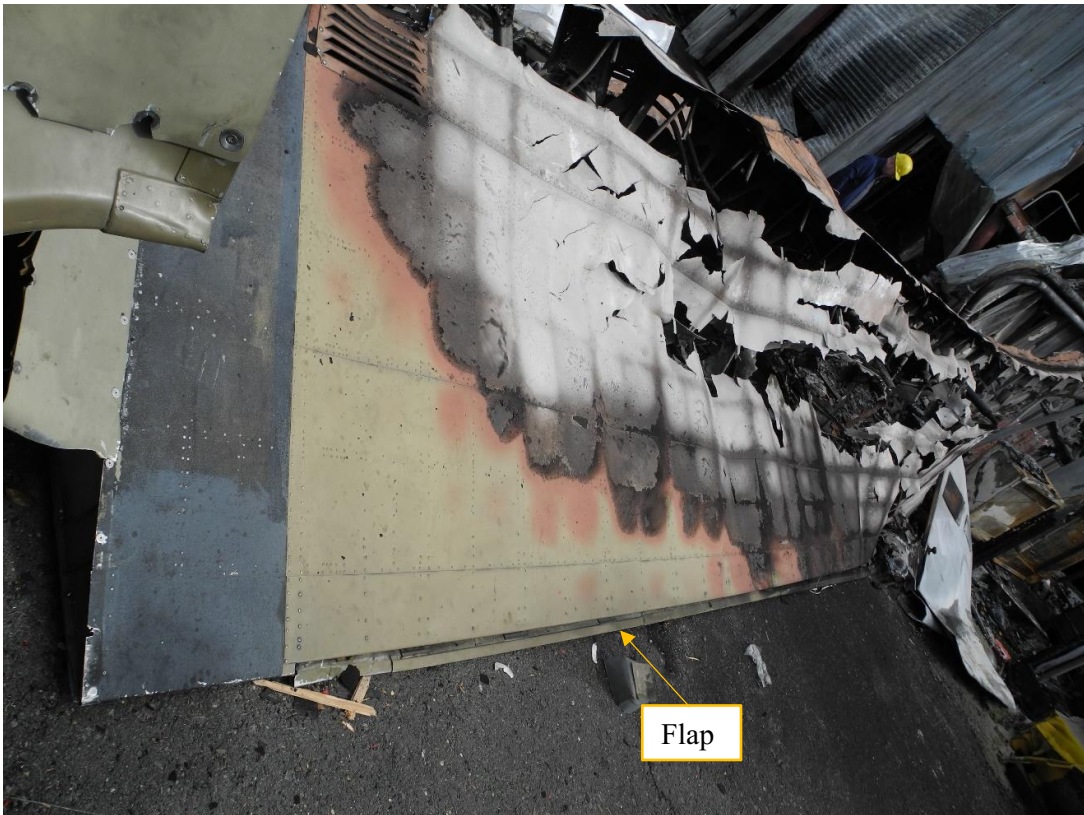
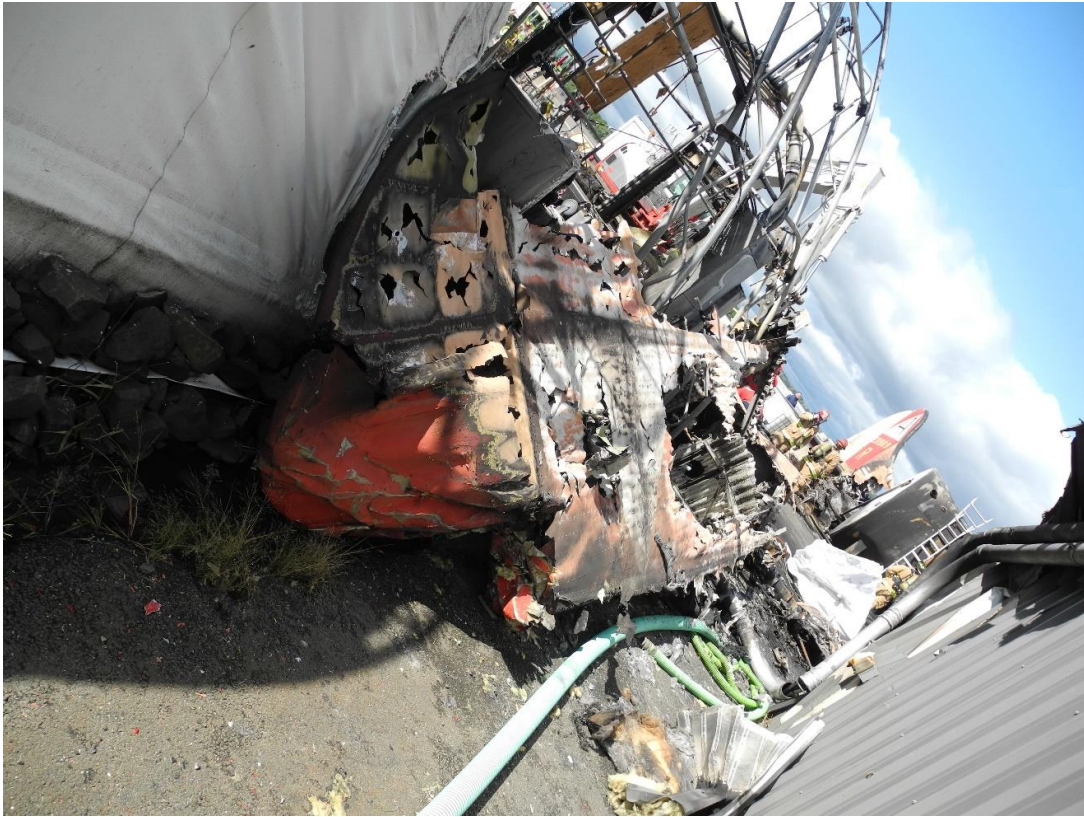
The entire right wing separated from the fuselage and impacted a nearby building (Figures 6-8). There was considerable post impact fire damage. There was impact damage at the leading edge near the wingtip (Figure 9). The aileron condition could not be determined, it was consumed by the fire. The flap appeared to be retracted and the inboard most flap jackscrew was observed to be in the fully retracted position, the cover was found detached from the normal position (Figure 10).

Figure 6 Right wing leading edge inboard portion

Figure 7 Right wing trailing edge inboard portion

Figure 8 Right wing outboard portion

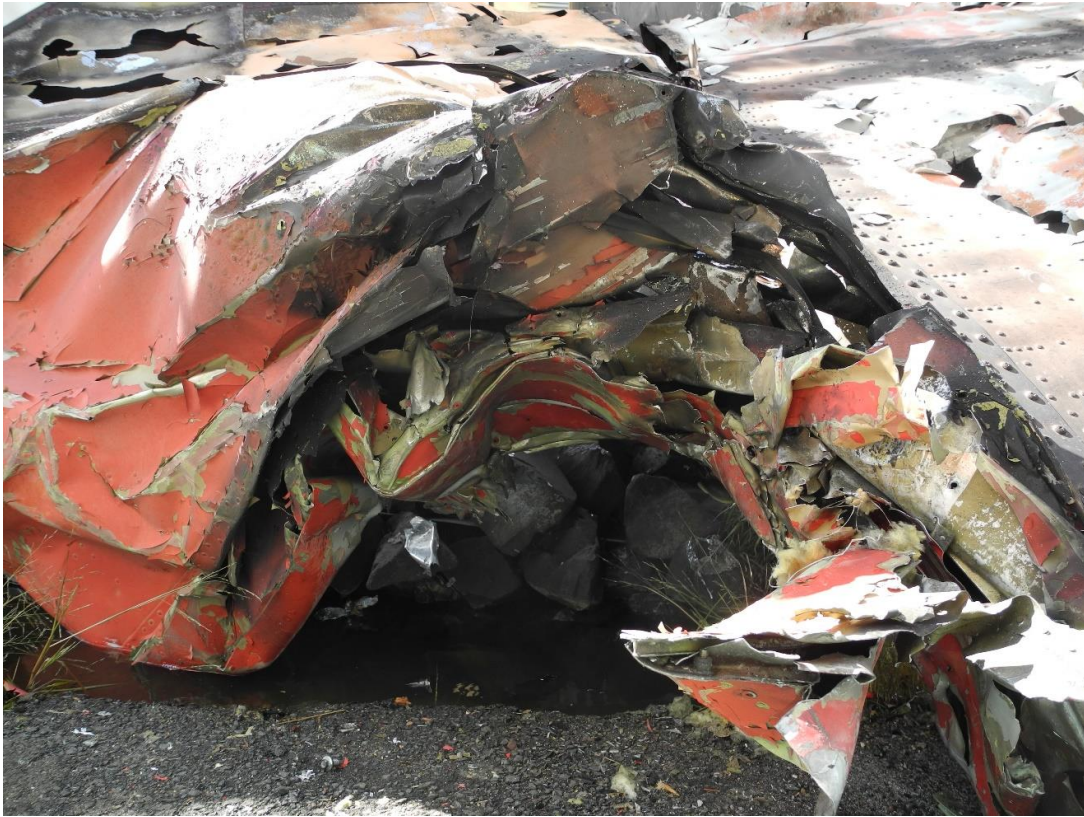
Figure 9 Right wing tip impact damage

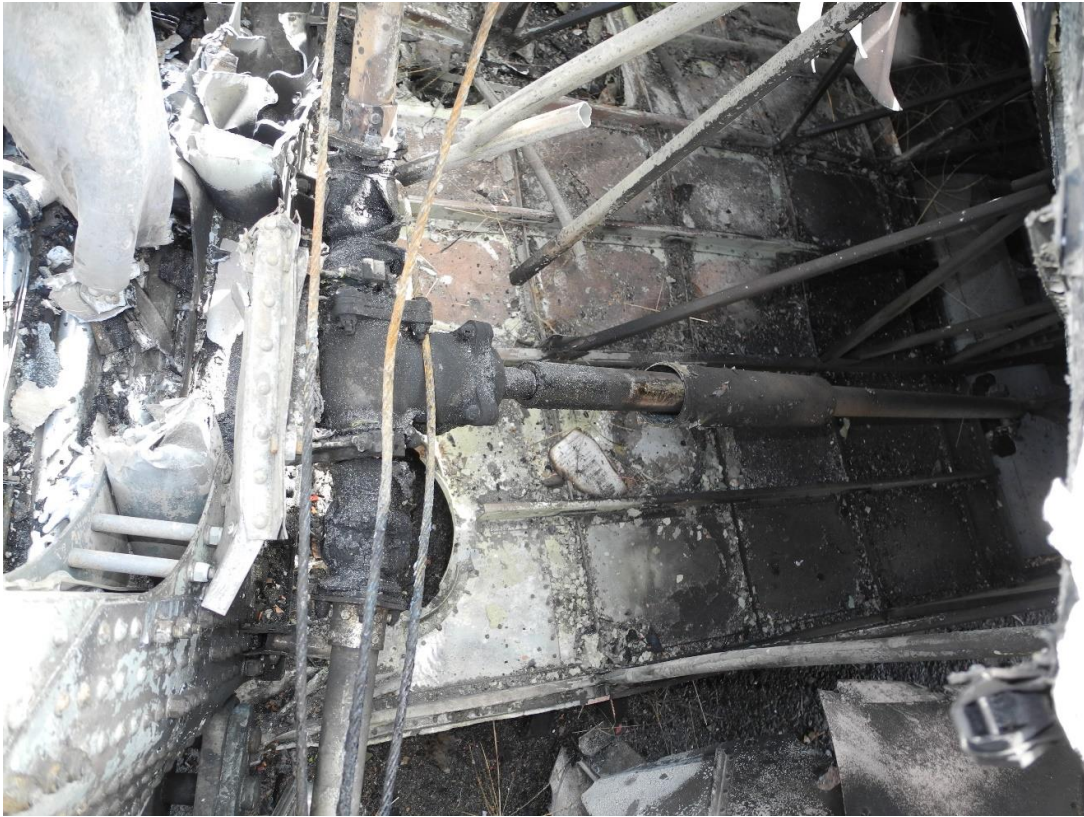
Figure 10 Flap jackscrew position

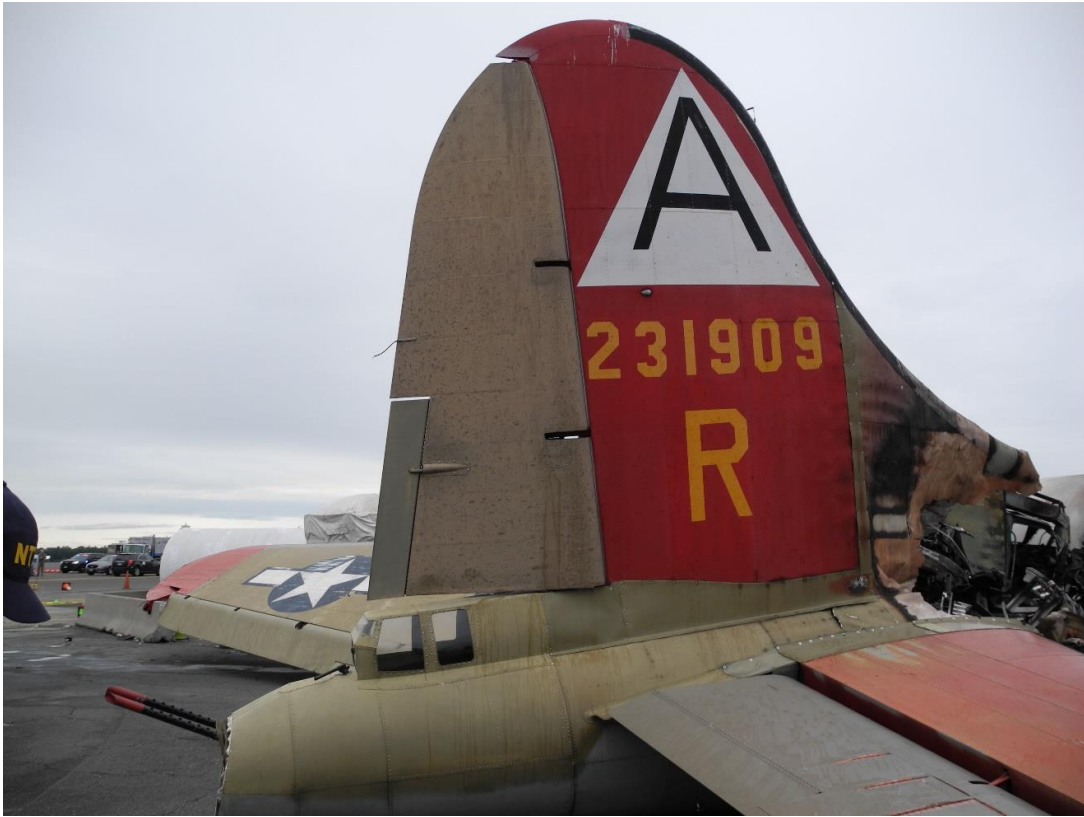
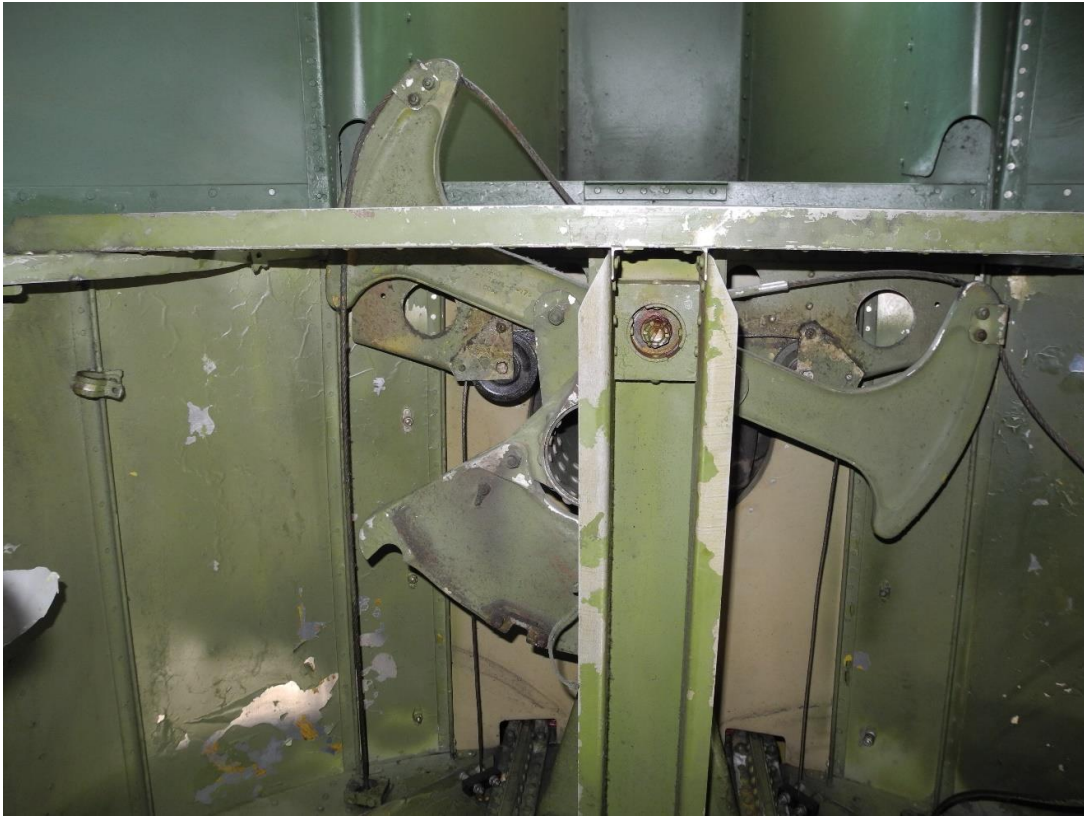
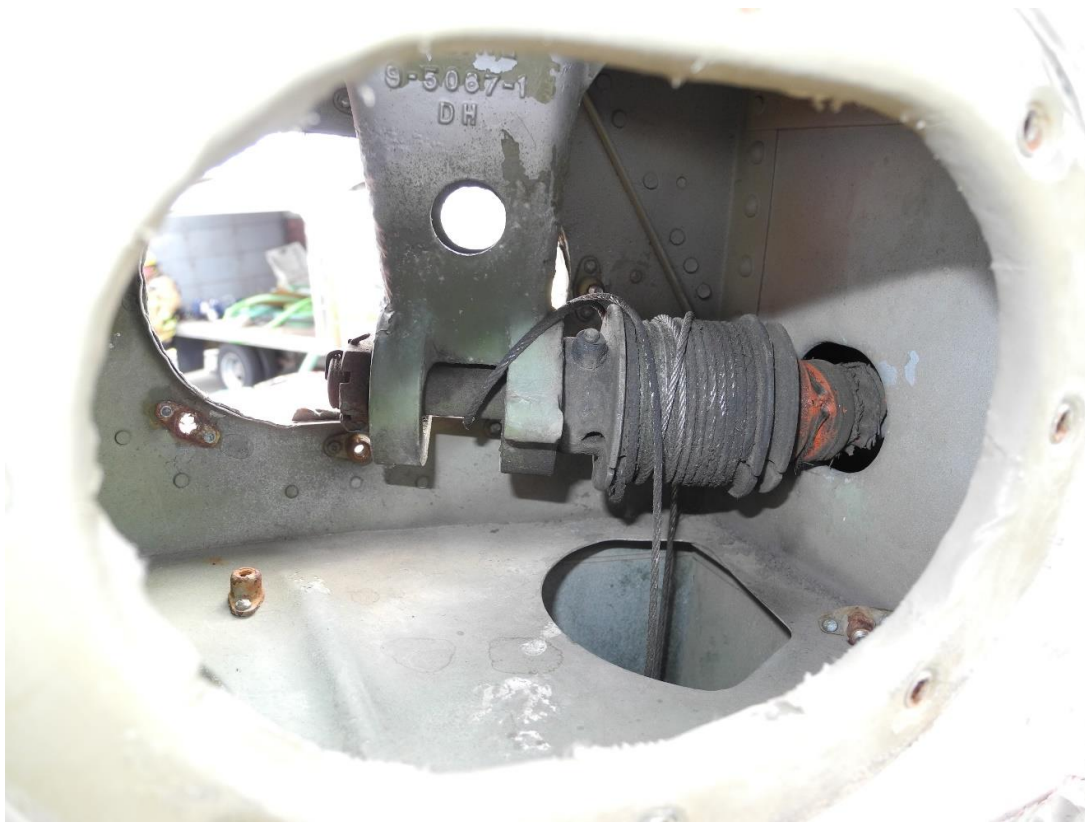
The vertical stabilizer, rudder and tab were intact (Figure 11). The rudder control quadrant and cables were intact (Figure 12). The rudder trim cable drum was intact (Figure 13).

Figure 11 Vertical Stabilizer, rudder, and trim tab

Figure 12 Rudder control quadrant

Figure 13 Rudder trim cable drum

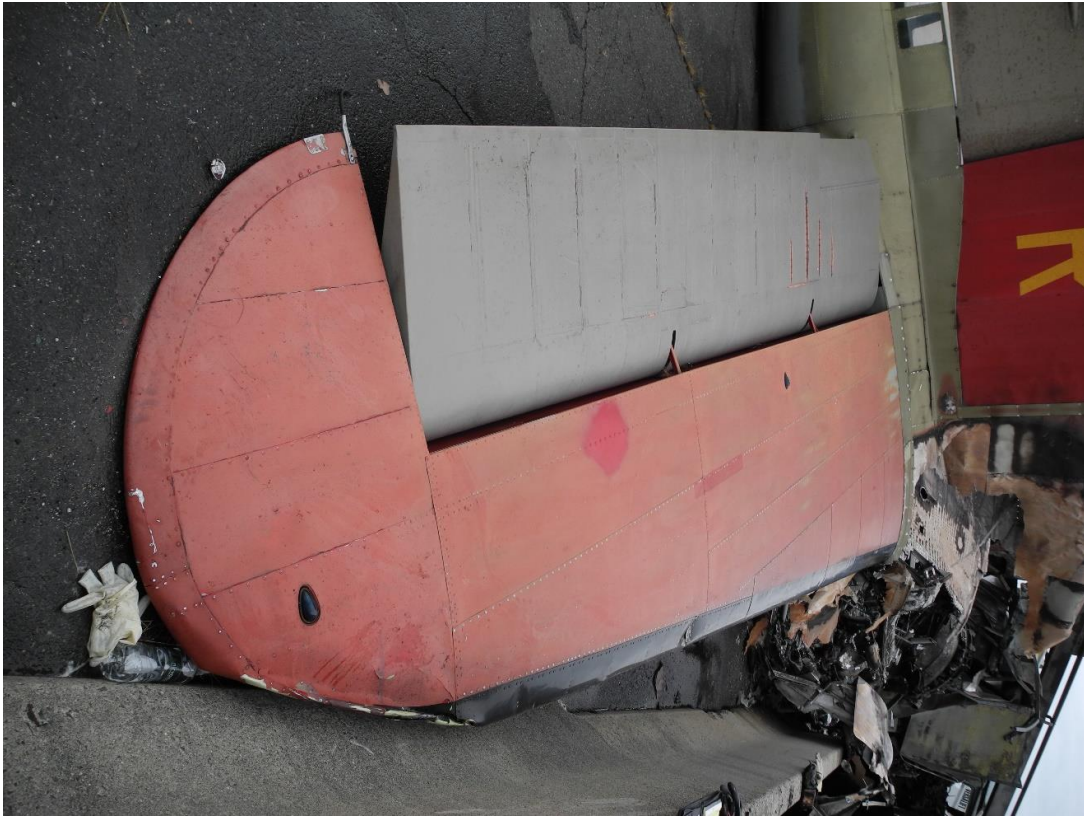
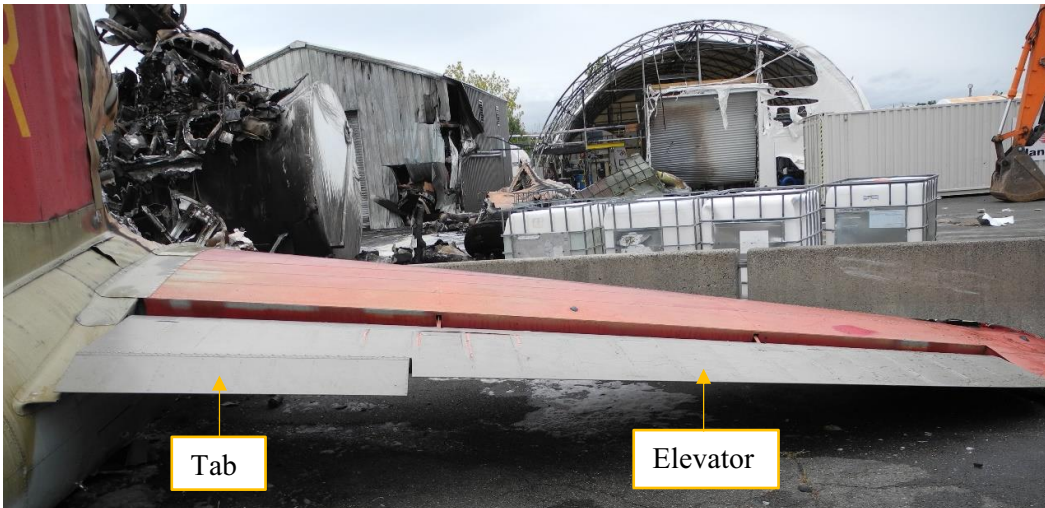
Figure 14 Right horizontal stabilizer, elevator, and tab

Figure 15 Right elevator and tab

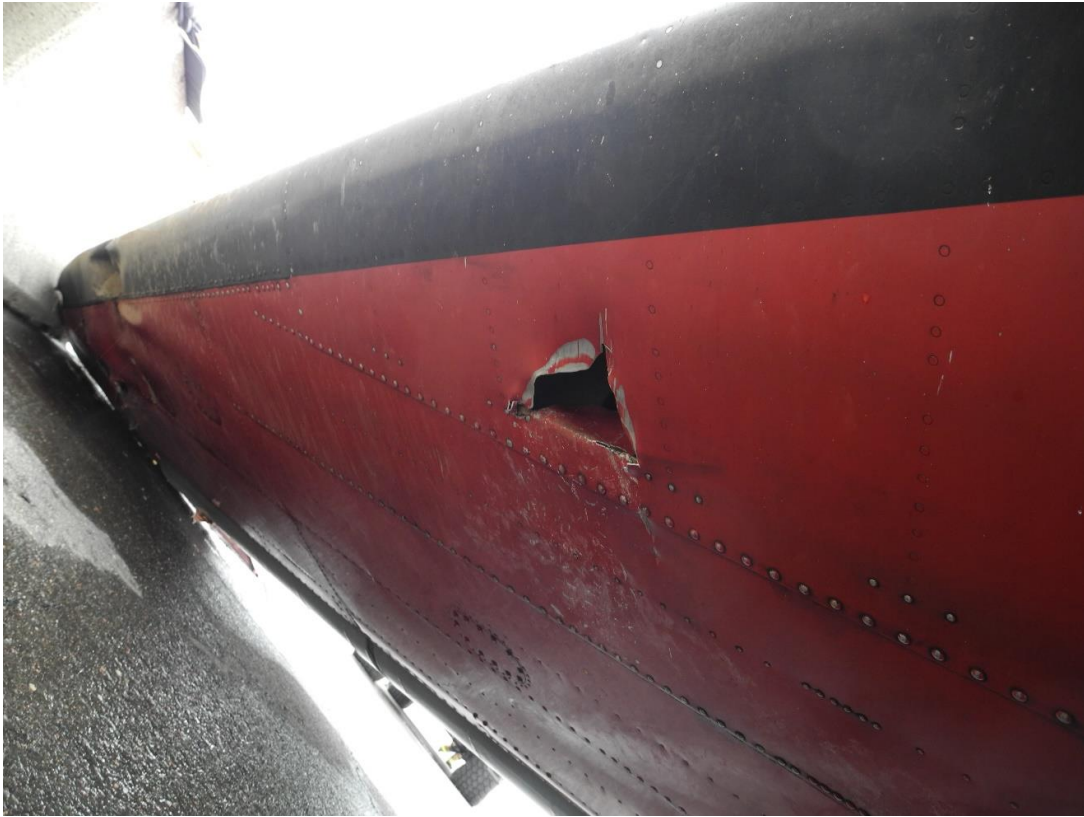
Figure 16 Right horizontal stabilizer impact damage

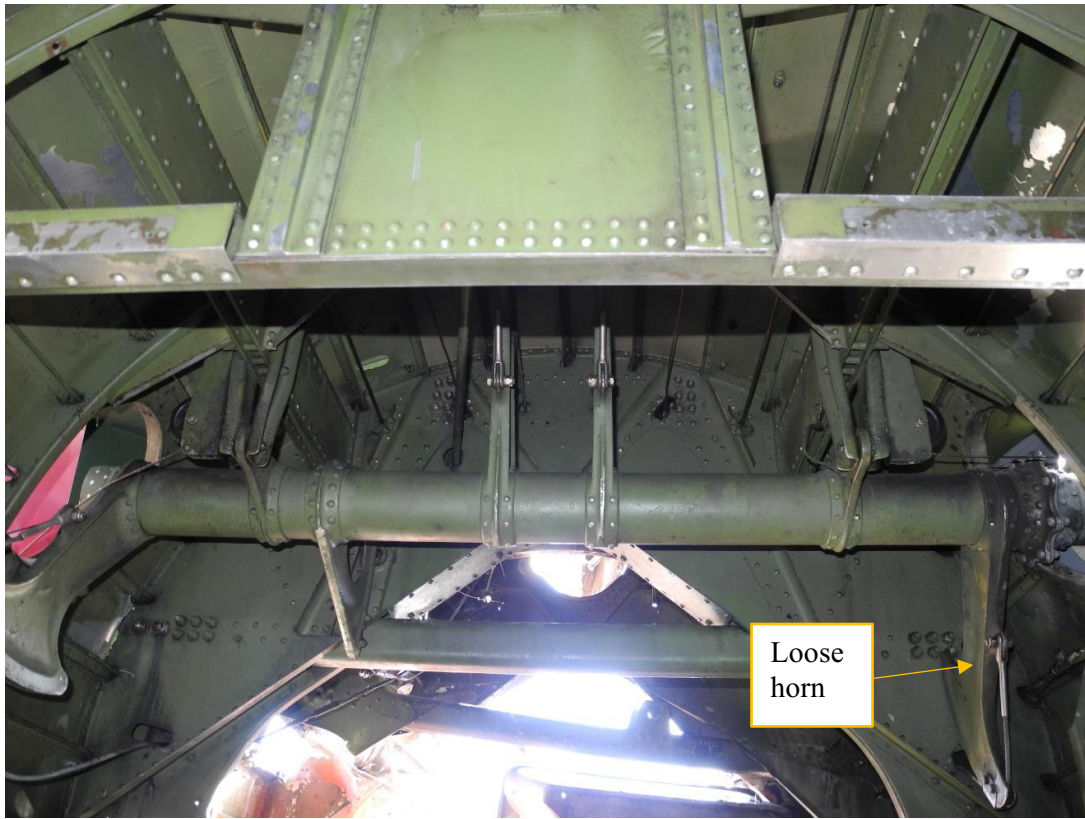
The right horizontal stabilizer, elevator and tab were all intact (Figure 14-15). There was impact at the leading edge of the tip and damage on the bottom (Figure 16). The elevator torque tube, horns, and cables were intact and connected to the right elevator (Figure 17). The torque tube was designed to provide a rigid connection between the right and left elevators, but the torque tube was fractured and detached from the left elevator. Also damaged was the right trailing edge down horn on the torque tube, it was loose and could rotate relative to the torque tube.

Figure 17 Elevator Controls

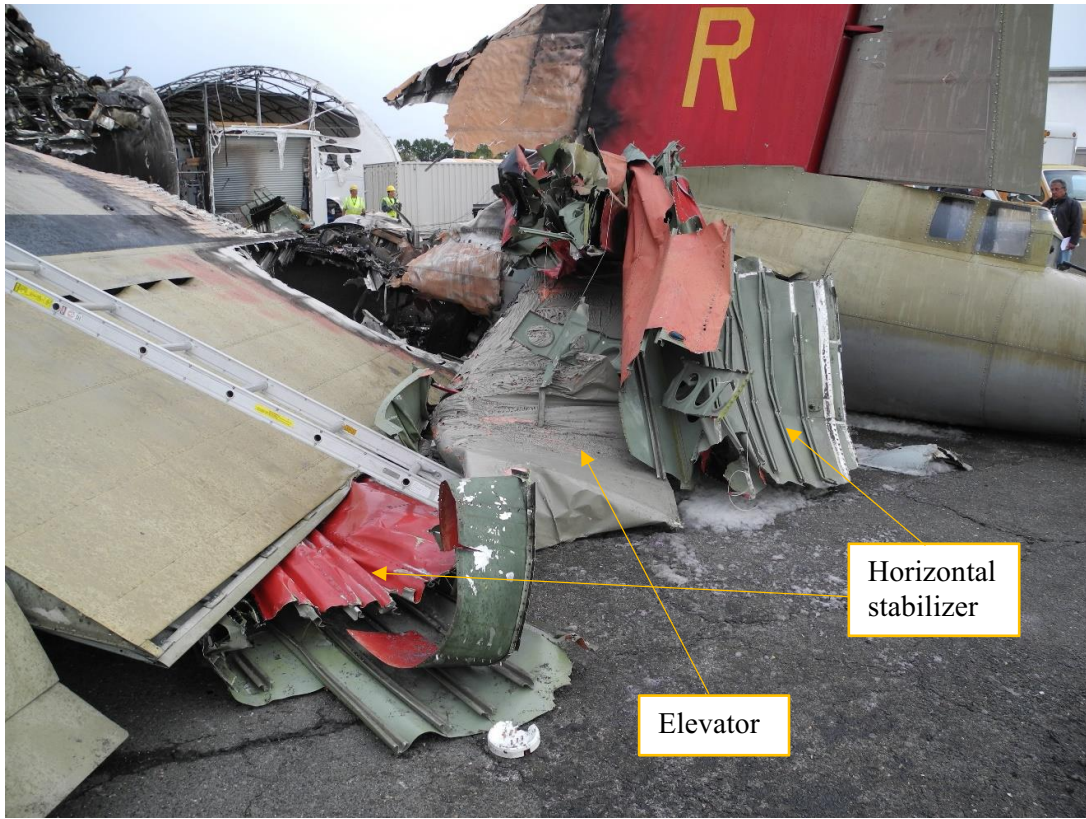
The left horizontal stabilizer was crushed at the leading edge and fractured such that the outer portion was upside down and underneath the left wing (Figure 18). The inboard portion of the elevator was separated from the stabilizer. After the wing was moved, the outer portion of the stabilizer and elevator could be seen to be present, including the tip (Figure 19). The trim tab was still connected to the elevator but had damage to the trailing edge. The trim cables were still attached to the drum and could be moved (Figure 20).

Figure 18 Left horizontal stabilizer and elevator

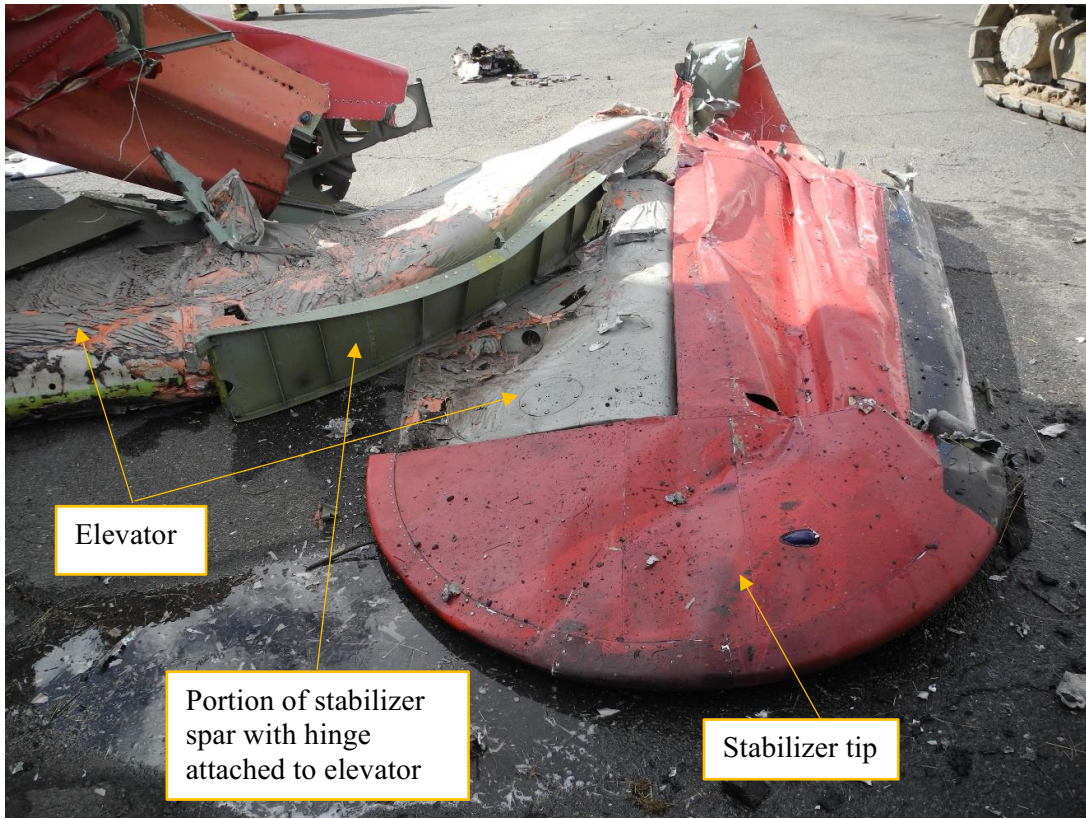
Figure 19 Right horizontal stabilizer tip inverted

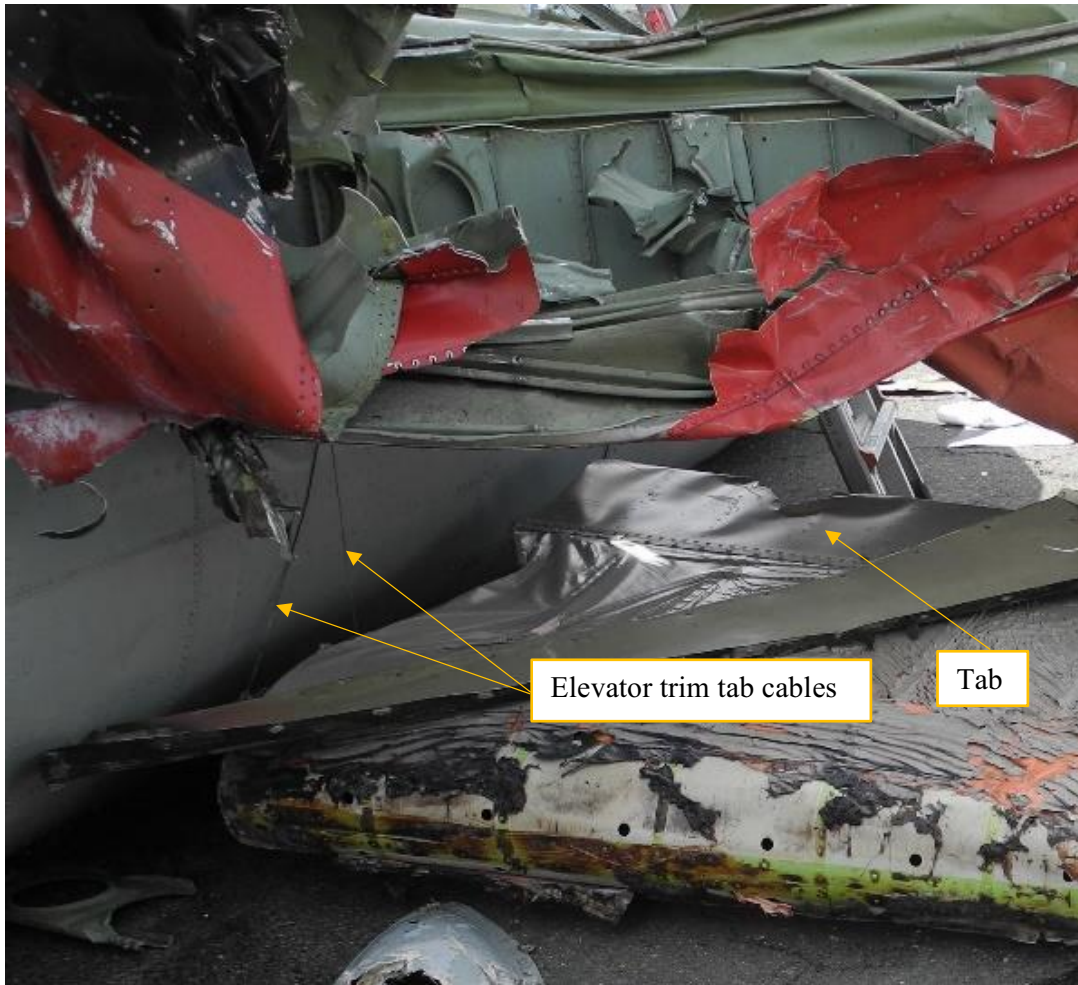
Figure 20 Left elevator trim tab cables

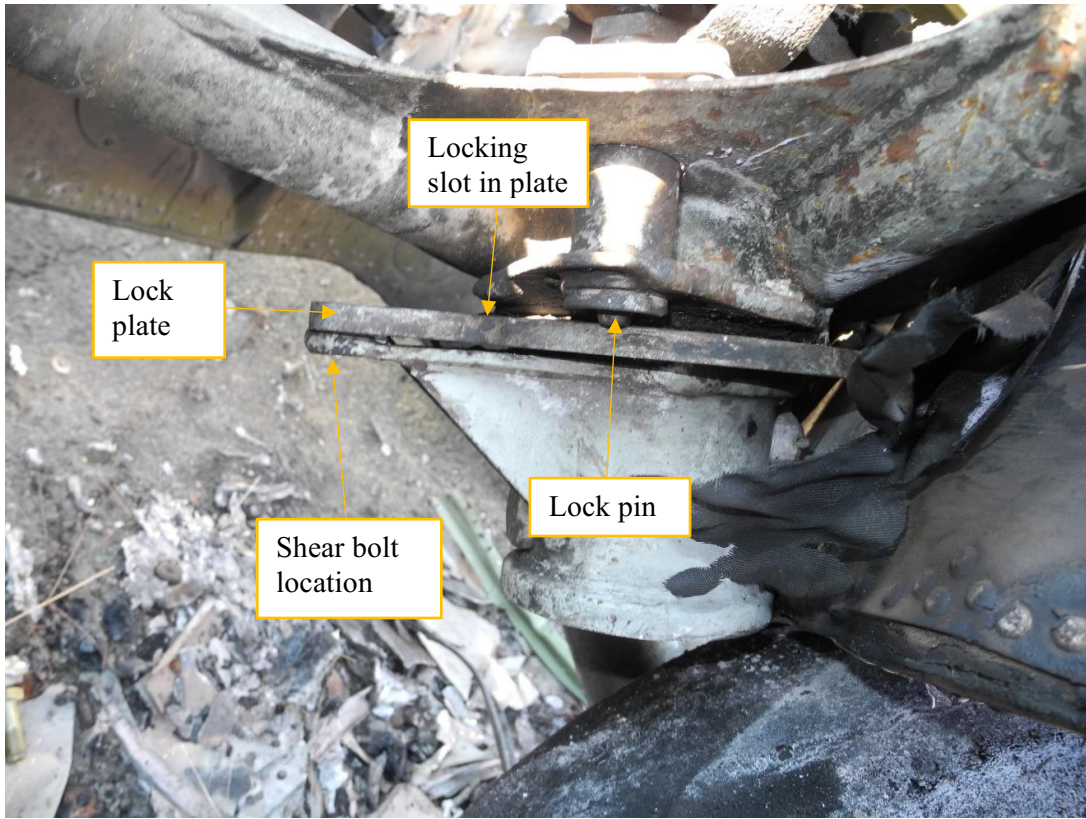
The tail wheel has a mechanical lock pin, controlled by cable from the cockpit. The pin is normally engaged for takeoff and landing and released for ground maneuvers. A shear bolt installed between the lock plate and the wheel structure prevents damage to the lock mechanism if the lock is not released during ground maneuvers. If the shear bolt fractures the wheel will be unlocked and free to turn 360 degrees even if the lock pin is engaged. The unlock cable was found to be still attached to the pin and the pulleys and levers intact in the area. The wheel lock pin was not engaged with the lock plate, it was rotated approximately 45 degrees. The shear bolt was missing from the mechanism (Figure 21). There was damage that caused a larger than normal gap between the upper structure (treadle) and the lock plate. The bottom half of the fractured shear bolt (Figure 22) was found approximately 100 yards from the wreckage, back along the accident path, near the taxi way barriers.

Figure 21 Tail wheel lock mechanism

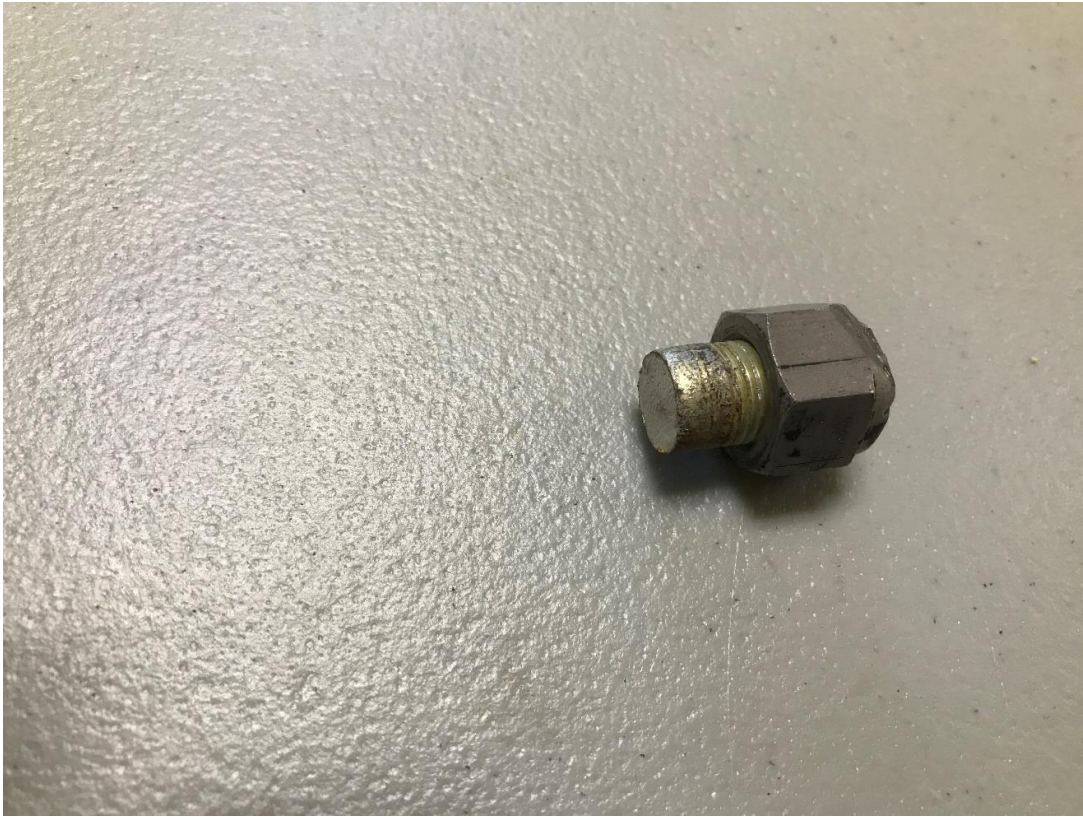
Figure 22 Bottom half of fractured shear bolt
