**NATIONAL TRANSPORTATION SAFETY BOARD
OFFICE OF AVIATION SAFETY
WASHINGTON, D.C. 20594**

Airworthiness Group Chairman's Factual Report

ERA20MA001

Operator: Collings Foundation
Aircraft: B-17G, N93012
Location: Windsor Locks, CT
Date: October 2, 2019
Time: 0953 EST

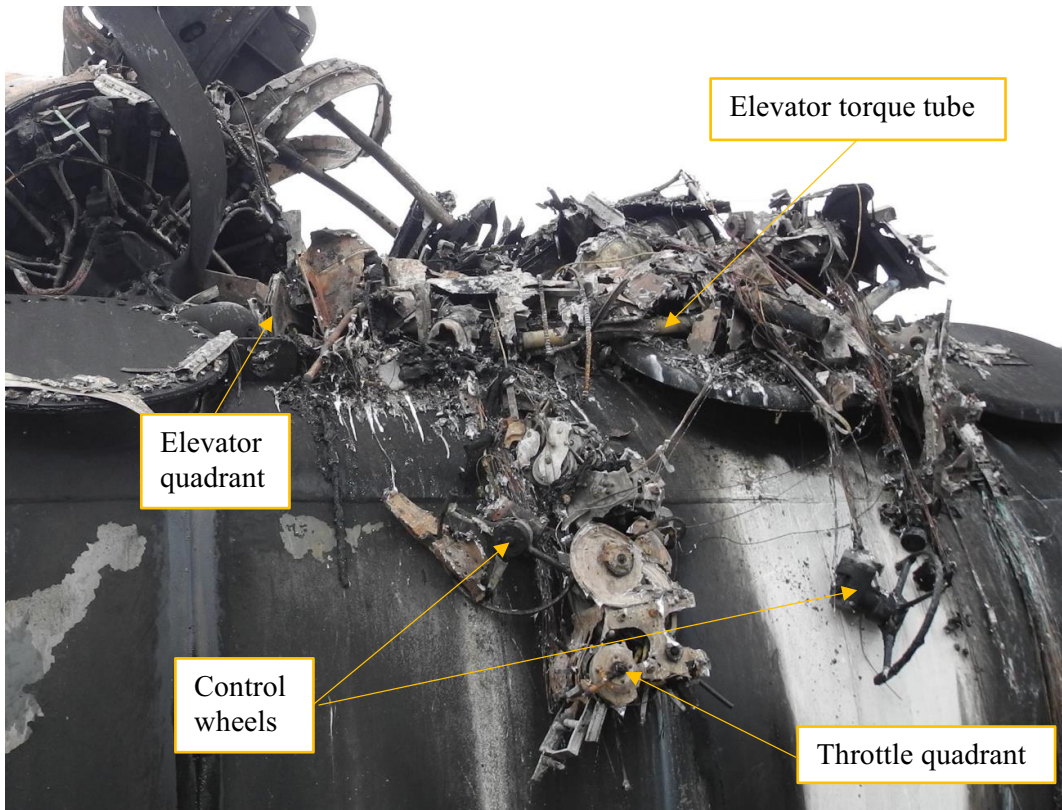
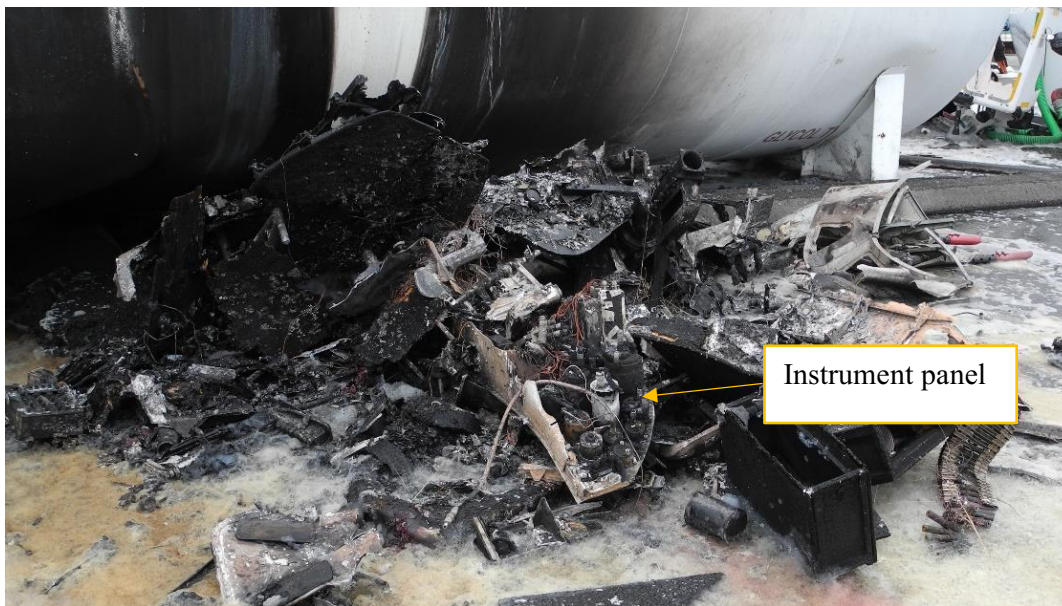
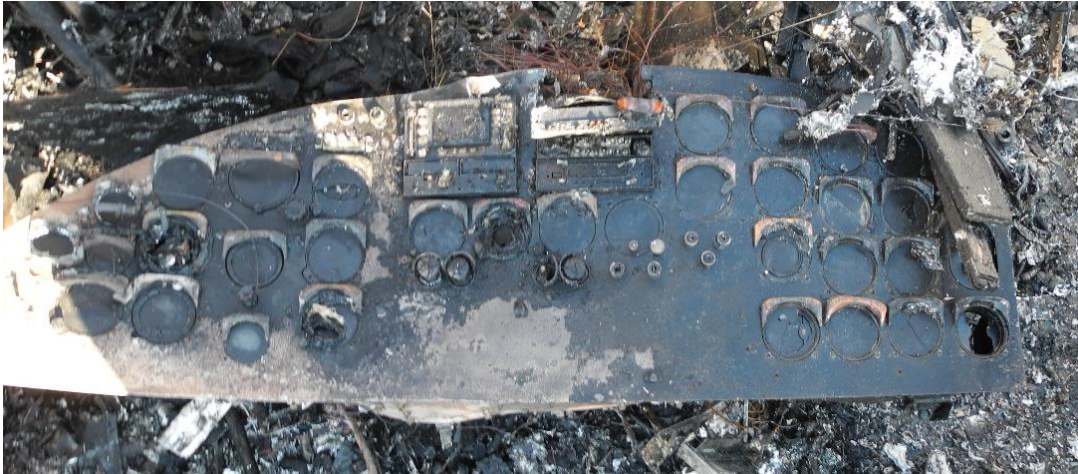
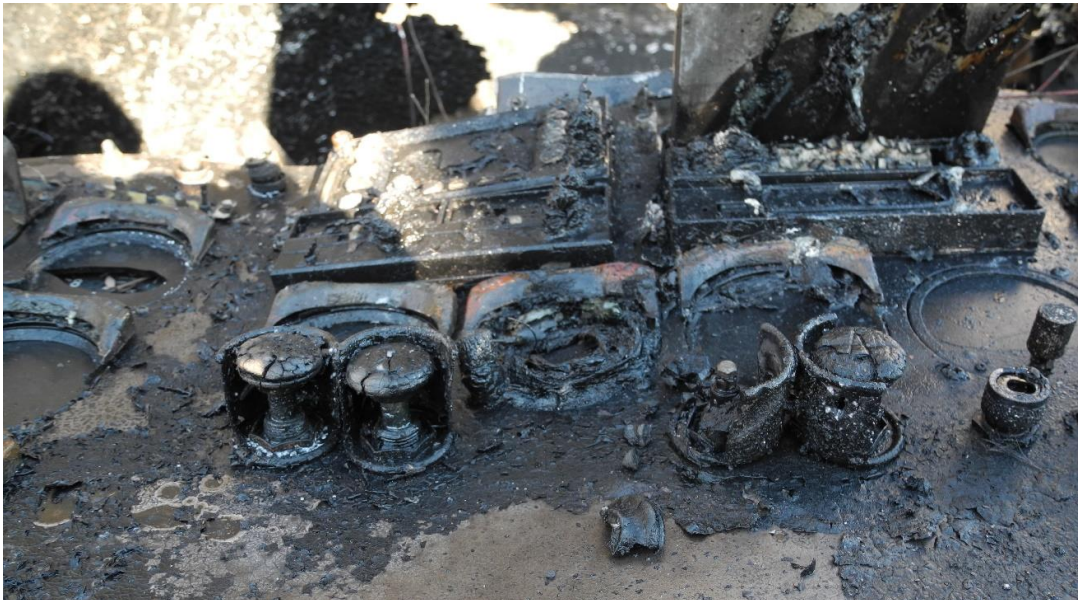
The fire damaged remnants of the cockpit controls were located on top of the glycol tank (Figure 23), The controls could not be documented in place, so they were removed by an excavator, resulting in additional damage. The instrument panel was found at the base of the tank on the opposite side as the fuselage (Figure 24-25). The instruments were heavily sooted so that the instruments could not be seen. The propeller feather push buttons were intact and in the extended position (Figure 26). In normal operation, the button is pushed, and, after the prop feathers, the push button automatically extends again.

Figure 23 Cockpit controls

Figure 24 Cockpit instruments

Figure 25 Instrument panel

Figure 26 Propeller feather switches

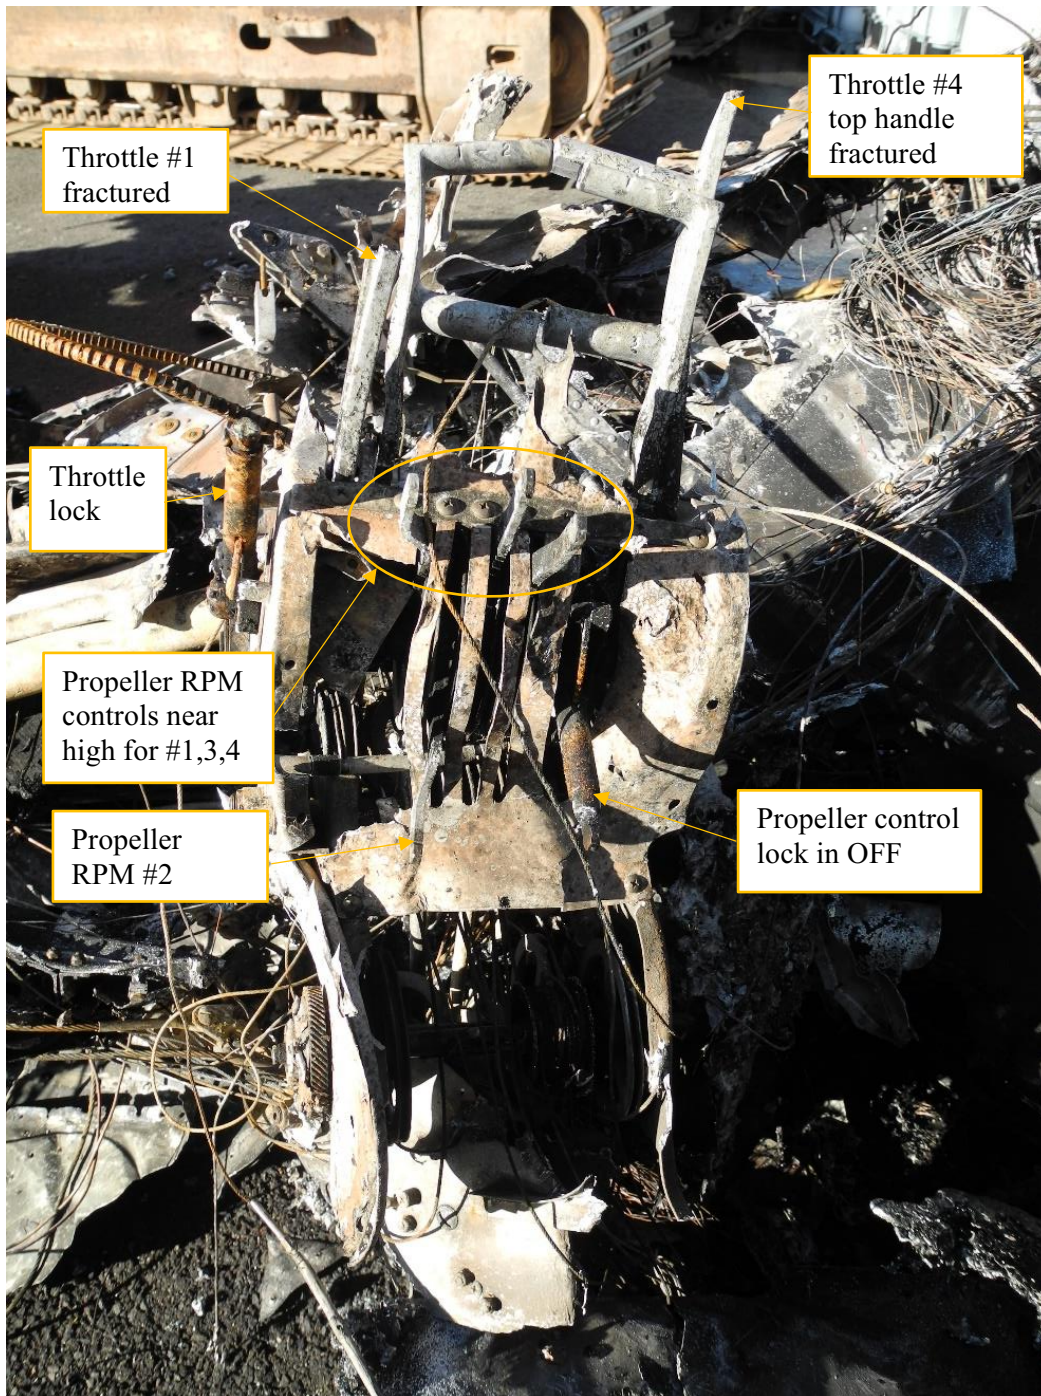
Figure 27 shows the arrangement of the throttle and propeller controls. Each throttle lever has two handles, with the inboard engine levers nested between and below the outboards. The throttle quadrant was badly damaged by impact and fire (Figure 28). The upper portion of throttle lever 1 was missing both handles. Throttle 2 was intact but bent. Throttle 3 was intact. Throttle 4 had the upper handle missing. The propeller RPM levers for 1, 3, and 4 were near the high position, #2 was near low in this photo, but at the midpoint between high and low prior to being moved from glycol tank. The propeller lock lever was in the OFF position. The mixture lock lever was in the ON position (Figure 29). The position of the #1 lever was different before recovery from the top of the tank, it was slightly forward of the #2 lever instead of against the aft stop.

Figure 28 Throttle quadrant

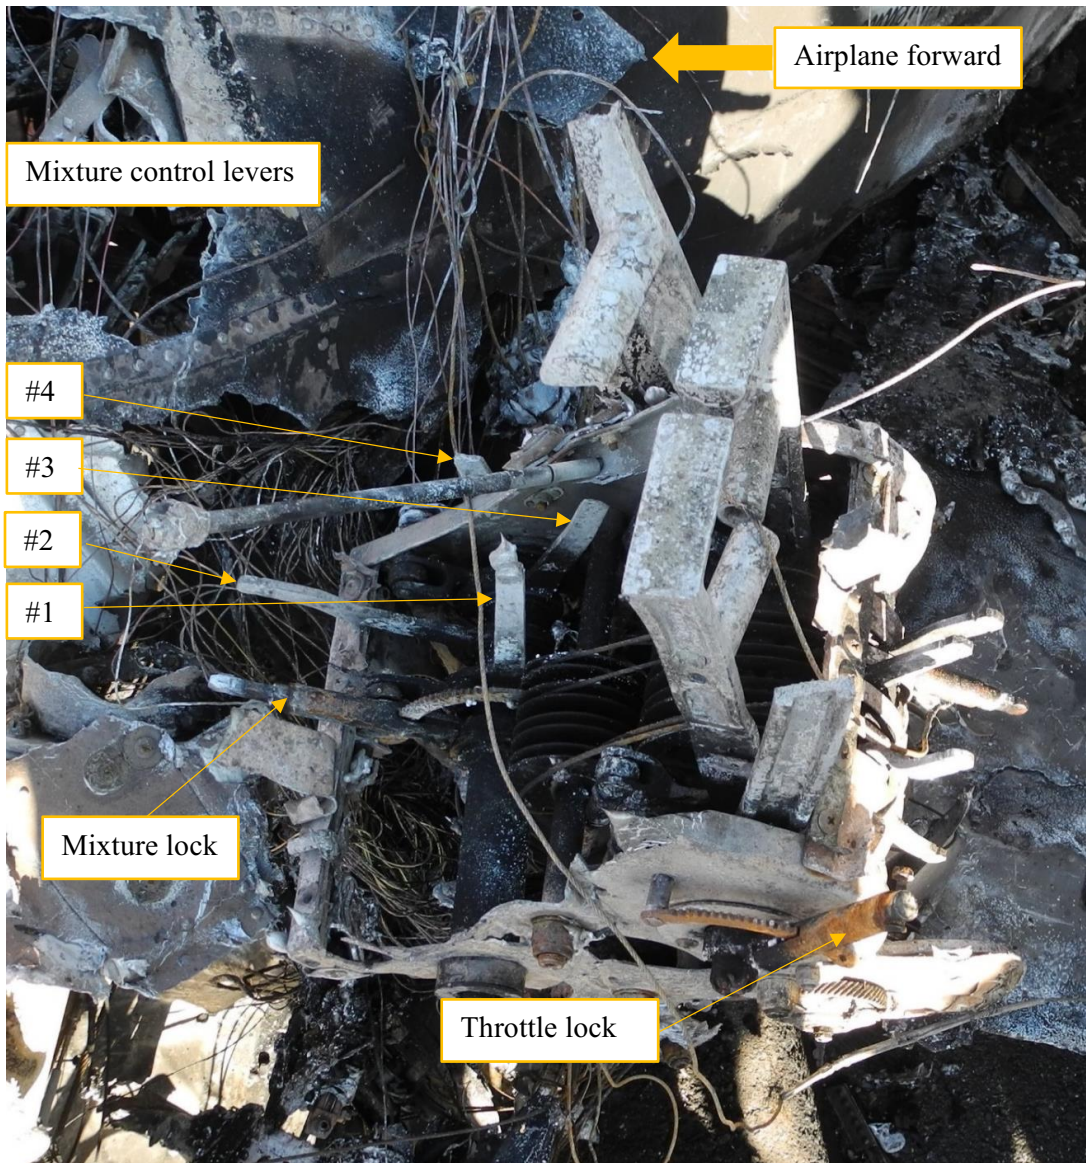
Figure 29 Mixture controls

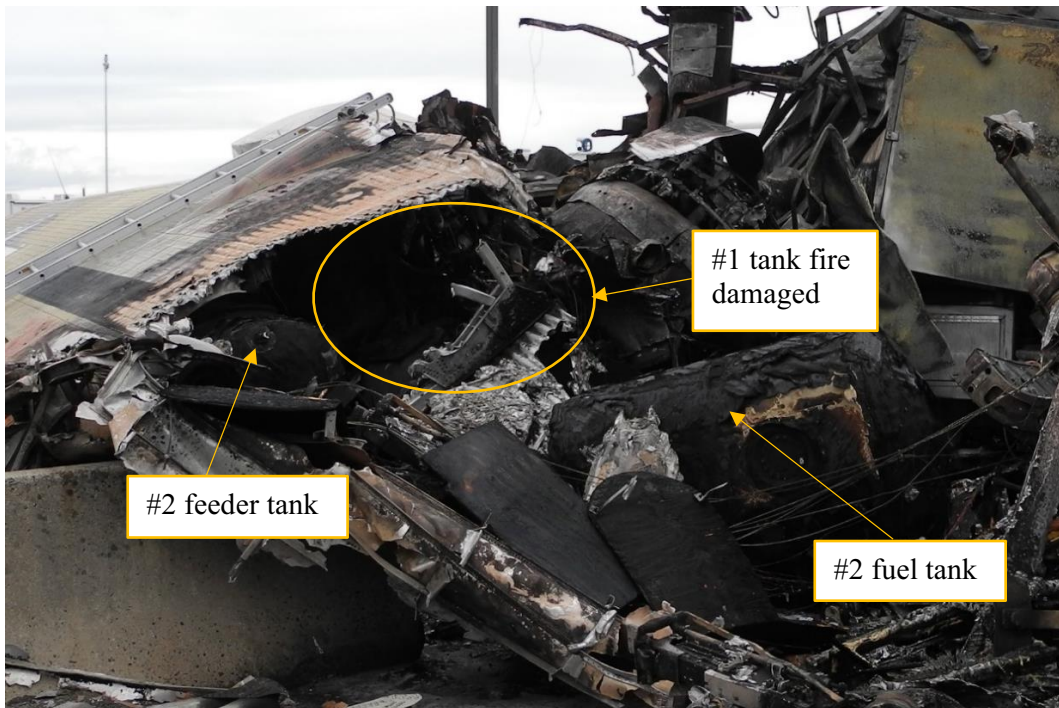
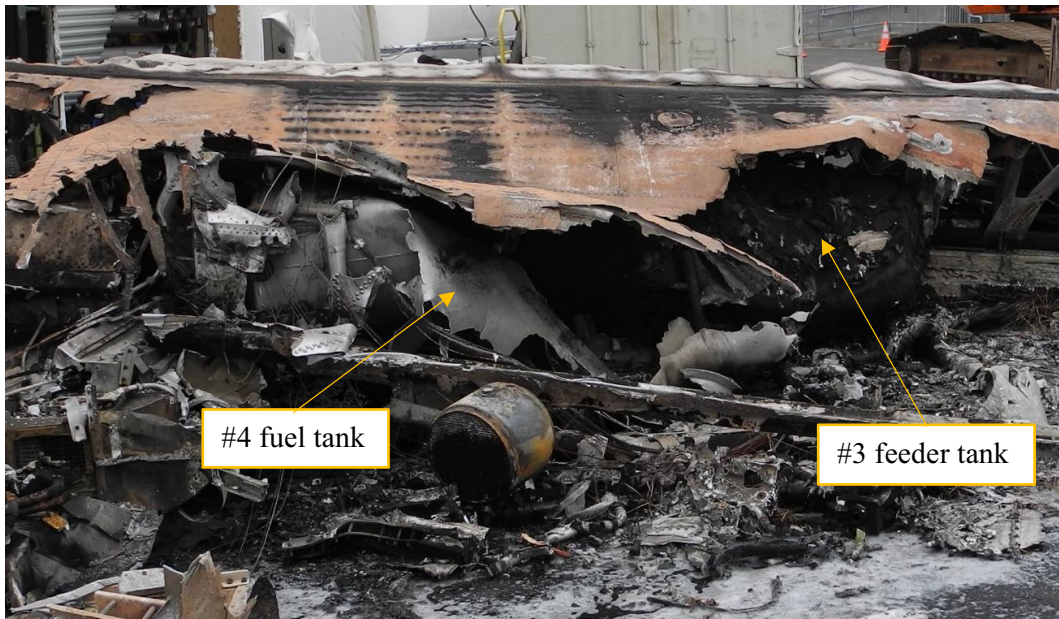
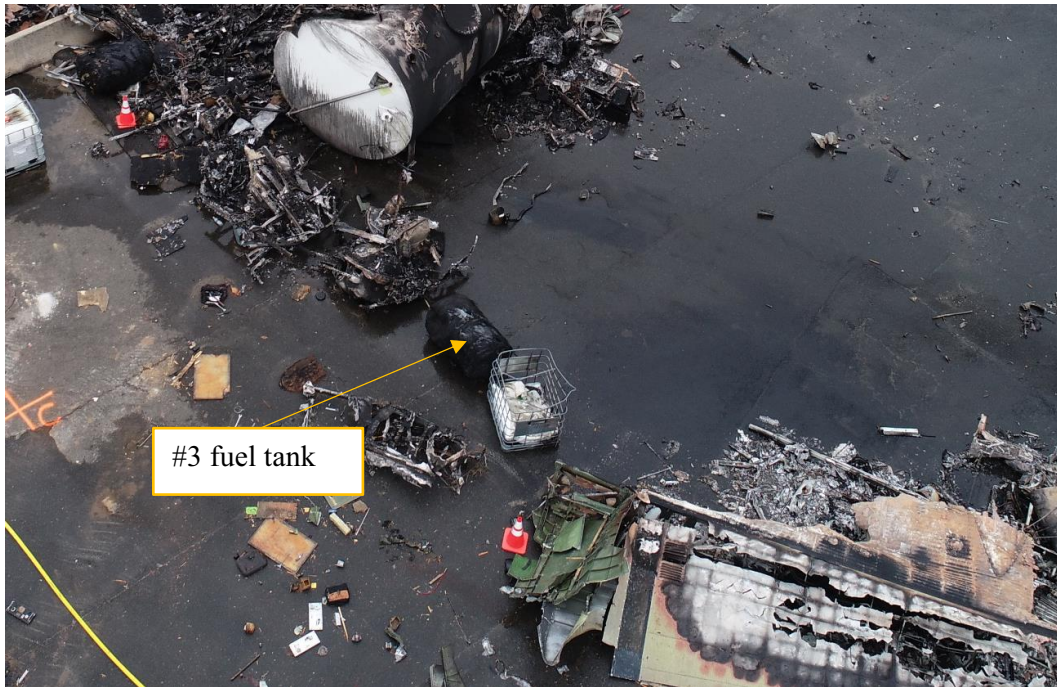
The airplane had one large (425 gallon) self-sealing rubber tank for the #1 engine, two smaller (213 gallon main, 212 gallon feeder) tanks for each inboard engine (#2 and #3), and one large (425 gallon) aluminum tank for the #4 engine (Figure 30). The airplane did not have the outboard “Tokyo” tanks or the bomb bay tanks installed. The bomb bay tanks were removable tanks only used on long range ferry flights. The tanks for #1 and #4 did not have a protective rubber covering and were consumed during the post impact fire (Figures 31-33). The tanks for #2 and #3 had a protective rubber covering and were still intact but heat damaged. A fuel sample was taken from the #3 tank (Figure 34).

Figure 31 Left wing fuel tanks

Figure 32 Right wing fuel tanks

Figure 33 Right wing fuel tank #3

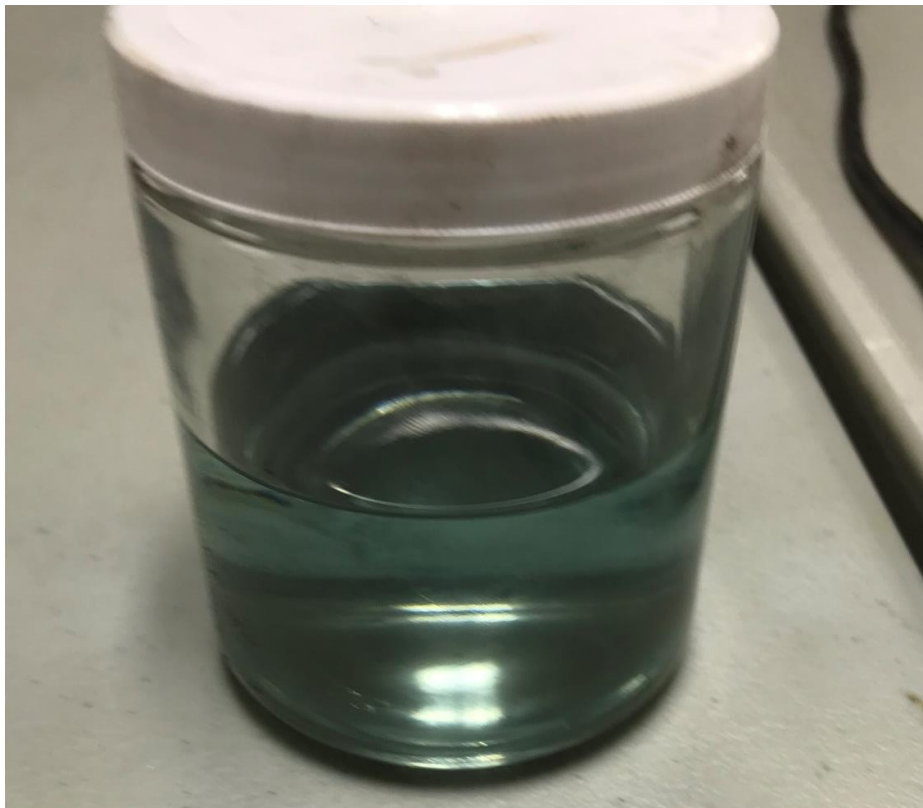
Figure 34 Fuel sample from #3 tank

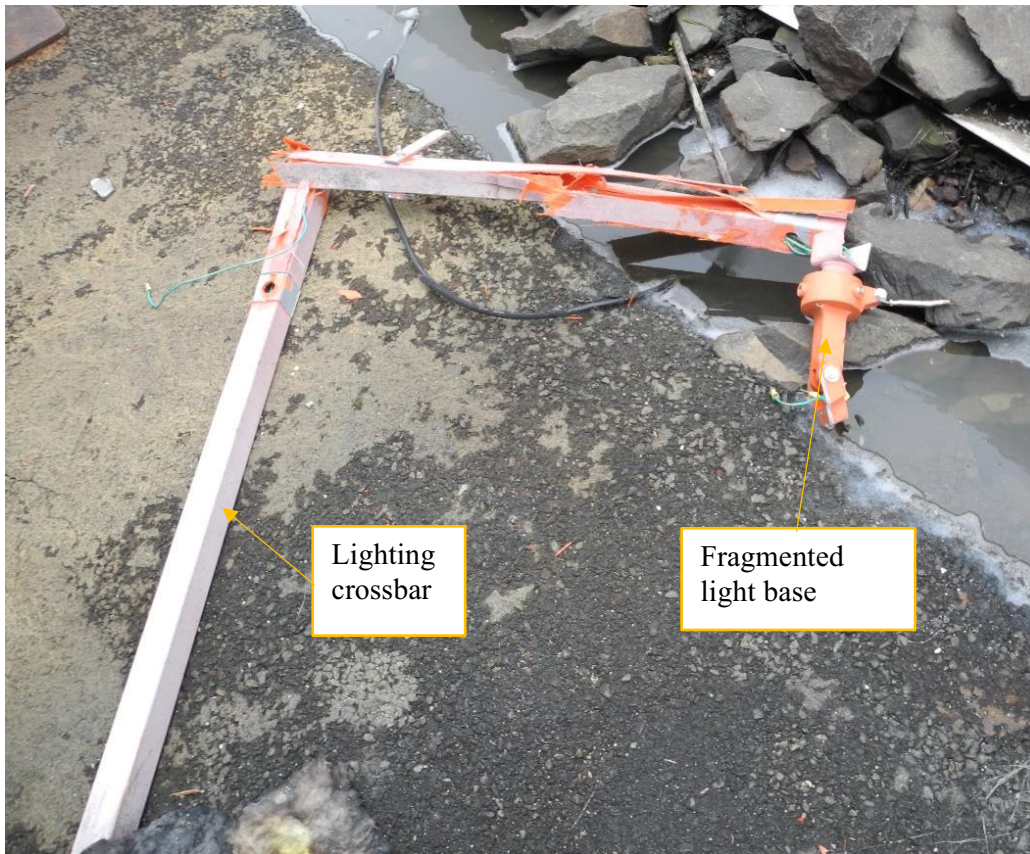
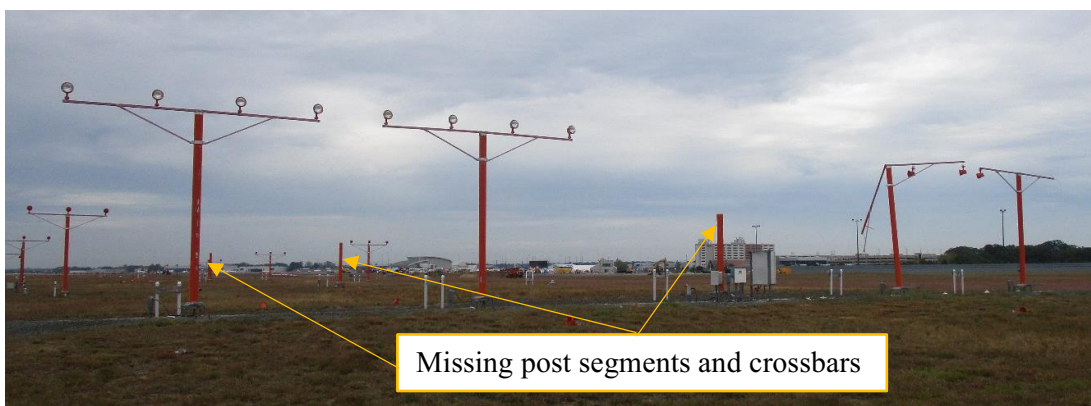
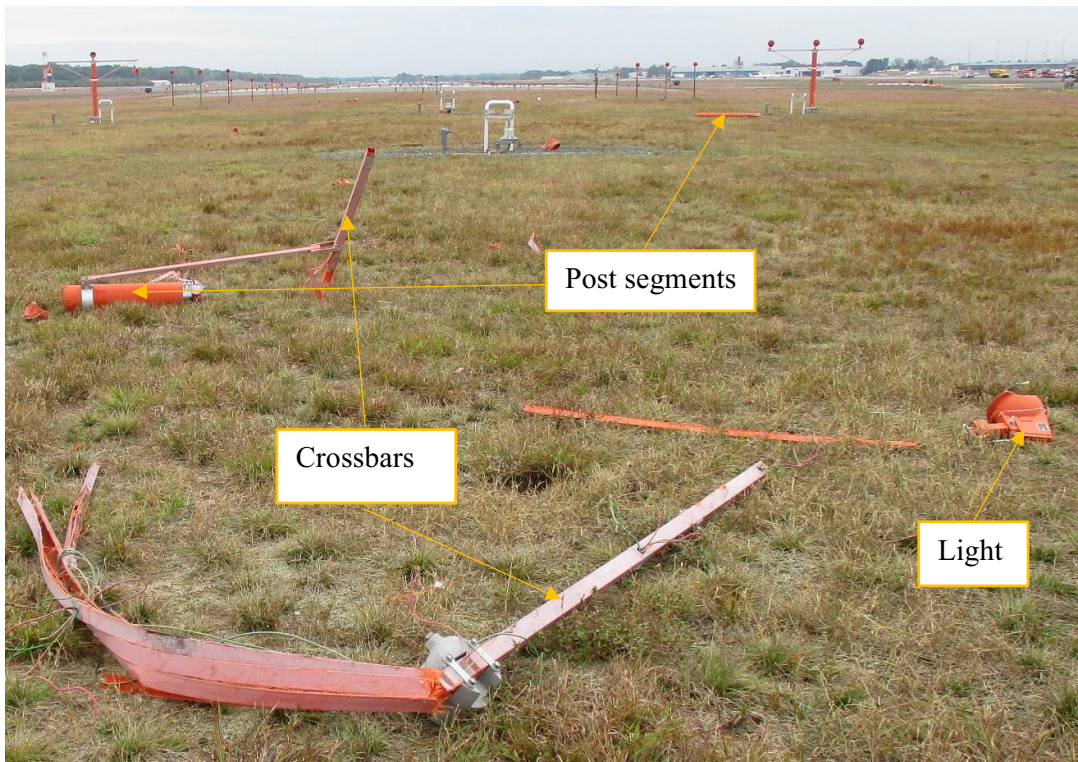
Near the tip of the right wing, between the buildings, a portion of the runway approach lighting was found (Figure 35). There were many damaged approach lighting support posts and crossbars (Figures 36, 37)

Figure 35 Approach lighting structure found near right wing tip

Figure 36 Damaged approach lighting

Figure 37 Damaged approach lighting

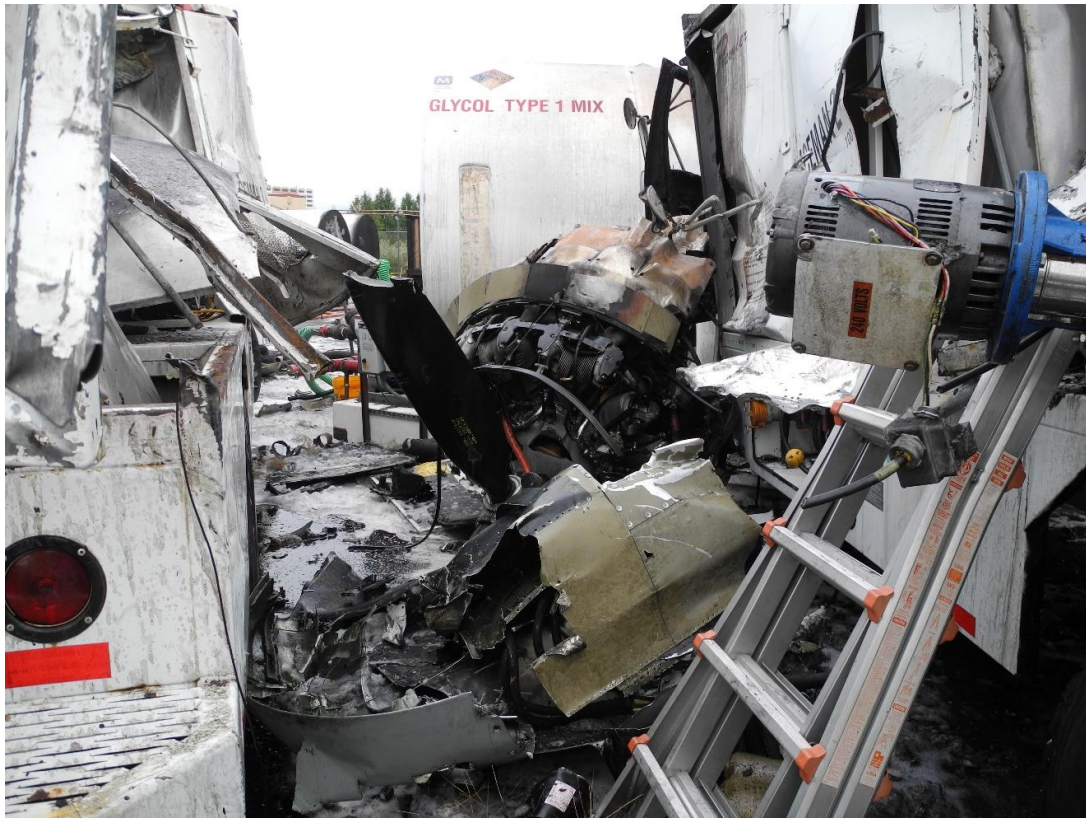
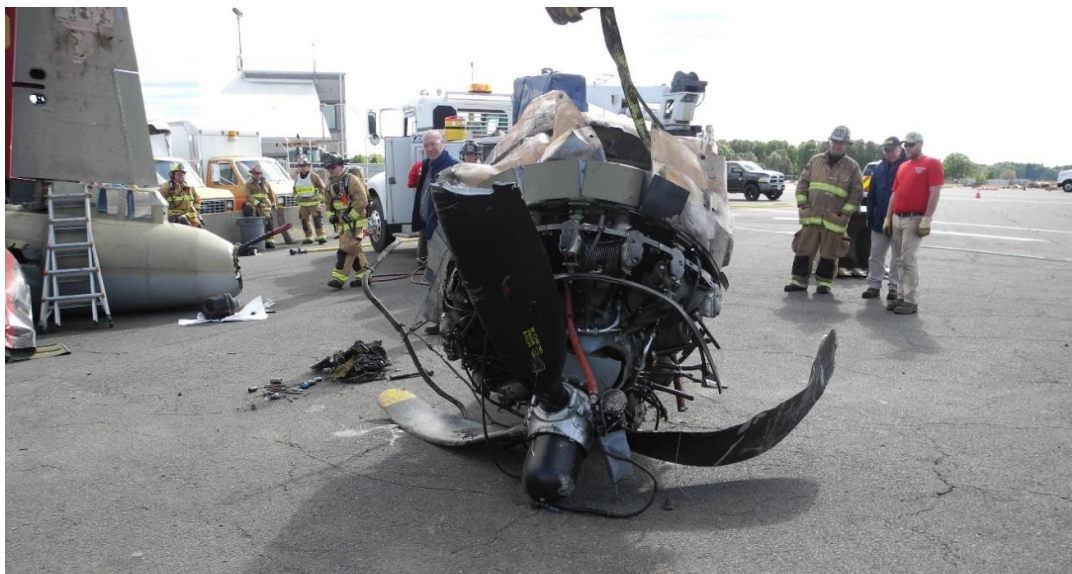
This engine was found detached from the nacelle and it came to rest between the two deicing trucks (Figure 38). The propeller remained attached to the engine and all three propeller blades were in place on the hub. Two of the propeller blades were intact but deformed (Figure 39). One of the propeller blades was fractured at the tip, and the tip was found approximately 700 feet away (Figure 40). The data plate showed the serial number (Figure 41).

Figure 38 Engine #1

Figure 39 Engine #1 after moving by excavator

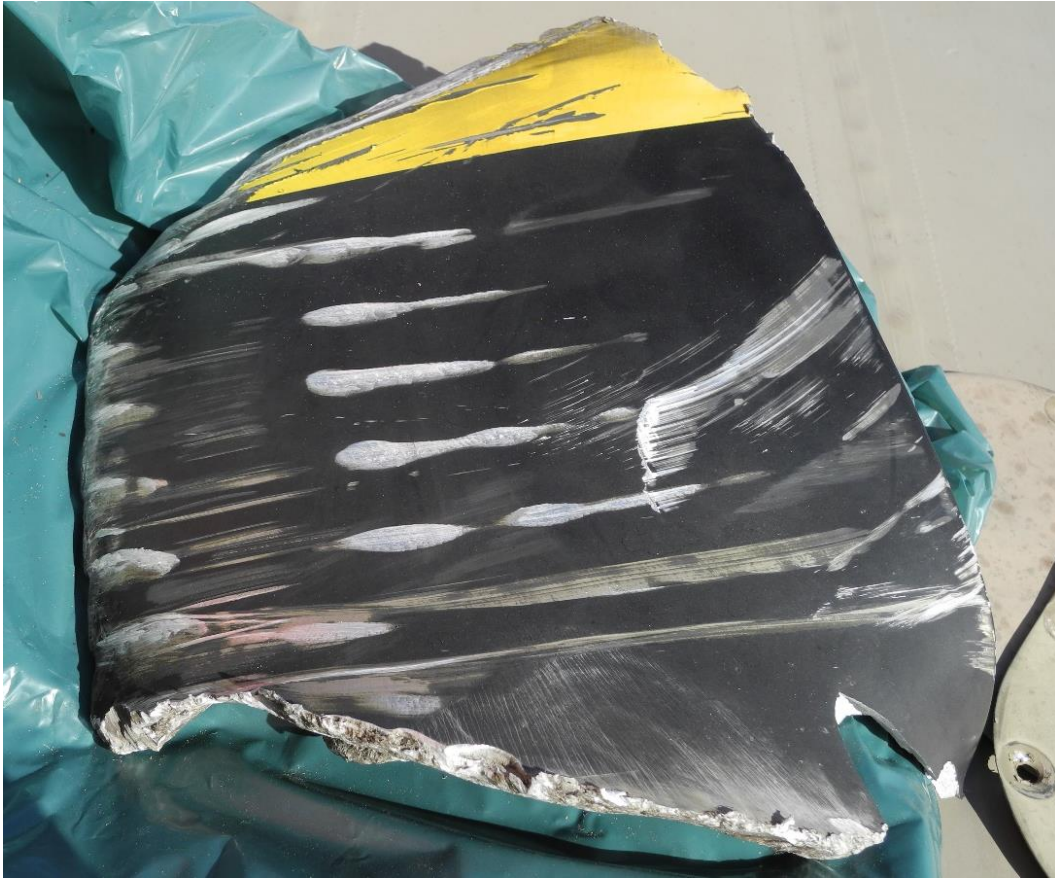
Figure 40 Fractured blade tip

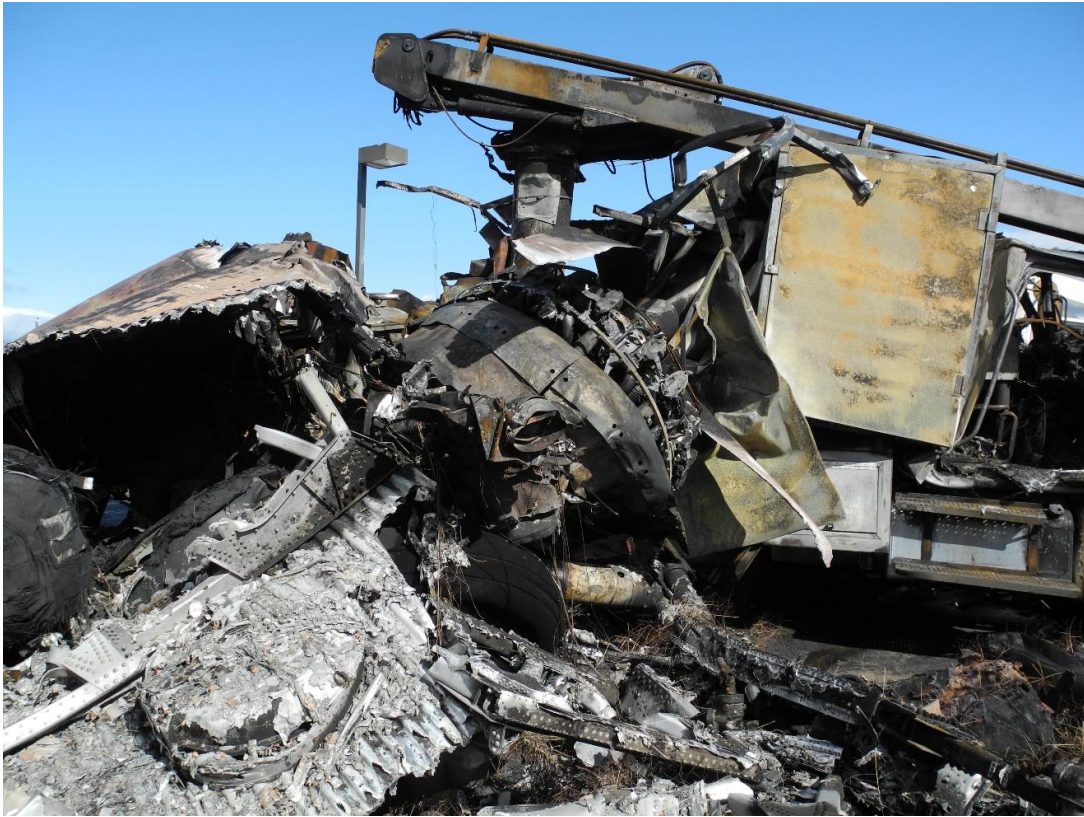
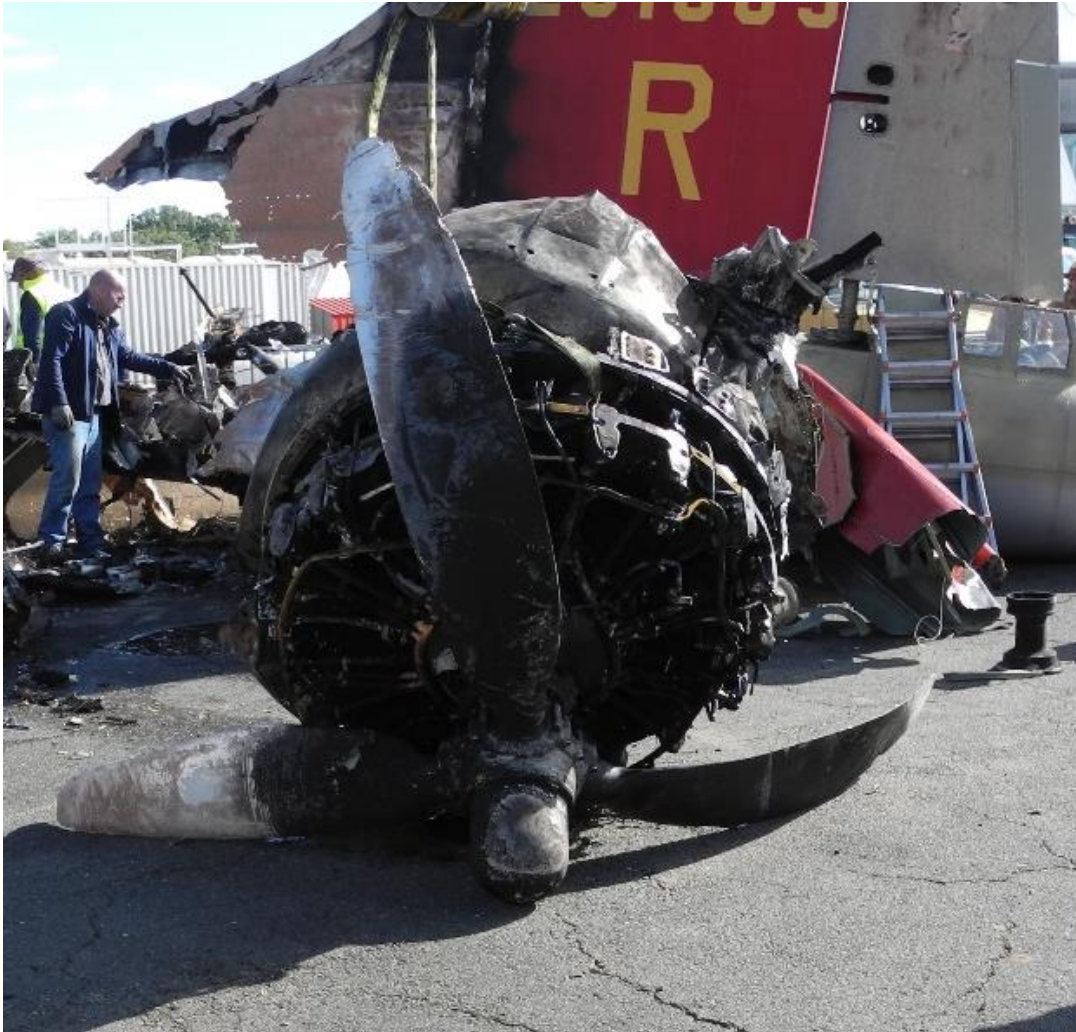
This engine was detached from the nacelle and situated between a deicing truck and the wing (Figure 42). The propeller remained attached to the engine and all three propeller blades were in place on the hub. All three of the propeller blades were intact but deformed (Figure 43). The data plate showed the serial number (Figure 44).

Figure 42 Engine #2

Figure 43 Engine #2 after moving

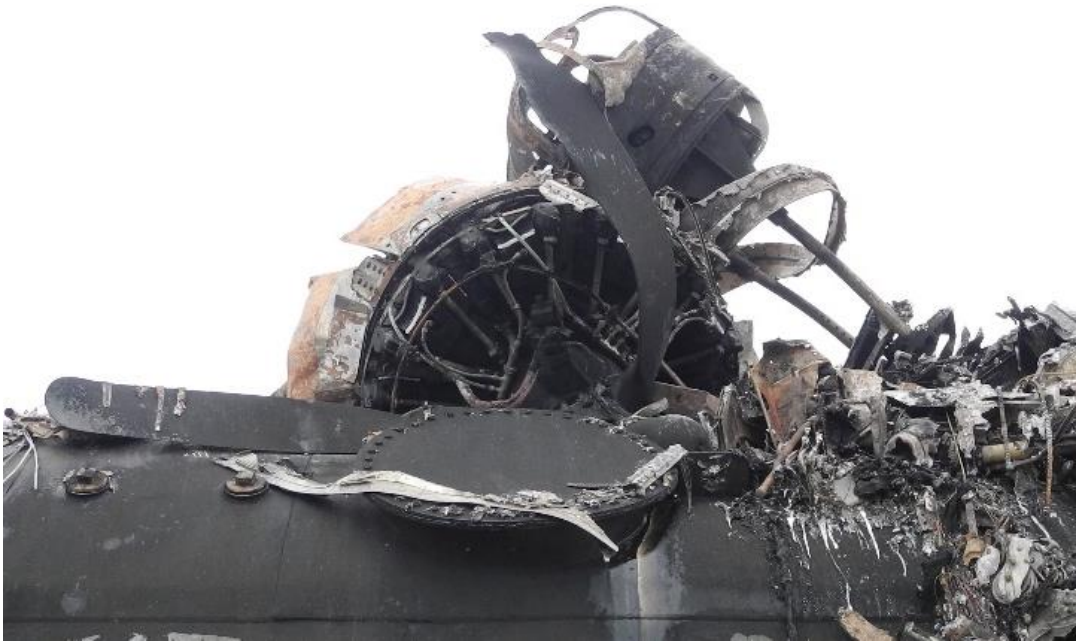
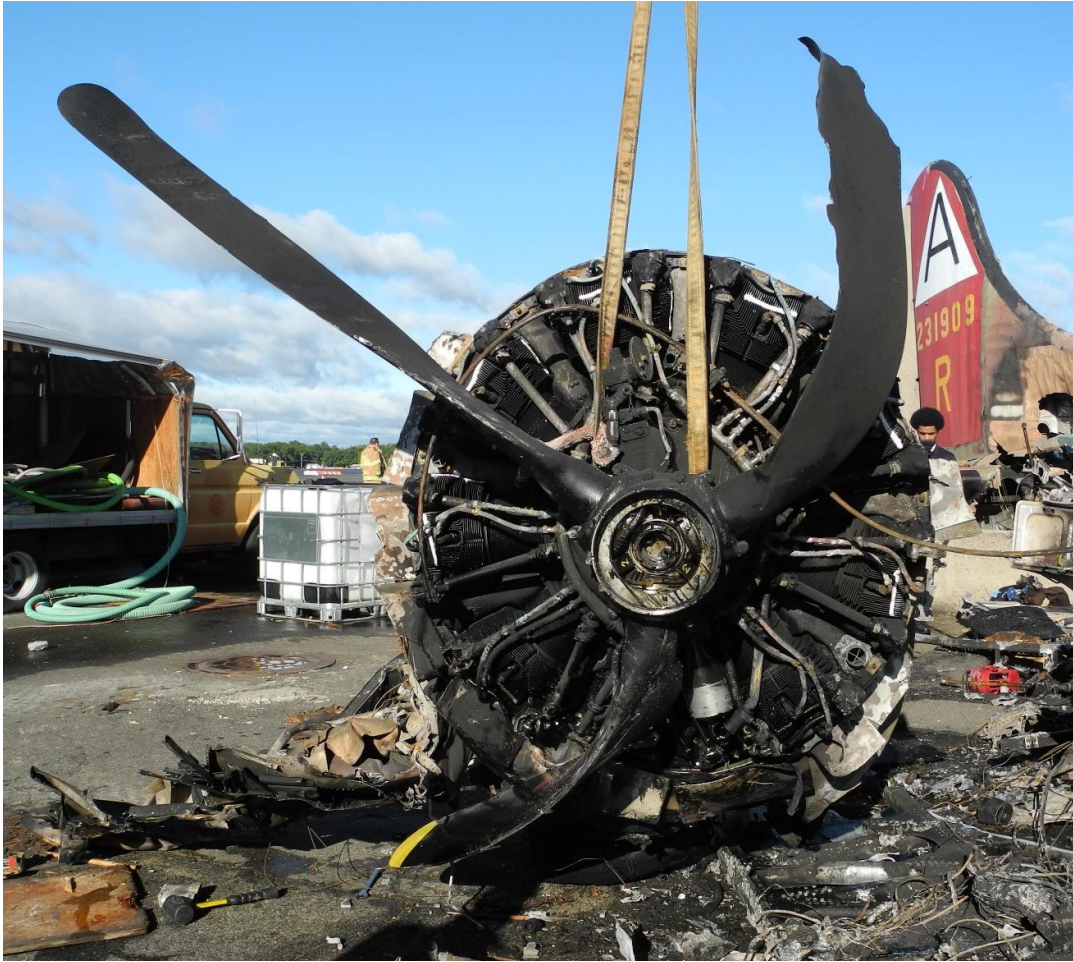
This engine was found on top of a glycol tank (Figure 45). The propeller remained attached to the engine and all three propeller blades were in place on the hub. The tank was punctured by the propeller (see UAS Aerial Imagery factual report, Figure 17). The propeller dome was observed to be detached before removal from the tank. The engine was lifted off the tank by an excavator. The propeller without the soot on the tip was inside the tank. Two of the propeller blades, the one that penetrated the tank and one of the blades that was outside of the tank, were intact but deformed (Figure 46). The other propeller blade that remained outside of the tank had the tip fractured, two fragments were found (Figure 47), one found near the other fractured tip from engine #1 (approximately 700 ft from wreckage) and one was found approximately 100 feet from the main wreckage in the direction of the other fragments. The data plate showed the serial number (Figure 48).

Figure 45 Engine #3 on top of glycol tank

Figure 46 Engine #3 after recovery from tank

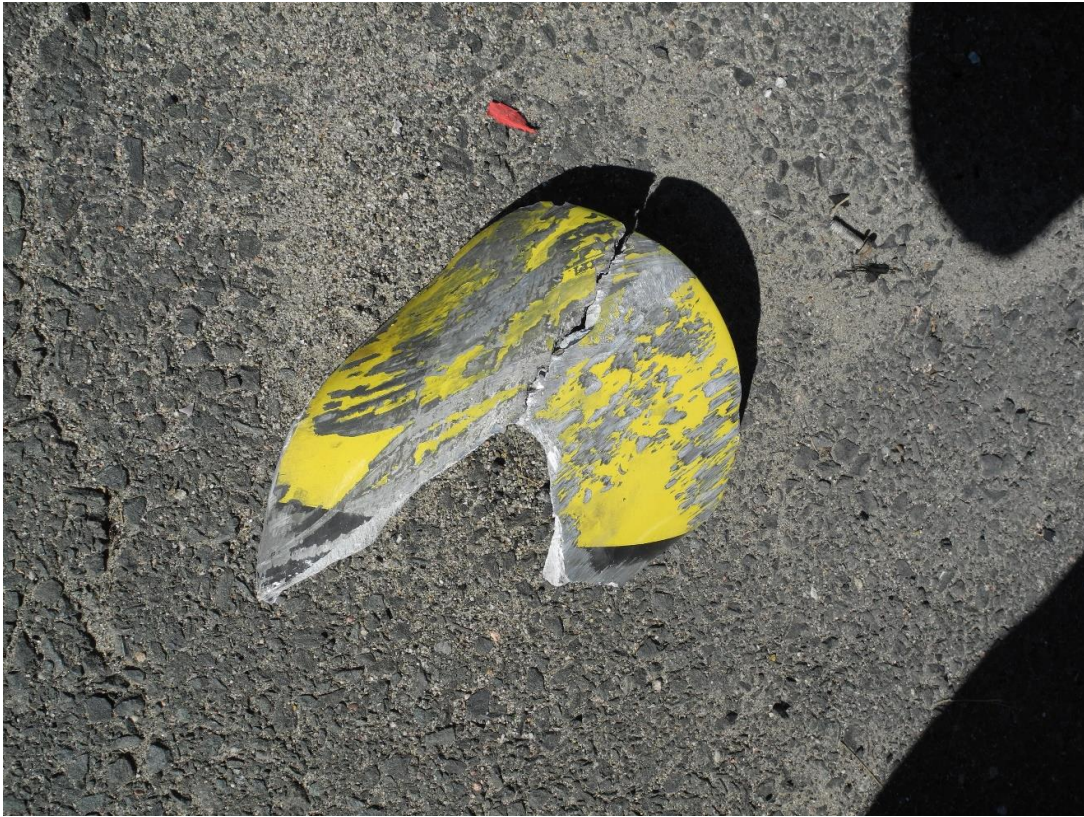
Figure 47 Fractured #3 Engine propeller tip (two pieces)

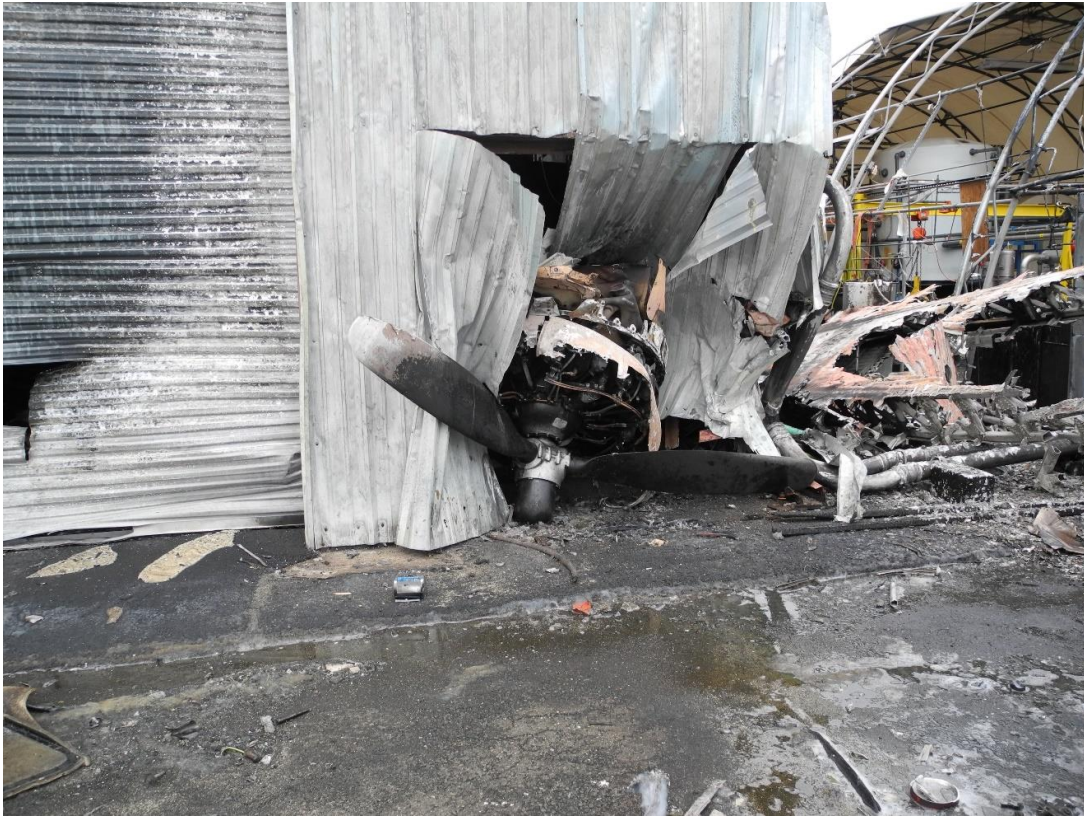
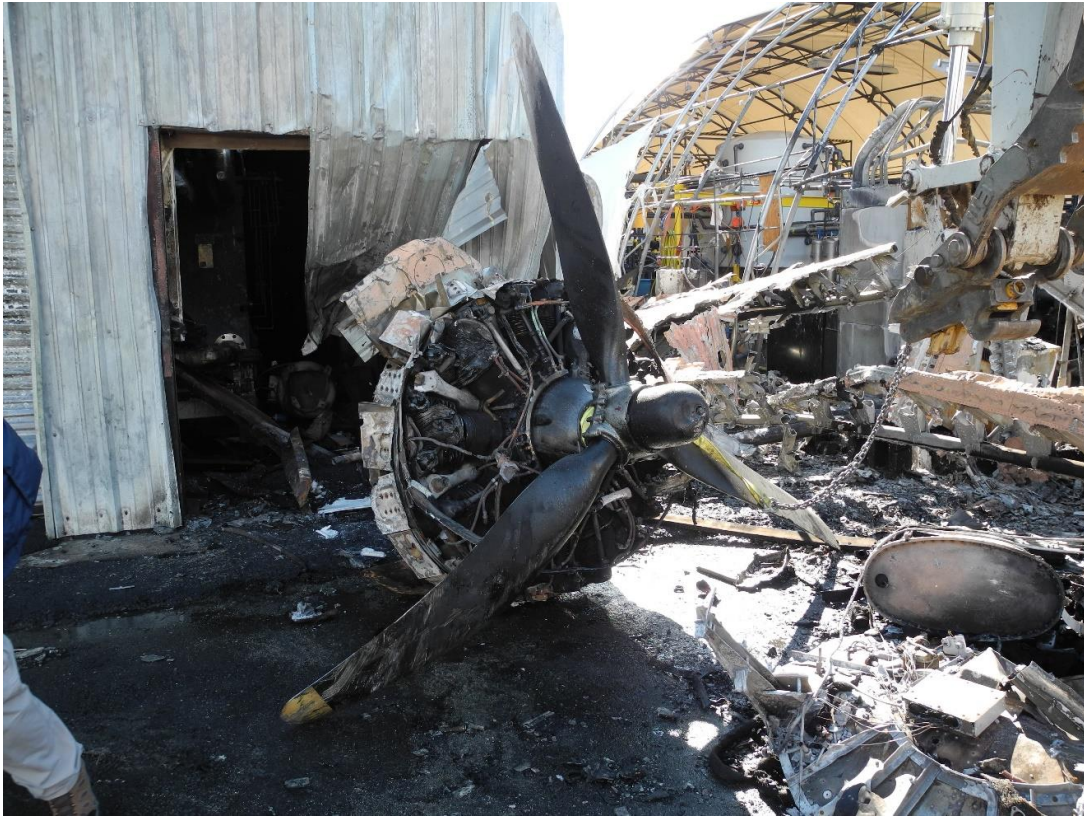
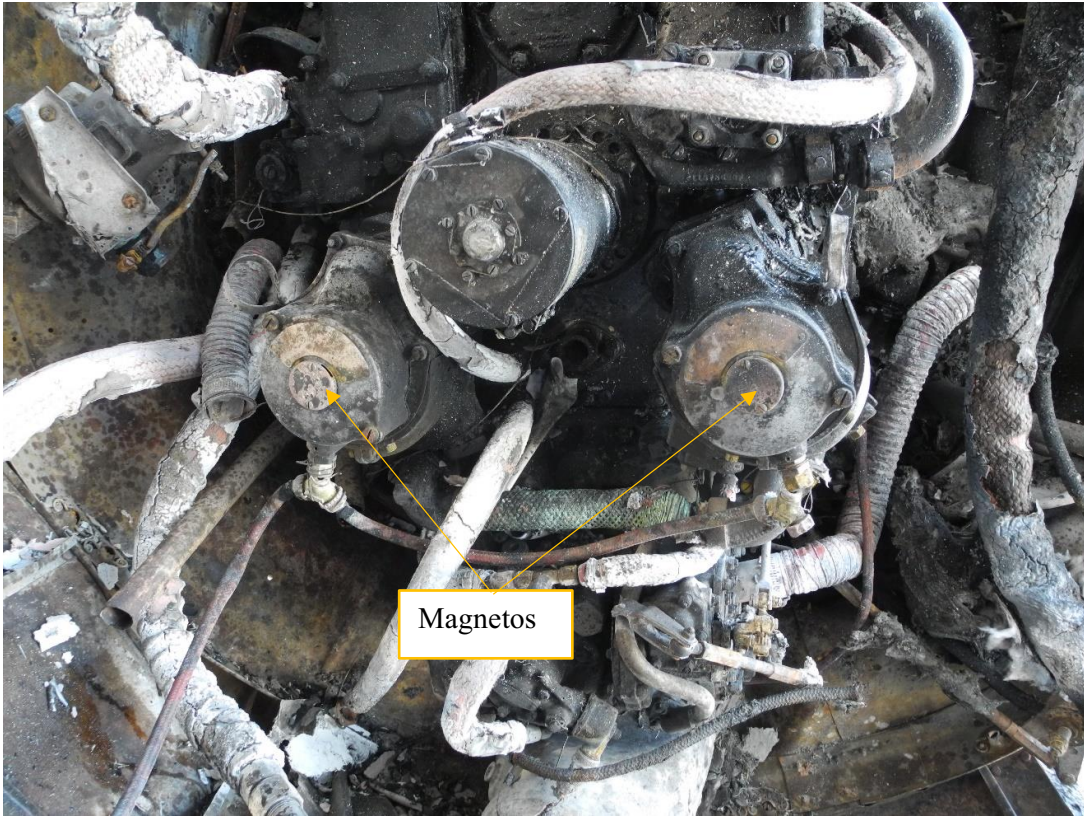
The engine was found separated from the nacelle and came to rest in a nearby building (Figure 49). The propeller remained attached to the engine and all three propeller blades were in place on the hub. The magnetos were in place on the back of the engine (Figures 50,51). The data plate showed the serial number (Figure 52).

Figure 49 Engine #4

Figure 50 Engine #4 propellers

Figure 51 Engine #4 magnetos
