National Transportation Safety Board

Performance Study

Specialist Report

Location: Brownsville, Tennessee
Date: April 20, 2021
Time: 20:52 central daylight time (CDT)
Airplane: Piper PA-28RT, N4303G
NTSB Number: ERA21FA189

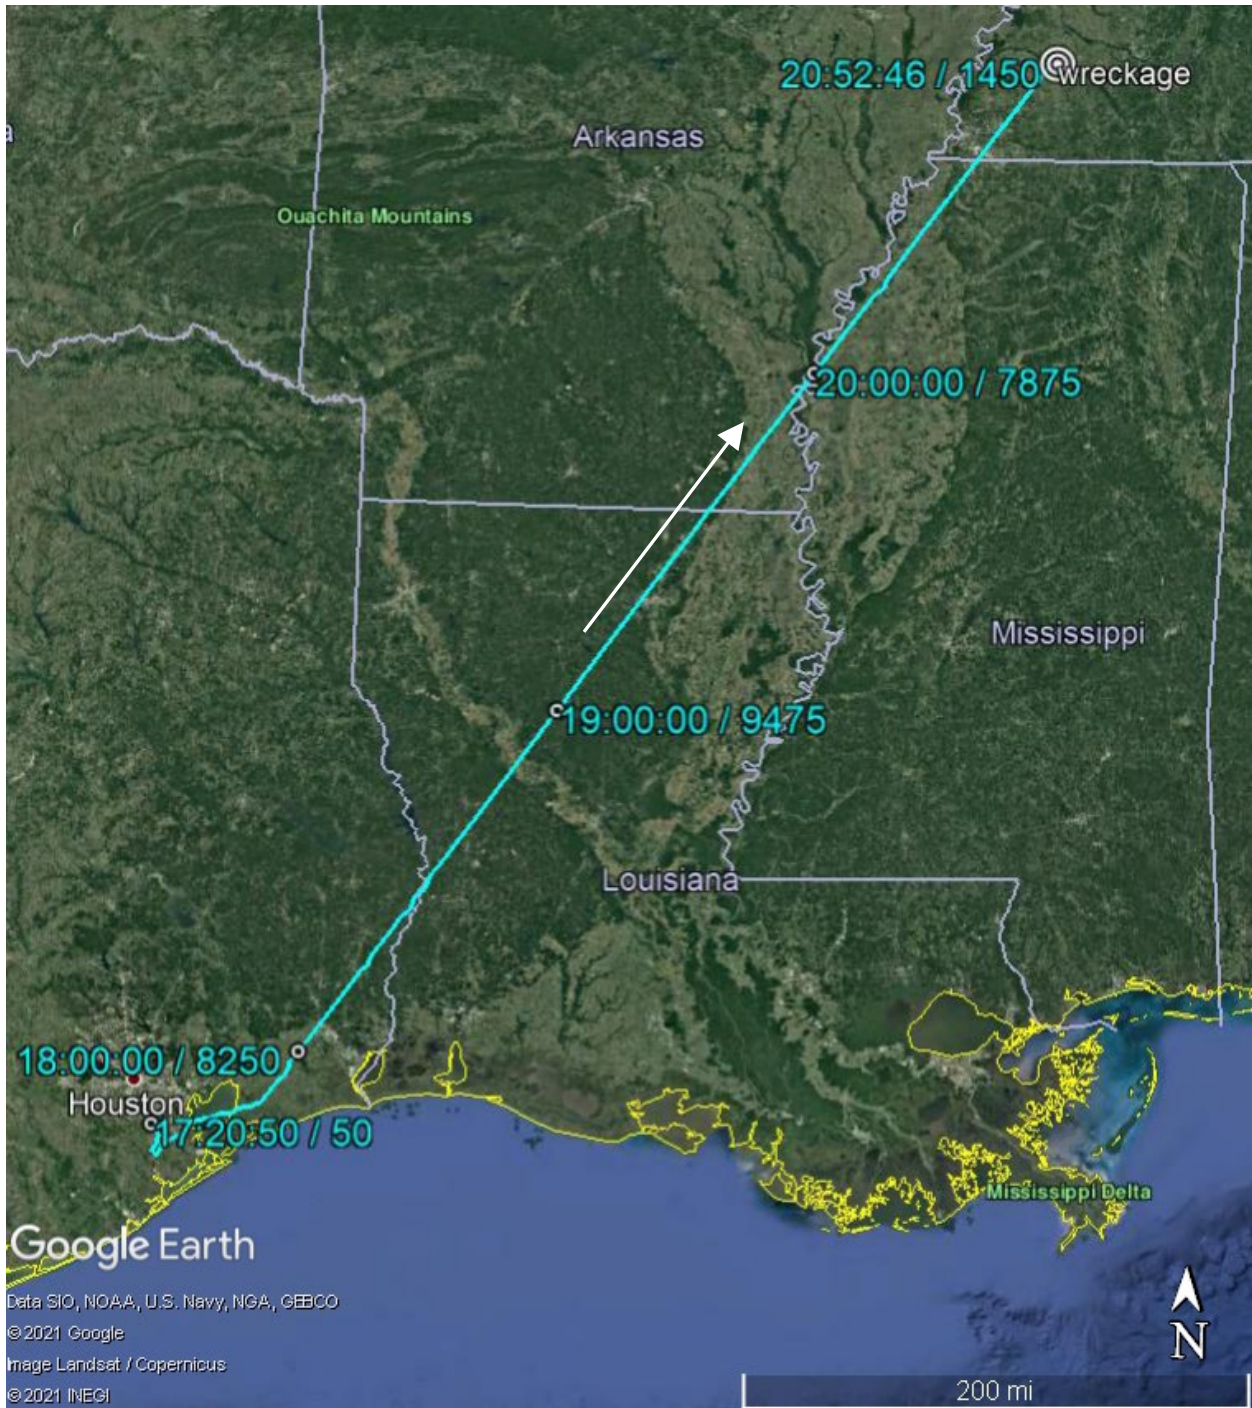
The airplane took off from Pearland Regional Airport in Pearland, Texas at about 17:20 CDT (Figure 1). It climbed to about 9,500 ft mean sea level (msl) (Figure 2) before beginning to descend about 19:45. By 20:50, the airplane was level at 7,300 ft and a calibrated airspeed of 160 kts.

Figure 1. Accident flight in blue with select times and altitudes (msl) annotated in blue.

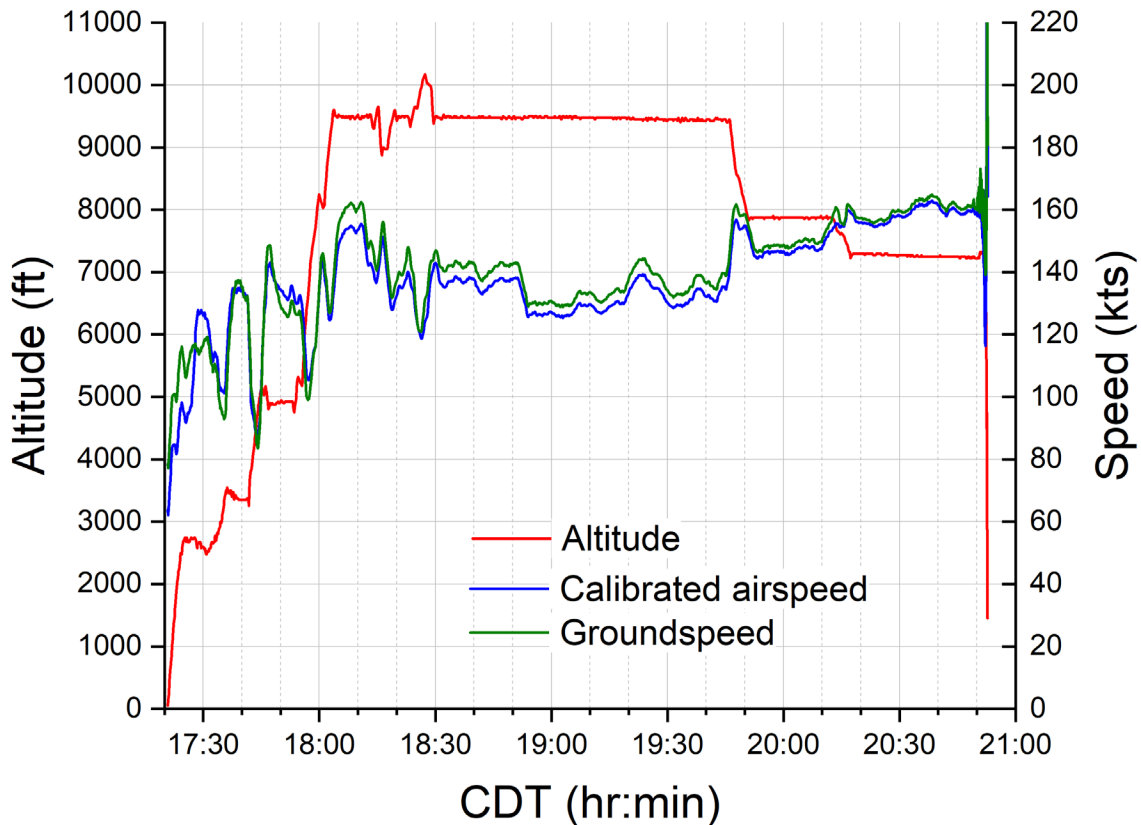
Figure 2. Altitude (msl) and calculated groundspeed and calibrated airspeed.

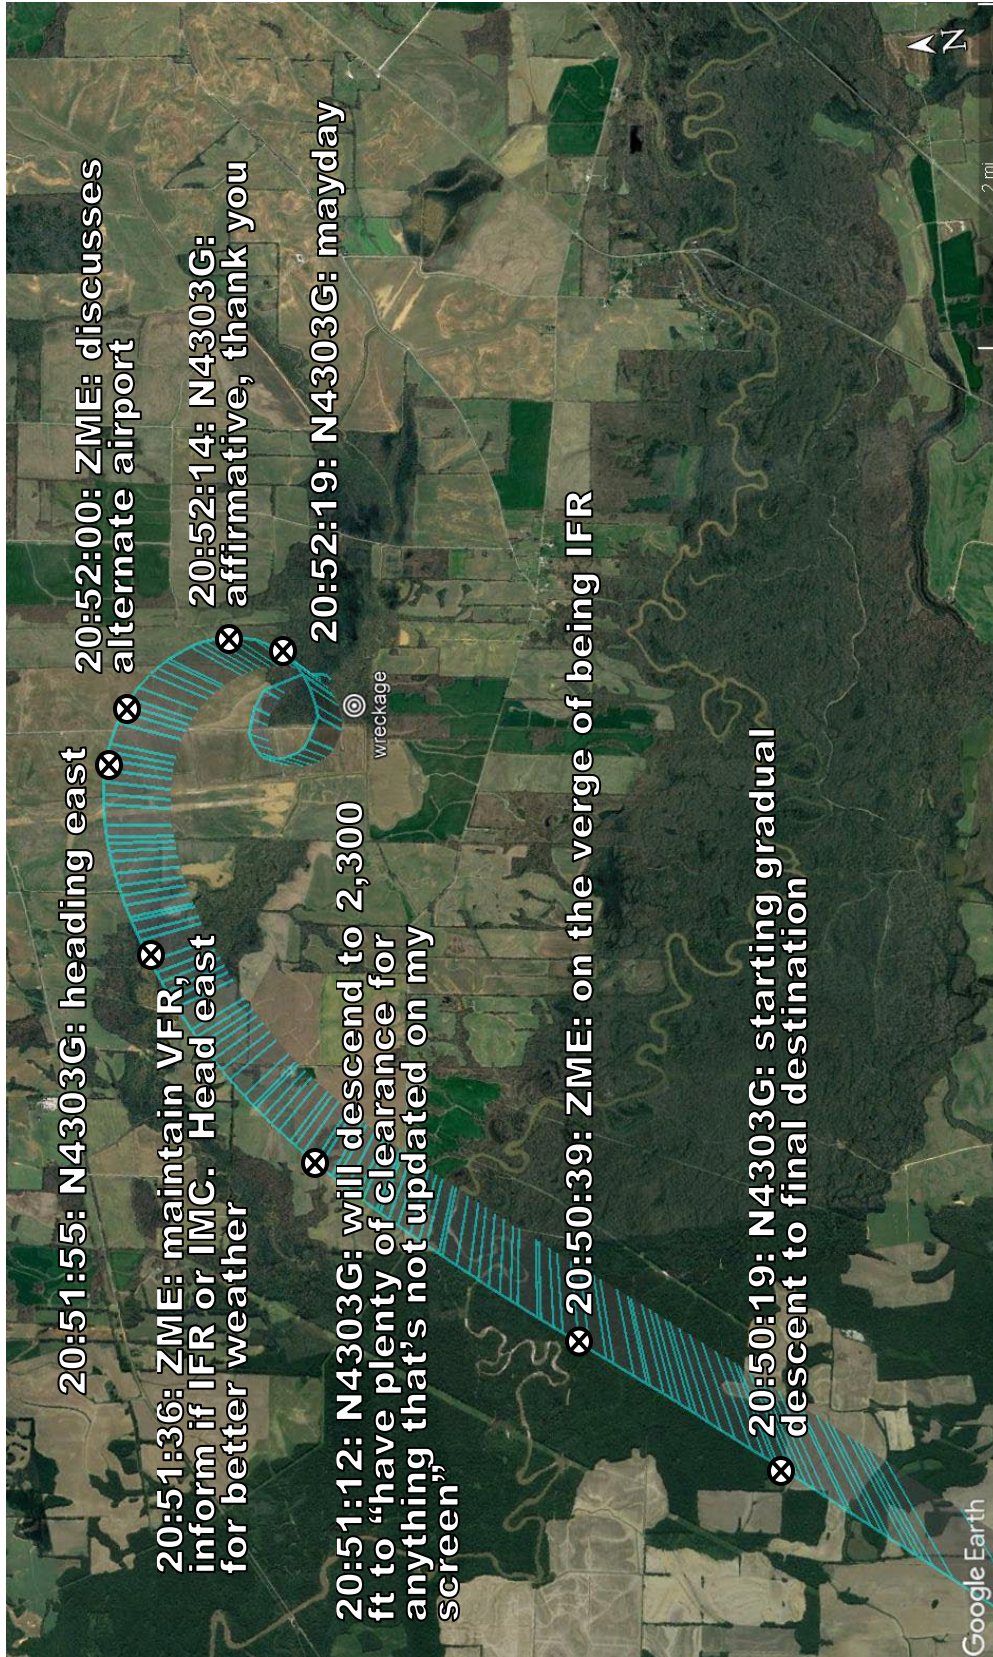
At 20:50:19, the accident airplane pilot contacted the Memphis Air Route Traffic Control Center (labeled ZME in Figure 3 and Figure 4) and stated he was going to begin the descent to his final destination (Kyle-Oakley Field in Murray, Kentucky, approximately 85 NM away) [2]. The air traffic controller (ATC) replied with weather conditions and stated that “everything between now and Kyle-Oakley is on the verge of being IFR conditions”. At 20:51, the airplane’s track angle began to turn right, leaving its prior 35° heading (Figure 4). The accident pilot responded affirmative and that he would descend to 2,300 ft to “have plenty of clearance for anything that’s not updated ...on my screen”. ATC replied to maintain visual flight rules (VFR) conditions and to report if he entered instrument flight rules (IFR) or instrument meteorological conditions (IMC). ATC also suggested to “go over to the east a little bit to stay out of the weather” which the accident pilot repeated back. At this point, however, the airplane had turned through 90° due east, the turn was tightening, and the airplane had begun to descend (Figure 5).

Figure 3. End of flight with ATC paraphrasing. N4303G is the accident airplane and ZME is Memphis Air Route Traffic Control Center.

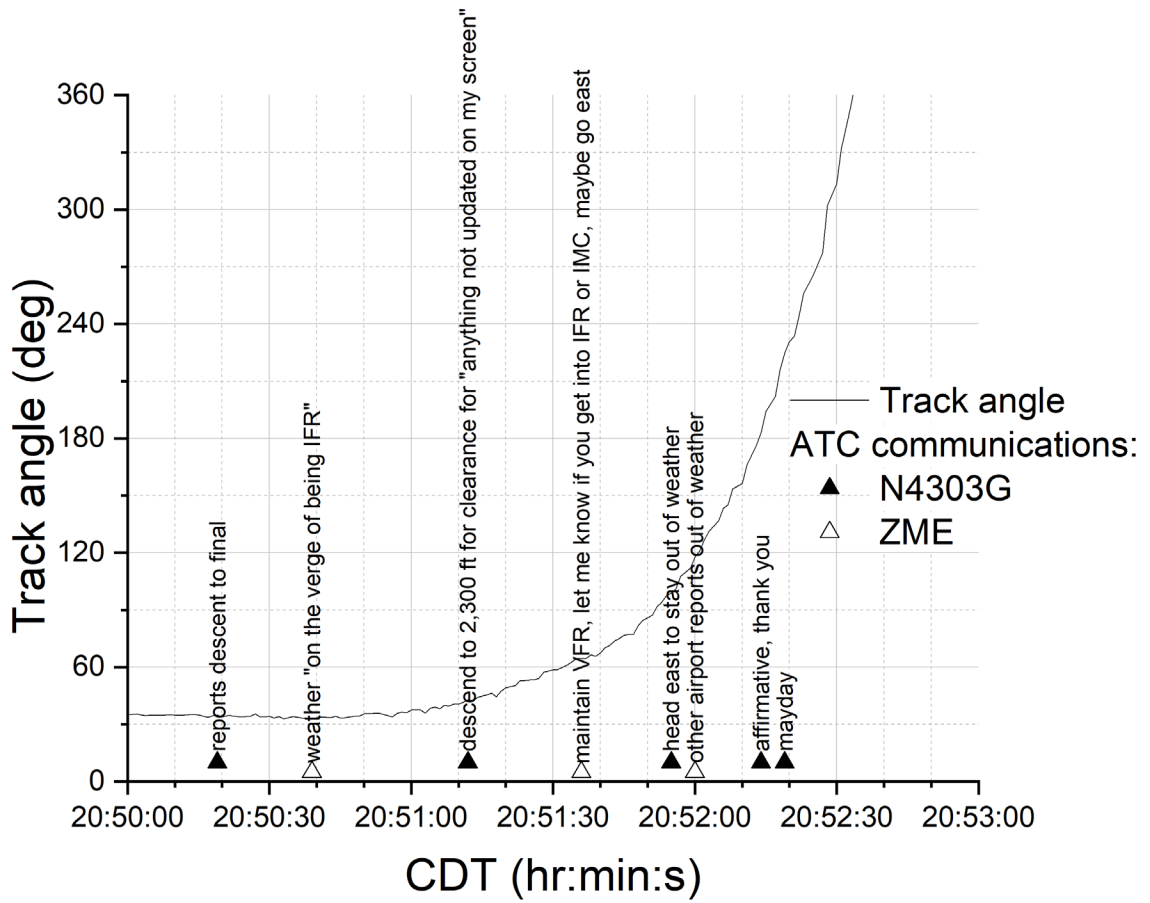
Figure 4. End of flight track angle with ATC paraphrasing.

The right turn began at 20:51 (Figure 4) and the descent at 20:51:50 (Figure 5). Initially, the airplane slowed from 160 kts calibrated airspeed to 120 kts by 20:52:10. At 20:52, ATC gave additional weather information and at 20:52:14, the accident pilot responded “affirmative, thank you”. At 20:52:19, the pilot radioed “mayday”. The airplane was then 1,000 ft below its earlier altitude and its speed was 125 kts calibrated airspeed.

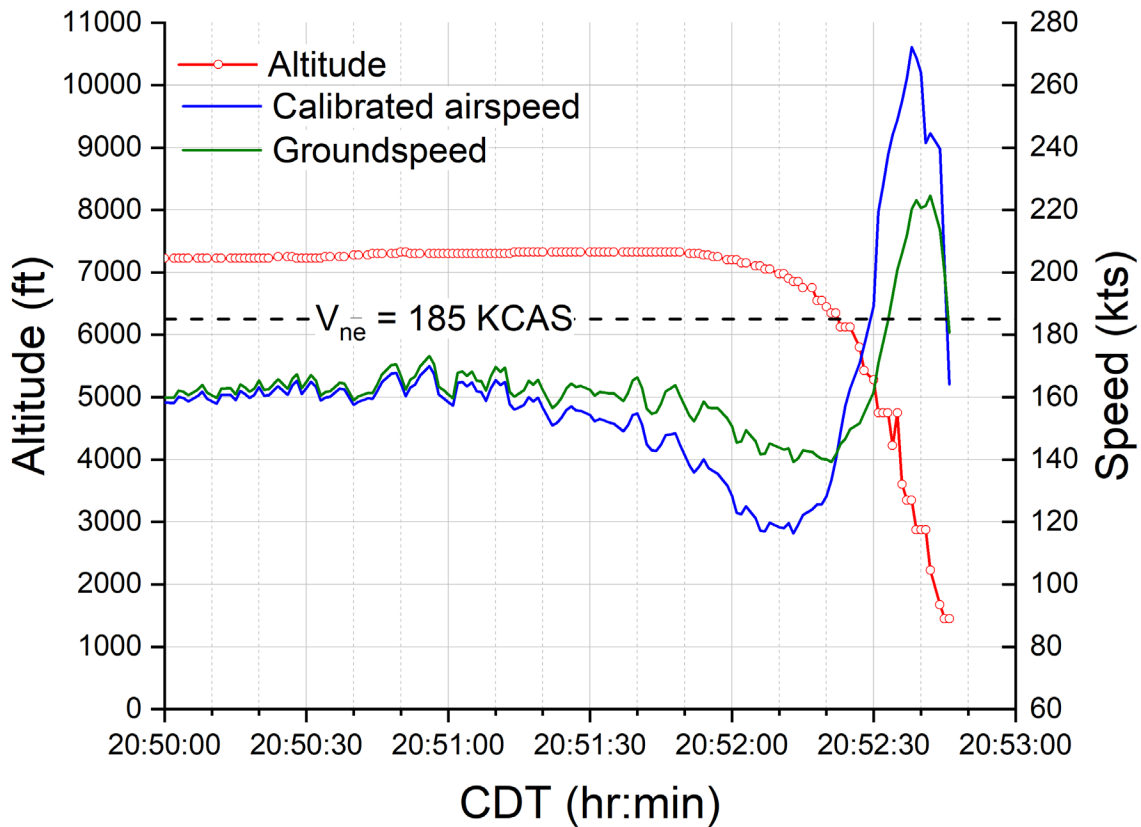
Figure 5. End of flight altitude (msl) and calculated groundspeed and calibrated airspeed.

The airplane then rapidly gained airspeed, the descent accelerated, and the turn tightened. At 20:52:29 the airplane exceeded its Do Not Exceed Speed (V_{NE}) of 185 kts calibrated airspeed. The final recorded data point was at 20:52:46 at an altitude of 1,450 ft. The wreckage was located 1,000 ft farther along the curving flight path at an elevation of 300 ft.
