# National Transportation Safety Board

ERA21FA195

Aircraft Performance Study

Location: Eden, North Carolina  
Date: April 28, 2021  
Time: 13:24 EDT  
17:24 UTC  
Aircraft: Bell 429, N53DE

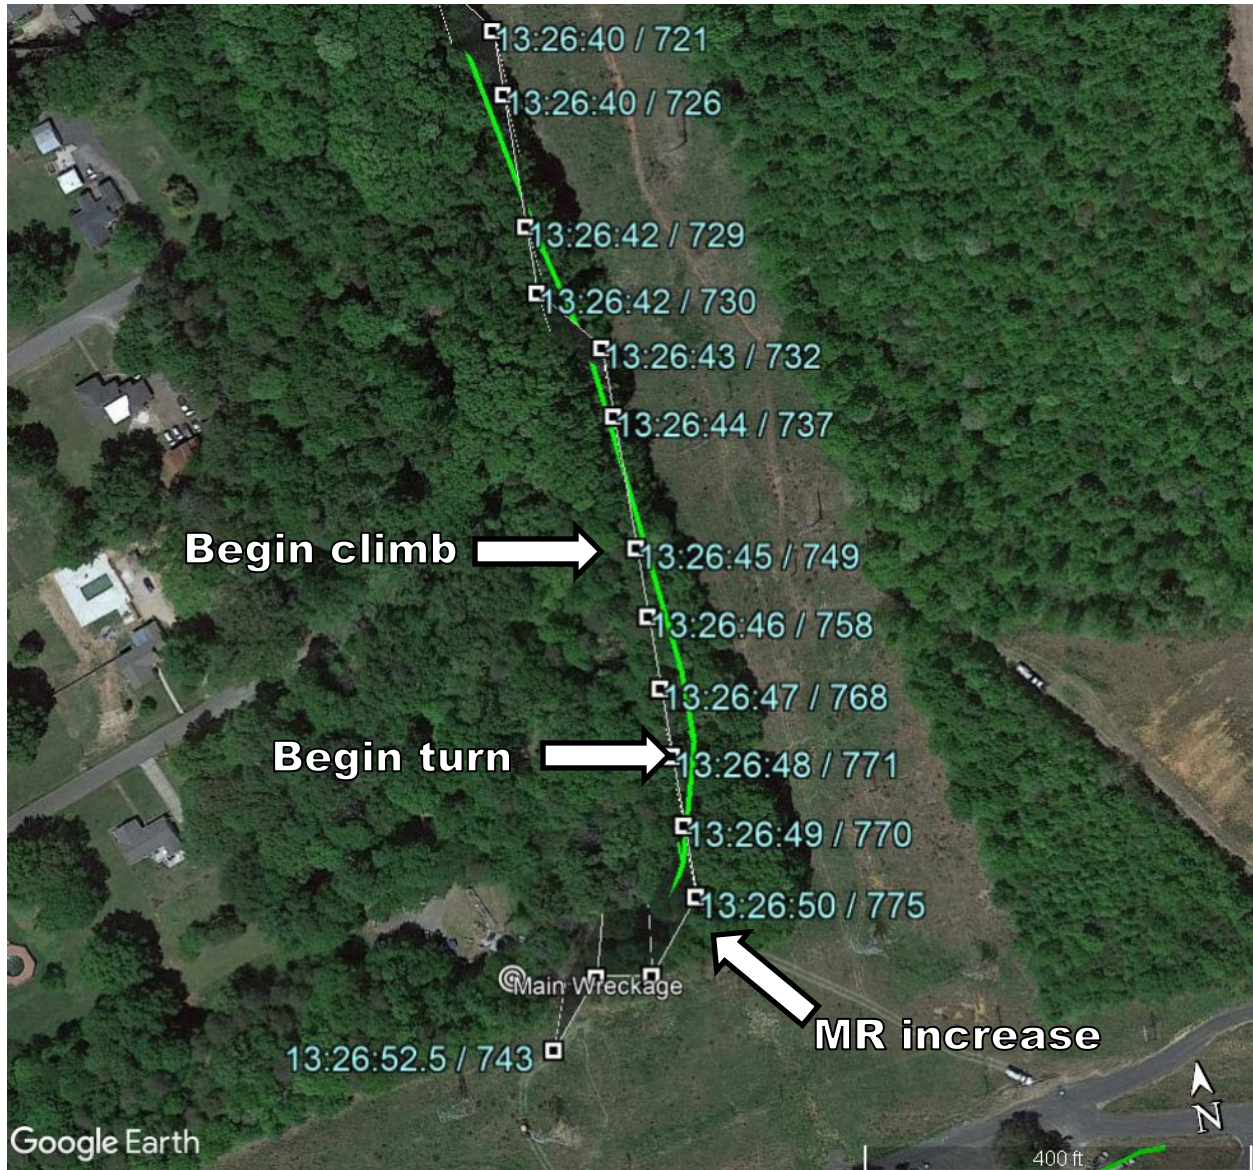
During the final minutes of flight, the helicopter was traveling at an airspeed between 50 and 60 kts along powerlines at an altitude between 700 and 775 ft msl (Figure 6 and Figure 7). Main rotor speed was near 100%, torque varied between 15% and 25%, and the engine N1 speeds<sup>1</sup> were between 84 and 88%.

**Figure 6.** End of flight. Onboard data is shown in blue and white, the ADSB path is shown in green.

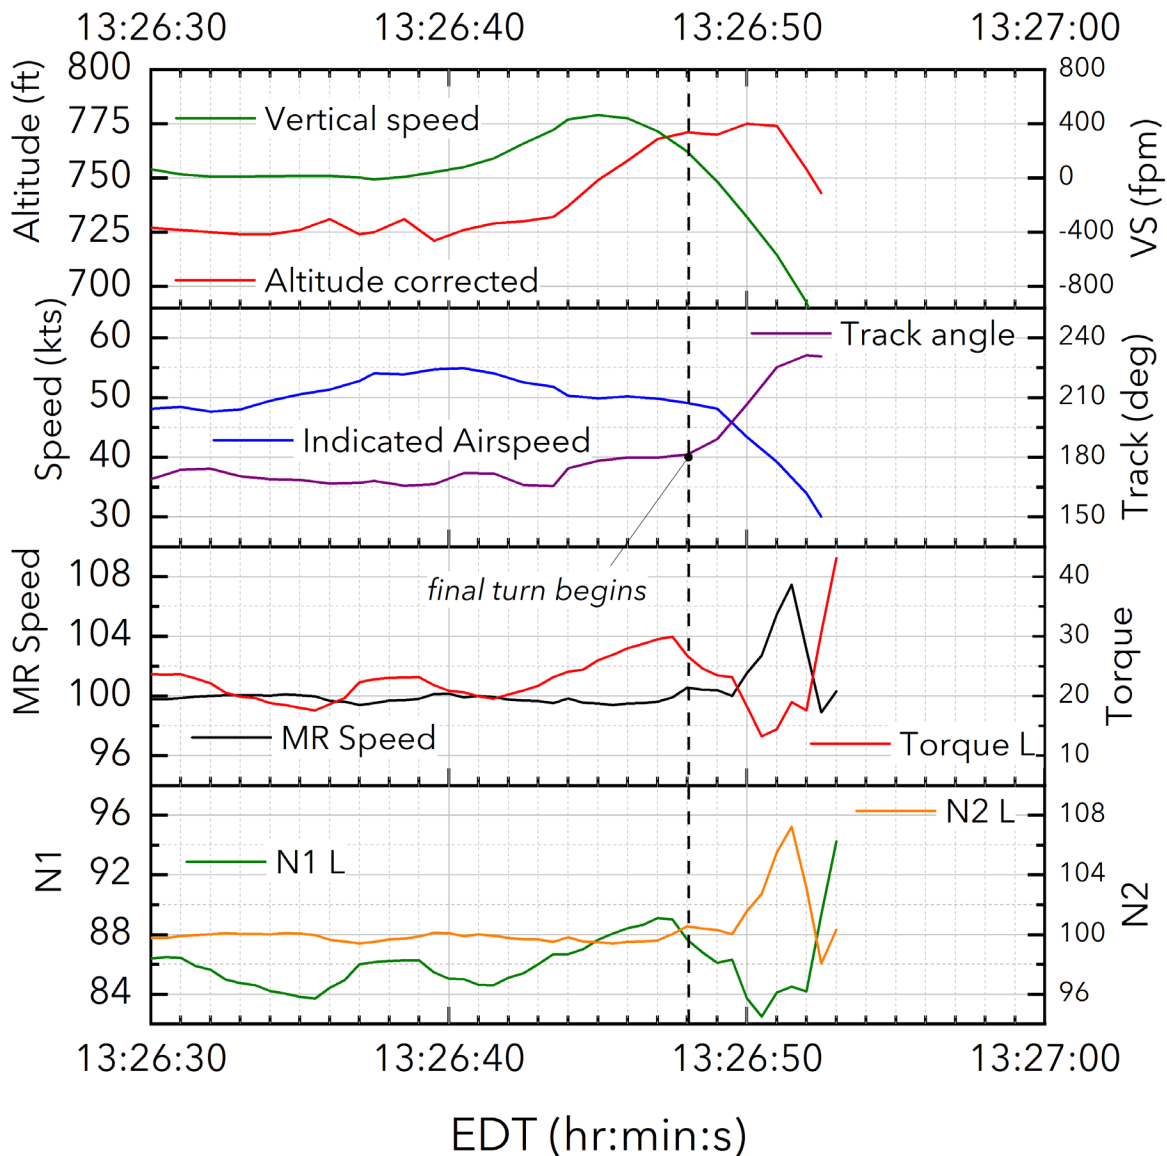
**Figure 7.** Altitude (msl), speeds, track, and engine parameters for the final two minutes of flight.

The helicopter began climbing at 13:26:45 reaching an altitude of about 775 ft msl by 13:26:48. The engine torque increased with the climb but fell off when the helicopter's altitude leveled off and it began to turn right. Two seconds later, just before 13:26:50, main rotor speed and engine N2<sup>2</sup> values spiked to over 107%. Torque and N1 increased from 13:26:52 until the end of the data. The aircraft lost altitude after 13:36:51.

during the final turn after which the aircraft descended into the trees. The wreckage examination found that two of the main rotor blades had impacted the tail boom and severed the tail rotor drive shaft. The sudden increase in main rotor speed likely correlates with the severing of the tail rotor drive shaft which would lead to all engine power to go to the main rotor system.

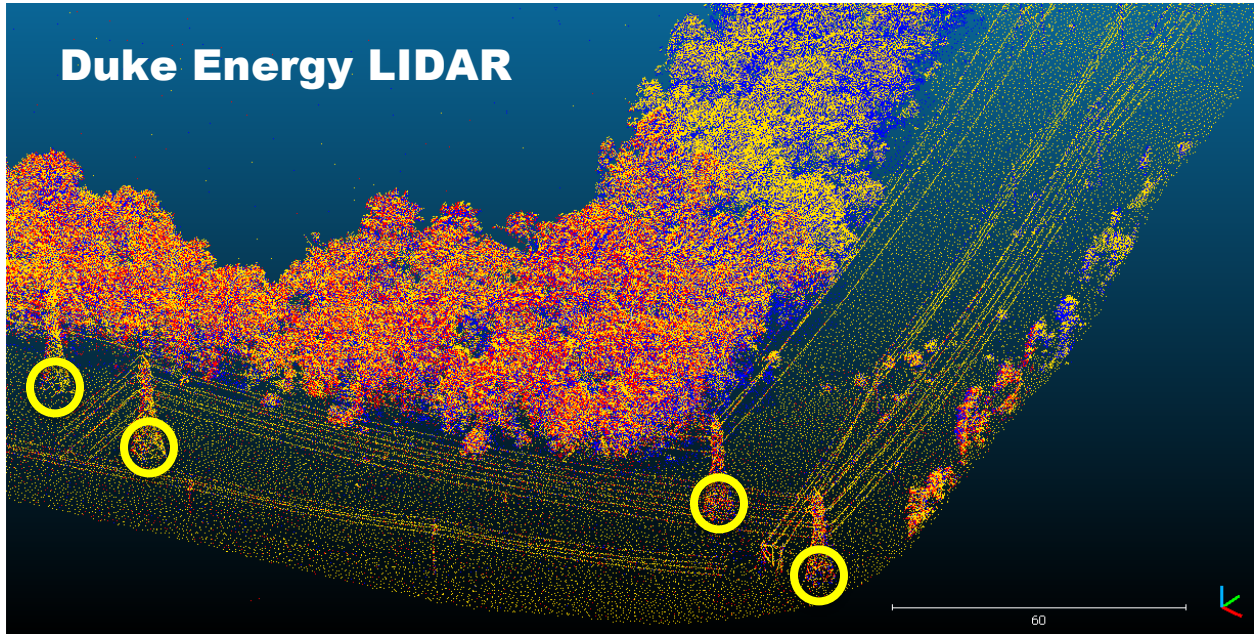
**Figure 8.** LIDAR data from Duke Energy corresponding to Figure 9. Yellow circles show the base of electrical towers.

Also of interest was the relative height of the oncoming power lines (see Figure 8). These wires were 100 ft above the terrain, the elevation of which was approximately the same as that at 13:26:50 (~570 ft). The helicopter was approximately 100 ft above these oncoming wires at the top of its climb and was 100 ft horizontally away at the end of flight.

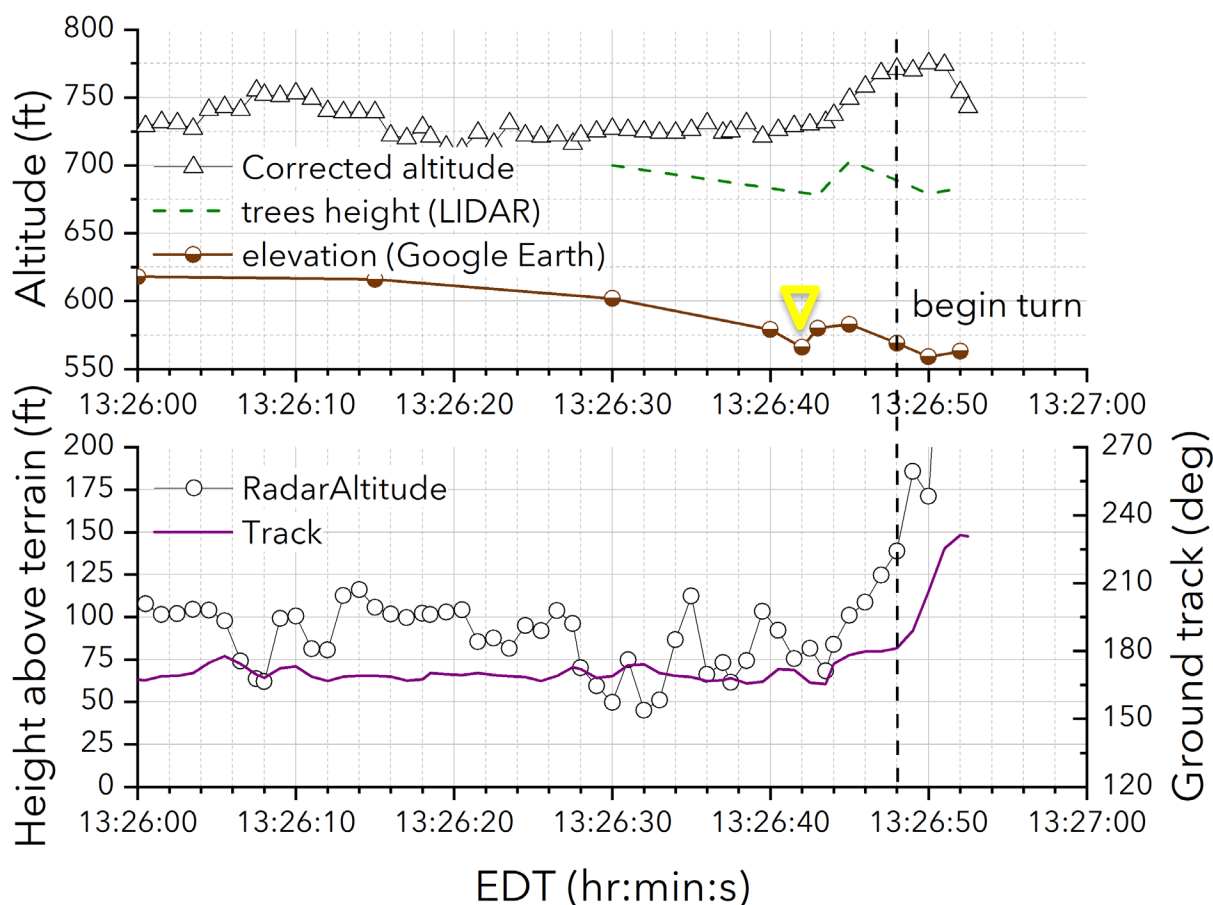
Figure 12 shows the corrected altitude and radar altitude from the onboard recording device, terrain elevation from Google Earth, and tree heights from Lidar for the last minute of flight. Figure 13 shows a Google Earth image of the same time frame. The water course depression is indicated with the yellow triangle. The aircraft's final climb began at 13:26:44. It climbed from about 720 ft msl to over 760 ft msl by 13:26:48 at which point the helicopter was 80 ft above the top of the tallest trees and 100 ft above local power lines. The helicopter then began to turn.

**Figure 12.** Altitude (msl), terrain, tree height, and track angle for last minute of flight. A yellow triangle indicates the small water course depression.

Radar altitude recorded slightly higher values than corrected altitude minus the tree heights. It recorded the aircraft was 80 ft above what was below it at 13:26:44 and 120 ft above what was below it at the beginning of the turn. GPS data has about 65 ft of resolution in position, both vertical and horizontal when recorded properly. Pressure altitude data is corrected using barometric information and checked against the aircraft's take-off location for reasonableness, but the calculation introduces uncertainty. The radar altimeter measures altitude above the terrain presently beneath an aircraft by timing how long it takes a beam of radio waves to travel to ground, reflect, and return to the craft. The corrected altitude and Lidar combination puts the aircraft very close to the tree height at 13:26:30, so it is unlikely any lower than calculated as that would put the aircraft into the trees earlier in the flight. Therefore, heights above terrain at the end of flight reflect the likely minimum separation.

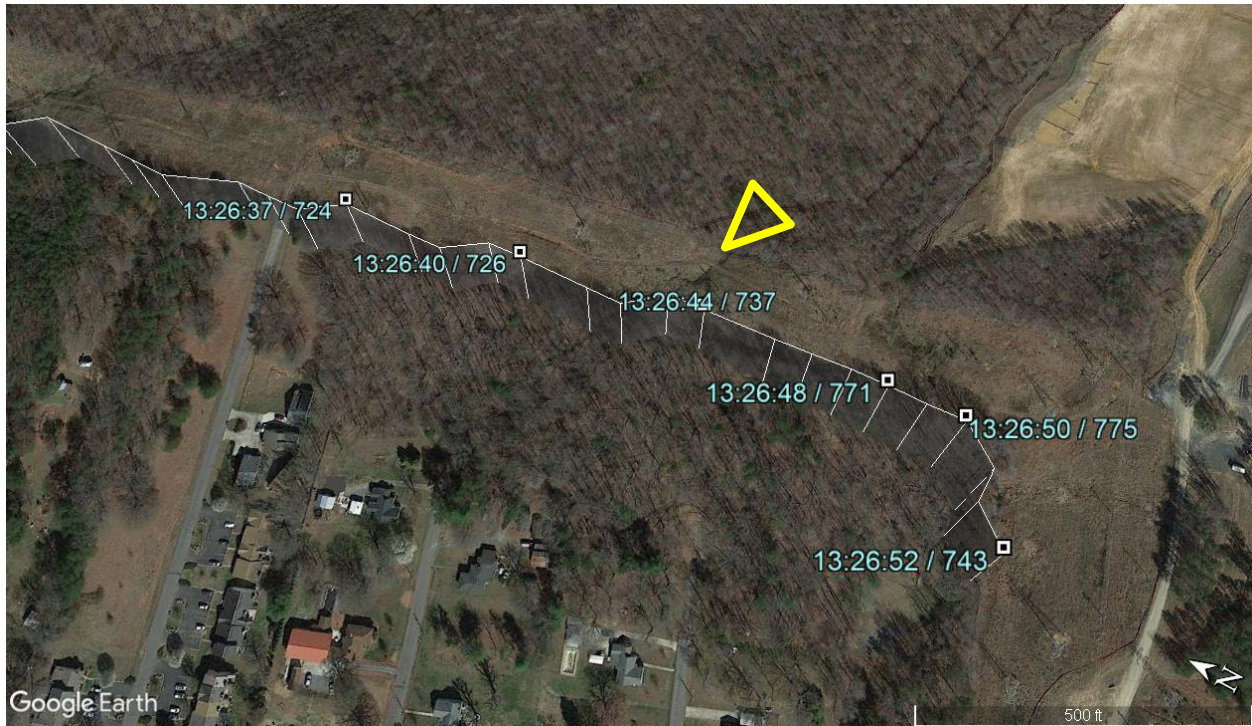
**Figure 13.** Flight path for last minute of flight. Selected altitudes and times are shown in blue. A yellow triangle indicates the small water course depression.

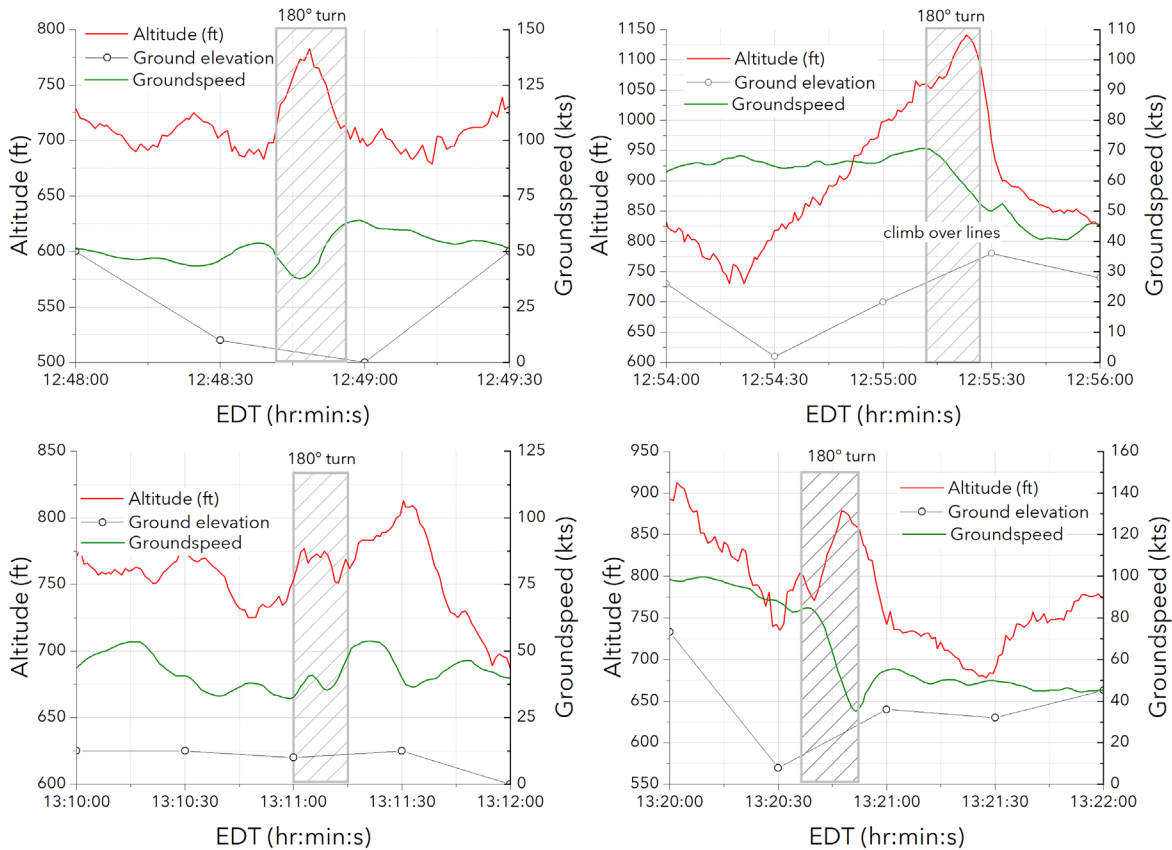
**Figure 16.** Altitude, ground elevation, and groundspeed for four earlier 180° turns.

The purpose of looking at the 180° turns was to see what control inputs they required and helicopter attitudes they resulted in. The two turns that were simulated were at 13:11 and 13:20:30 (Figure 16). The turn at 13:11 was made at a relatively level altitude and a groundspeed that was increasing from 30 to 50 kts. The simulation

showed that the maneuver required no more than a 5% input in collective or cyclic and resulted in a 25° bank angle to complete the turn. The second turn simulated had a 100 ft climb, then descent as the speed slowed from 80 kts to 50 kts. This maneuver required a 15% increase in collective, a 10% change in longitudinal cyclic, and a 5% change in lateral cyclic. The helicopter attitude was a 30° bank angle and a greater than 15° nose up attitude on the climb and not quite 10° nose down on the descent. Neither maneuver exceeded nor approached the performance limitations of the helicopter.
