# NATIONAL TRANSPORTATION SAFETY BOARD

## COMPONENT EXAMINATION FACTUAL REPORT

Place: Smyrna, Tennessee  
Date: May 29, 2021  
Vehicle: Cessna 501 Citation, Reg. No. N66BK  
NTSB No: ERA21FA234  
IIC: L. Read

### B. COMPONENTS EXAMINED

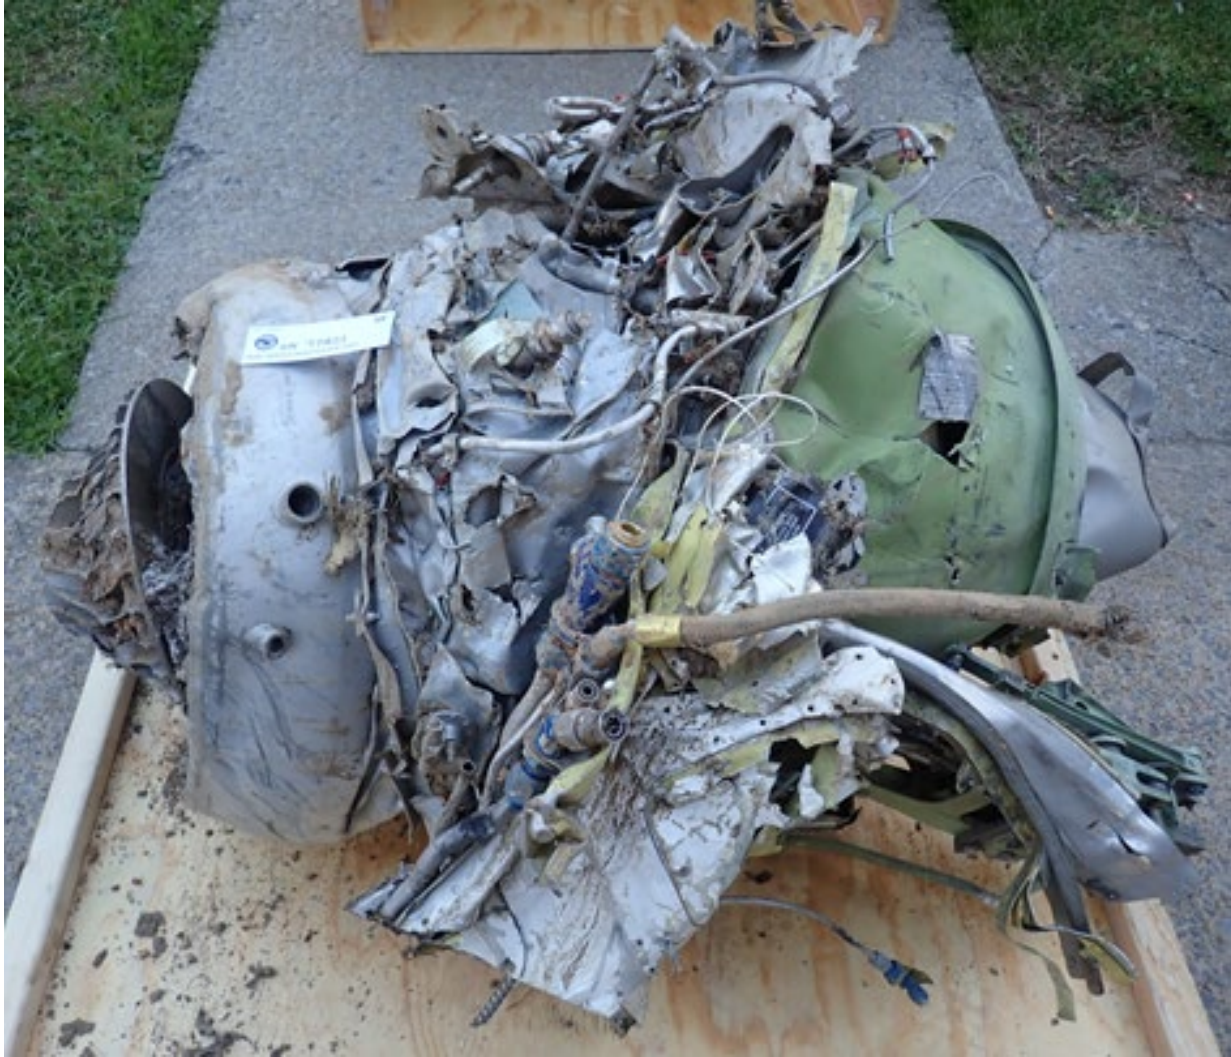
The left engine, S/N 77407, was missing all structure forward of the gas generator case including the inlet cone, the fan case, a forward section of the low compressor shaft, the No. 1 bearing, the No. 2 bearing, the intermediate case/oil tank, the tower shaft, and the accessory gearbox. The impeller shroud and the high compressor shaft were also missing. The gas generator case, low turbine stator support assembly and turbine exhaust duct were compressively deformed. The

compressive damage was centered, and the most pronounced at 6 o'clock. See Figure 1.<sup>1</sup>

**Figure 1.** Representative photograph of engine S/N 77407, left side view

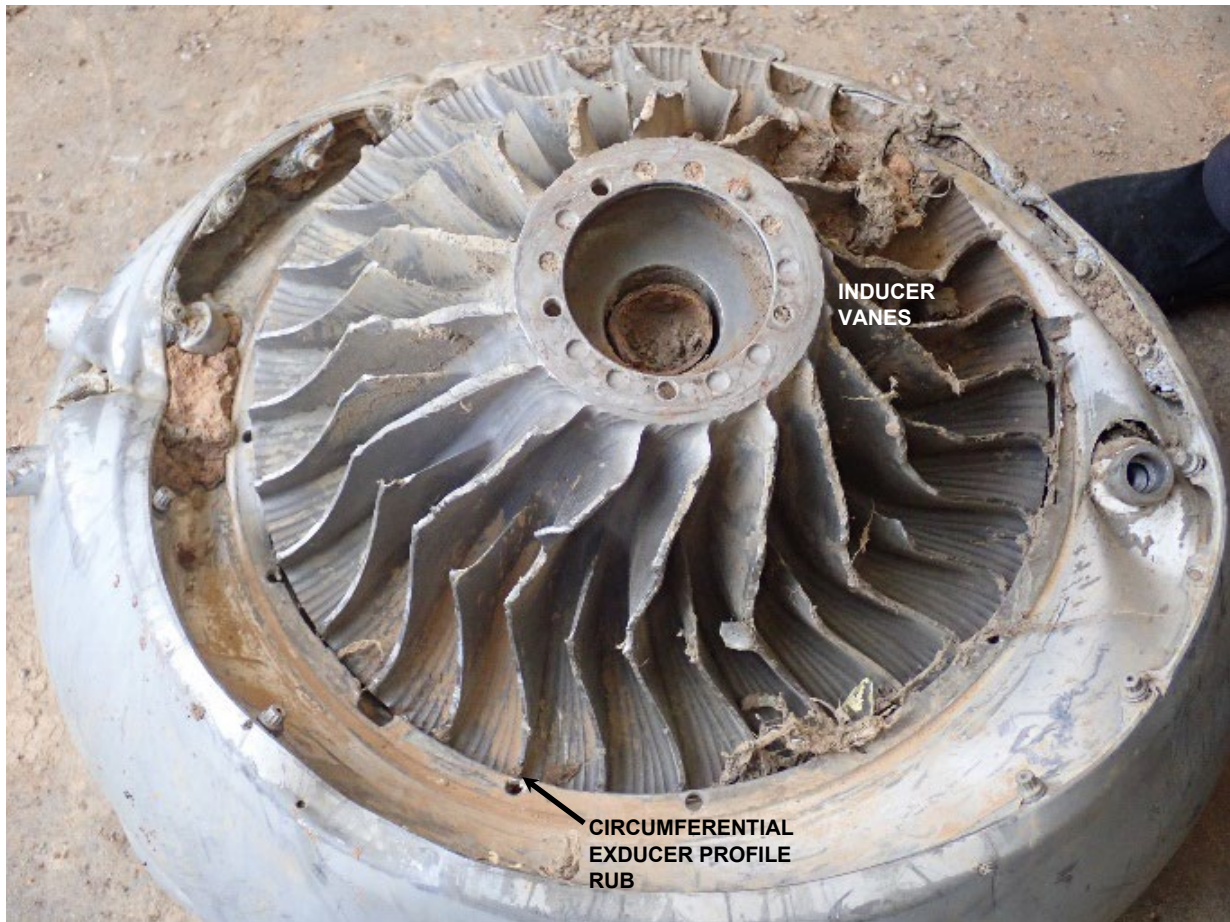
The compressor impeller vane inducer profiles were fractured or missing material. The fracture surfaces exhibited local bending in the direction opposite to impeller rotation. The vanes were heavily scored at the exducer end. See Figure 2.

**Figure 2.** Front view of engine S/N 77407 showing impeller damage

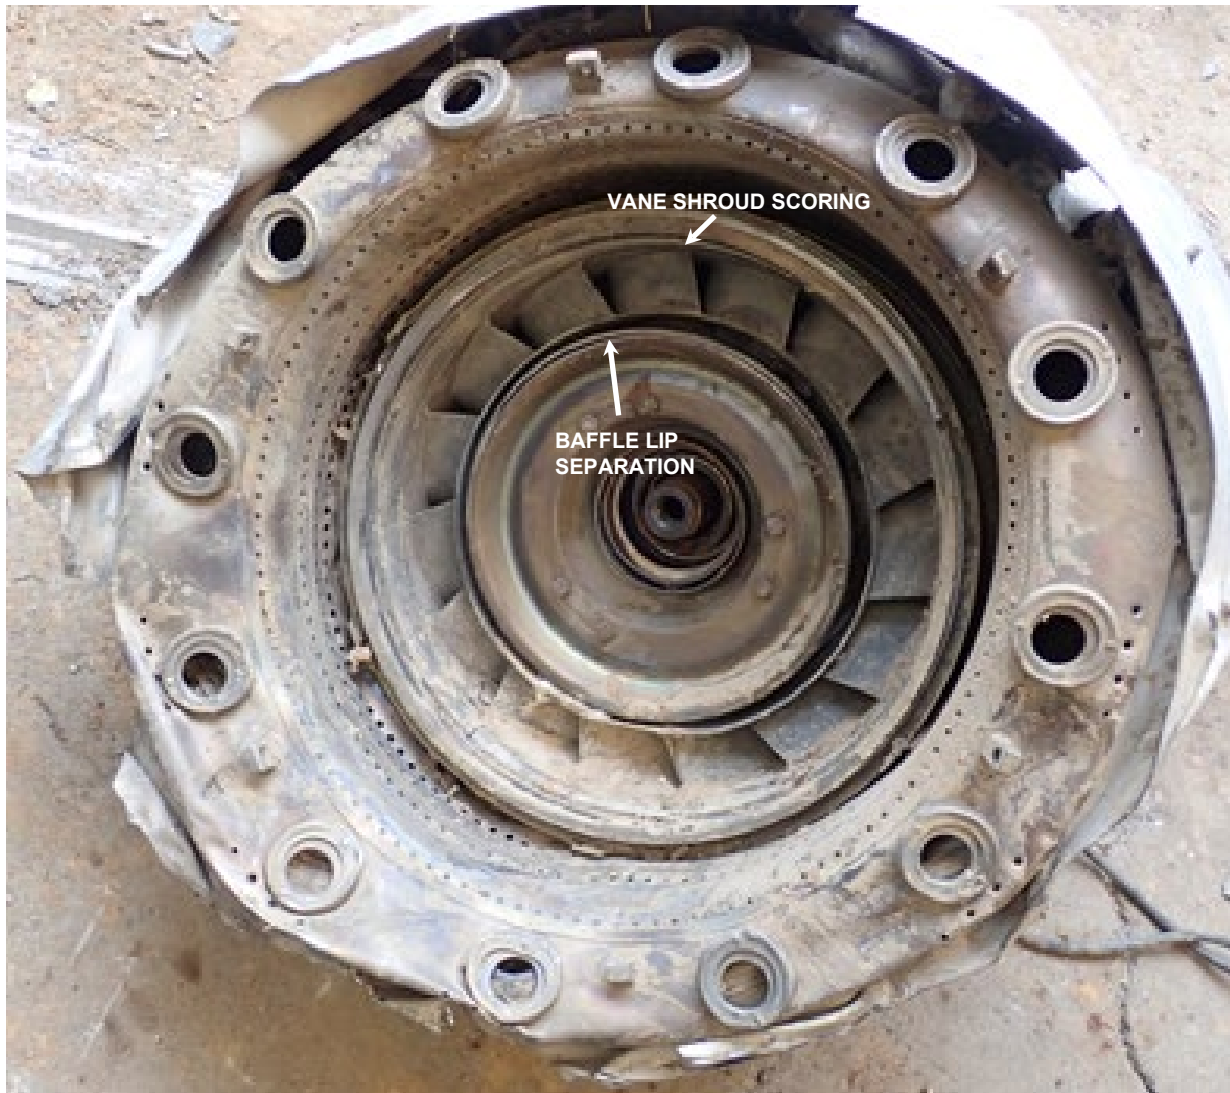
The downstream<sup>2</sup> side of the high turbine stator assembly was circumferentially scored along the vane shroud and along the baffle edge. An arc of the baffle was machined to separation. The high turbine vane shroud segments were scored 360°. See Figure 3.

**Figure 3.** Downstream view of the high turbine stator, showing 360° rub at the shroud and the baffle lip

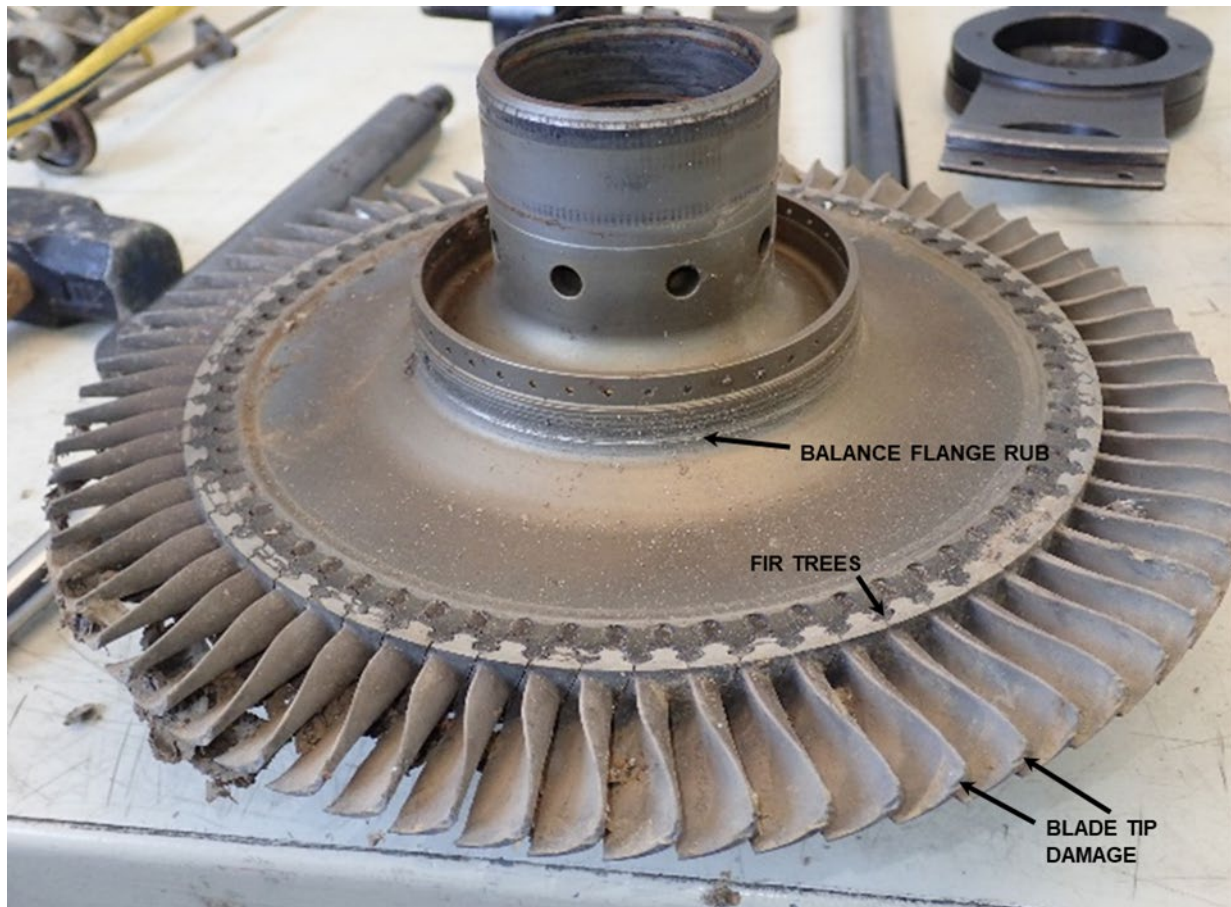
The high turbine upstream face was circumferentially scored along the balance flange and along the fir tree roots and blade platform edges. This damage was axially coincident with the scoring observed on the high turbine stator downstream face.<sup>3</sup> The blade tips exhibited rub damage consistent with the damage to the shroud segments. See Figure 4.

**Figure 4.** High turbine upstream face showing blade tip rub damage and circumferential scoring along balance flange and fir tree root/blade area

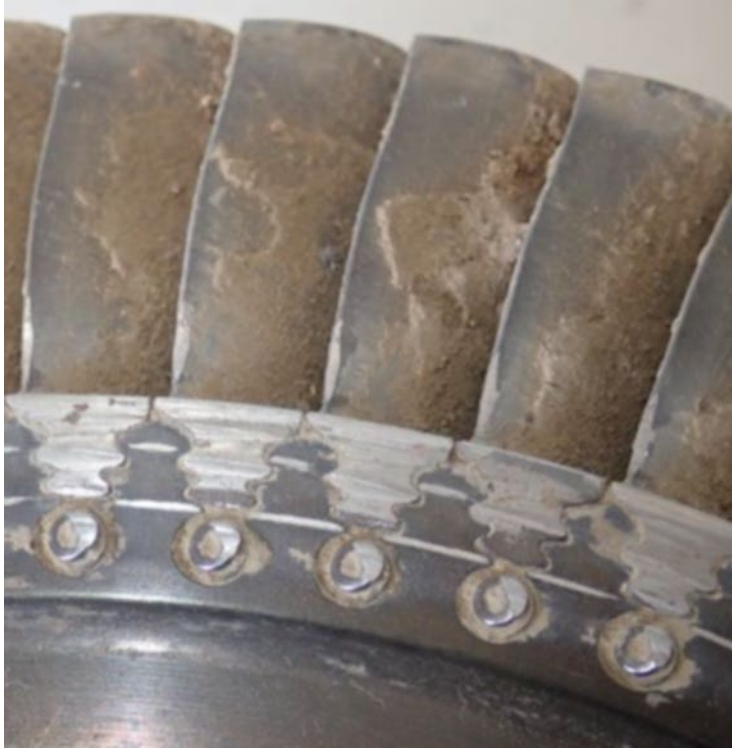
The high turbine downstream face was rubbed along all blade retention rivets, fir tree root and adjacent disk, blade platforms and blade trailing edges. 360° rub was also observed at the balance flange. See Figures 5 and 6.

**Figure 5.** High turbine downstream face showing circumferential scoring along the blade retention rivets, fir tree root area, and blade platform and trailing edges

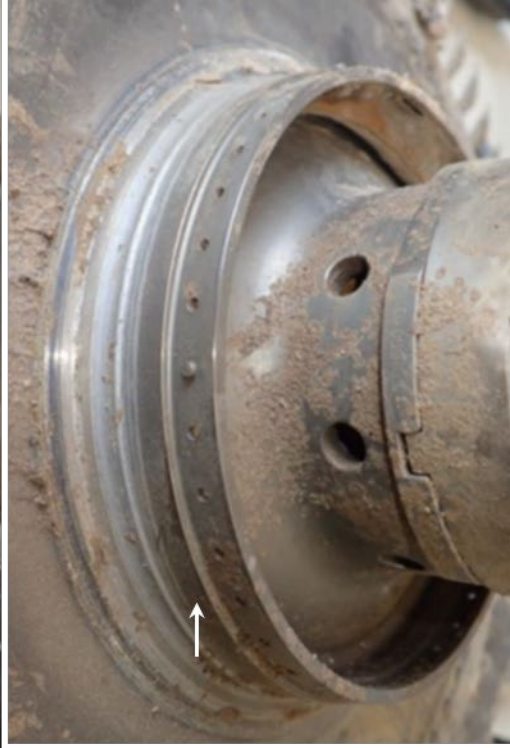
**Figure 6.** 360° scoring at high turbine balance flange

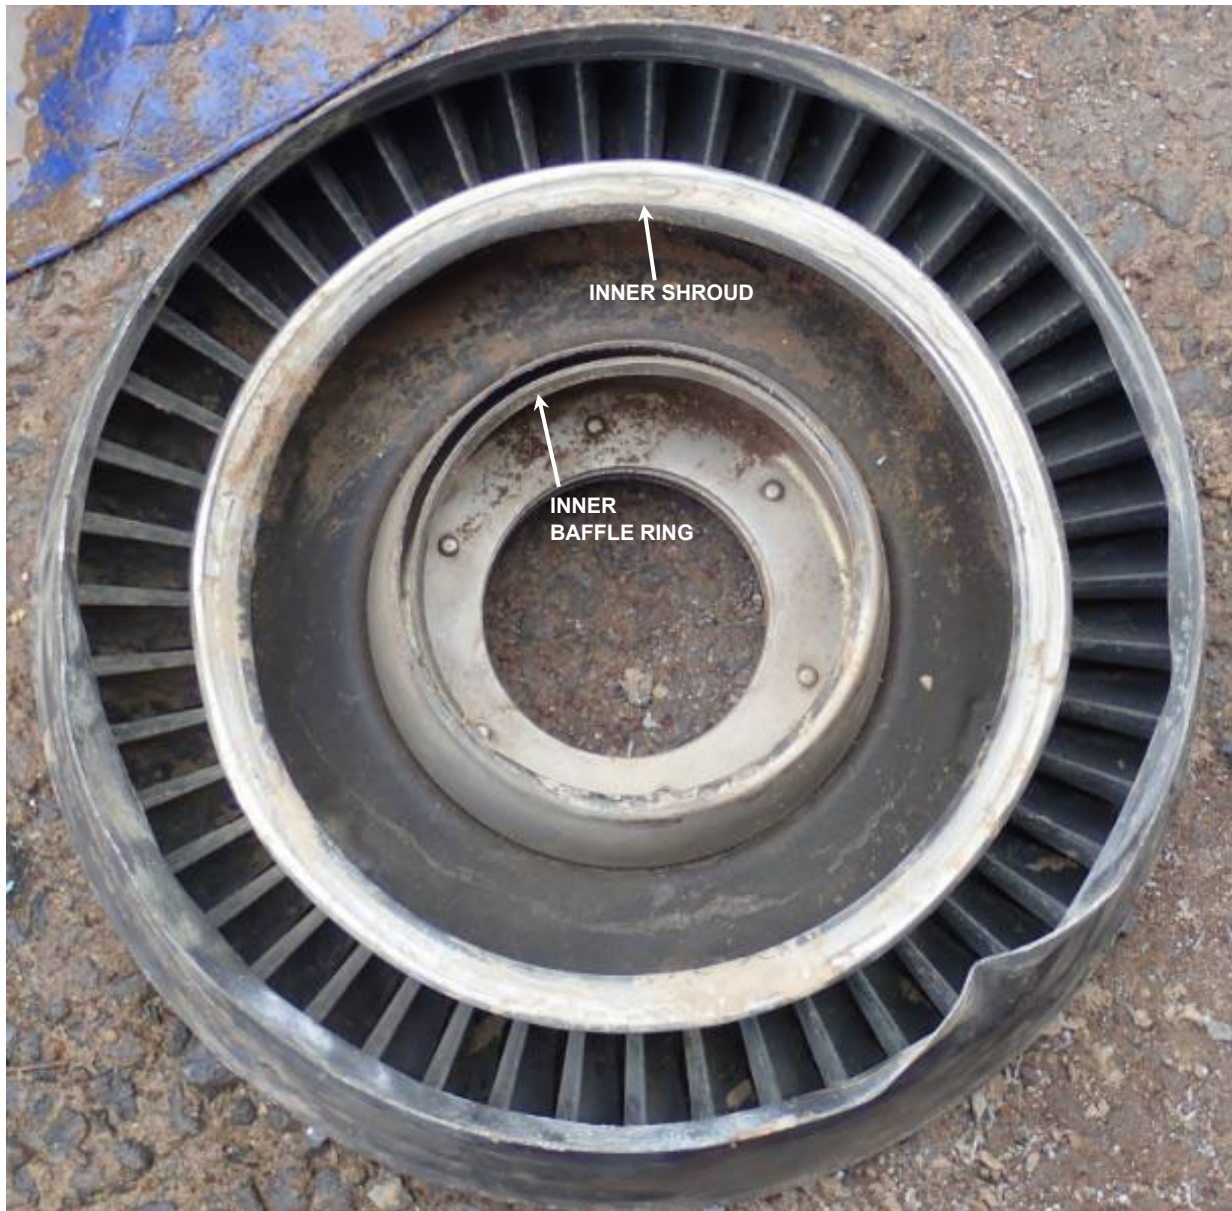
The upstream side of the 2<sup>nd</sup> stage low turbine stator (T2 stator) was circumferentially scored along the vane inner rim and the inner baffle rim. See Figure 7. The scoring was axially coincident with the damage observed to the high turbine downstream face.

**Figure 7.** T2 stator upstream side showing 360° scoring damage along vane inner shroud and inner baffle ring

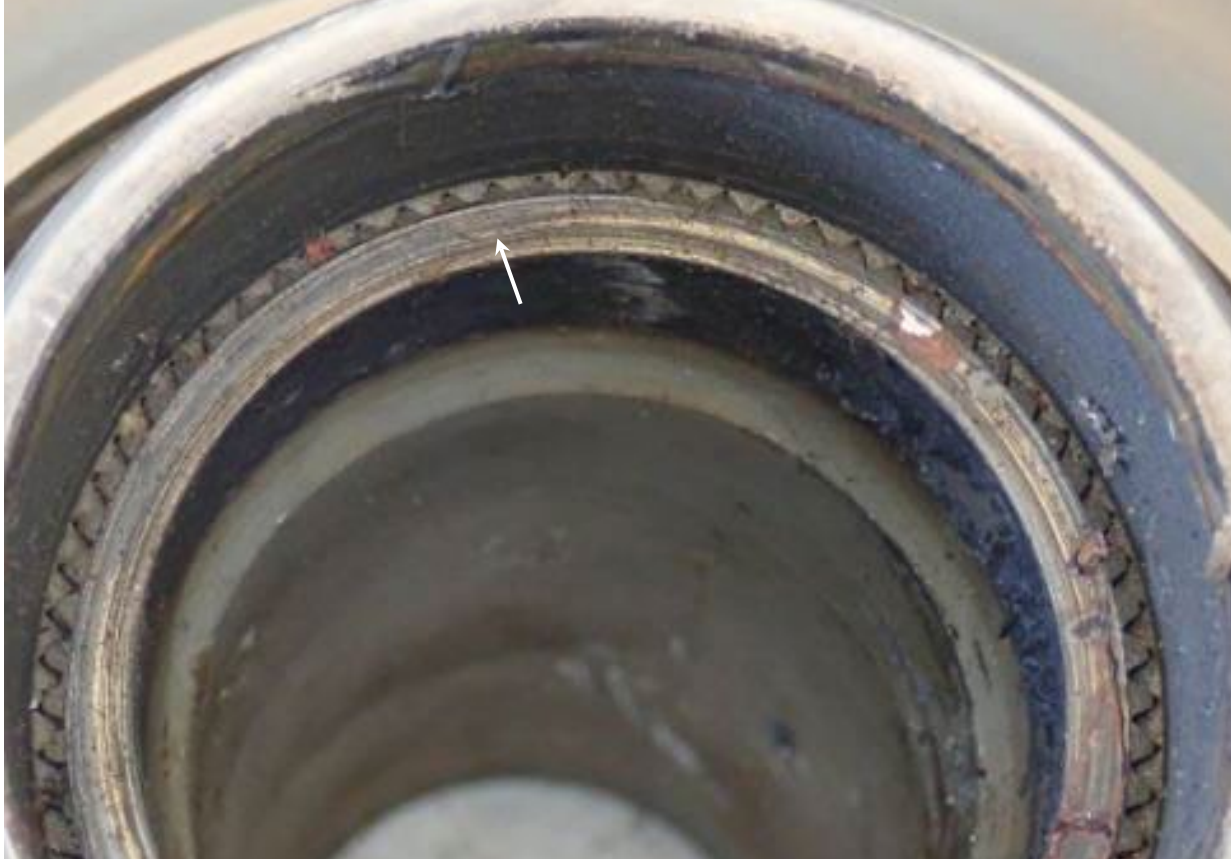
The high turbine shaft was separated aft of the high turbine disk splines. Circumferentially-oriented scoring was observed on the shaft fracture surface. See Figure 8.

**Figure 8.** Rotational scoring damage marring the high turbine shaft fracture surface

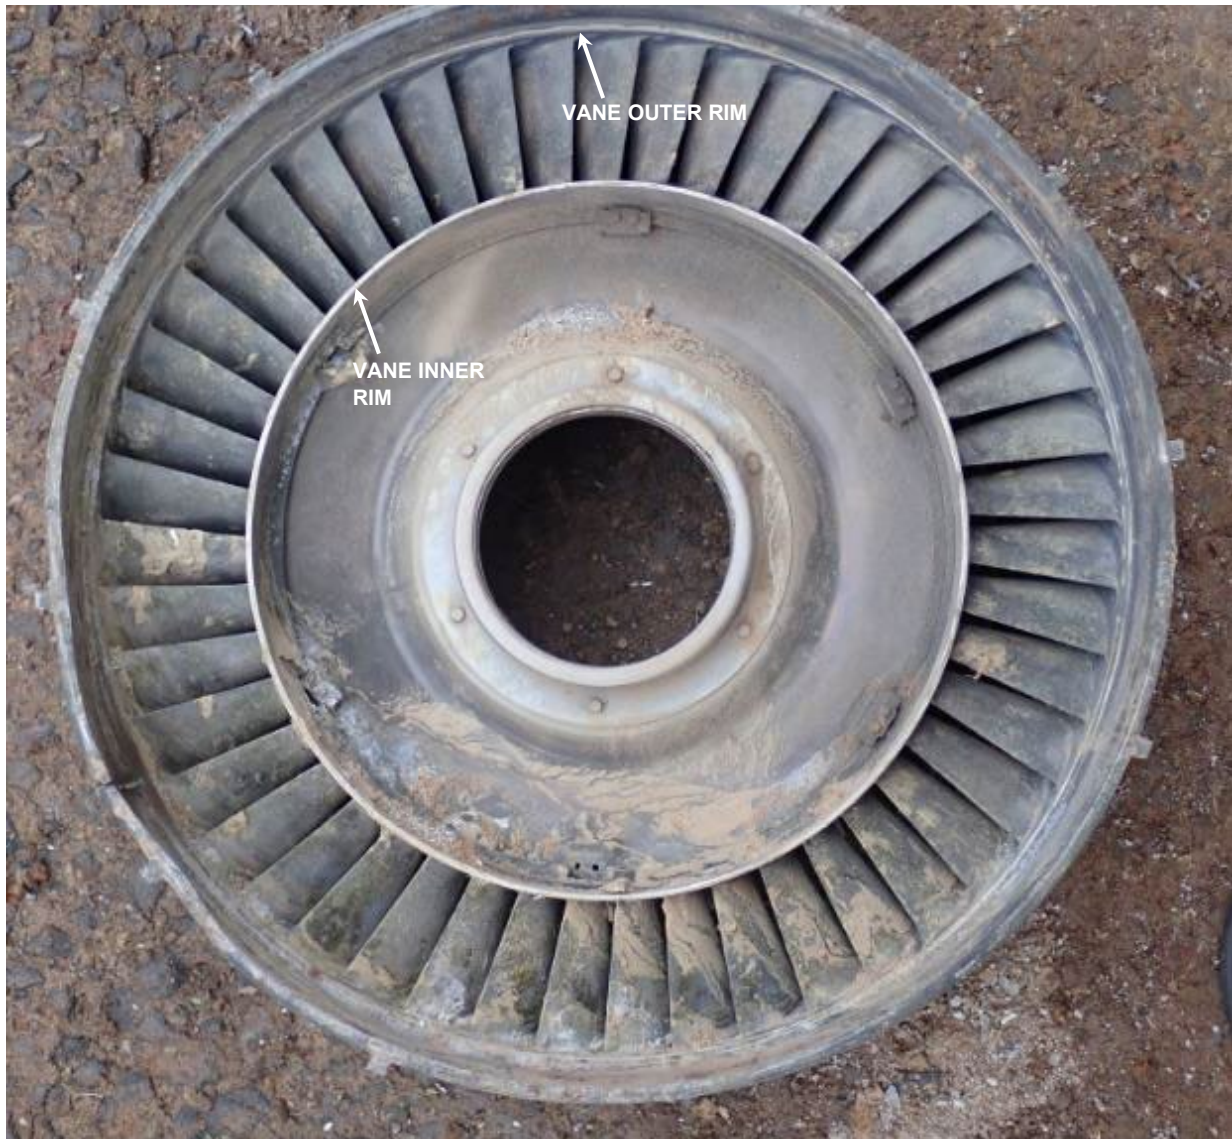
The downstream side of the T2 stator was scored 360° along the vane inner rim. See Figure 9.

**Figure 9.** T2 stator downstream side showing 360° scoring along the vane inner and outer rims

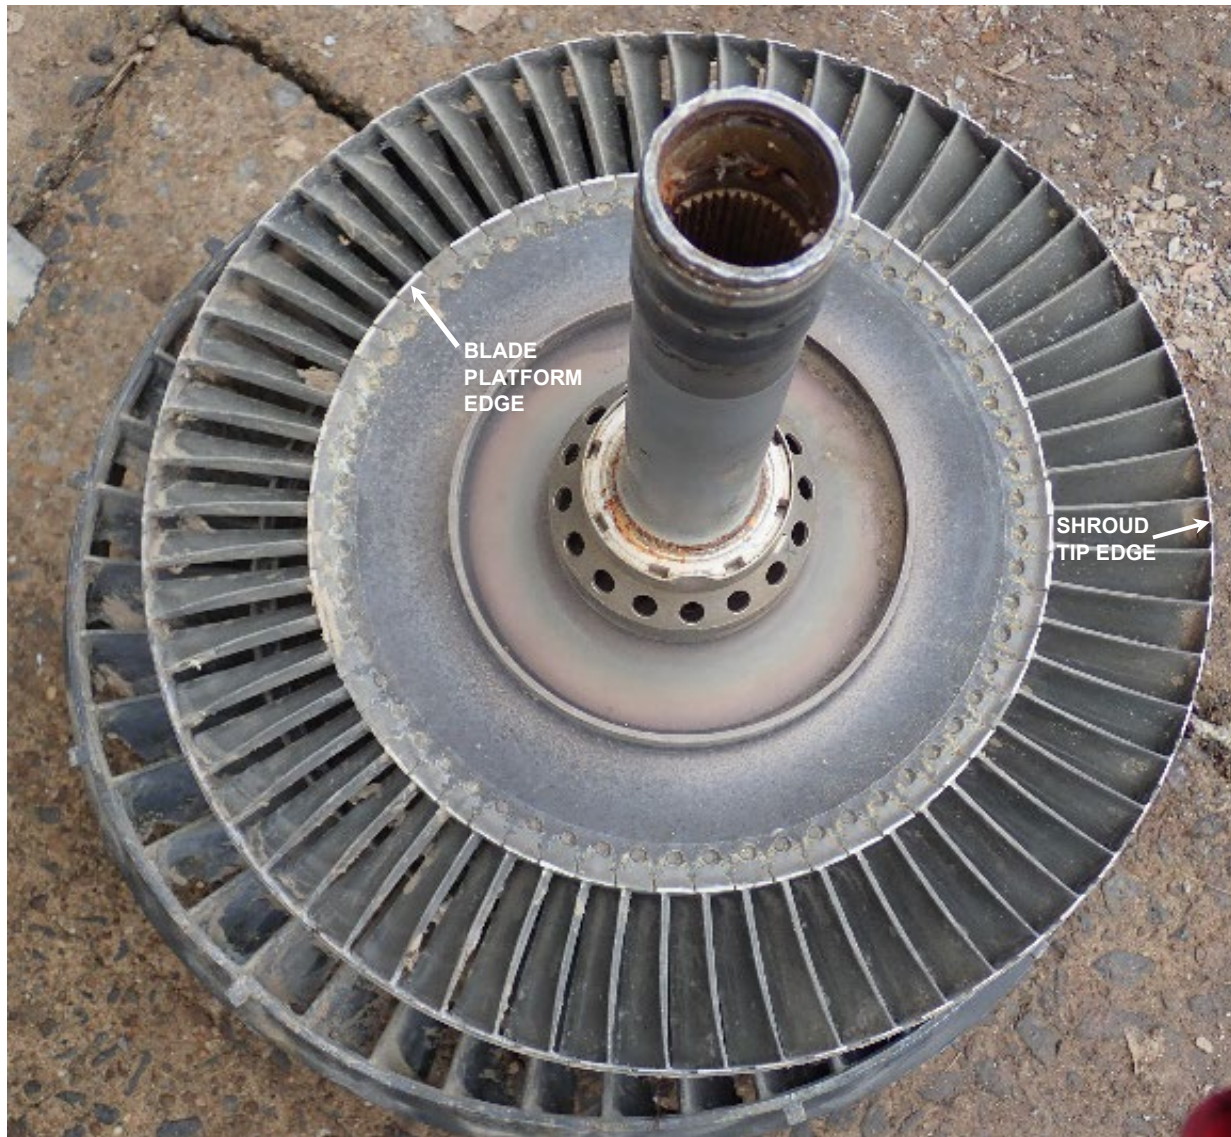
The T2 upstream face was scored 360° at two diameters, along the blade platform edge and along the blade shroud tip edge. The scoring was axially coincident with the scoring damage observed to the high turbine downstream face. See Figure 10.

**Figure 10.** T2 showing circumferential rub along the blade platform and shroud tip edge

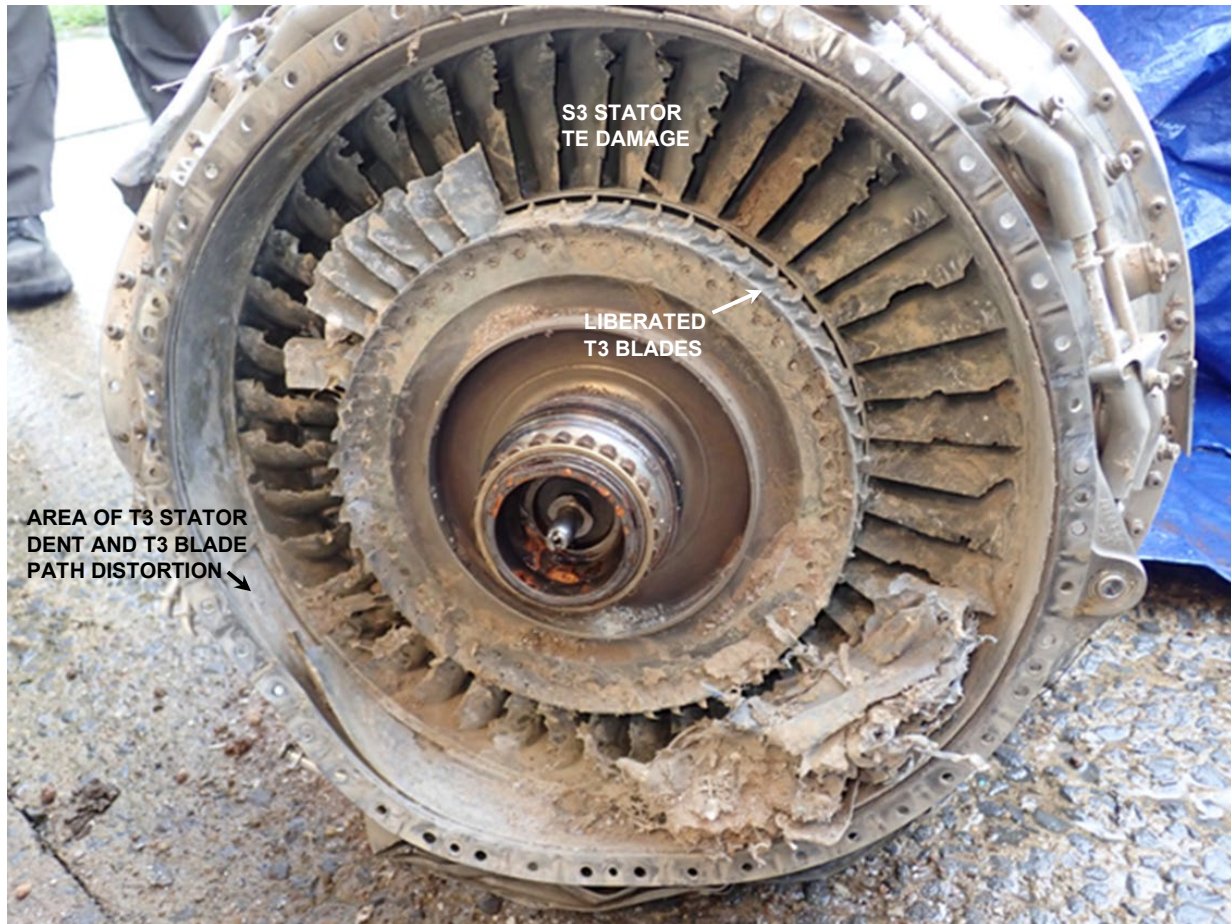
The 3<sup>rd</sup> stage low turbine stator (T3 stator) was inwardly deformed at 6 o'clock. The T3 blade shroud/blade path at this location was cracked and missing material. The stator vane trailing edges were impact damaged and missing material.

The T3 blades were separated near the platform except for seven that were fractured mid-span. See Figure 11.

**Figure 11.** View of the aft end of the low turbine rotor showing deformed T3 blade path, liberated T3 blades and T3 stator trailing edge damage

The T3 blade fracture surfaces showed fracture features consistent with overload where not obscured by secondary damage.

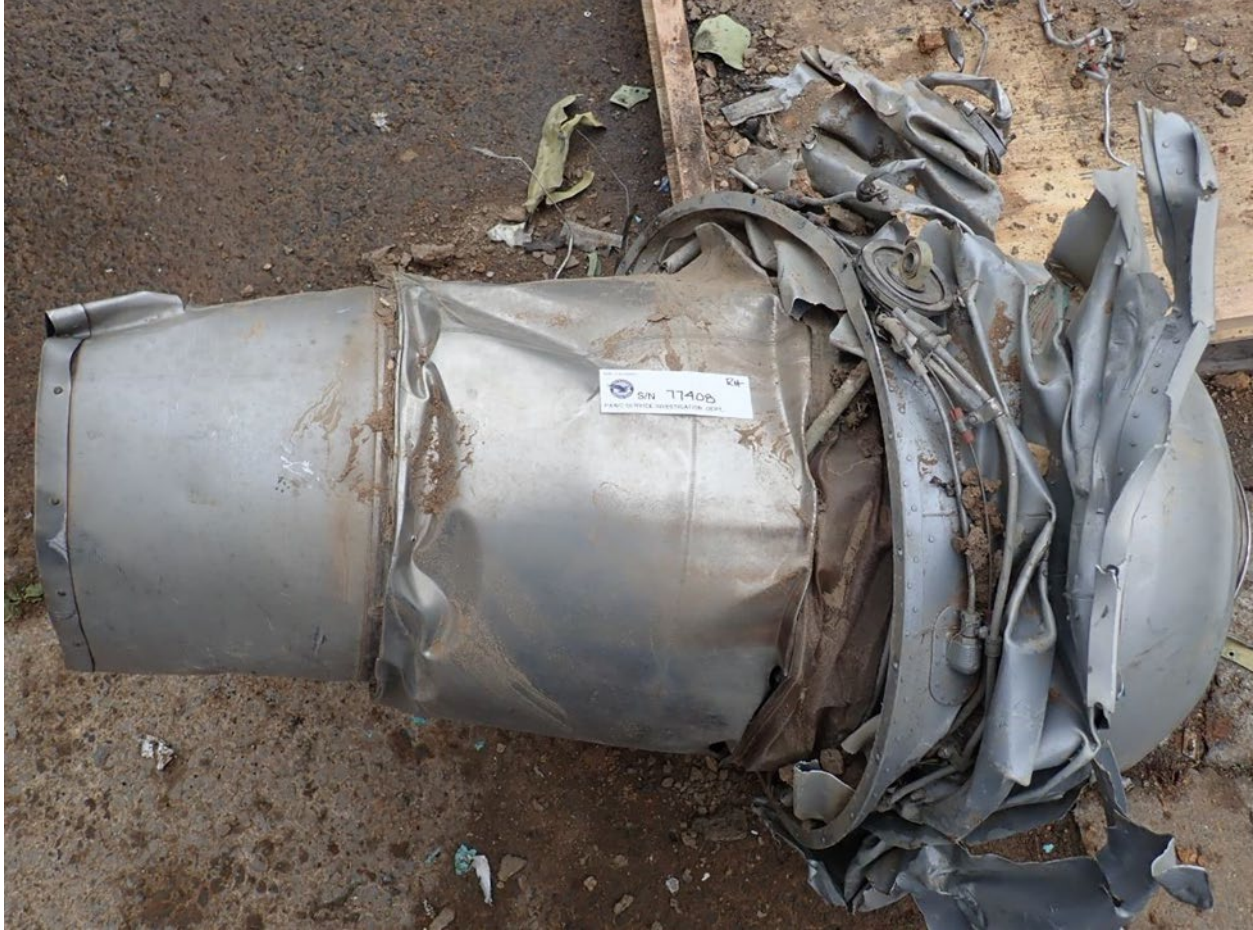
The right engine, S/N 77408, was missing all structure forward of the gas generator case forward flange except a section of the accessory gearbox, the fuel pump/fuel control assembly, and the hydraulic pump. The gas generator case and low turbine stator support assembly were compressively deformed. This damage was the most pronounced at 6 o'clock. The turbine exhaust duct exhibited a 360° wavy compressive signature just aft of the strut weldment. See Figure 12.

**Figure 12.** Representative photograph of engine S/N 77408

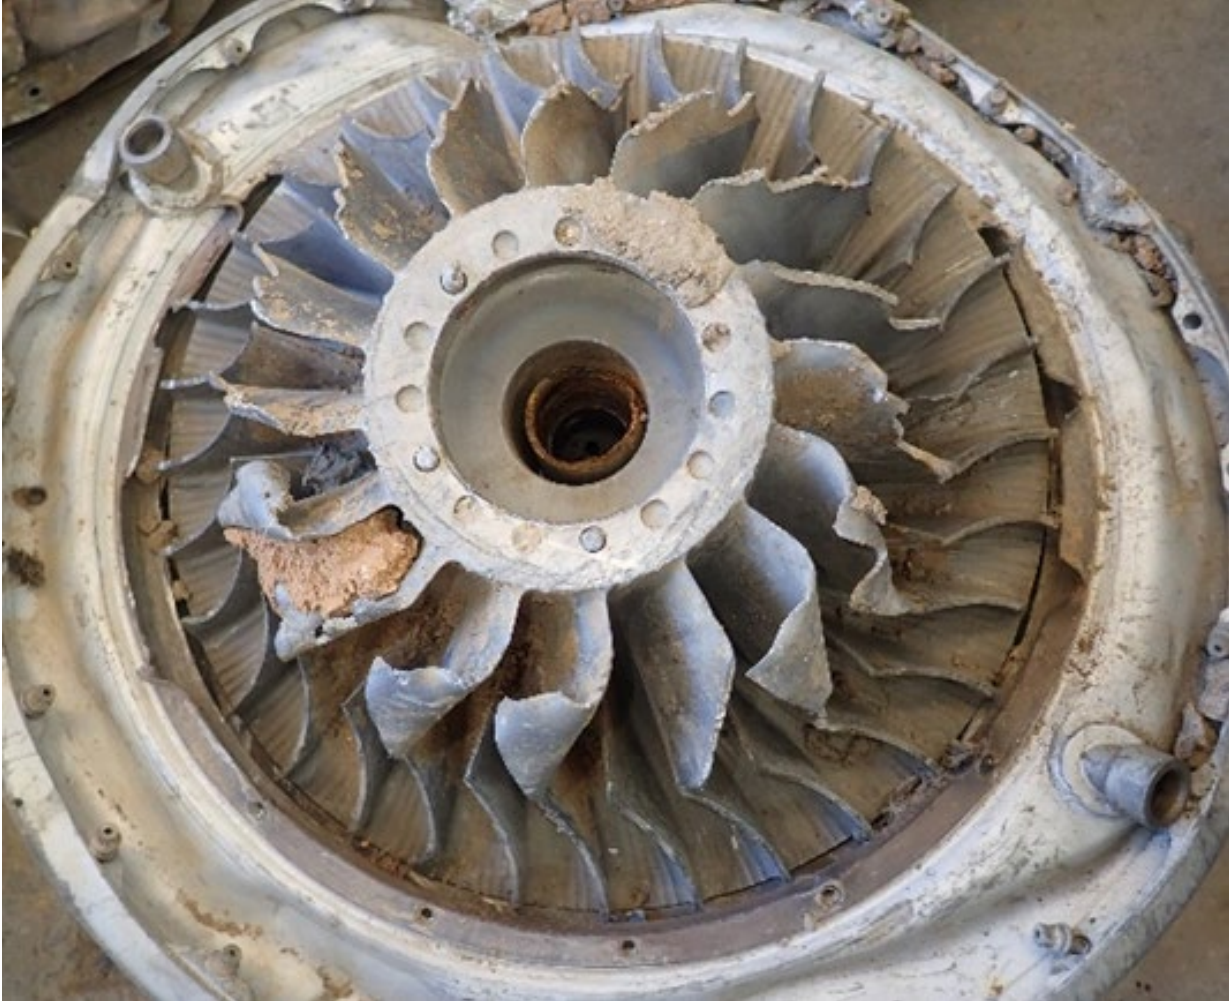
Seven compressor impeller vane inducer profiles showed pronounced curling in the direction opposite rotation; the inducer profiles of all remaining vanes were fractured off. The exducer ends of the vanes were heavily scored 360°. All the vane edges were gouged and torn and there was local post-fracture curling of fracture edges in the direction opposite of rotation. See Figure 13.

**Figure 13.** Right engine front view showing impeller damage

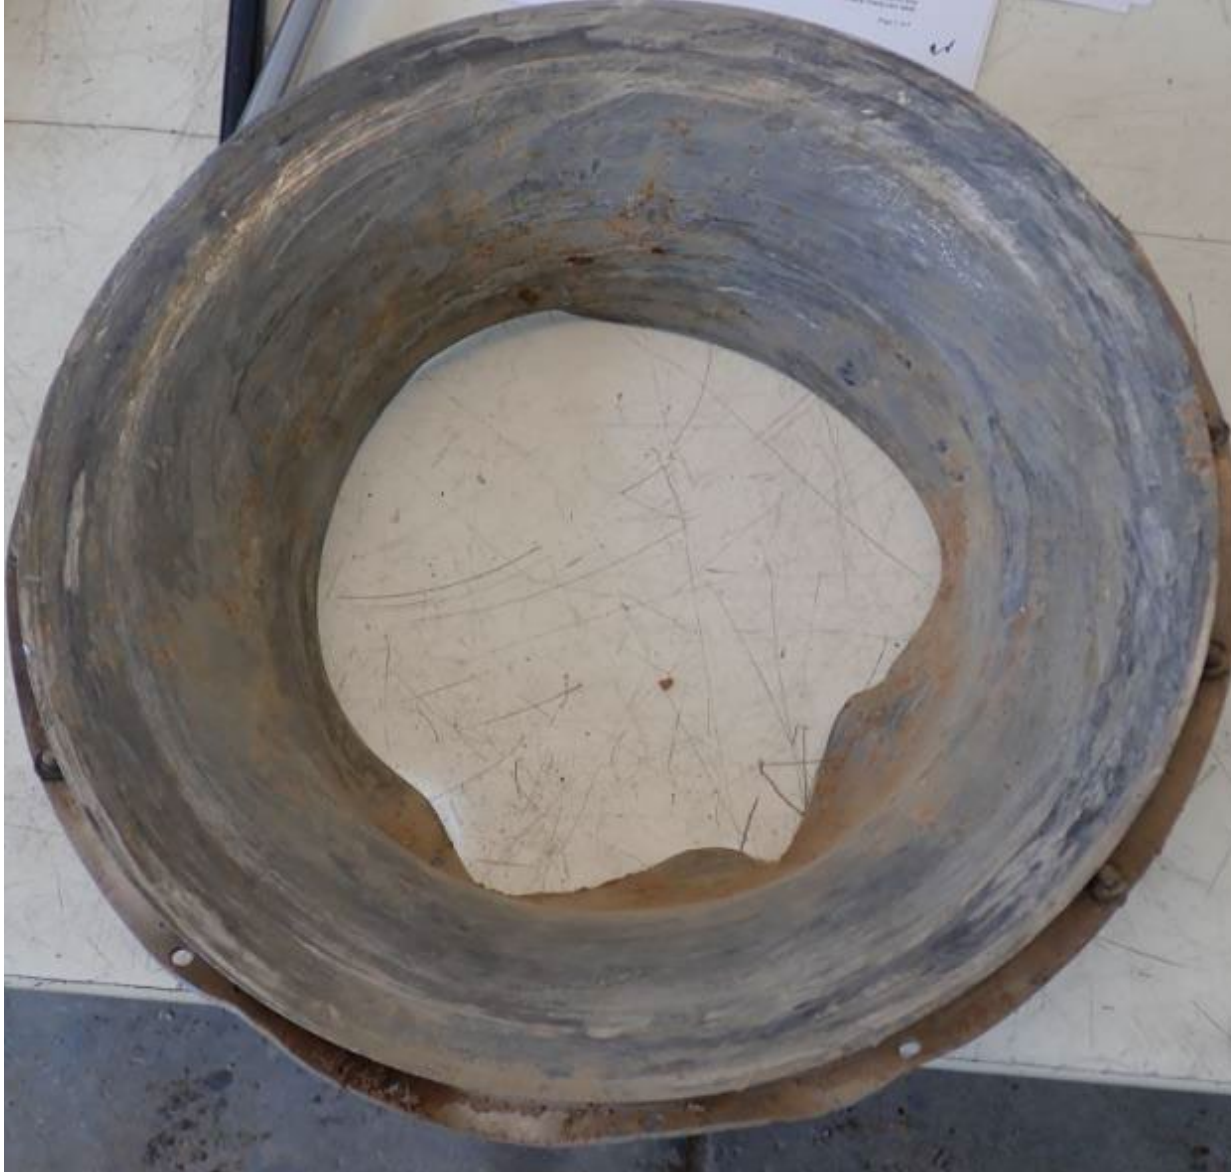
The impeller shroud was severely distorted at the forward (inducer) end. The inside surface displayed heavy circumferential rub consistent with the damage observed to the compressor impeller. See Figure 14.

**Figure 14.** Impeller housing/shroud showing rotational scoring

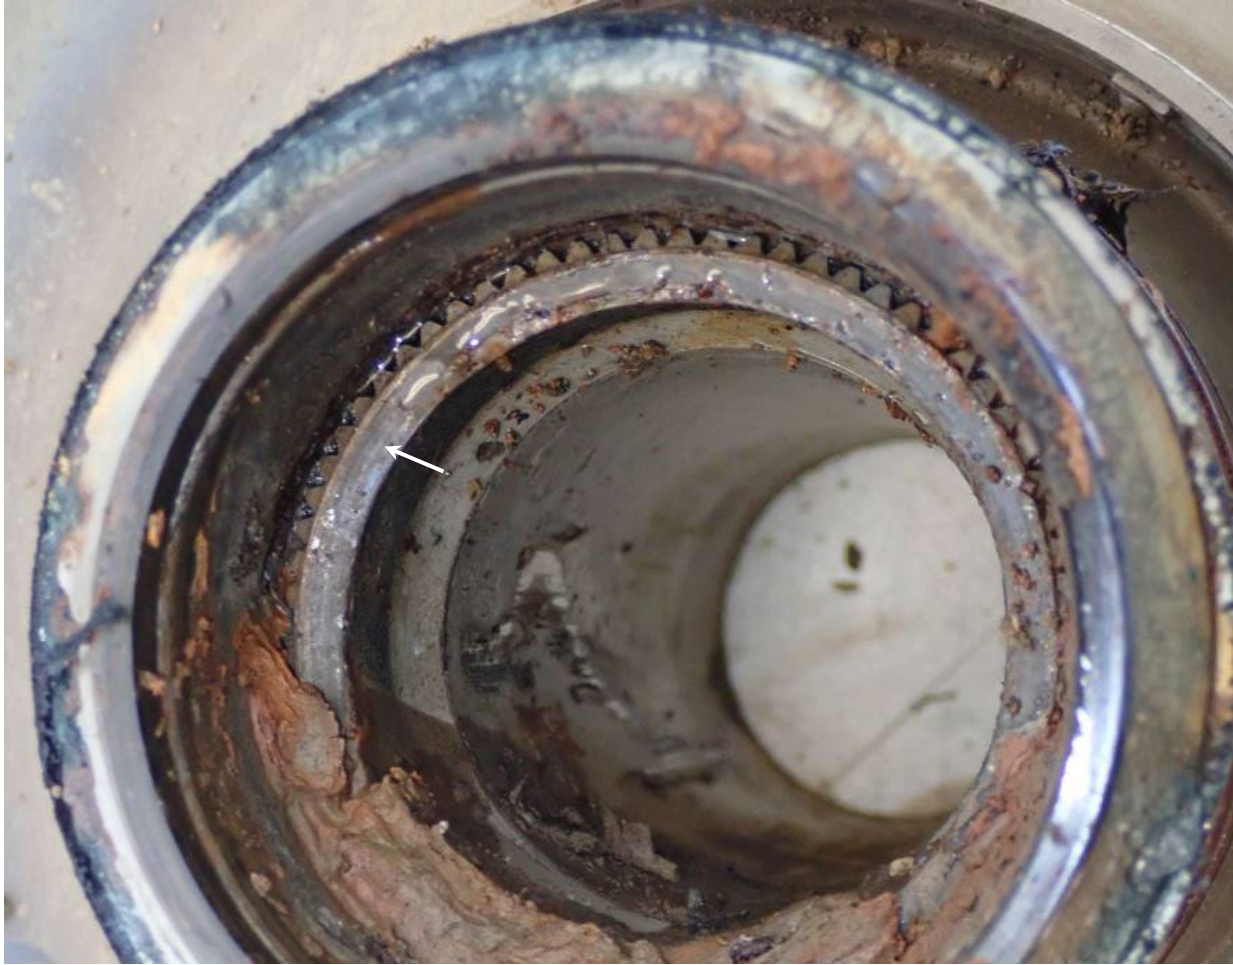
The high turbine shaft was separated aft of the high turbine disk splines. Circumferentially-oriented scoring was observed on the shaft fracture surface. See Figure 15.

**Figure 15.** Post-separation rotational scoring to the high turbine shaft fracture surface

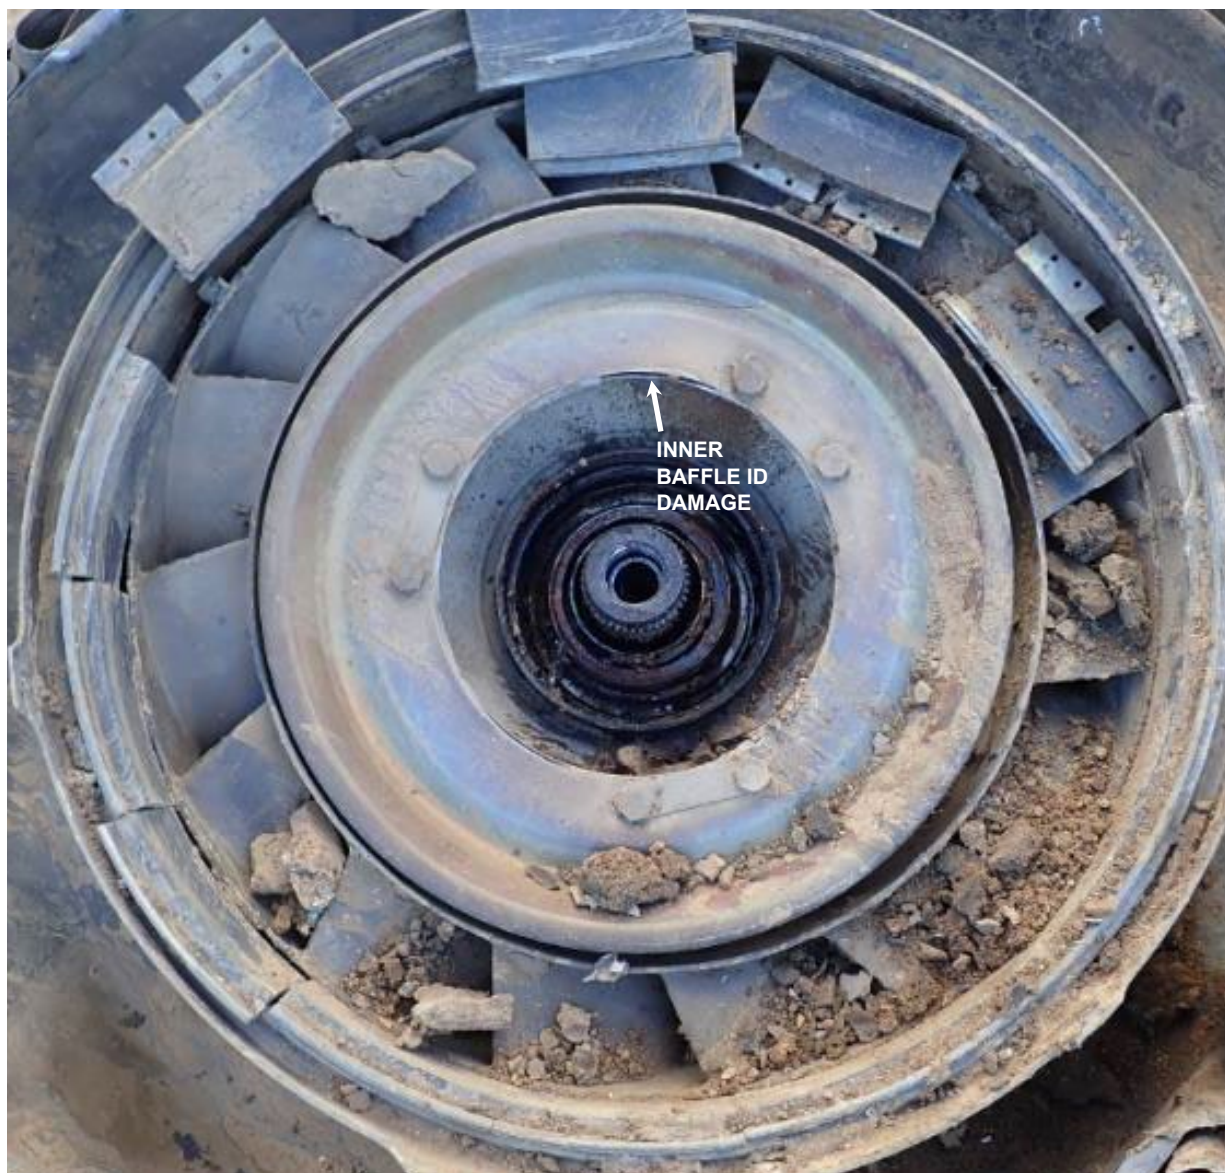
The high turbine stator inner baffle exhibited scoring along the inner diameter (ID). See Figure 16.

**Figure 16.** Downstream view of the high turbine stator assembly showing circumferential scoring at inner baffle ID

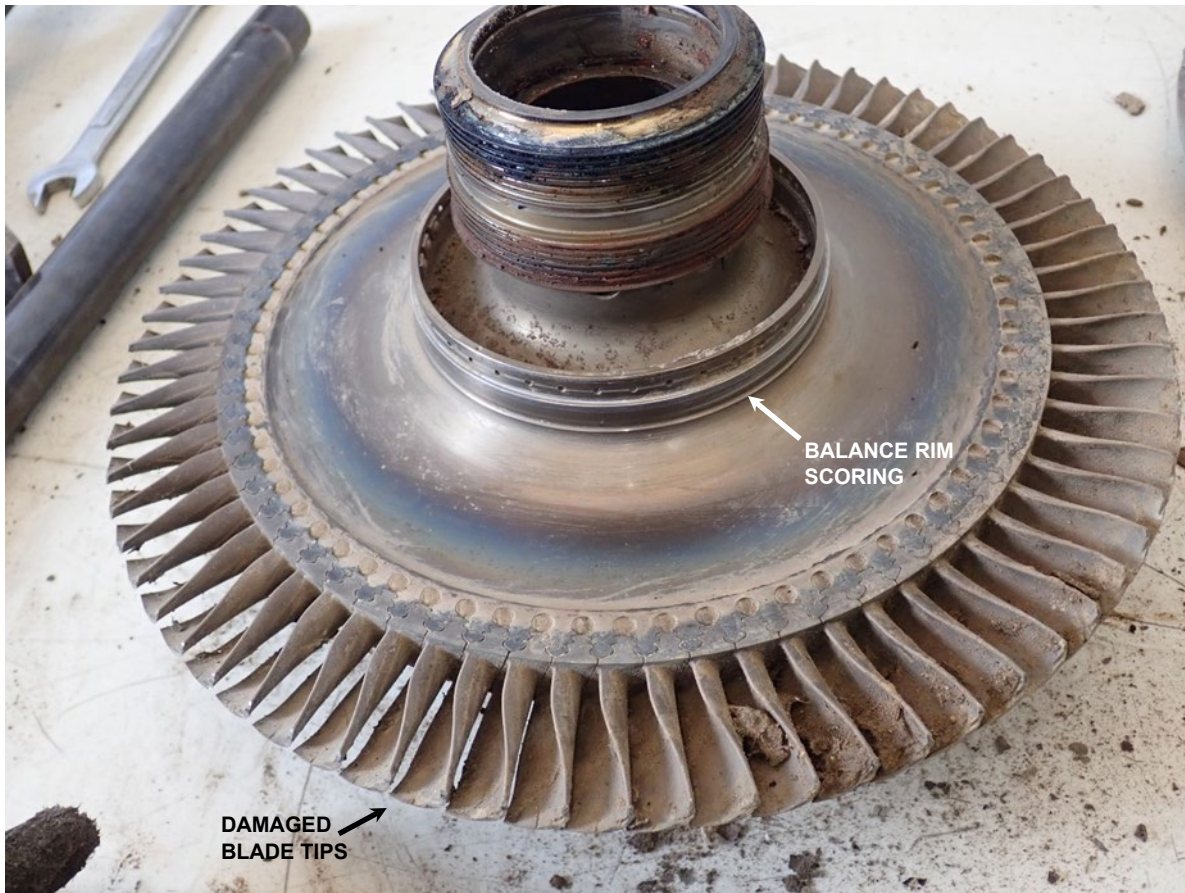
The high turbine upstream face exhibited deep 360° scoring at the center hub radius and along the balance rim. The balance weight retention rivets were machined /missing material. This damage was axially coincident with the inner baffle scoring observed to the high turbine stator downstream face. See Figure 17.

**Figure 17.** Upstream face of high turbine showing 360° scoring damage at the balance rim

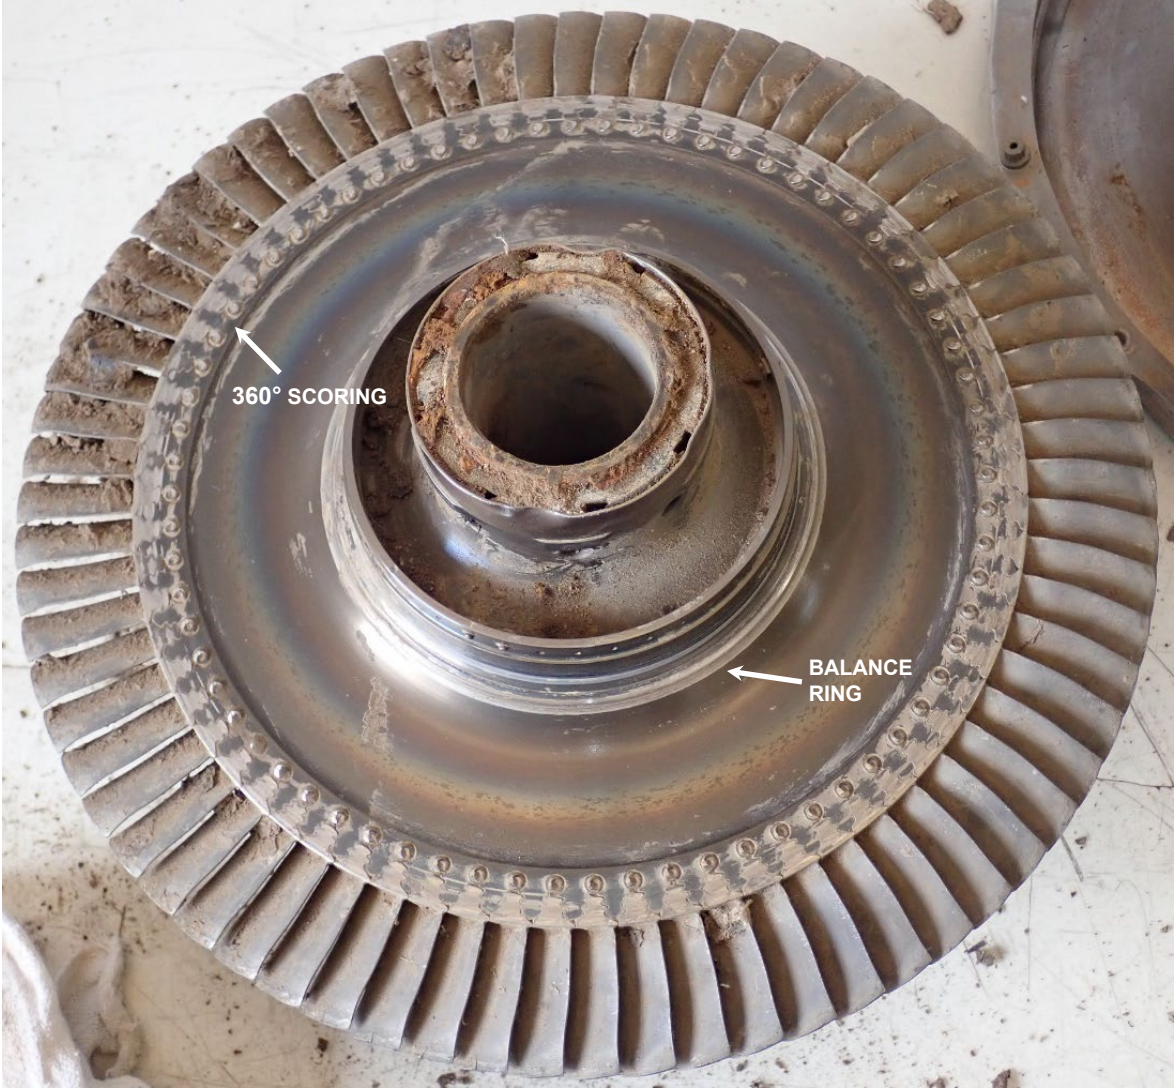
The high turbine downstream face was circumferentially scored along the fir tree roots and rivets, and balance ring diameter. See Figures 18 and 19.

**Figure 18.** Rotational scoring to high turbine downstream face
