# NATIONAL TRANSPORTATION SAFETY BOARD

## COMPONENT EXAMINATION FACTUAL REPORT

Place: Smyrna, Tennessee  
Date: May 29, 2021  
Vehicle: Cessna 501 Citation, Reg. No. N66BK  
NTSB No: ERA21FA234  
IIC: L. Read

### B. COMPONENTS EXAMINED

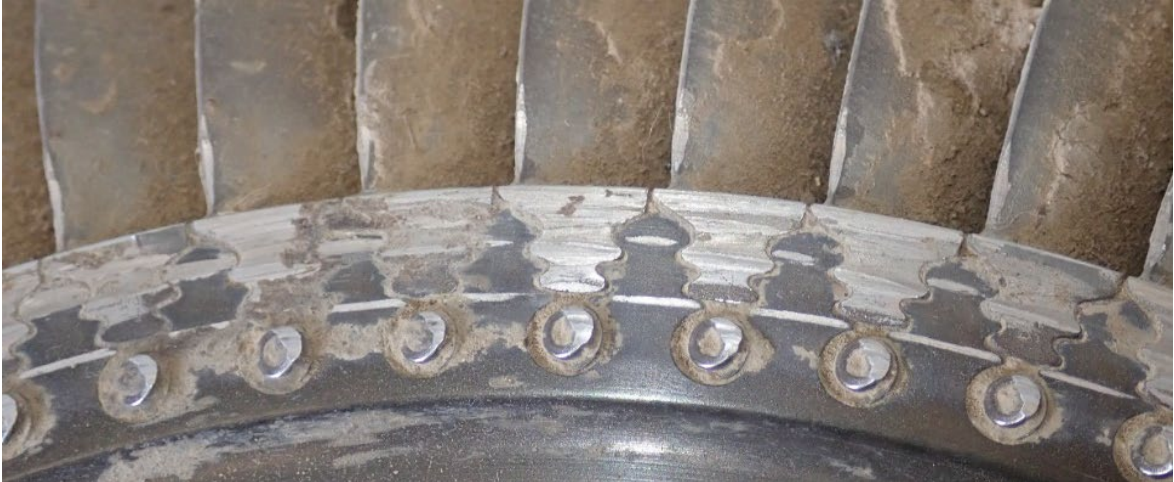
The high turbine downstream face was circumferentially scored along the fir tree roots and rivets, and balance ring diameter. See Figures 18 and 19.

**Figure 19.** Detail of circumferential scoring along fir tree/blade area on high turbine downstream face

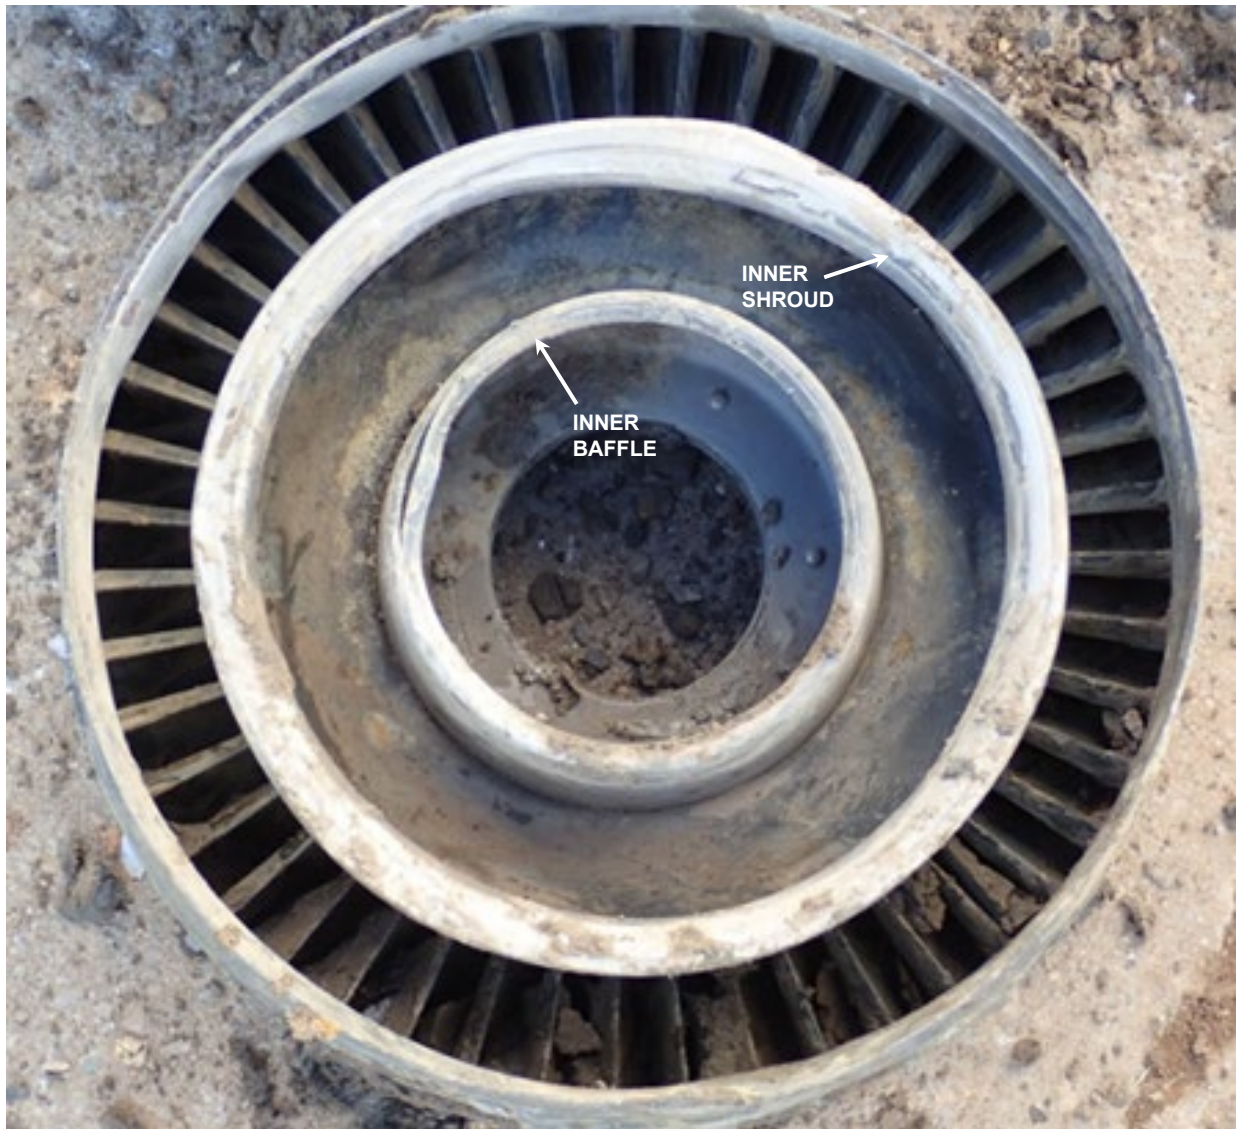
**Figure 20.** T2 stator upstream face

The T2 stator upstream face was heavily scored 360° along the vane inner shroud and the inner baffle rim. The damage was severe enough to deform structure and an arc of the inner baffle lip was machined to separation. The locations of the scoring were axially coincident with damage observed to the high turbine downstream face. See Figure 20.

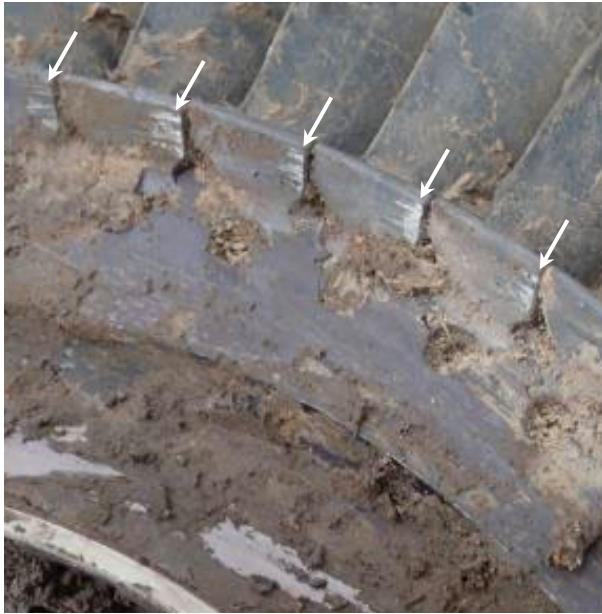
All the T3 blades exhibited under platform scoring. See Figure 21. The turbine exhaust duct inner shroud exhibited local scoring consistent with contact with the T3 low turbine blade platforms. See Figure 22.

**Figure 21.** T3 blade under platform rub

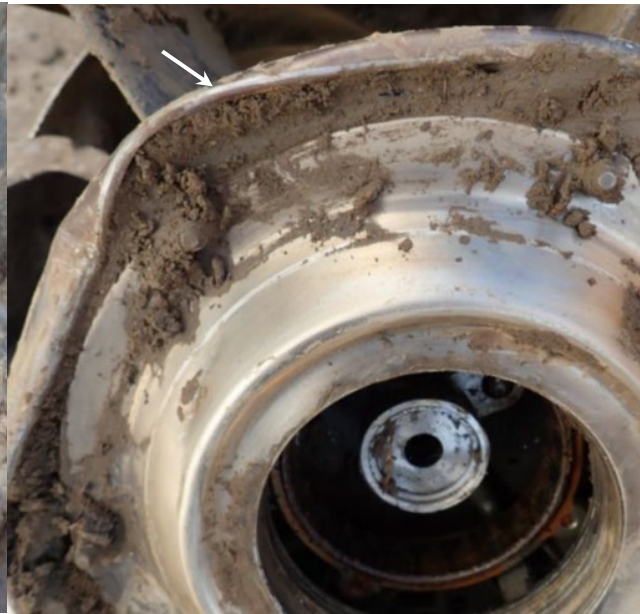
**Figure 22.** Local circumferential scoring to turbine exhaust duct inner shroud
