**GROUP CHAIRMAN'S FACTUAL REPORT OF INVESTIGATION**

**ERA21FA346**

## **Cockpit Voice Recorder**

Location: Farmington, CT  
Date: September 2, 2021  
Aircraft: Cessna 560, N560AR  
Operator: Brookhaven Properties, LLC.  
NTSB Number: ERA21FA346

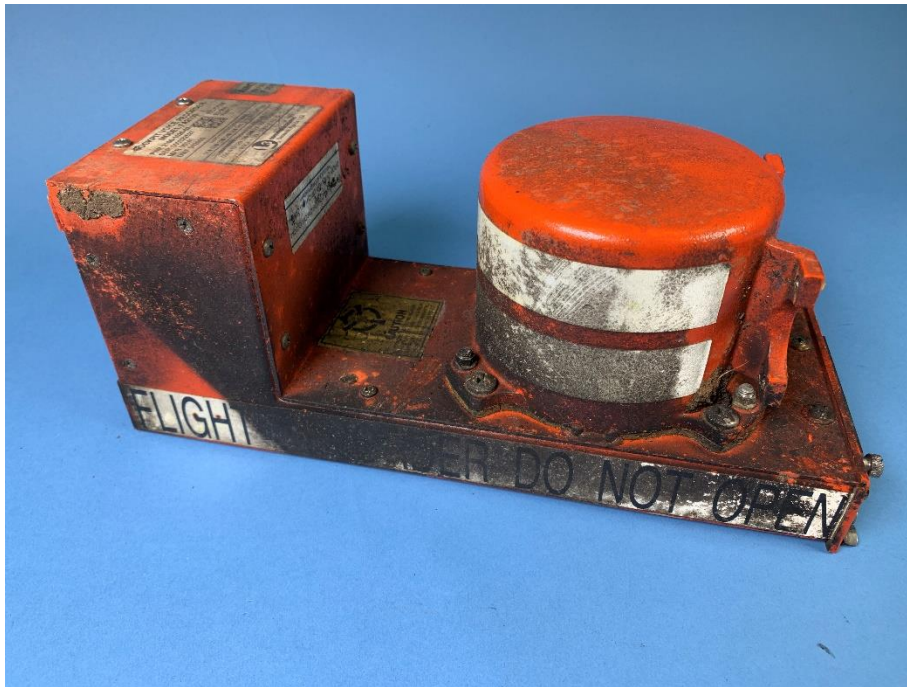
The recorder did not show obvious signs of deformation damage. The recorder was filled with earthen material in some areas, particularly around protruding hardware. The recorder showed some evidence of heat damage. The recorder's crash survivable memory unit (CSMU) appeared undamaged and was still affixed to the recorder's chassis. Figure 1 shows the condition of the recorder upon arrival to the NTSB laboratory. Note that the recorder's Underwater Locator Beacon (ULB) had been removed from the device for shipping.

**Figure 1.** The arrival condition of the CVR from N560AR.

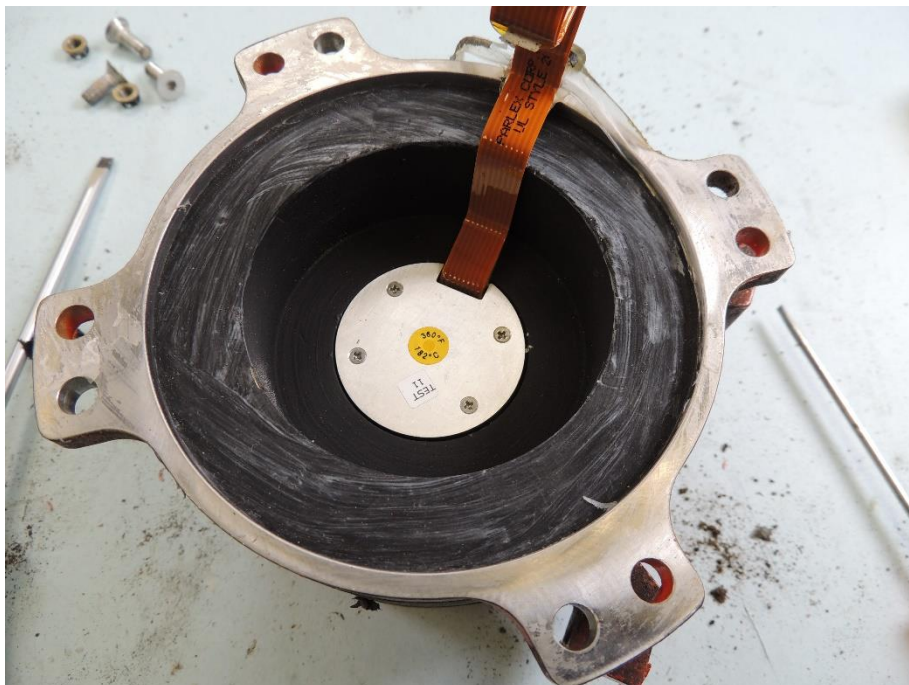
Figure 2 shows the internal condition of the CSMU when removed from the chassis. The CSMU appeared undamaged, and the internal non-volatile memory (NVM) chip stack also appeared undamaged.

**Figure 2.** The condition of the CSMU and associated NVM chip stack.

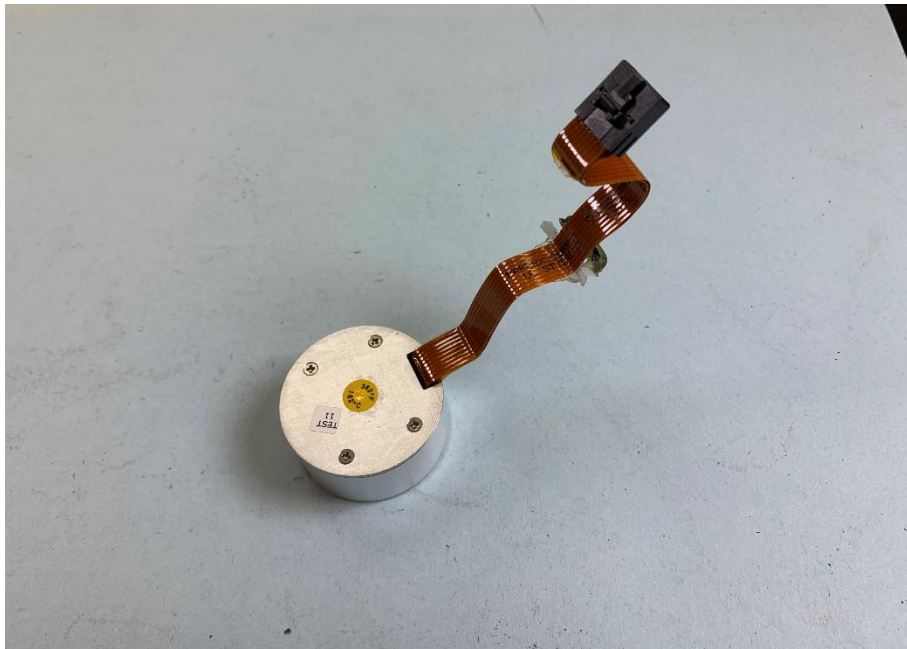
Figure 3 shows the NVM chip stack removed from the CSMU. The chip stack and associated ribbon cable were in good condition and were read out normally using an NTSB owned L3 FA-2100 surrogate.

**Figure 3.** The NVM chip stack and ribbon cable shown in good condition.
