NATIONAL TRANSPORTATION SAFETY BOARD
Office of Aviation Safety

WRECKAGE EXAMINATION SUMMARY

A. ACCIDENT ERA21LA003

Location: Corfu, New York
Date: October 2, 2020
Time: 1144 Eastern Daylight Time (EDT)
Operator: Private
Aircraft: Socata TBM 750
Registration: N965DM

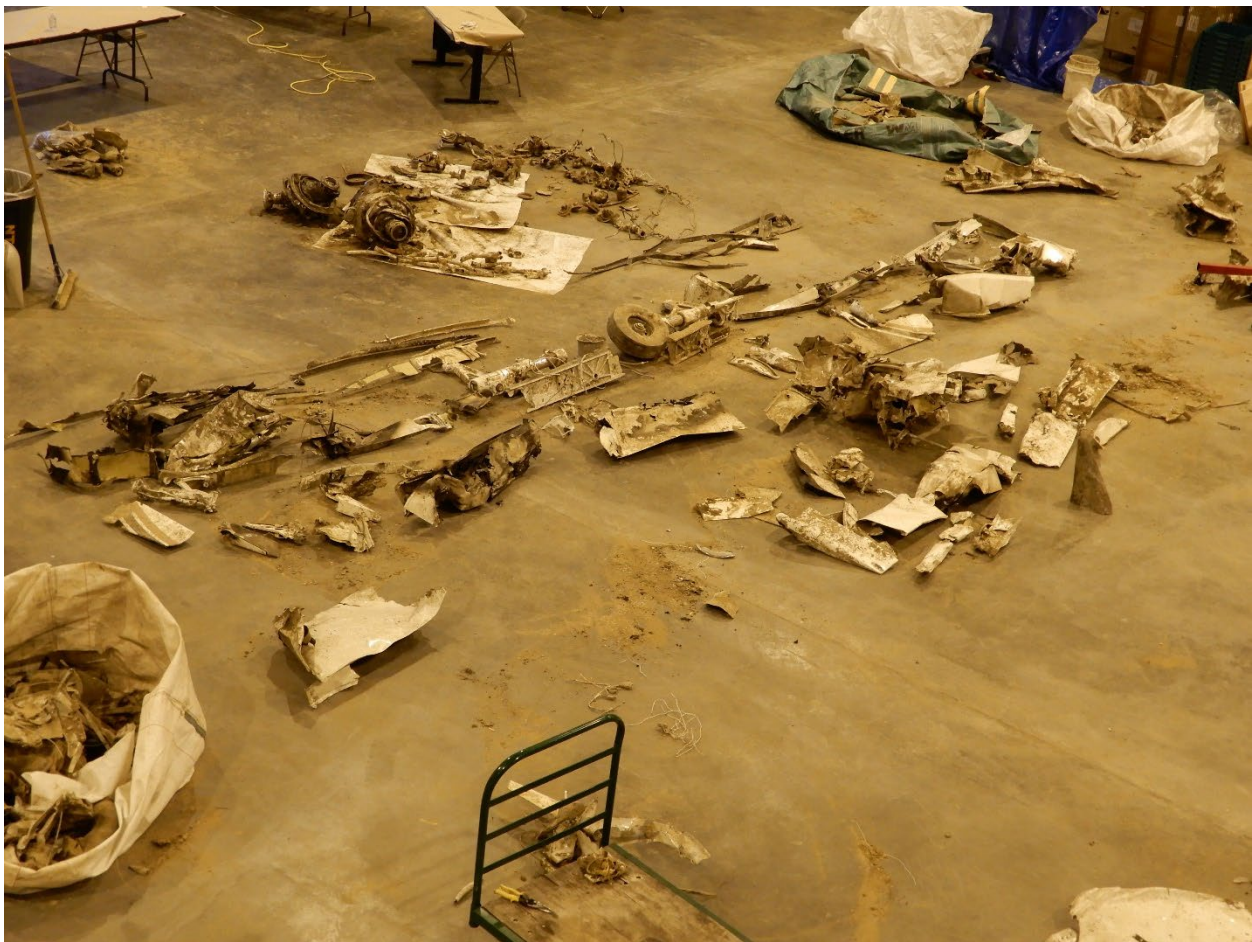
The airplane was manufactured in 2009 and its most recent annual inspection was December 6, 2019. The wreckage was located in a 15 ft deep crater.

Figure 1. Overview of wreckage layout.

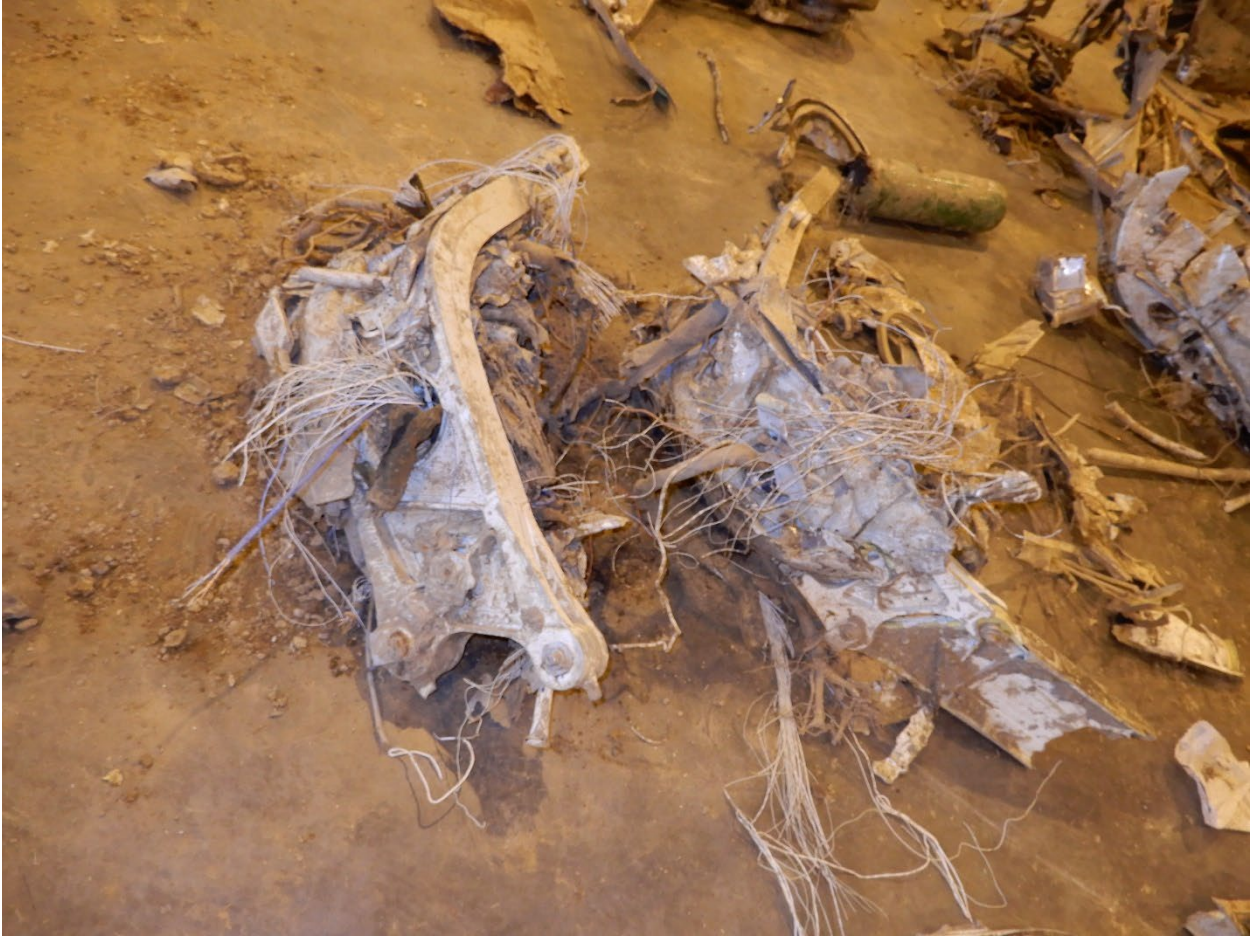
The wings were fragmented. Multiple sections of cap spars were impact separated from the spar and located with the wreckage. The center section of the wing spar was impact damaged. Both the forward and aft section of the center wing spar was bent symmetrically about 43° from the original position.

Figure 2. View of forward and aft sections of center wing spar.

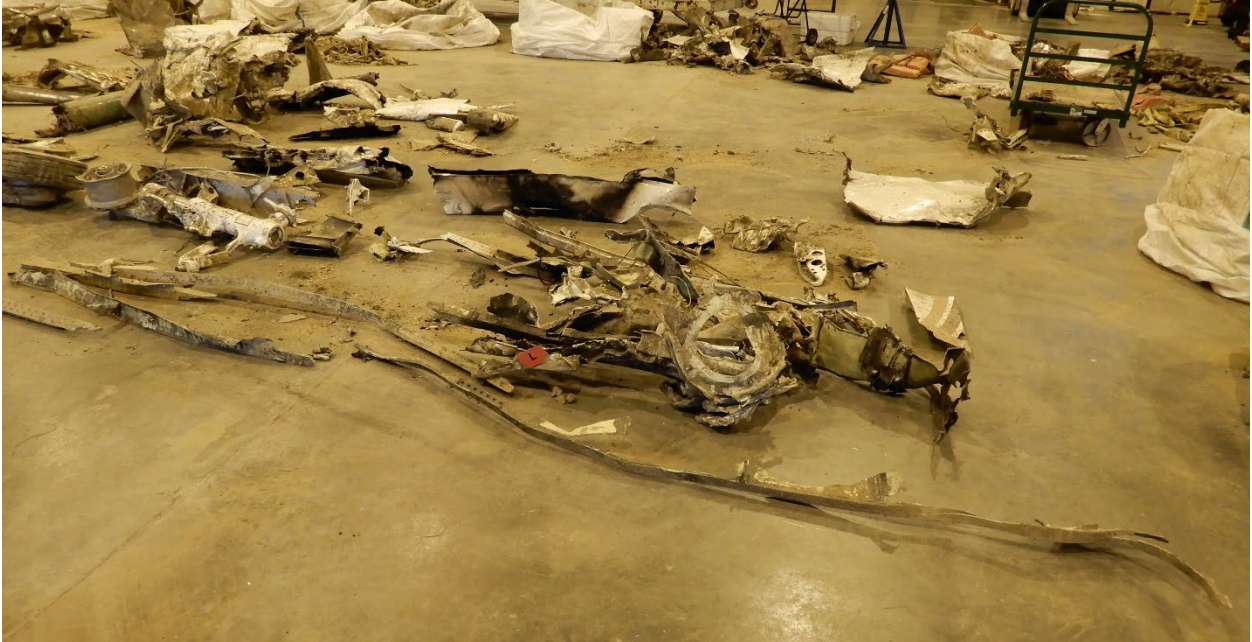
The left-wing tip was impact separated and the aft section was located with the wreckage. The radar pod on the left wing was impact separated and exhibited compression damage. The left flap actuator indicated the flaps were in the retracted position. The left spoileron was impact separated into several sections. The left aileron was impact separated and a bottom section was located. The left flap was impact separated and about 12 ft of about 16 ft of flap was located in 3 pieces. All 3 left flap tracks were impact separated and located. The left spoileron mechanism was impact separated and located. The outboard section of the left wing was fire damaged. However, no soot tailing was noted.

Figure 3. View of left wing.

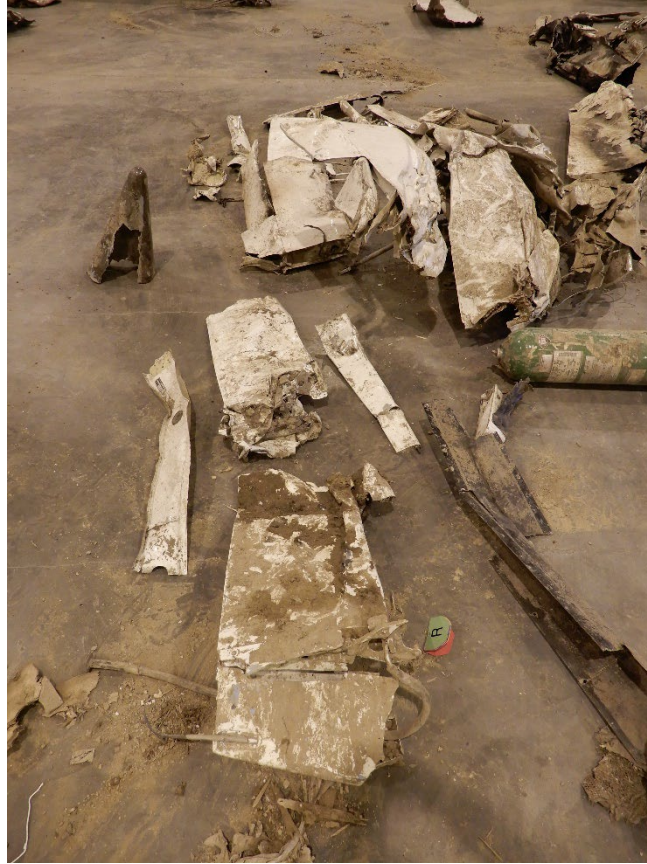
The right-wing tip was impact separated and the aft section located with the wreckage. A majority of the right spoileron was located separated from the right wing. The right aileron was impact separated and located. The right flap was impact separated and about 3 ft of the inboard section of the flap was located. Two of the 3 right flap tracks were located in the wreckage. The right flap rooftop was separated into several pieces.

Figure 4. View of right wing.

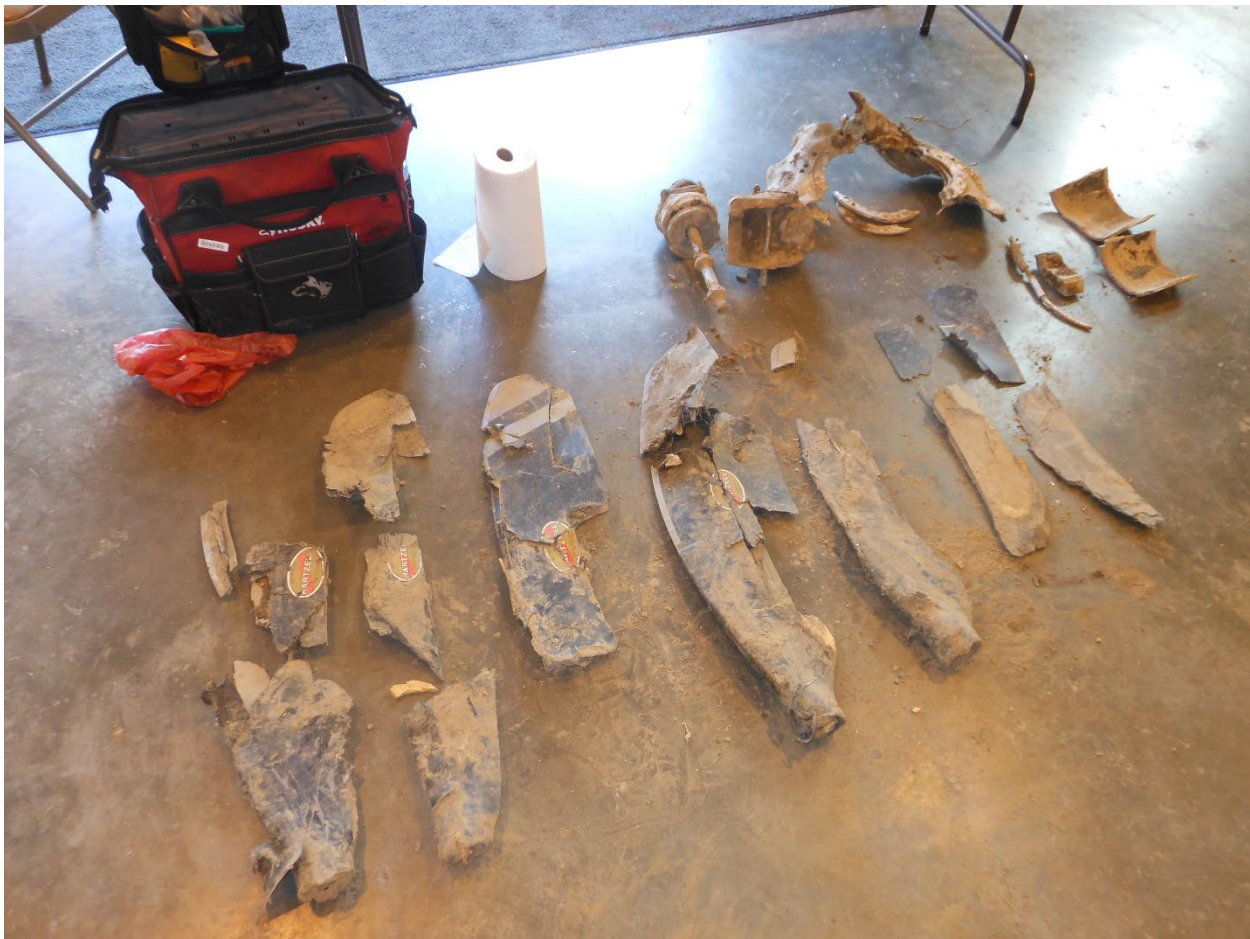
The propeller hub was impact separated from the engine. All 5 blades were impact separated from the hub. A portion of each of the 5 blades was located in the vicinity of the wreckage.

Figure 5. Propeller blades.
