**Date:** December 15, 2021  
**Subject:** ERA21LA287 - Propeller Examination Summary  
**Contact:** Les Doud  
Air Safety Investigator  
Hartzell Propeller

Propeller Model: HC-E4N03Q/E8501B-3.5 82.5" diameter 4-blade

Assembly S/N: HH2173

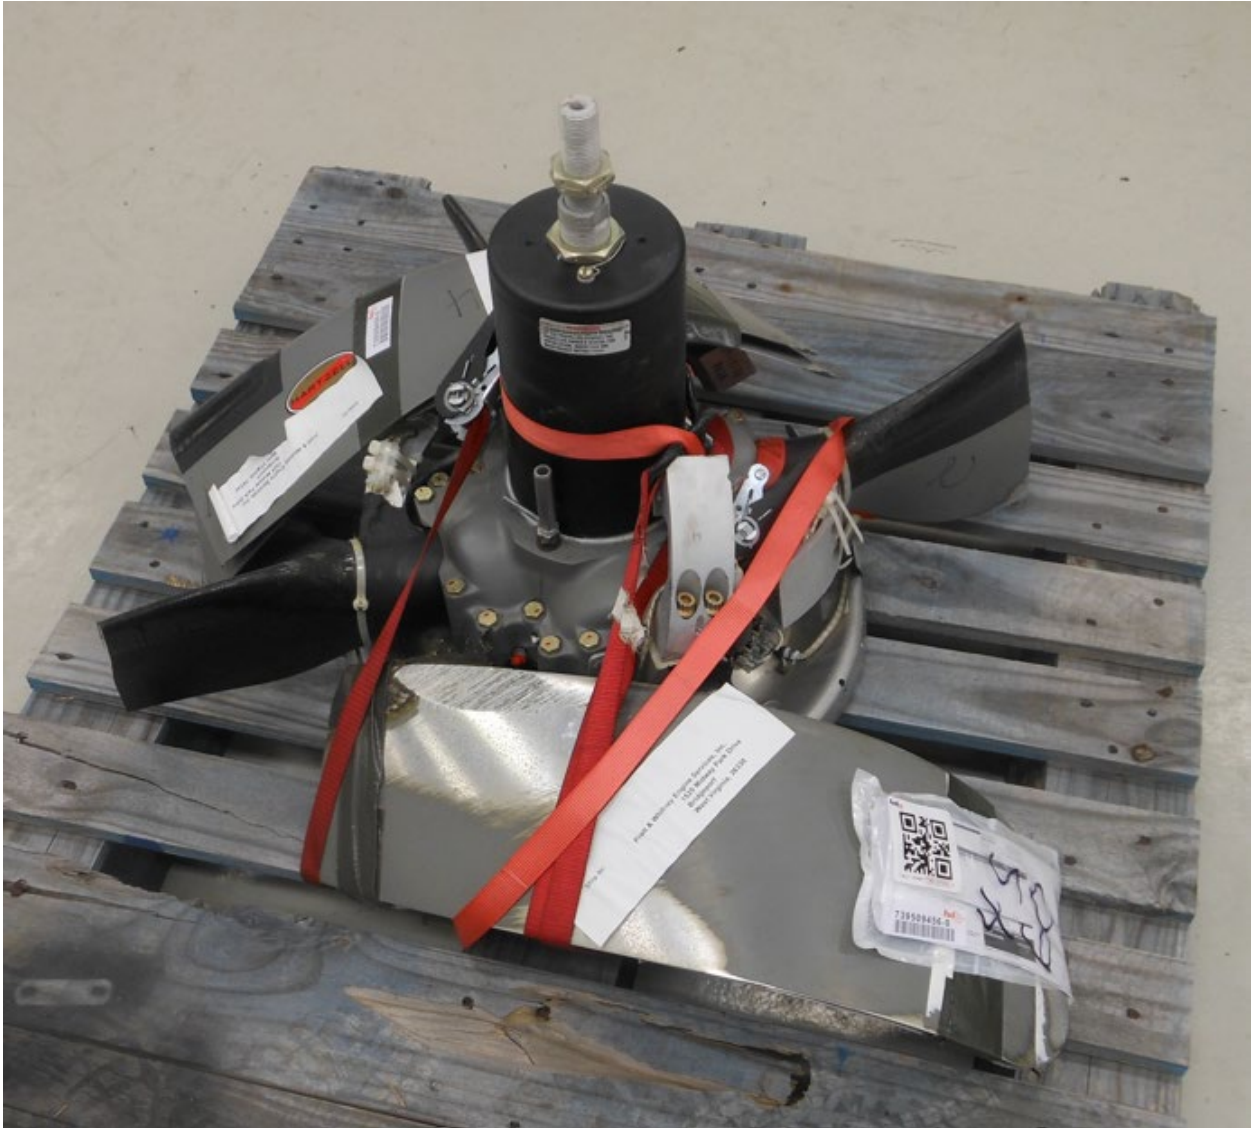
The propeller was removed from the engine by on-scene investigators and presented for examination as shown in Photo #1. Two beta rods were pulled forward by spacers under the beta sleeves to facilitate propeller removal. All four blades were cut approximately 9.5-10" from the blade aperture to facilitate shipment. The pitch change rod was extended approximately 0.6" from the feather stop sleeve. The blades were numbers 1-2-3-4- with the assembly S/N between the number 1 and 2 blades. Blades 1, 2 and 4 were in a high pitch position near feather. Blade 3 was in a position lower than the reverse stop and could be rotated by hand indicating a fractured pitch change bracket. The blade 3 counterweight was jammed into blade 2 counterweight and prevented propeller actuation after aircraft recovery. The blade 3 counterweight was loosened by on-scene investigators to allow propeller actuation. There were no indications of any oil leaks on the propeller assembly.

Photo #1 - Propeller as-presented

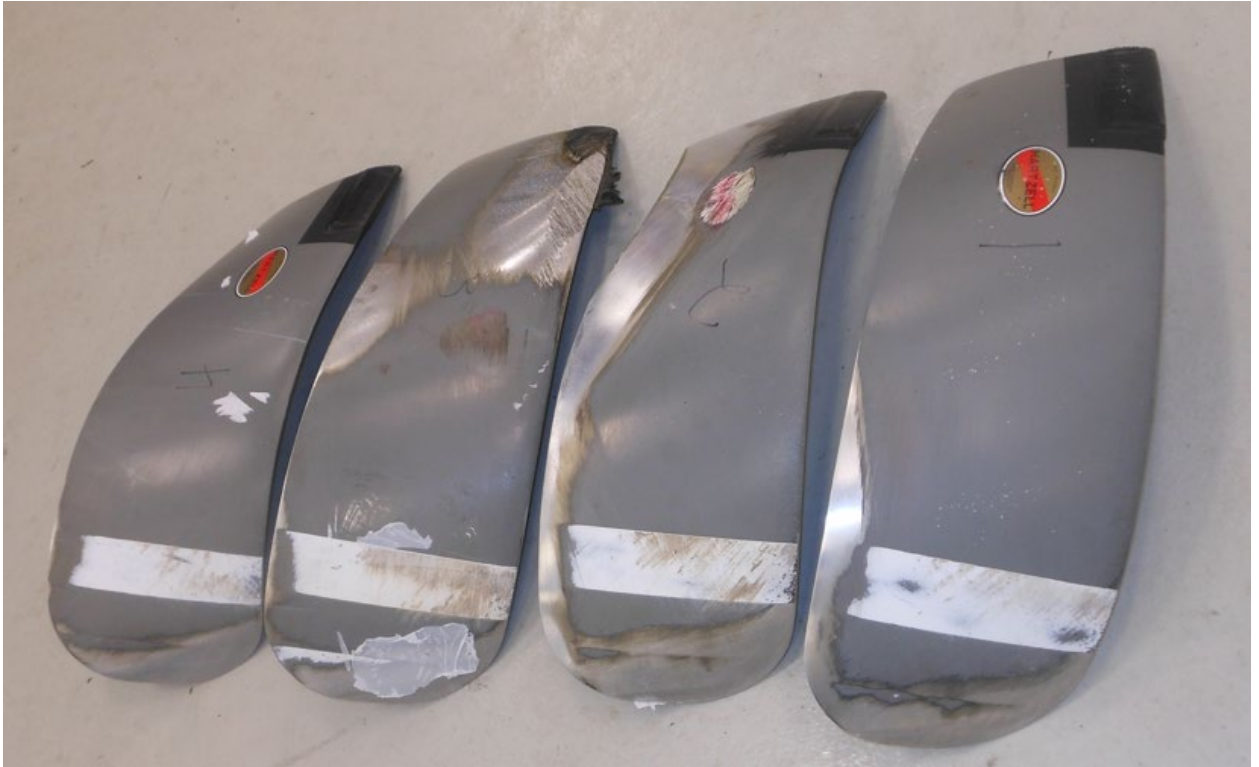
All four blades were bent aft, bent opposite rotation and twisted towards low pitch. All four blades exhibited chordwise/rotational scoring in the tip region as shown Photo #2. The leading edge of blade 3 and trailing edge of blade 2 exhibited grinding erosion suggesting rotation stopped with these two blades underneath the nose of the aircraft.

Photo #2 - Blade damage

All four blades were bent aft, opposite rotation and twisted toward low pitch with chordwise/rotational scoring in the tip region. The blade #3 pitch change bracket was fractured but blades #1, #2 and #4 actuated normally with shop air pressure. There were no visible discrepancies noted that would prevent or degrade normal propeller operation prior to impact. All visible damage was consistent with high impact forces while rotating at low power.
