National Transportation Safety Board

ERA22FA004

AUTOMATIC DEPENDENT SURVEILLANCE- BROADCAST (ADS-B) STUDY

Aircraft Performance Study

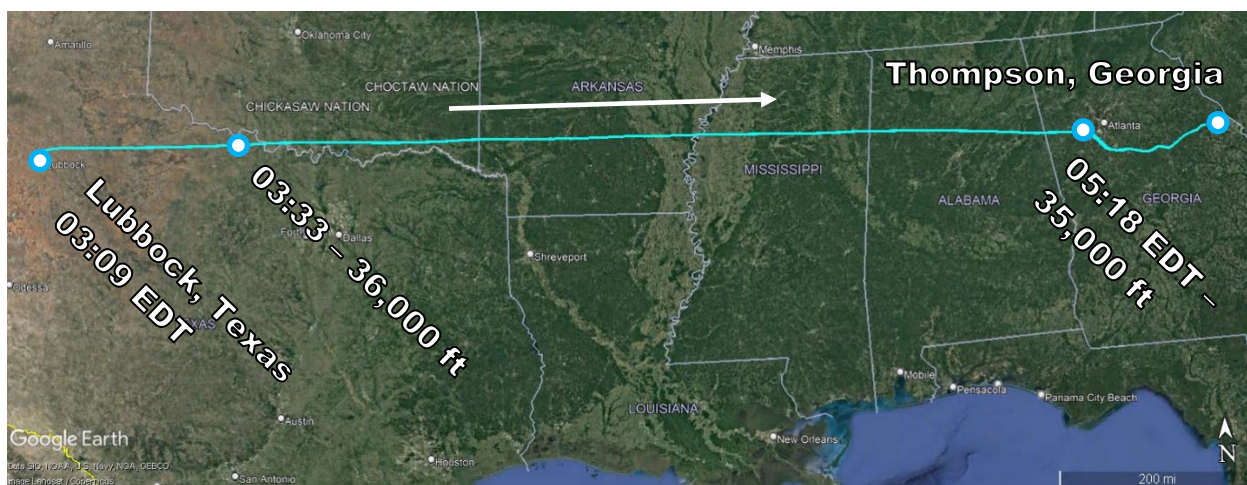
Figure 2. Flight path from ADS-B.

The airplane departed Lubbock, Texas about 0309 EDT (0209 CDT, local). It climbed to an altitude of about 36,000 ft above mean sea level (msl), which it maintained until 05:18 when the airplane began to descend (Figure 2). As the airplane descended it left its easterly track and flew south of the Atlanta, Georgia area. The airplane descended to 3,000 ft by 05:35 (Figure 3) and held at that altitude.

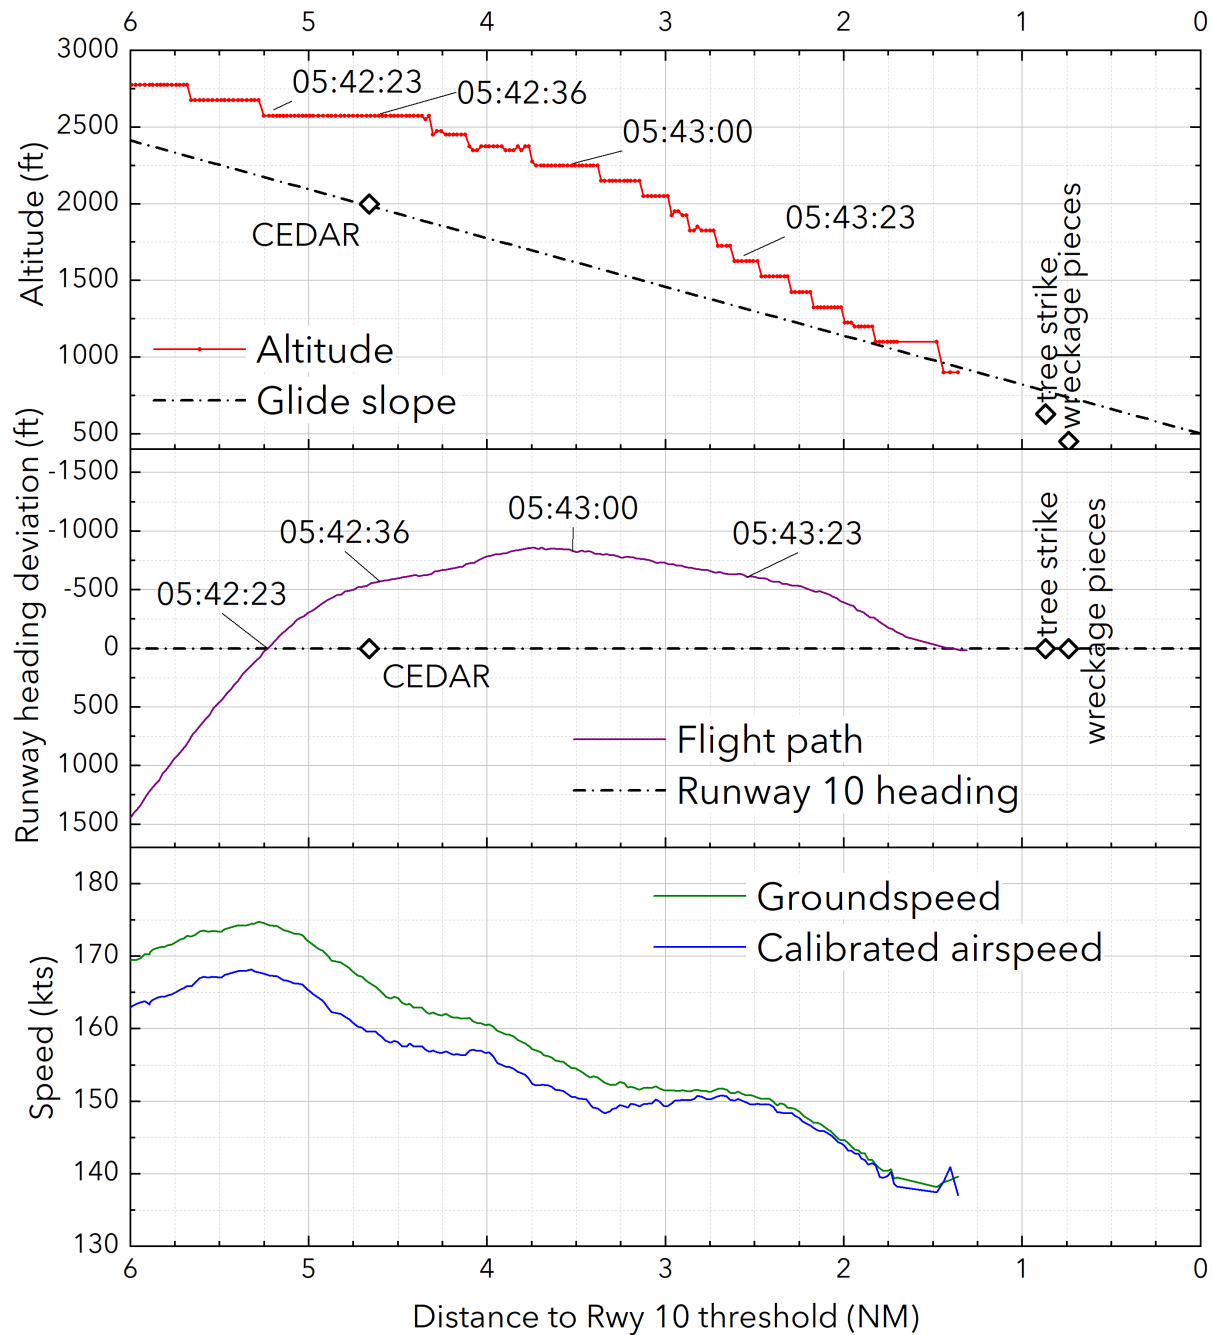
Figure 5. Altitude compared to 3° glide slope, flight path compared to runway heading, and calculated ground and airspeeds for final 6 NM of the approach.

Figure 5 shows the airplane's altitude and flight path for the final 6 NM to the threshold of runway 10. The crew were instructed by air traffic control (ATC) to cross CEDAR at 3,000 ft. However, crossing CEDAR at 2,000 ft, as shown on the approach plate, would have the airplane join the 3° glide slope to runway 10. The airplane crossed CEDAR at 2,600 ft and 500 ft to the left of the extended runway centerline. It continued to be about 600 ft above the 3° glide slope and further deviated to the left of the runway heading until about 3 NM from the threshold when the descent rate increased. Airspeed at that time was about 150 kts. ADS-B coverage ended at 05:43:54, about 3,000 ft short of the first recorded tree strike. The final recorded altitude was 900 ft msl (400 ft agl) and the calculated airspeed was 137 kts. About 3,000 ft farther on, the airplane impacted the tops of trees at an altitude 150 ft below the glide slope at that location. The main wreckage was another 600 ft beyond the tree strikes at a ground elevation of 480 ft.

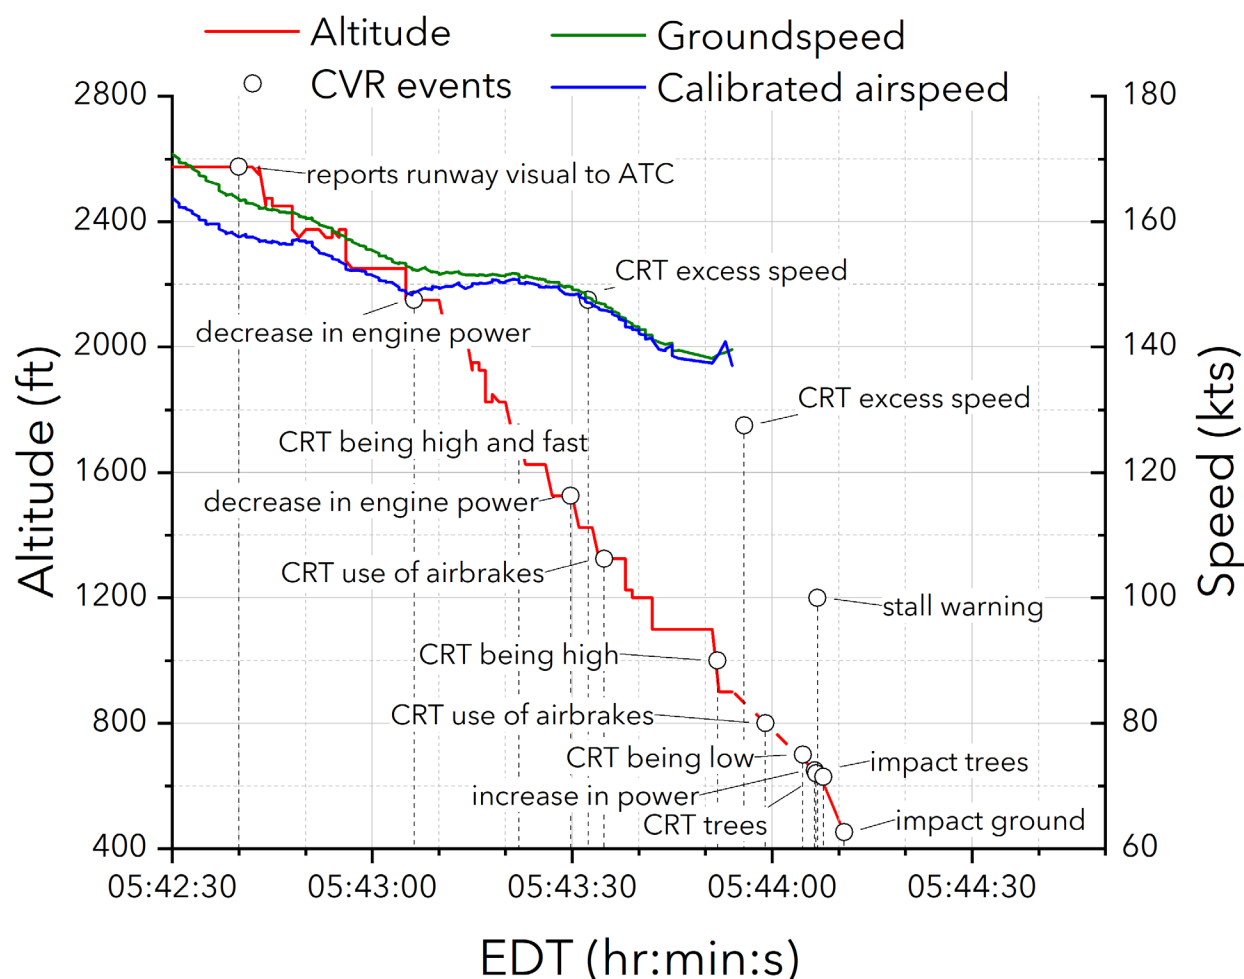
Figure 6. Altitude, calibrated airspeed, and groundspeed with selected end of flight CVR events. "CRT" is "Comment related to -". Red dotted line shows estimated altitude trend. ADS-B data ended at 05:43:54.

Figure 6 shows selected end of flight events with the altitude and calculated speeds. Comments or events are paraphrased or abbreviated from the CVR transcript. It was not possible to determine whether the "high" and "low" comments were in reference to the PAPI lights, a visual glidepath assessment based upon the crew's perception of the lighted runway environment, or cockpit instrumentation. The glideslope portion of the ILS was not broadcasting a signal; however, the investigation was unable to determine what the glideslope indication displayed in the cockpit due to impact related damage.

At 05:43:22 a comment related to being high (about 400 ft above the glideslope) and fast (the airspeed was 150 kts) was made and was followed by a second decrease in engine power. The airplane continued to descend and slowed about 5 kts before a second comment related to excess speed and then airbrakes was made. Another comment related to the airplane being high was made as it descended

through the glide slope. The ADS-B data ended at 05:43:54, but the CVR recorded until 05:44:10.8.

The airplane's landing reference speed, V_{REF} , for flaps 40 (which was indicated in the CVR transcript), 20,000 lbs, and no airbrakes was 113 kts, indicated airspeed [2]. With airbrakes, the V_{REF} would be 123 kts (published as $V_{REF} + 10$ for airbrake use, as part of Abnormal Procedures, Airbrake Failure). There were no normal published approach speeds for airbrakes extended because under normal conditions, airbrakes are required to be stowed when flaps are deployed and the anti-ice system is off. There was no evidence the crew was utilizing anti-ice for the approach. When the ADS-B data ended at 05:43:54, the airplane's airspeed was 137 kts, 25 kts above the V_{REF} and 48 kts above the 89 kts calibrated stall speed for flaps 40, no airbrakes. Two seconds later a comment related to excess speed was made and at 05:43:59, another comment related to airbrake use was made.

At 05:44:05, six seconds after the airbrakes comment, a comment related to being low was made. Starting at 05:44:06.4, there was an increase in power, the captain called out a comment related to trees, and the stall warning activated. The first sound of impact with trees was at 05:44:07.7 and the final impact at 05:44:10.8.

The cause for the stall warning is not known. The stall speed for 20,000 lbs could be as low as 89 kts for flaps 40 or as high as 102 kts for no flaps. The stall speeds with airbrakes are not published but based on the V_{REF} guidance, airbrakes may add 10 kts.

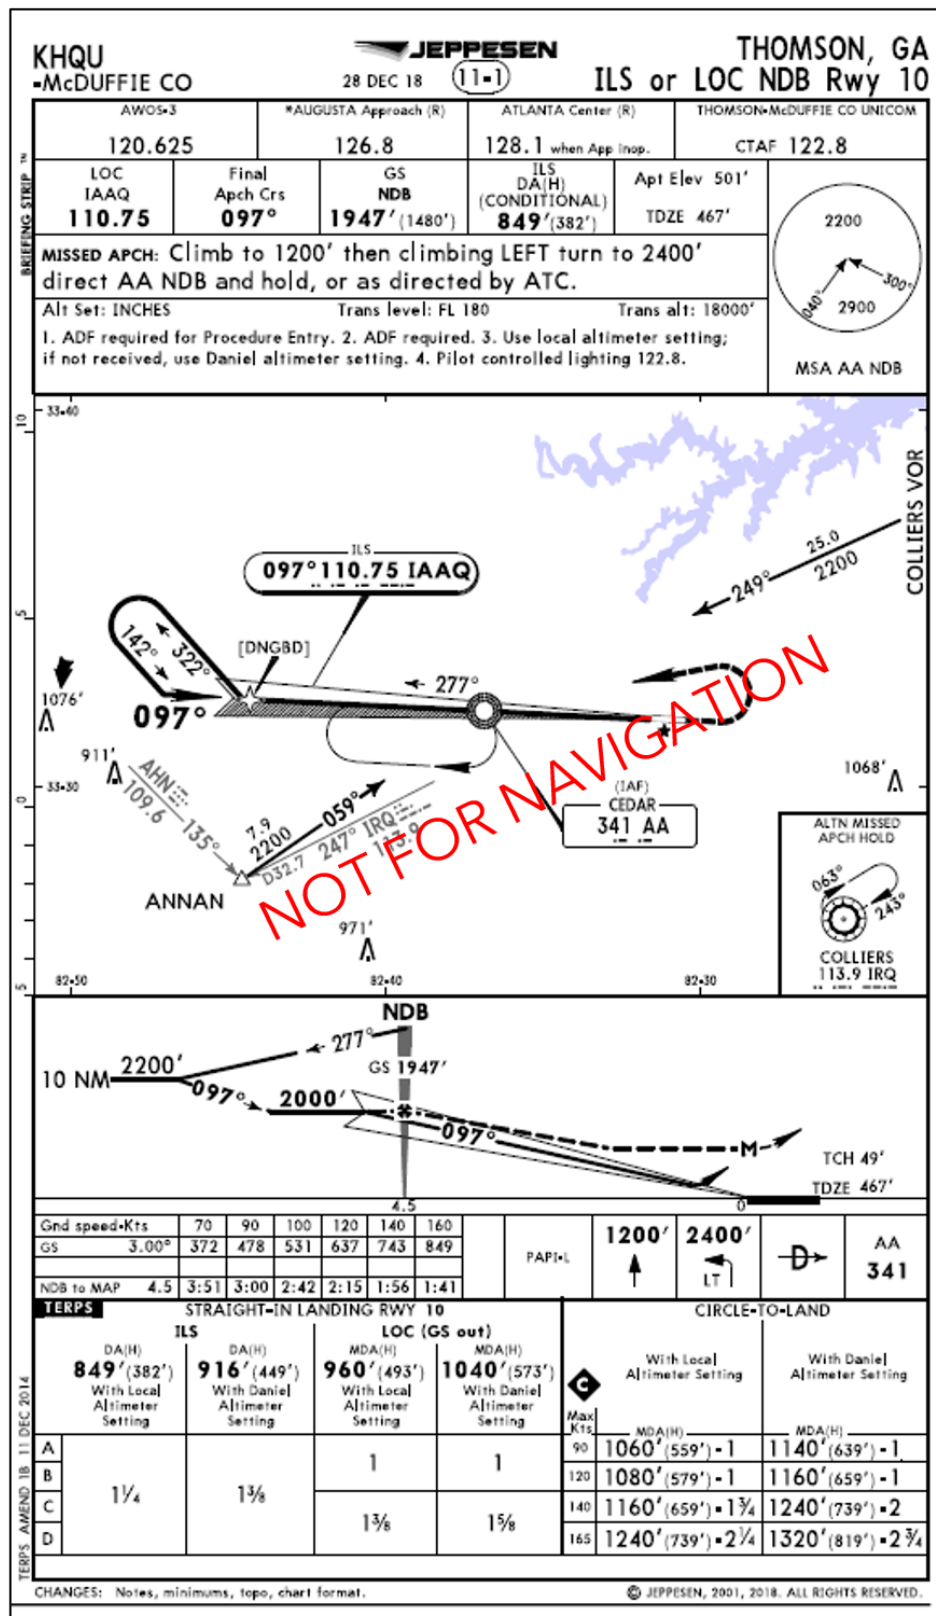
The terrain elevation on the 4.5 NM between the approach fix CEDAR and the runway 10 threshold varied between 450-500 ft. Runway 10 at KHQU has a two-light precision approach path indicator (PAPI) for the 3° glide slope. The instrument landing system (ILS) approach plate for runway 10 is shown in the Appendix, but at the time of

the accident, the glide slope signal had been taken out of service and was not available, only the localizer.
