National Transportation Safety Board

ERA22FA058

VEHICLE PERFORMANCE

Location: Branchville, New Jersey
Date: November 11, 2021
Time: 1048 EST
1548 GMT
Airplane: Cessna 172S Skyhawk, N90559

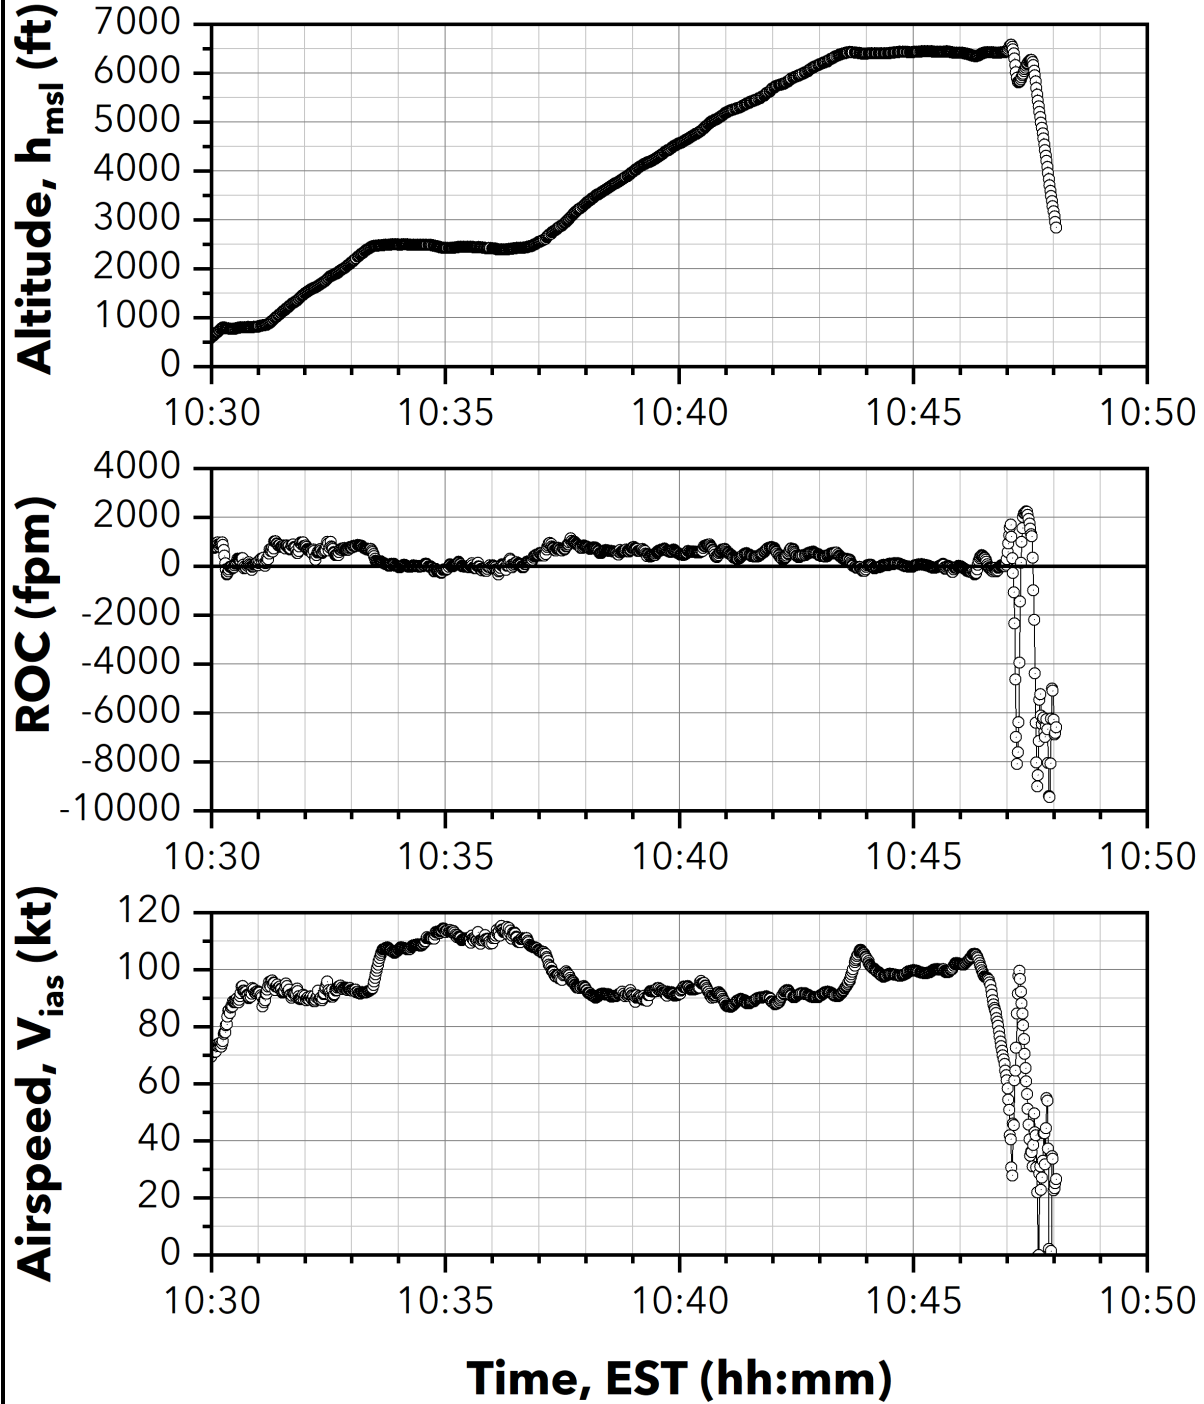
Figure 3 contains the G1000 altitude and airspeed for the accident flight that departed CDW around 1029 EST. The airplane climbed to a cruise altitude of approximately 6,400 ft and remained largely on a northwesterly heading for the first 17 min of the flight. Airspeeds were consistent with climb and cruise for a C-172.

Figure 3: Recorded Altitude, ROC, and Indicated Airspeed for Accident Flight

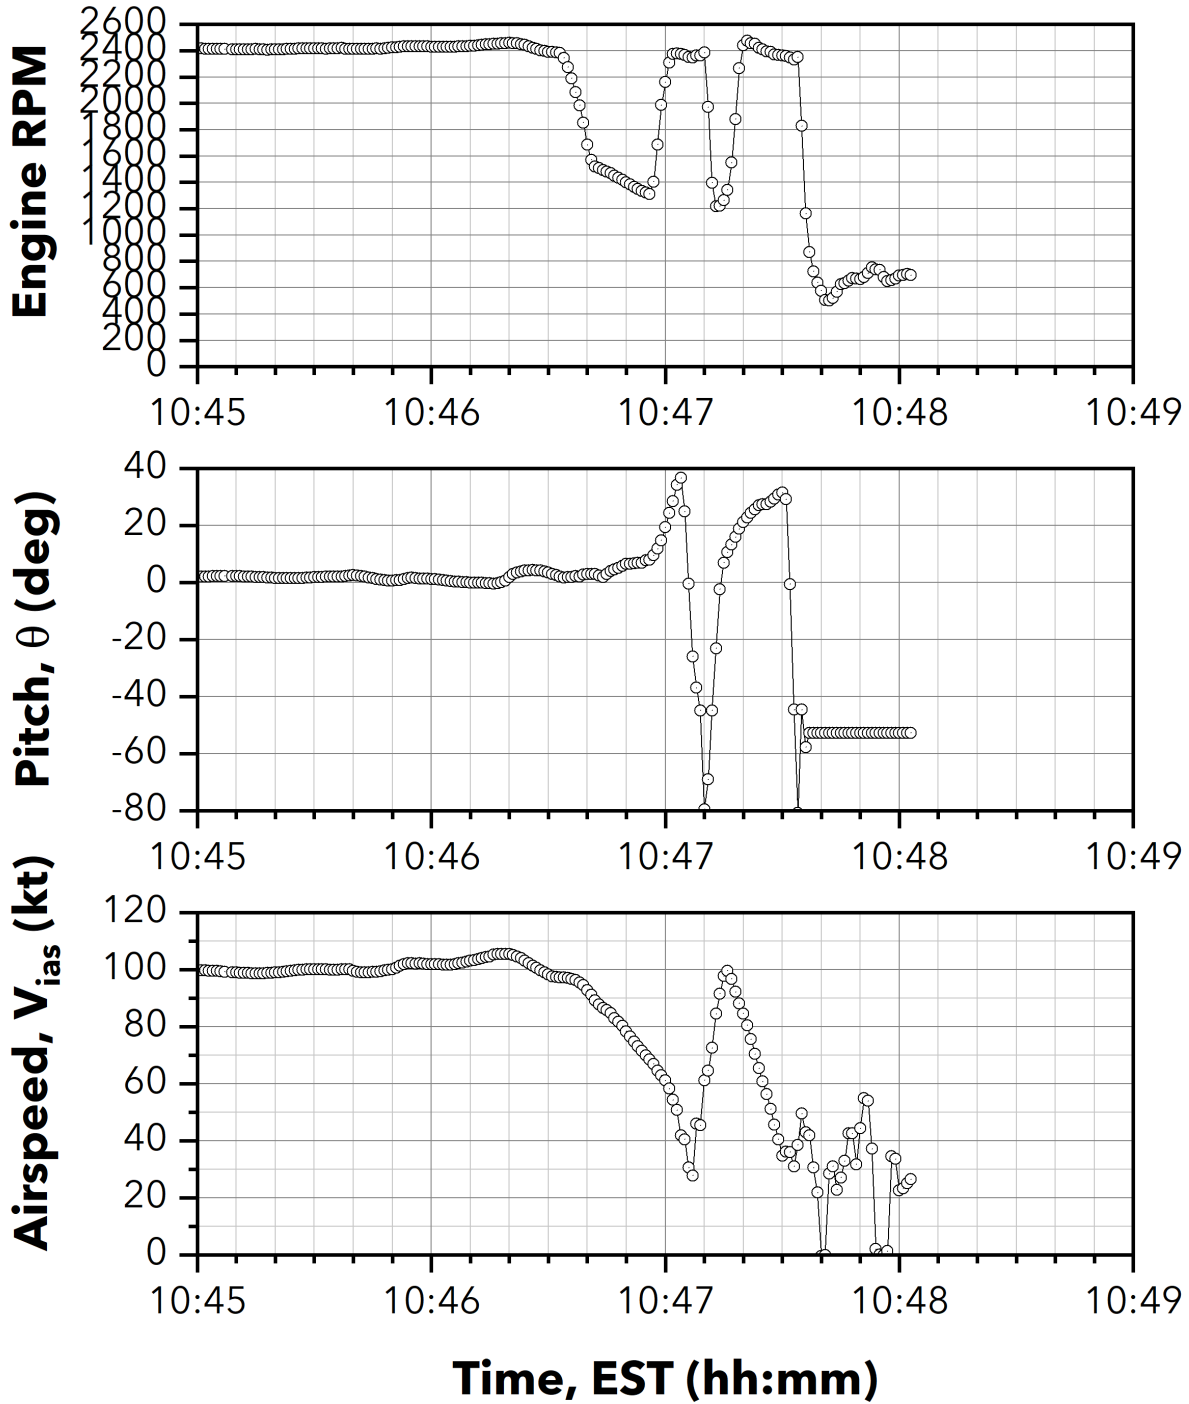
At 1046:30, the airspeed began to decay as the result of a power reduction from about 2,400 revolutions/min (rpm) to 1,300 rpm around the same time. Shortly before 1047, the airplane began to pitch nose-up, ultimately reaching a maximum pitch attitude of approximately 37° at 1047:04 as the airspeed slowed to 28 kt indicated¹. See Figures 4 through 7.

Figure 4: Power, Pitch, and Airspeed for Final Three Minutes

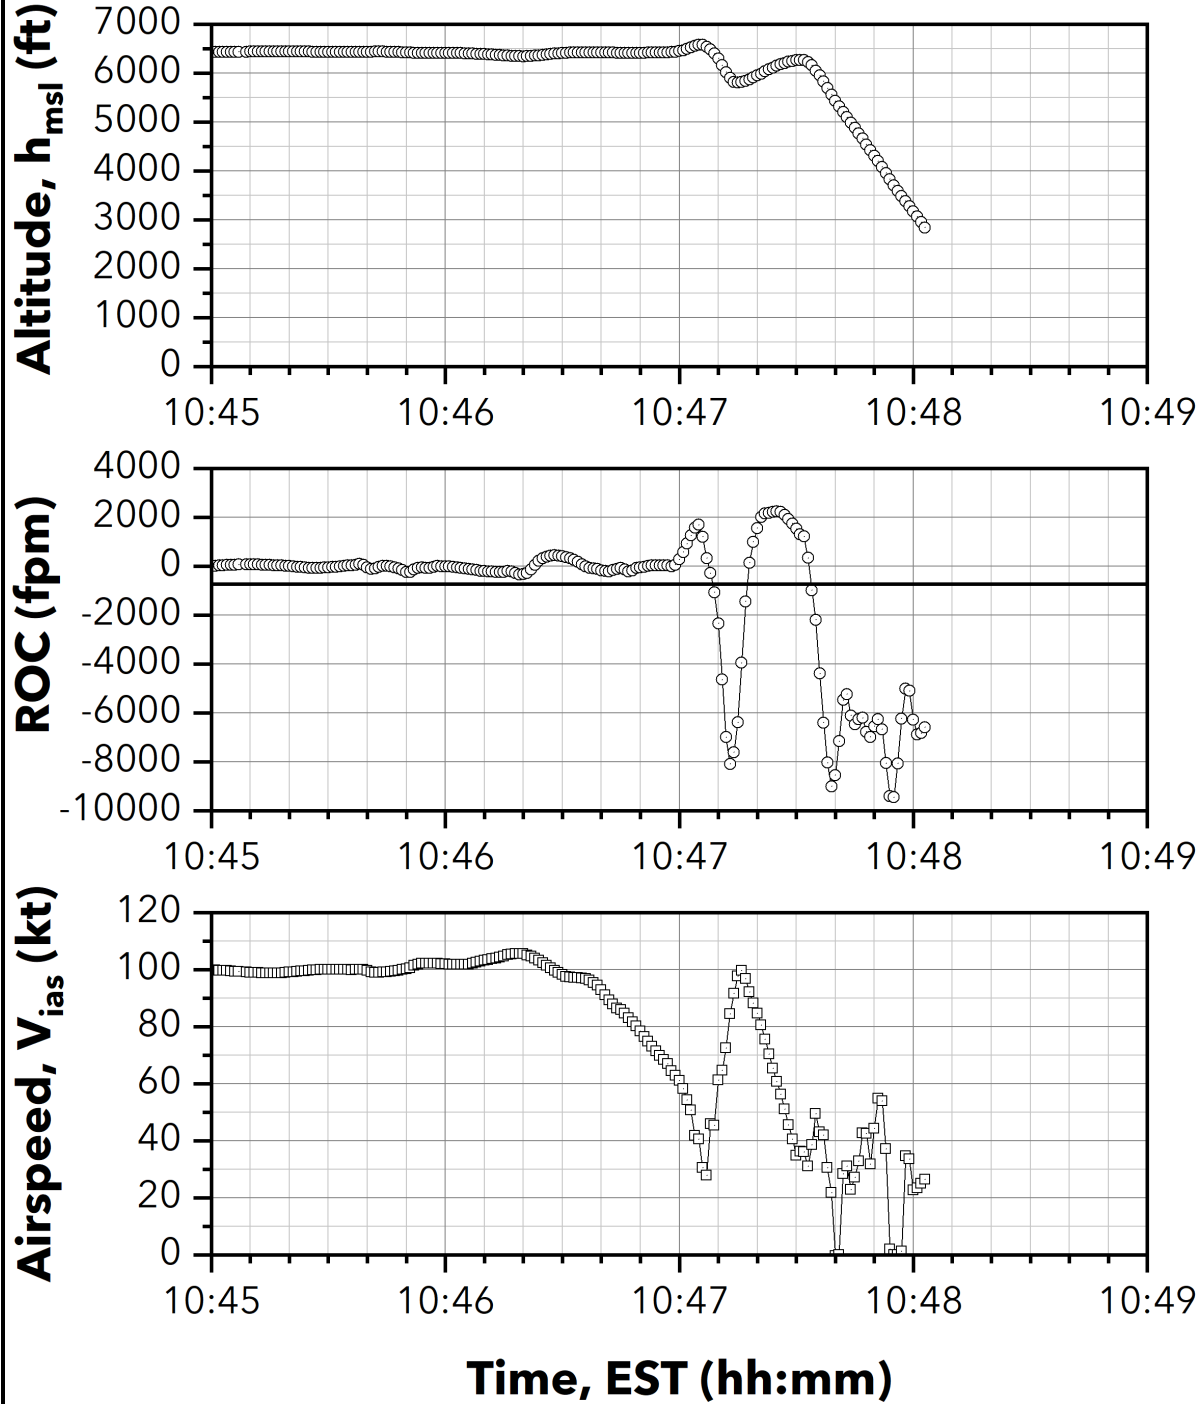
At 1047:10, the airplane reached a left-wing-down bank angle of 102° and a nose-down pitch attitude of 79°. The G1000 recorded the airplane's decent rate at over 8,000 ft/min three seconds later.

The recorded airplane data indicate that the pilot made a recovery attempt between 1047:10 and 1047:30. The pitch attitude increased to 32°, the rate of climb (ROC) increased to over 2,000 ft/min, and the airplane was wings-level for the 20 seconds as power was increased to 2,400 rpm. However, airspeed only momentarily recovered at 1047:16.

Figure 5: Recorded Altitude, ROC and Indicated Airspeed for Final Three Minutes

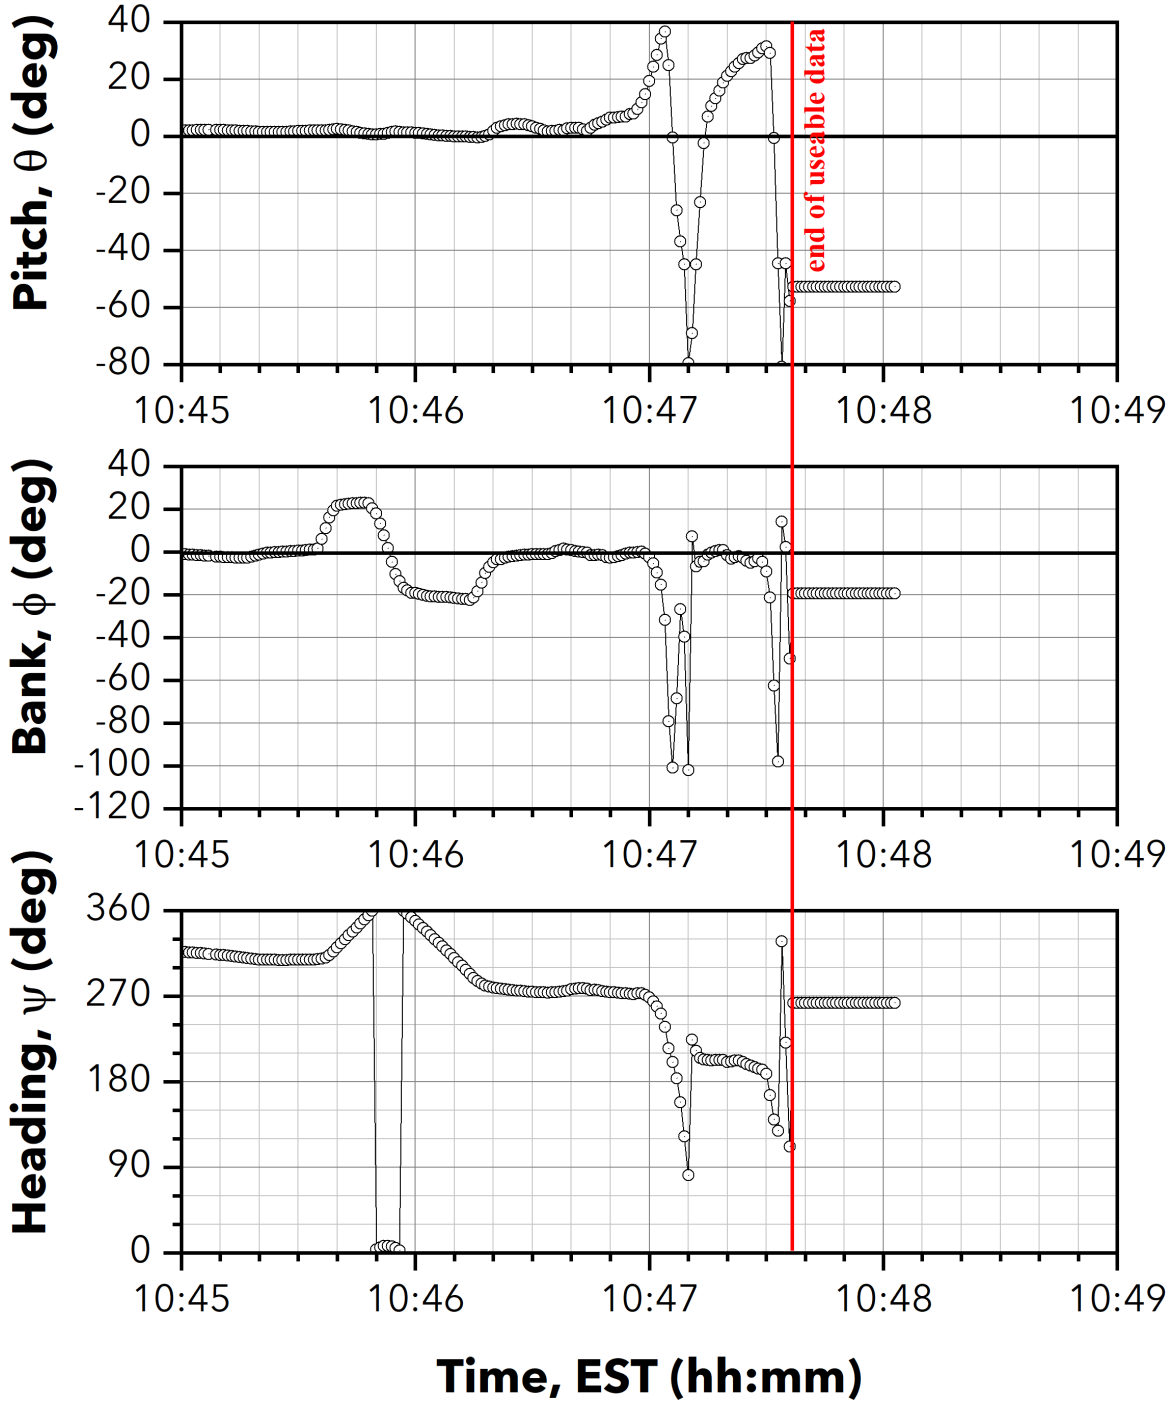
Figure 6: Recorded Pitch, Bank, and Heading Angles for Final Three Minutes

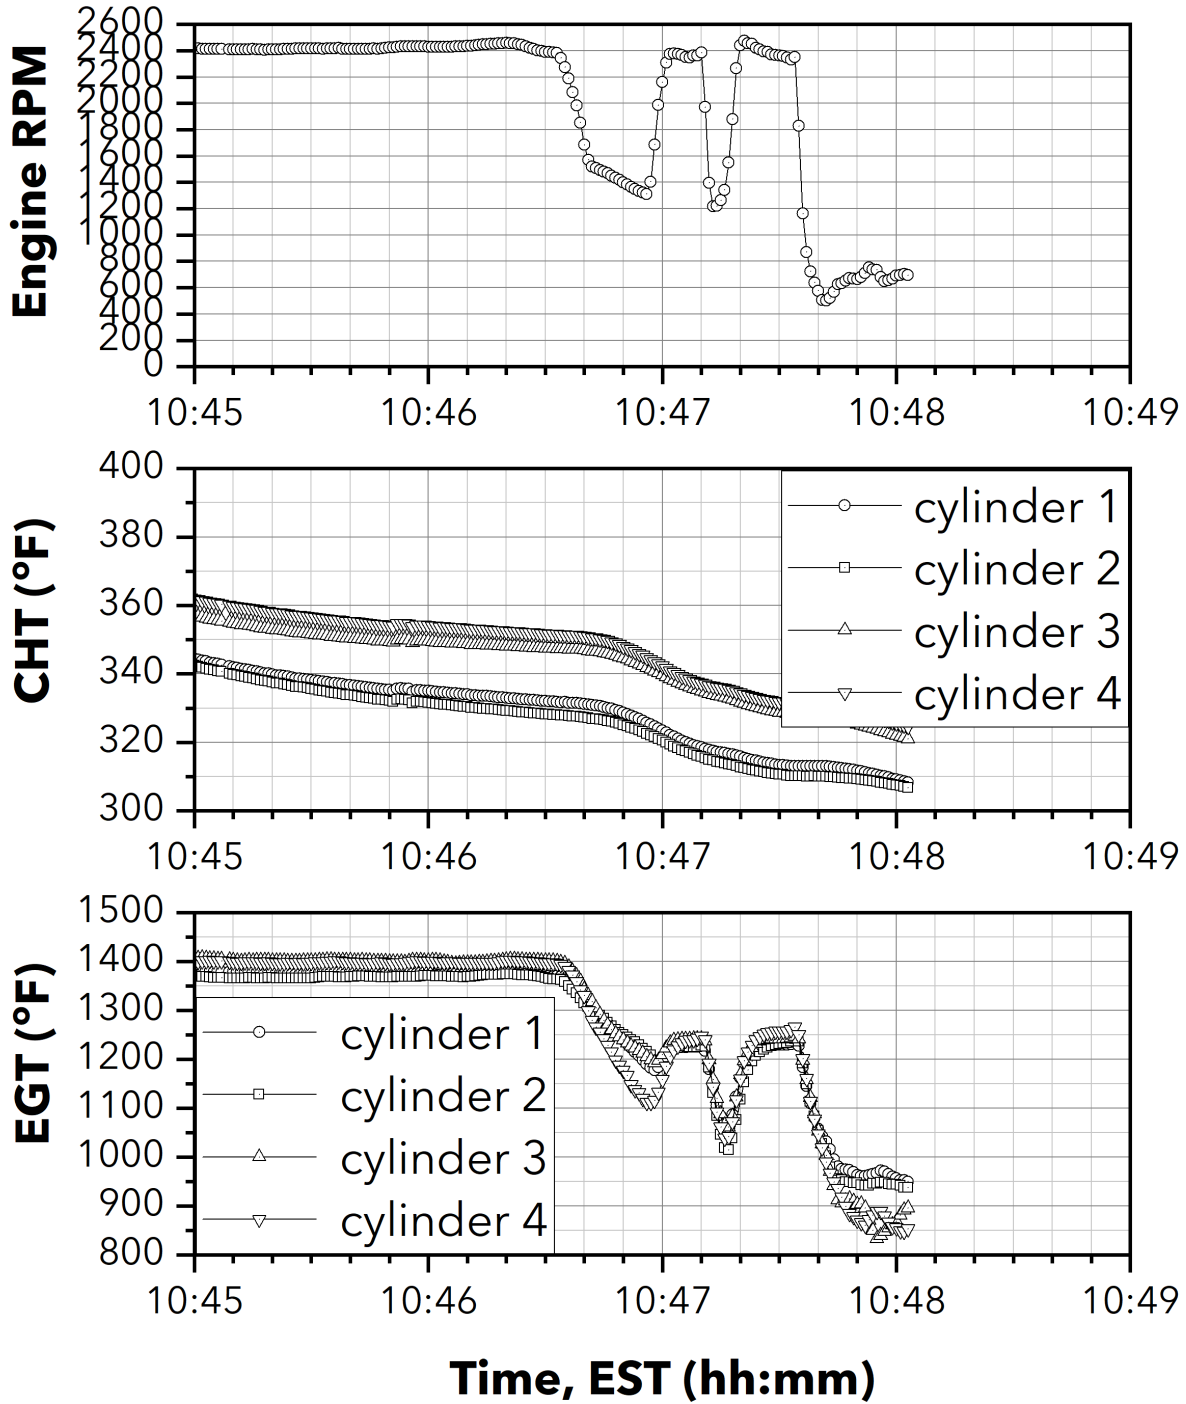
Figure 7: Recorded Engine Parameters for Final Three Minutes

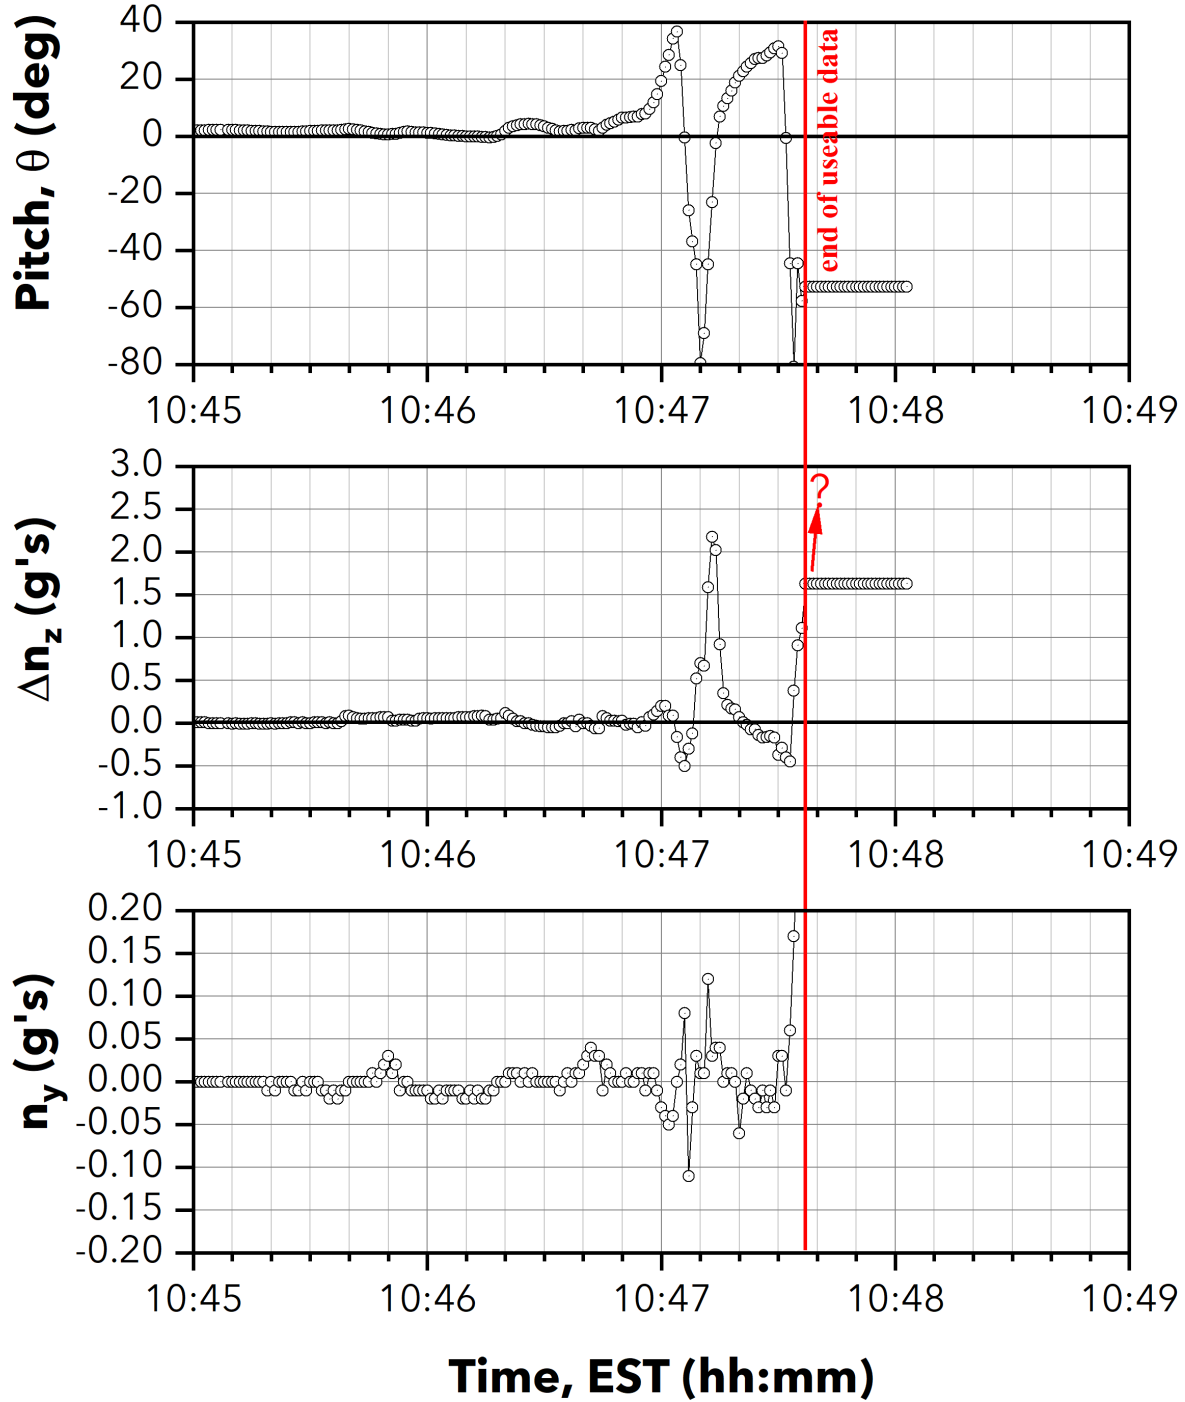
Both normal and lateral load factors for most of the final three minutes of the flight are shown in Figure 7. However, the G1000 did not capture load factors for the final seconds of the flight, likely due to buffering between volatile and non-volatile memory². Also note that normal acceleration is typically around 1g in cruise flight, but the normal acceleration recorded by the G1000 system is an increment relative to 1g.

It is unknown if high normal load factors experienced by the pilot played a role in the accident. The normal load factor recorded by the G1000 was over 3g's and increasing when the device stopped updating.

Figure 8: Recorded Normal and Lateral Load Factors for Final Three Minutes
