National Transportation Safety Board

ERA22FA149

AIRWORTHINESS FACTUAL REPORT

Location: Panama City, Florida
Date: March 8, 2022
Time: 1846 central standard time
0046 UTC
Airplane: Cessna 182, N182XT

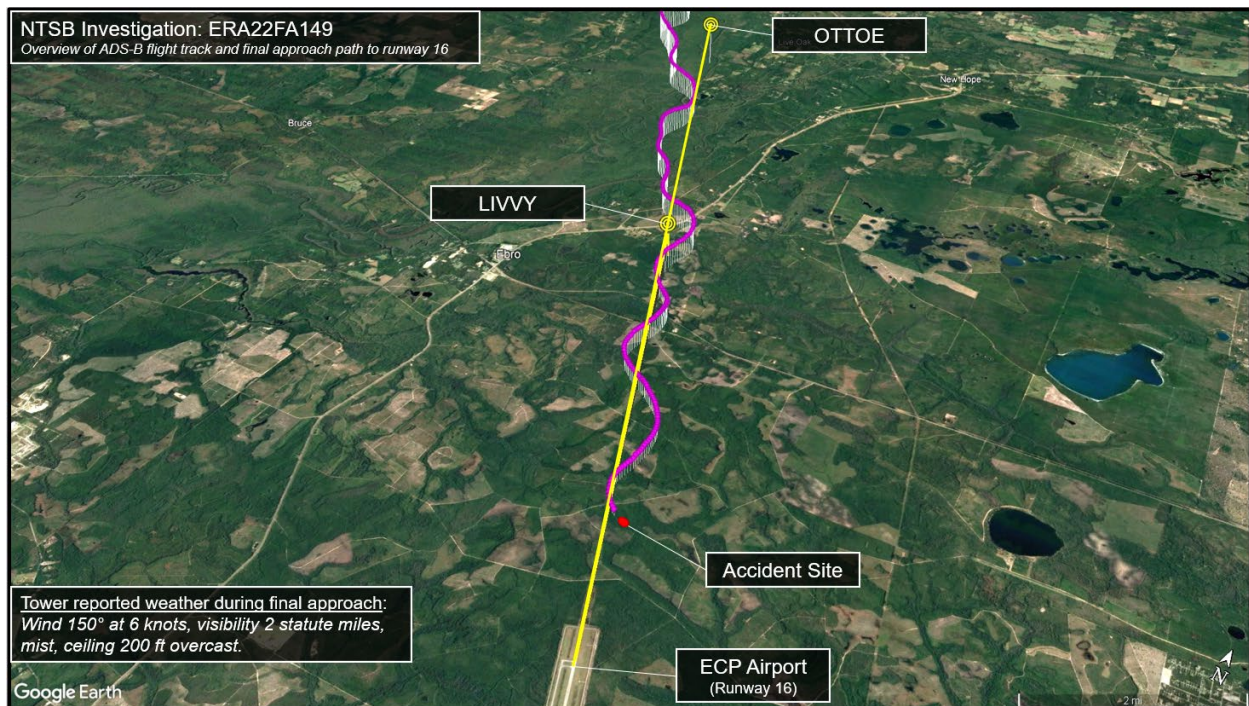
Figure 1: Overview of the final approach path for the ILS runway 16 approach at ECP Airport and the airplane's ADS-B track.

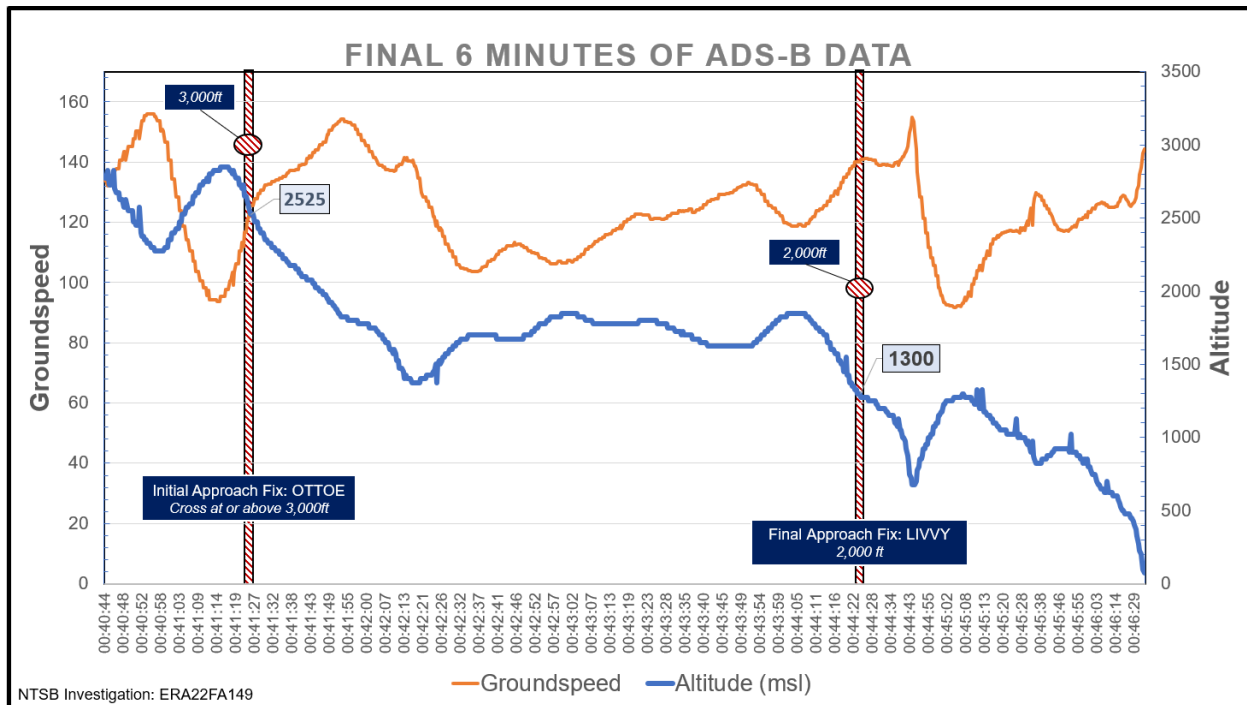
Figure 2: Final six minutes of ADS-B altitude and groundspeed data overlaid with waypoint information pertaining to the ECP ILS Runway 16 approach.

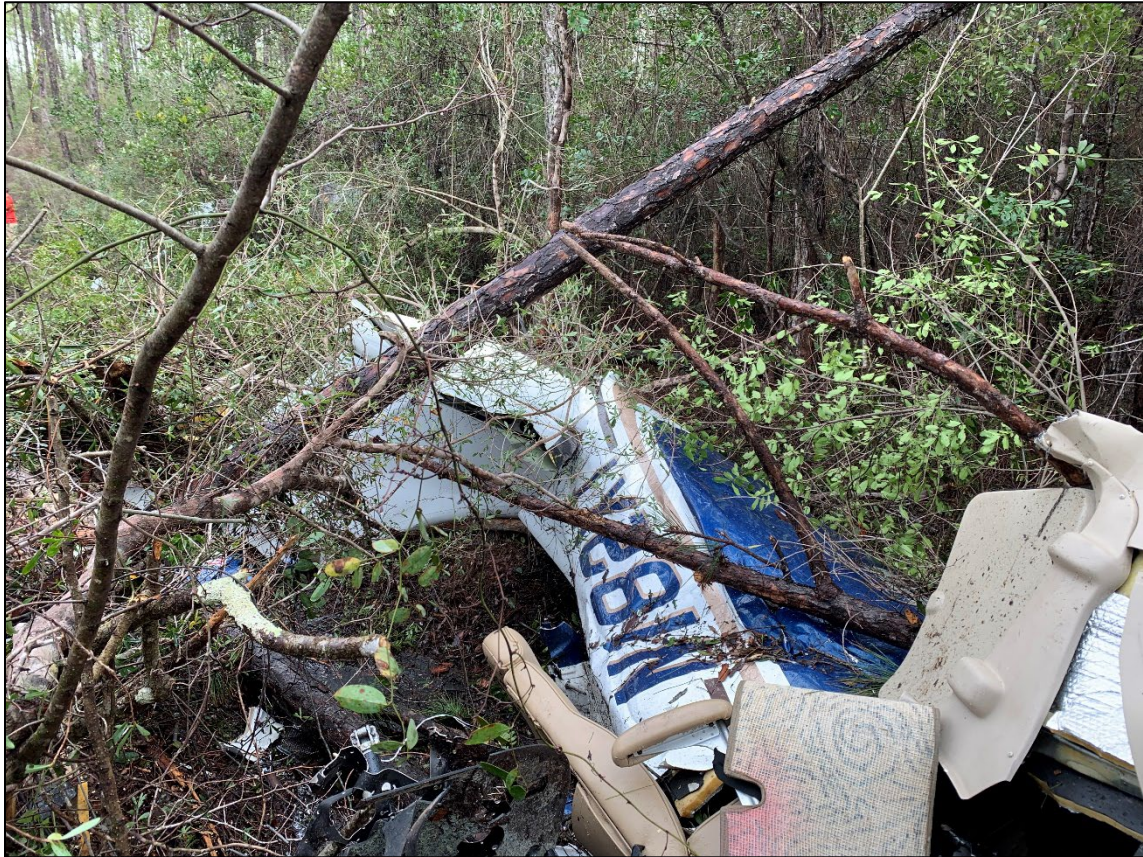
The fuselage had fragmented aft of the baggage area to the empennage. The horizontal and vertical stabilizers, elevator, and rudder remained attached to the fuselage. The elevator trim remained attached and measured approximately 1 inch and 5/8ths, which correlated to about 10° trailing edge up (nose up elevator trim).

Photo 1: Overview of the empennage

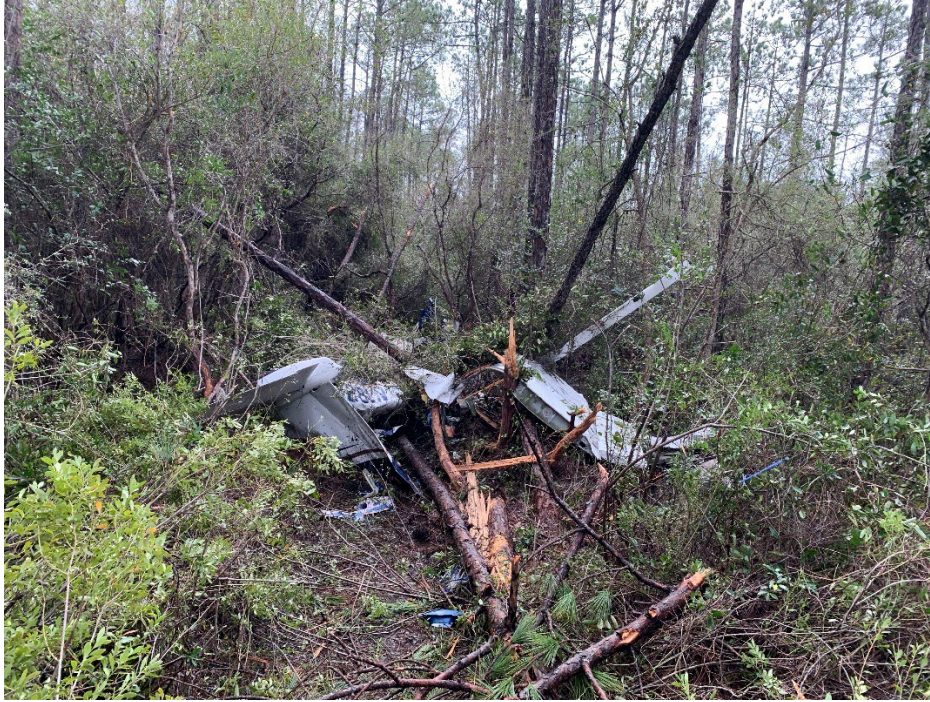
Photo 2: View of the empennage and fragments of wing

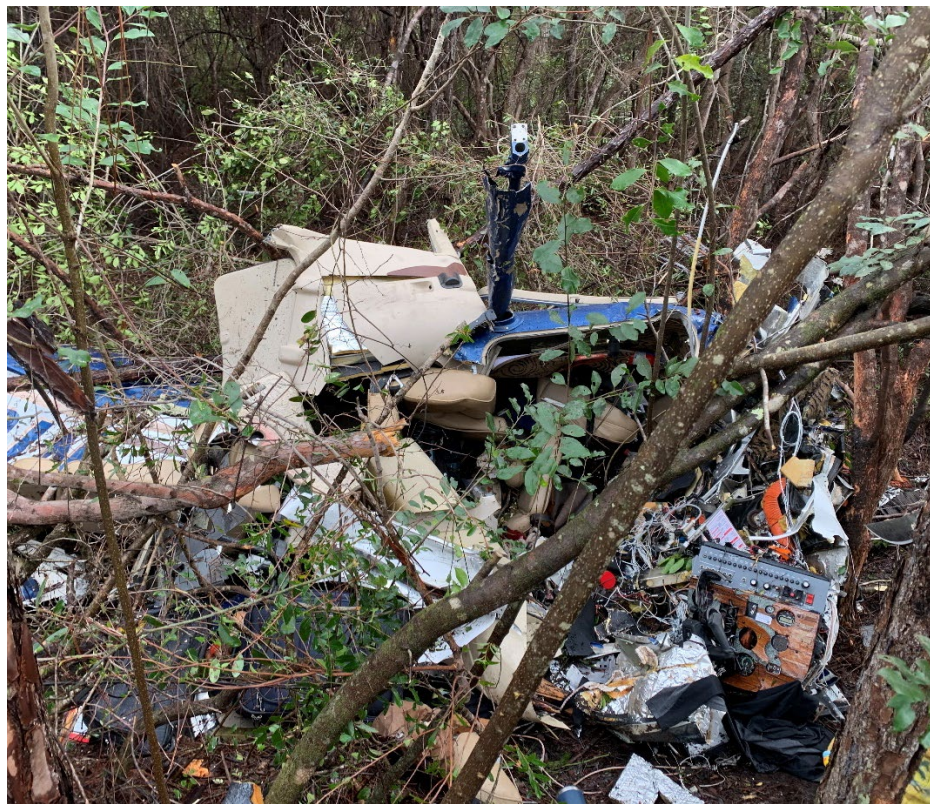
Photo 3: View of the fragmented cockpit area

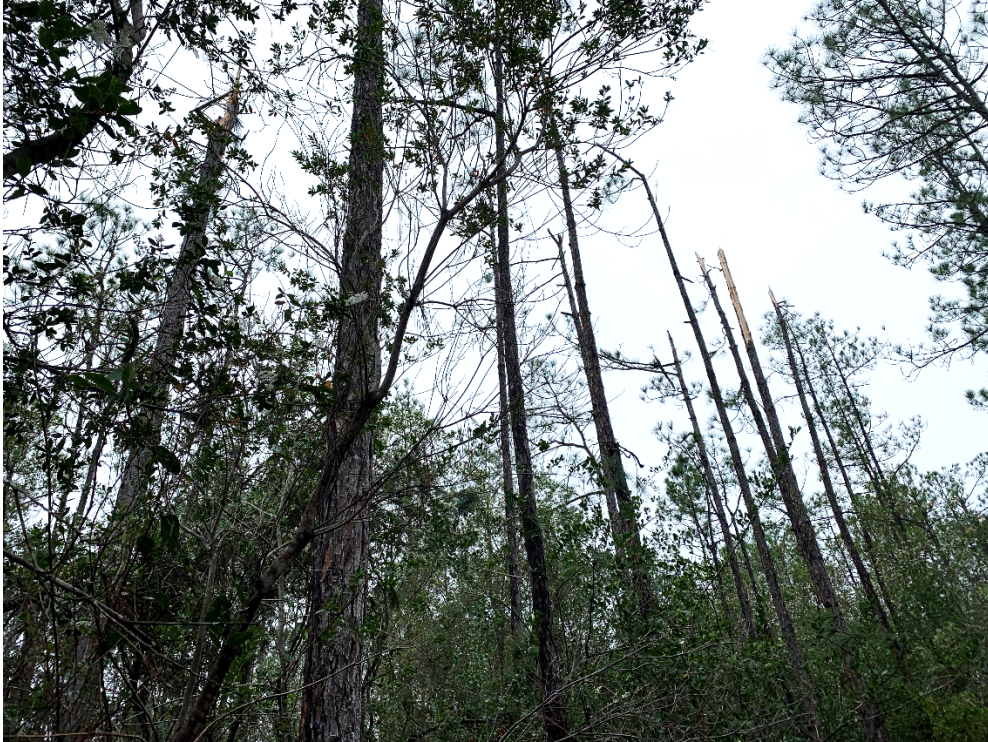
The wreckage was highly fragmented and was oriented on a debris path of about 145° magnetic heading. It came to rest inverted in heavily wooded terrain and brush. The initial impact was associated with trees and fragments of wreckage that remained fixed in the trees. Several trees were struck in the debris path, which corresponded to about an 18-20° descent angle from the initial impact to the main wreckage. The main wreckage was located about 1.55nm from the runway 16 threshold.

Photo 4: View of multiple trees displaying impact related damage.

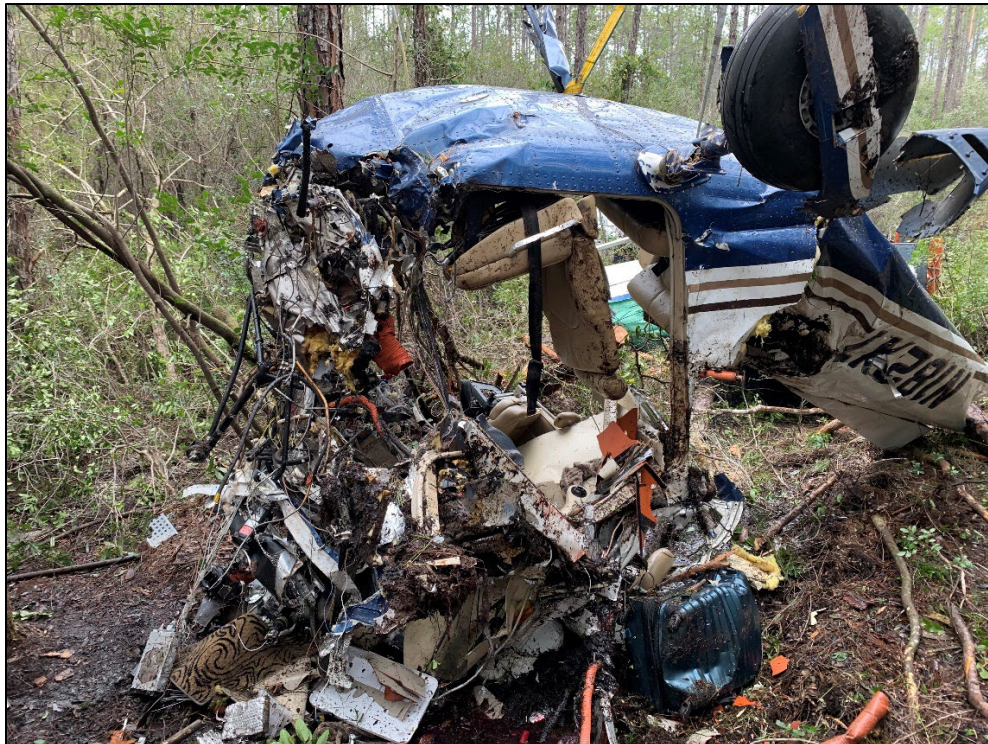
Photo 5: View of the cockpit and fuselage during recovery operations

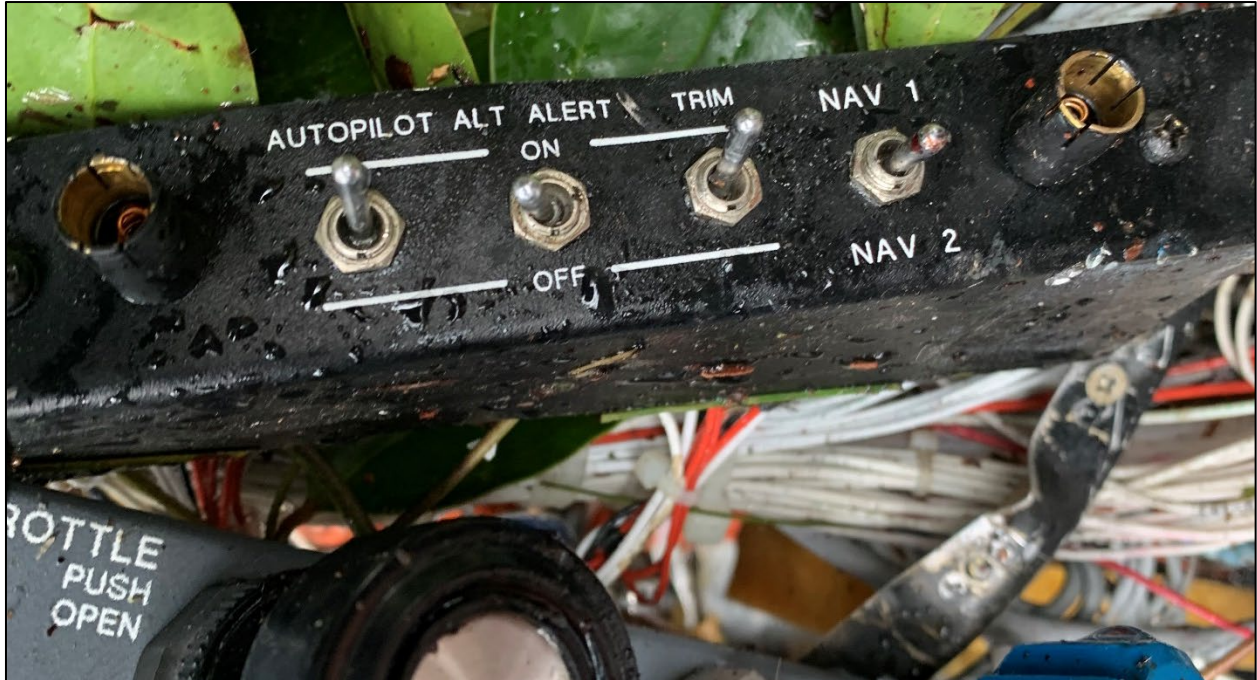
A second autopilot mode control panel had fragmented, sustained significant impact damage, and was loose in the cockpit. The autopilot ON/ OFF toggle switch was found on. The altitude alert ON/ OFF toggle switch was found in a middle position that did not correspond to any setting. The ON/ OFF trim was found on, and the NAV 1/2 was found in the NAV2 position.

Photo 6: View of the autopilot, altitude alerter, and elevator trim ON/ OFF mode control panel

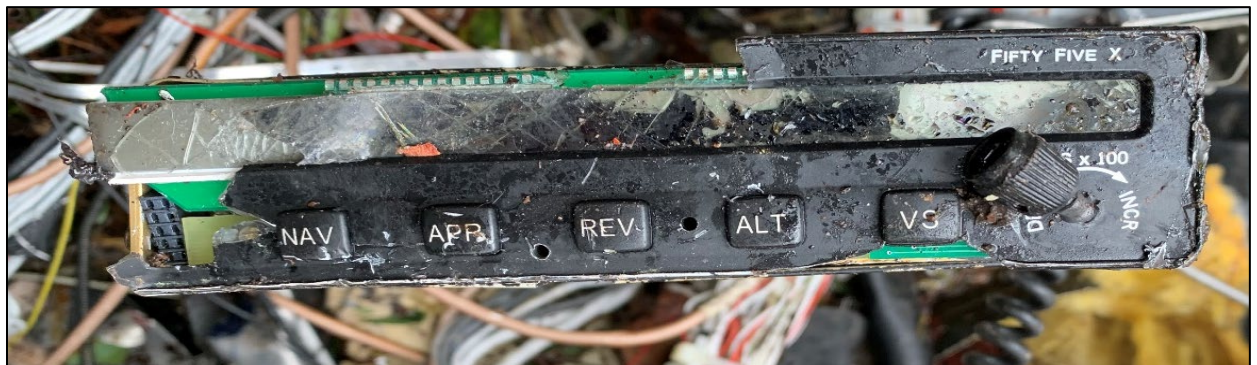
An S-TEC 55 X autopilot mode control unit was found loose in the cockpit and displayed significant impact damage. An S-TEC altitude alerter was found separated in the cockpit with impact damage. In the tail compartment near the ELT an S-TEC component contained venting tubes and electrical wires, which remained connected to the unit.

Photo 7: View of the autopilot STEC-55X mode control panel

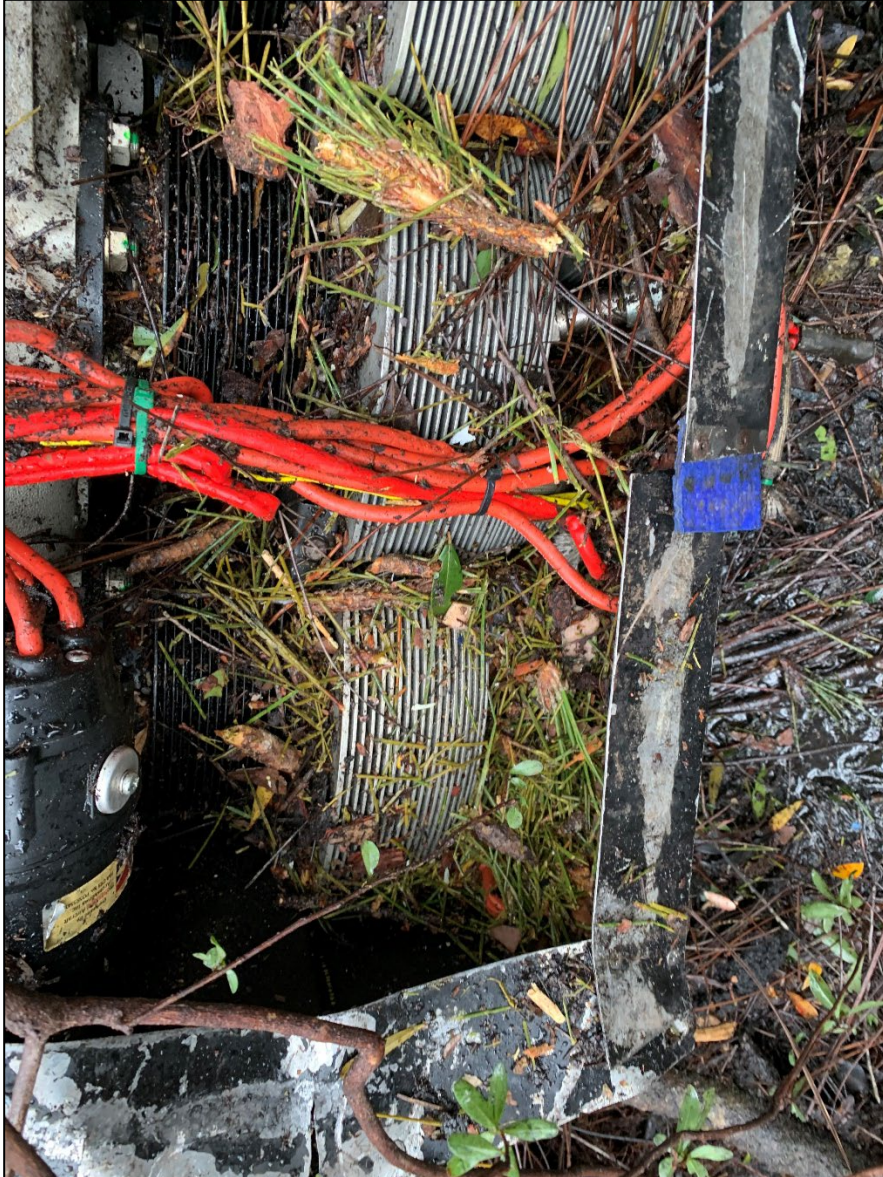
The engine sustained impact damage, most concentrated in the forward left and underside of its casing. It had separated from its mounts and airframe and was found a few feet forward of the cockpit. Evidence of fresh cut pine tree branches were observed covering the rear top cylinders.

Photo 8: View of small chopped up pine tree debris located spread across the top and rear of the engine.

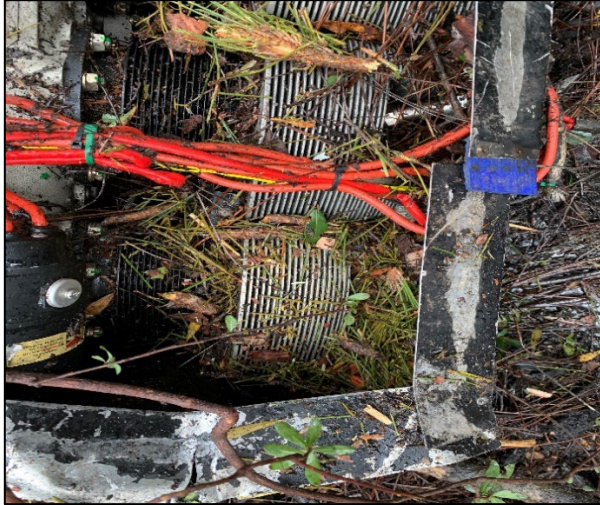
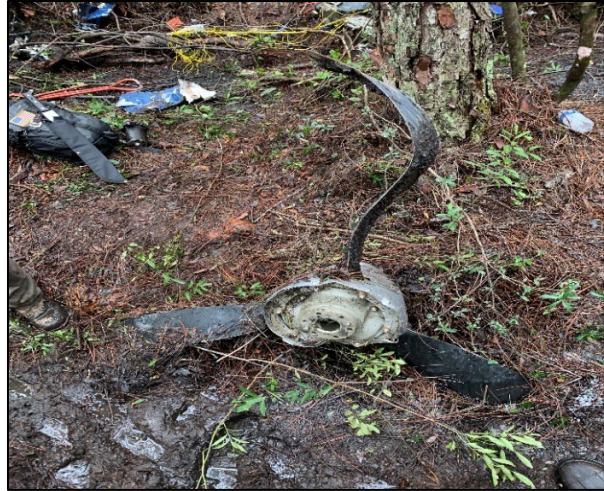
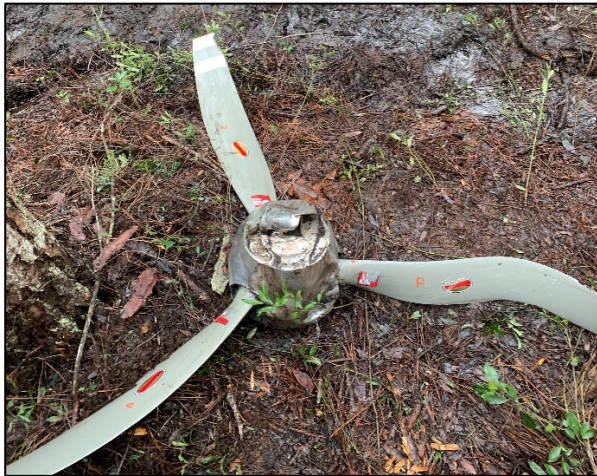
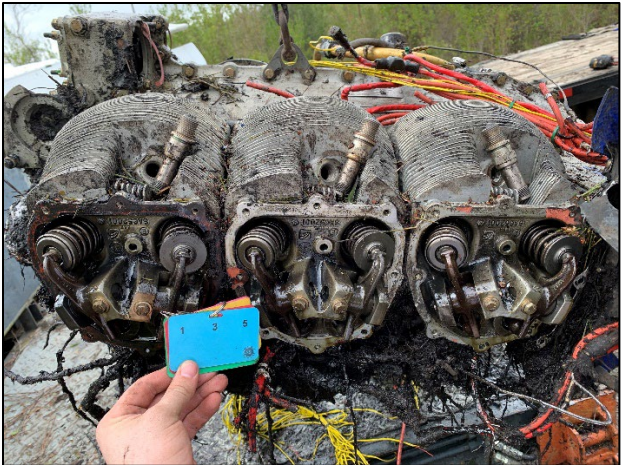
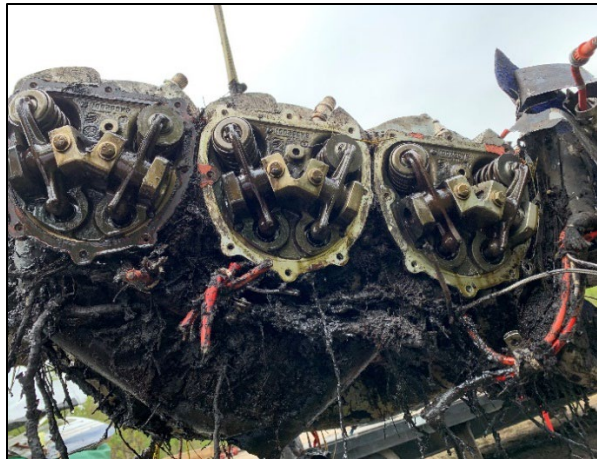
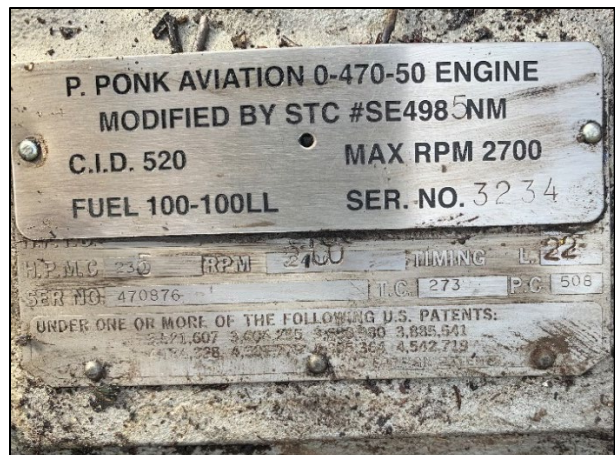
The three bladed propeller had sheared from the propeller flange and was located a few feet forward of the main wreckage. The blades exhibited varying degrees of blade polishing, leading edge gouging, chordwise scratches, s-bending, and torsional twisting.

Photos 9-14: View of the engine, propeller, at the accident site
