National Transportation Safety Board

ERA22FA279

OPERATIONAL FACTORS

Group Chair's Factual Report

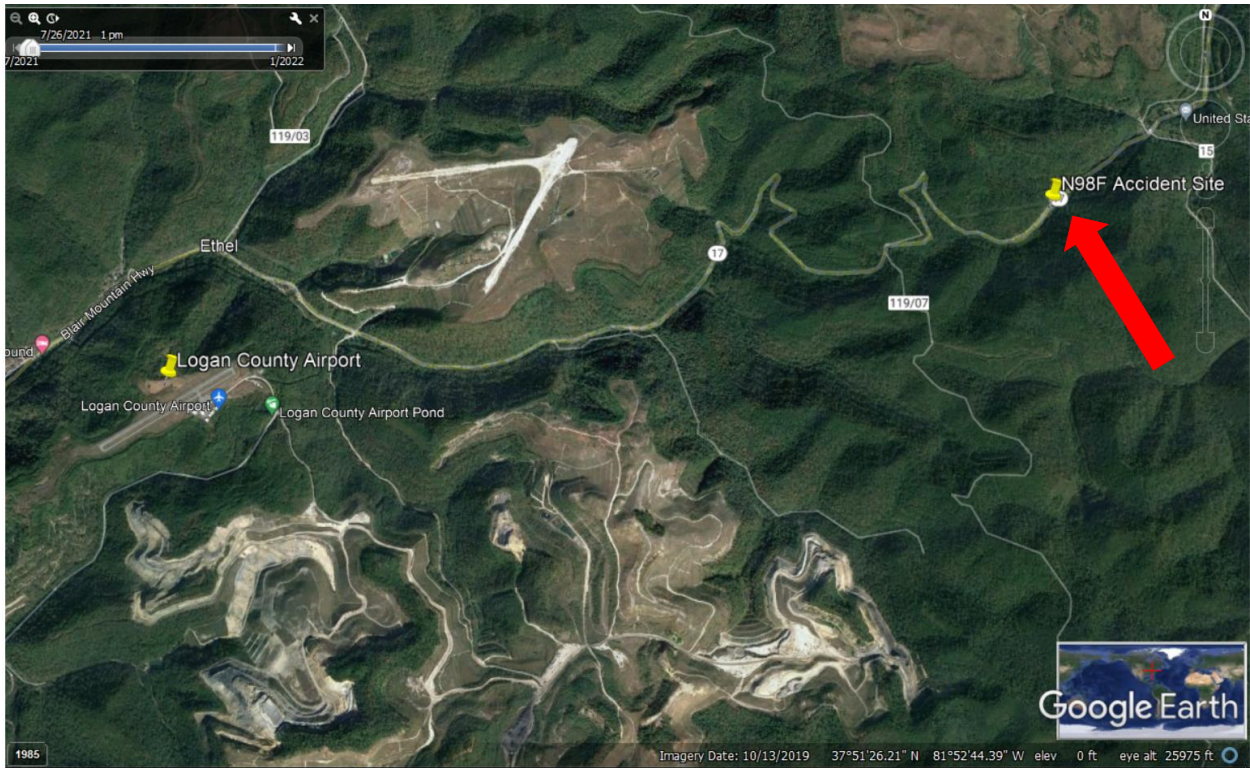
Figure 8: Google Earth image showing N98F accident site (red arrow).⁵¹

⁵¹ The accident location was approximately 1 1/2 miles to the east of the 15-minute route's most eastern leg. Elevation of the accident site was 1,167 ft above mean sea level. The investigation found numerous YouTube videos of N98F flight operating within the valleys of West Virginia surrounding Logan County Airport. For example, see <https://www.youtube.com/watch?v=rJp1xt2X2AY&t=711s> and https://www.youtube.com/watch?v=3l_D33DXGe4.
