# National Transportation Safety Board

ERA22FA399

## **VEHICLE PERFORMANCE**

Location: Bay City, Wisconsin  
Date: September 6, 2022  
Time: 1325 CDT  
1825 GMT  
Airplane: Experimental Glasair Super II SFT, N11HC

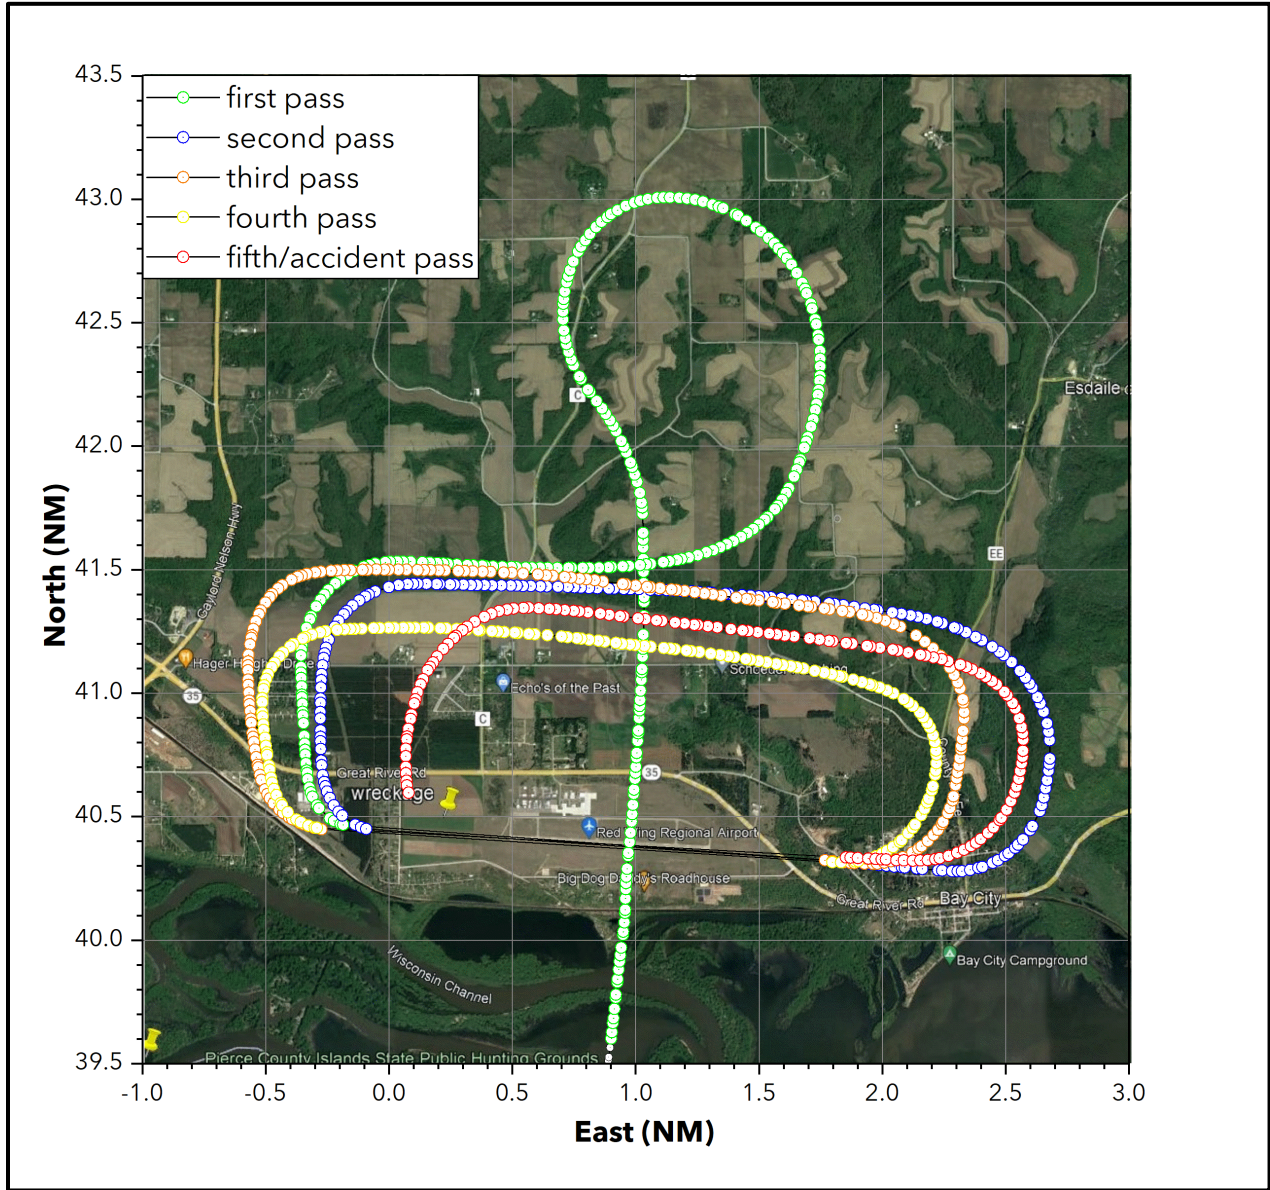
The flight departed from Rochester Regional Airport (RST), Rochester, Minnesota about 1218. Following some air work, the flight proceeded to Red Wing Airport (RGK), Bay City, Wisconsin and entered left traffic for the visual airport traffic pattern to runway 9. According to Automatic Dependent Surveillance-Broadcast (ADS-B) data, four circuits of the traffic pattern were flown without landing and a fifth traffic pattern was initiated. The ADS-B data indicated that the airplane turned onto the base leg of the airport traffic pattern about 1 mile sooner than on the previous approaches. A witness reported that the airplane, while on base leg, banked sharply to the left and pointed nose down before it crashed. The airplane impacted the ground about 1/3 nautical mile (NM) west-northwest of runway 9. See Figure 1.

**Figure 1: Pattern Work in the Left Traffic Pattern to Runway 9 at Red Wing Regional Airport and Wreckage**

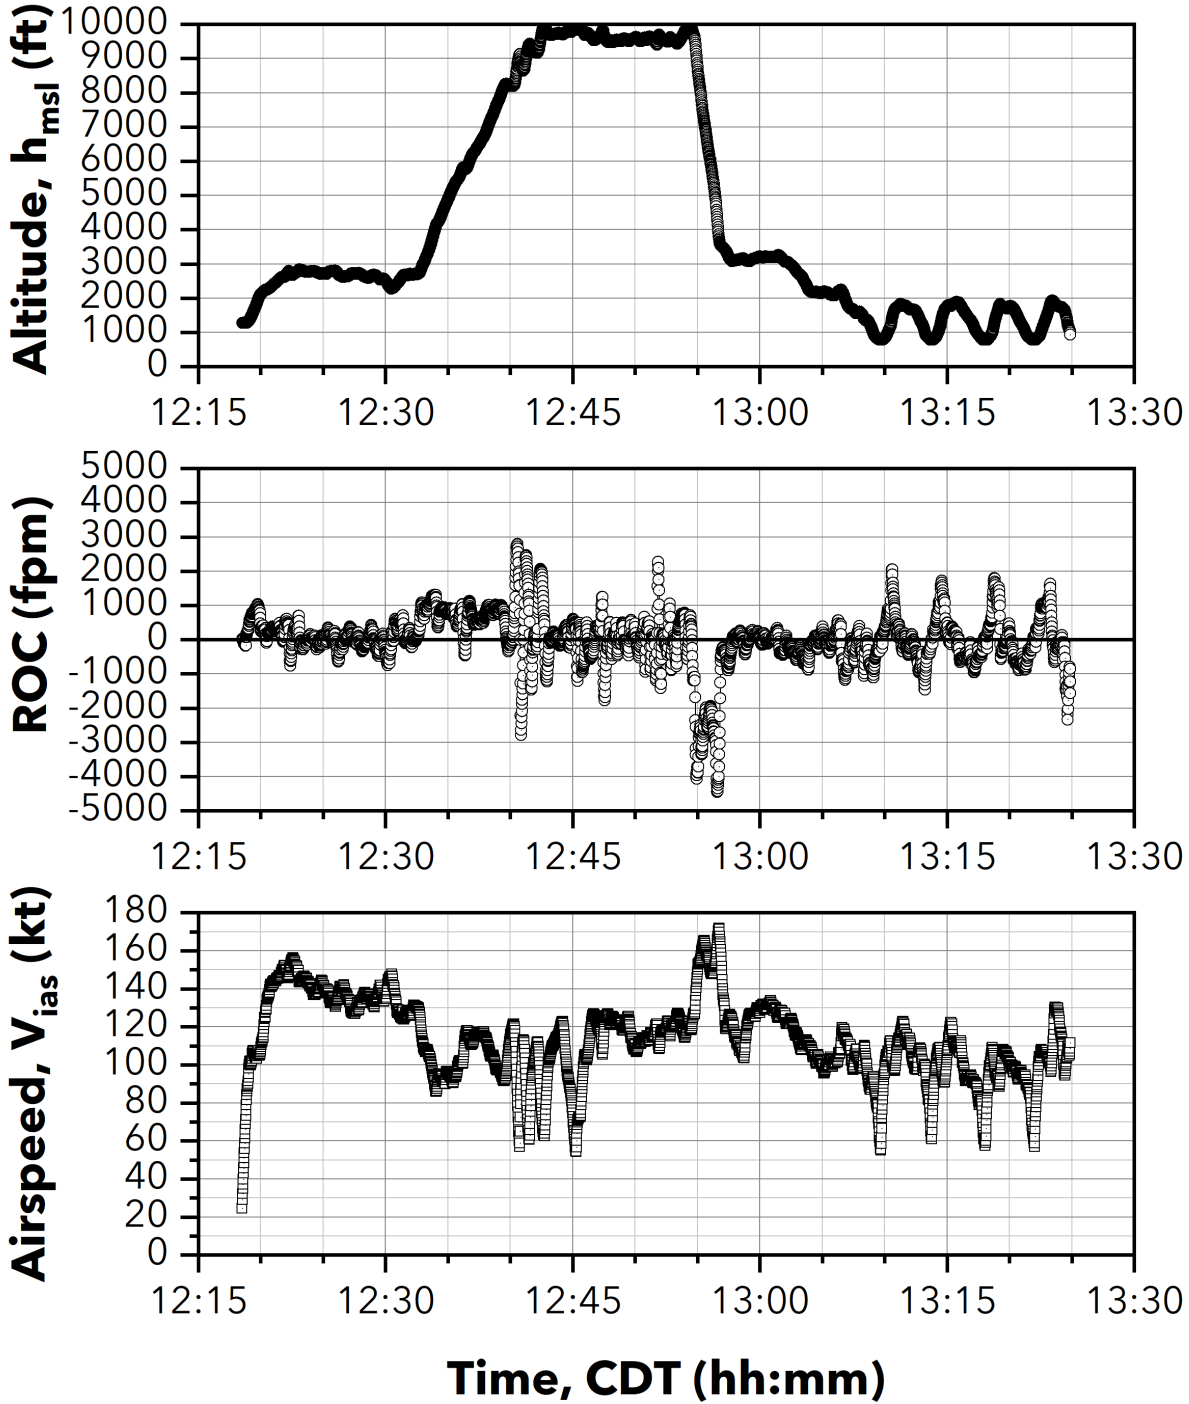
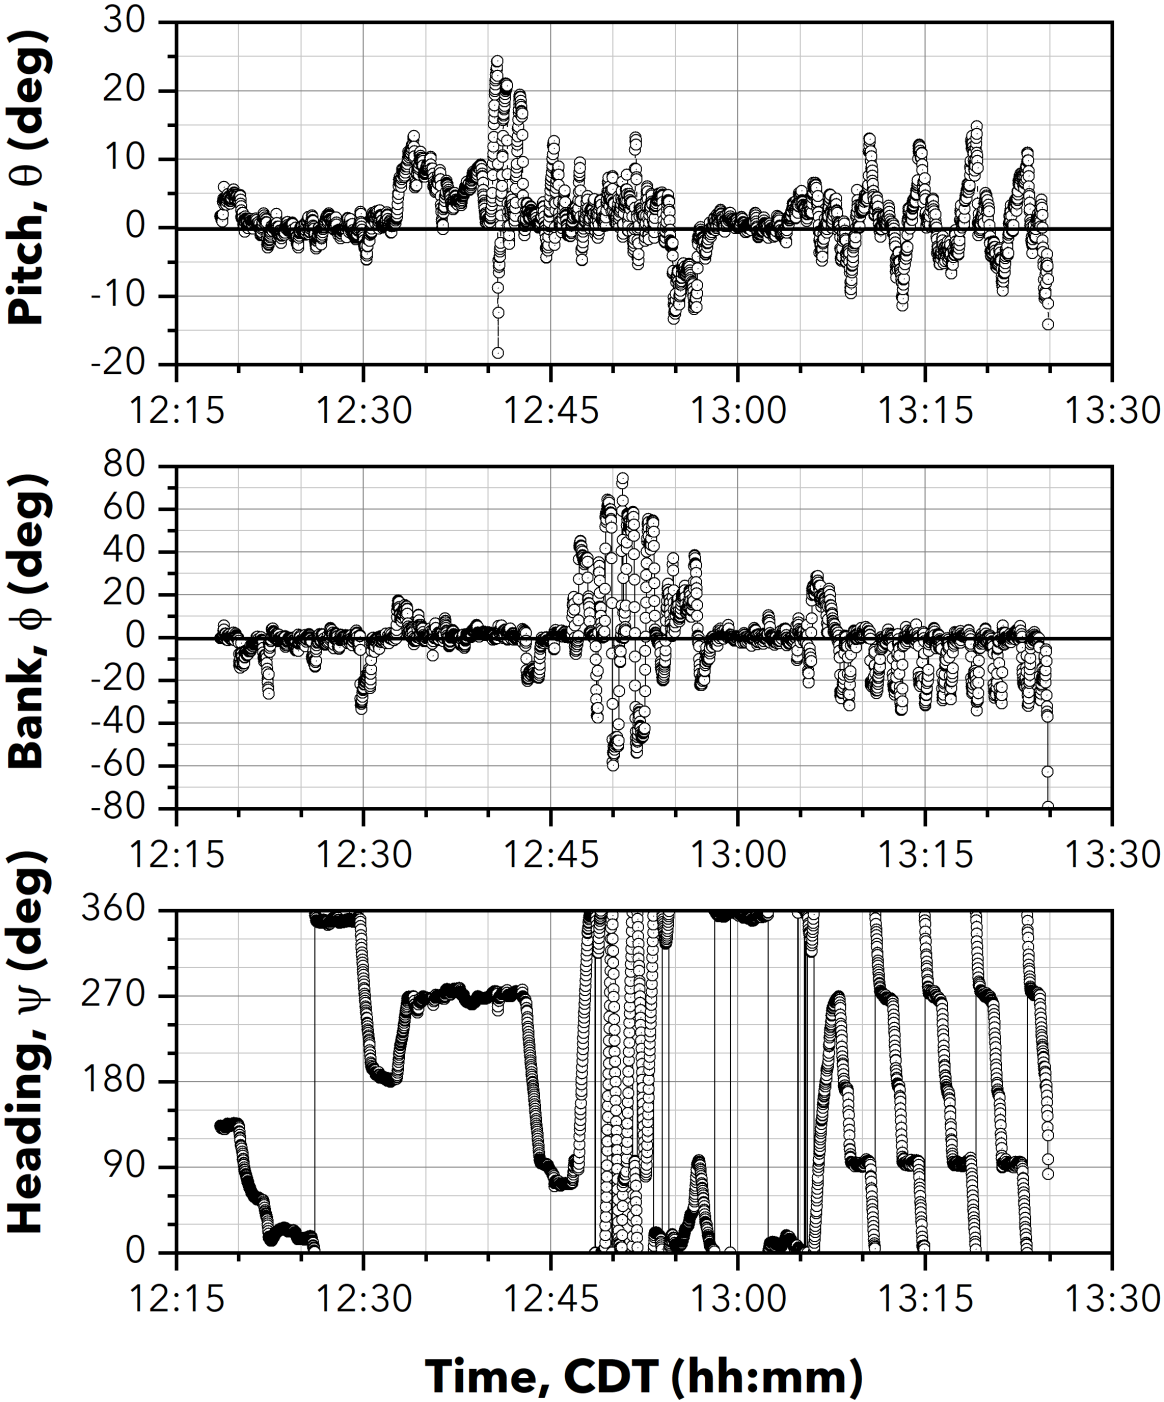
Figures 3 and 4 show G3X parameters for the entire one hour and five-minute flight. Speed and altitude information indicate that N11HC first climbed to about 10,000 ft to perform a series of level, 60°, 2g turns. The air work lasted for approximately 45 minutes. The airplane then descended at over 4,400 fpm north towards RGK for pattern work that lasted the remainder of the flight. The pilots performed four low passes and the airplane crashed on the fifth.

**Figure 3: Garmin G3X Altitude, ROC, and Airspeed for Accident Flight**

**Figure 4: Garmin G3X Pitch, Bank, and Heading Angles for Accident Flight**

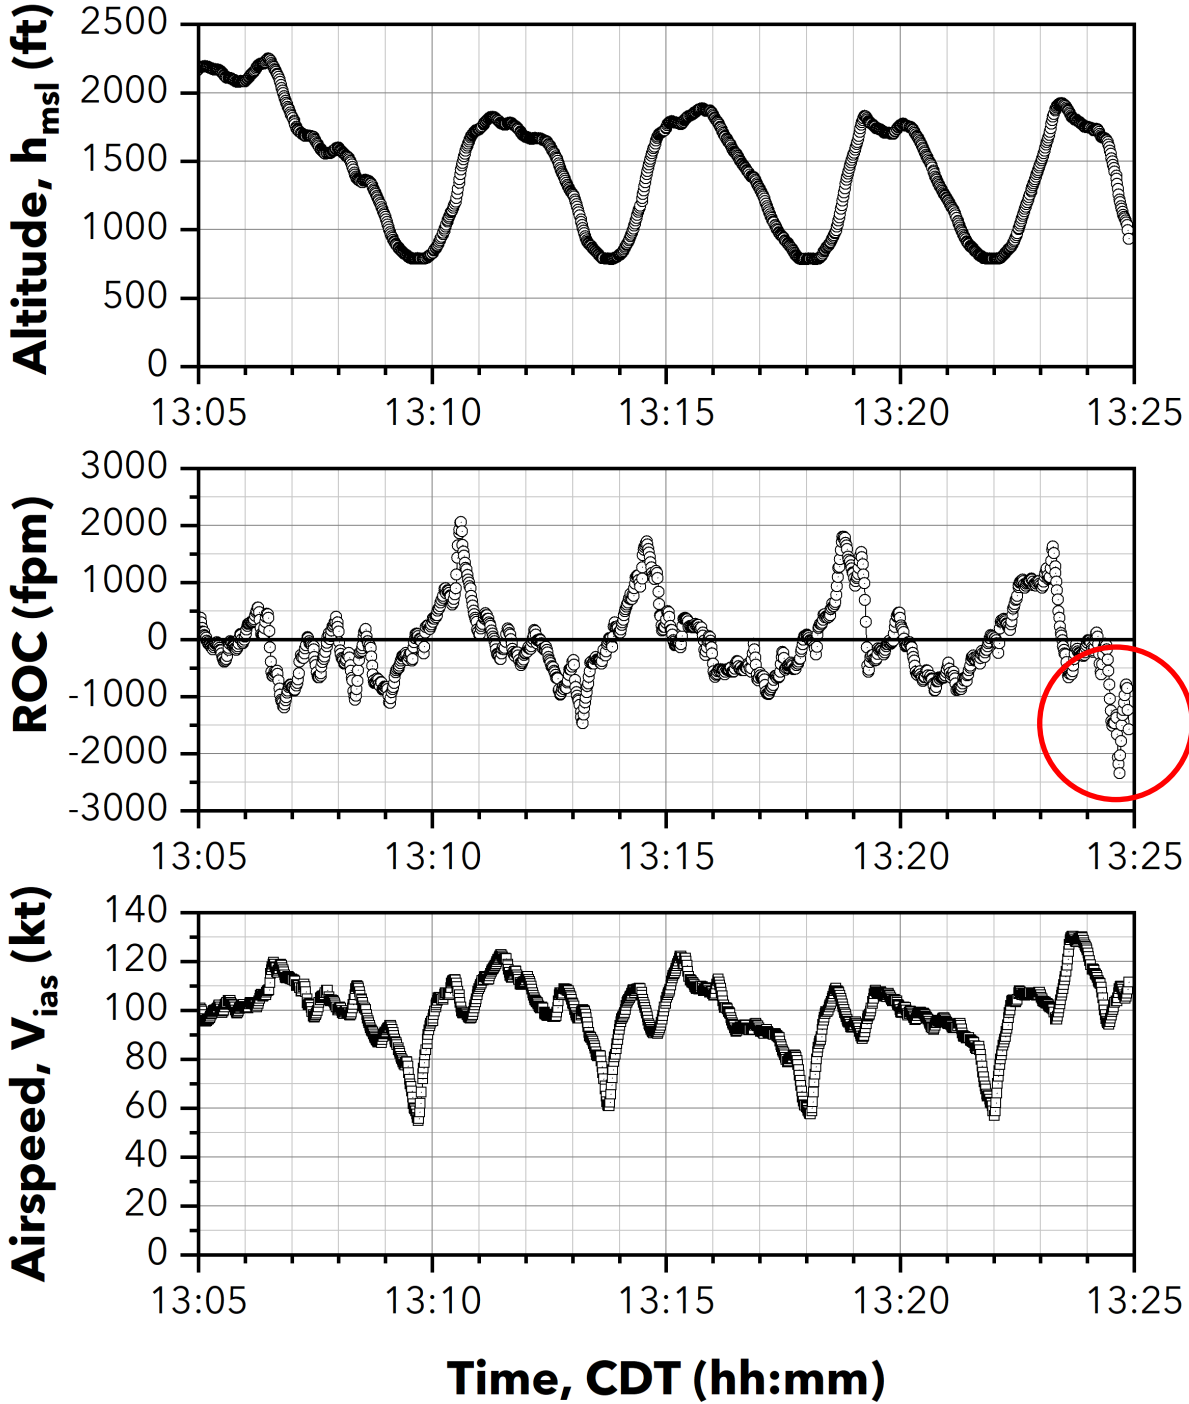
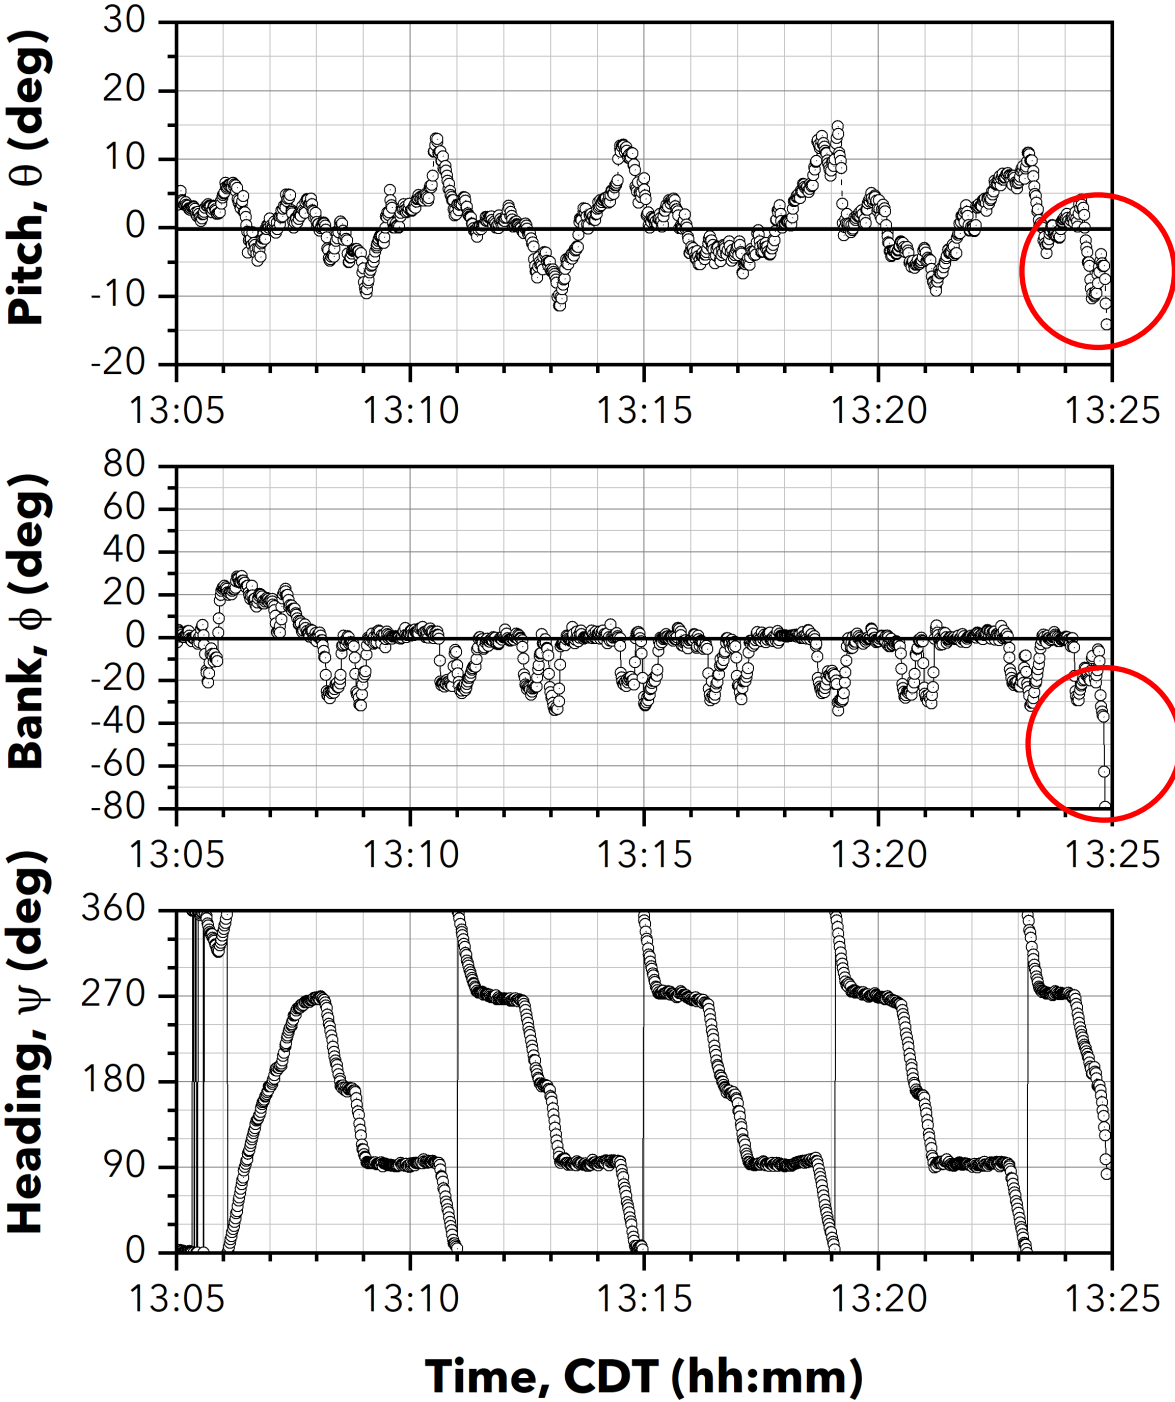
Figures 5 and 6 indicate that the fifth approach (base to final turn just prior to impact) was flown at a higher descent rate, bank angle, and pitch attitude. The descent rate approached 2,500 fpm, the left bank angle reached 100°, and the pitch attitude was 15° airplane-nose-down.

**Figure 5: Garmin G3X Altitude, ROC, and Airspeed for Pattern Work**

**Figure 6: Garmin G3X Pitch, Bank, and Heading Angles for Pattern Work**

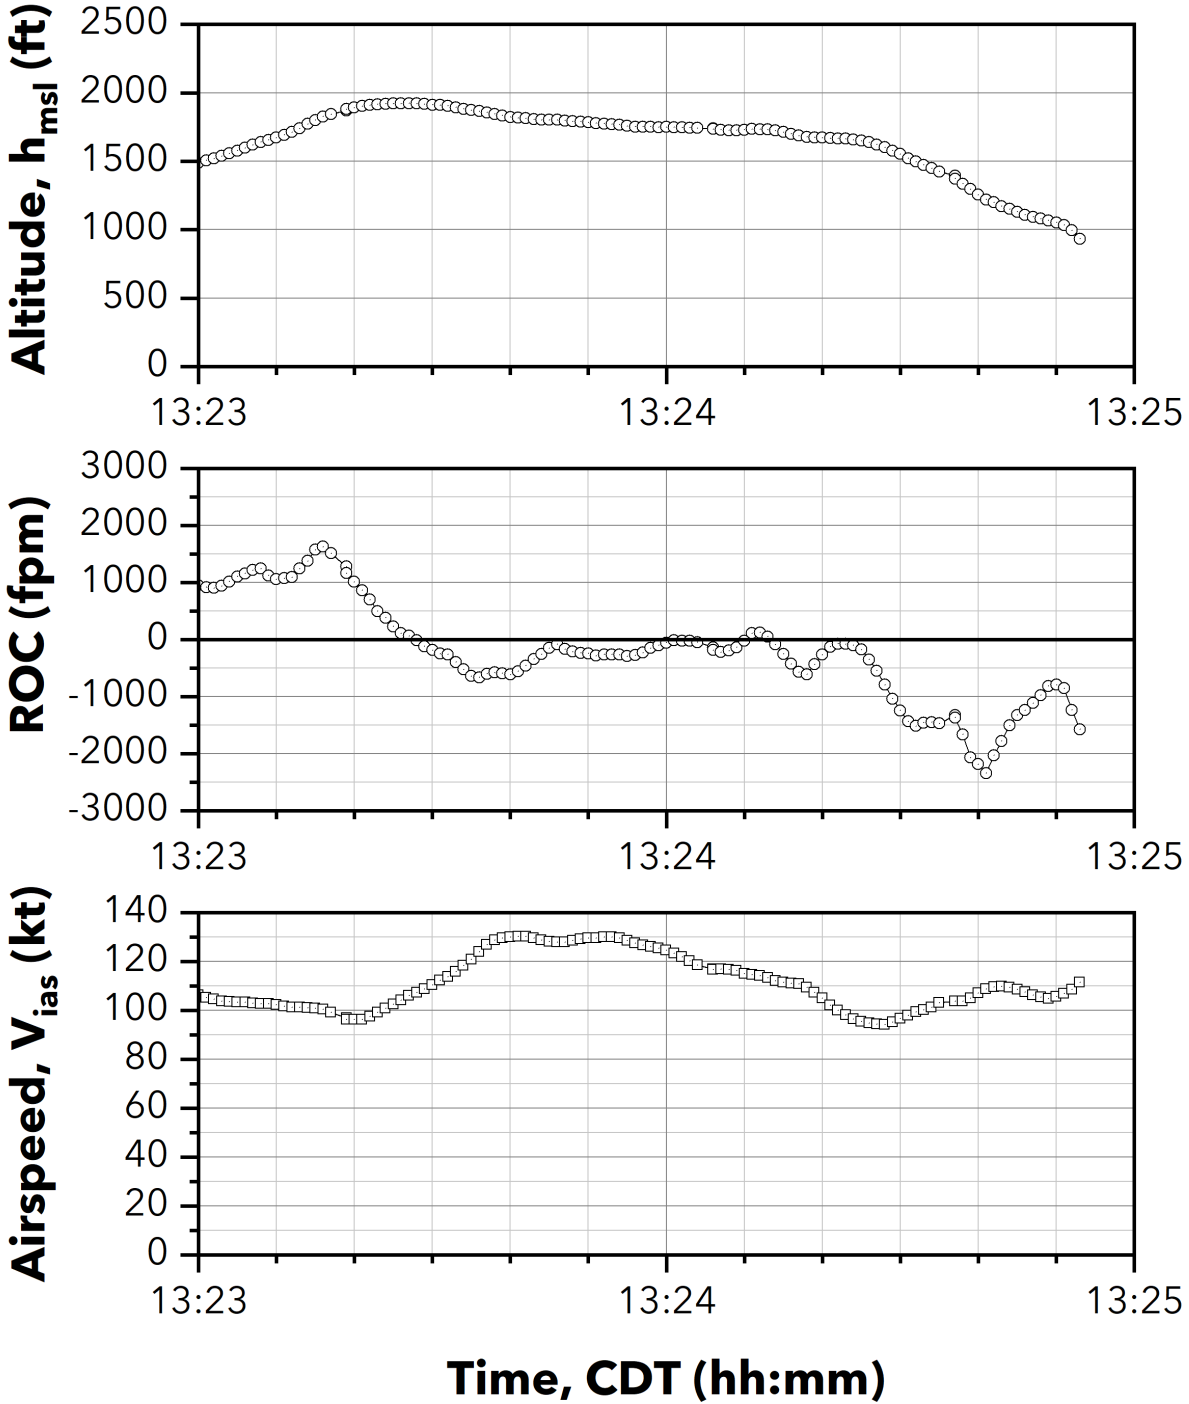
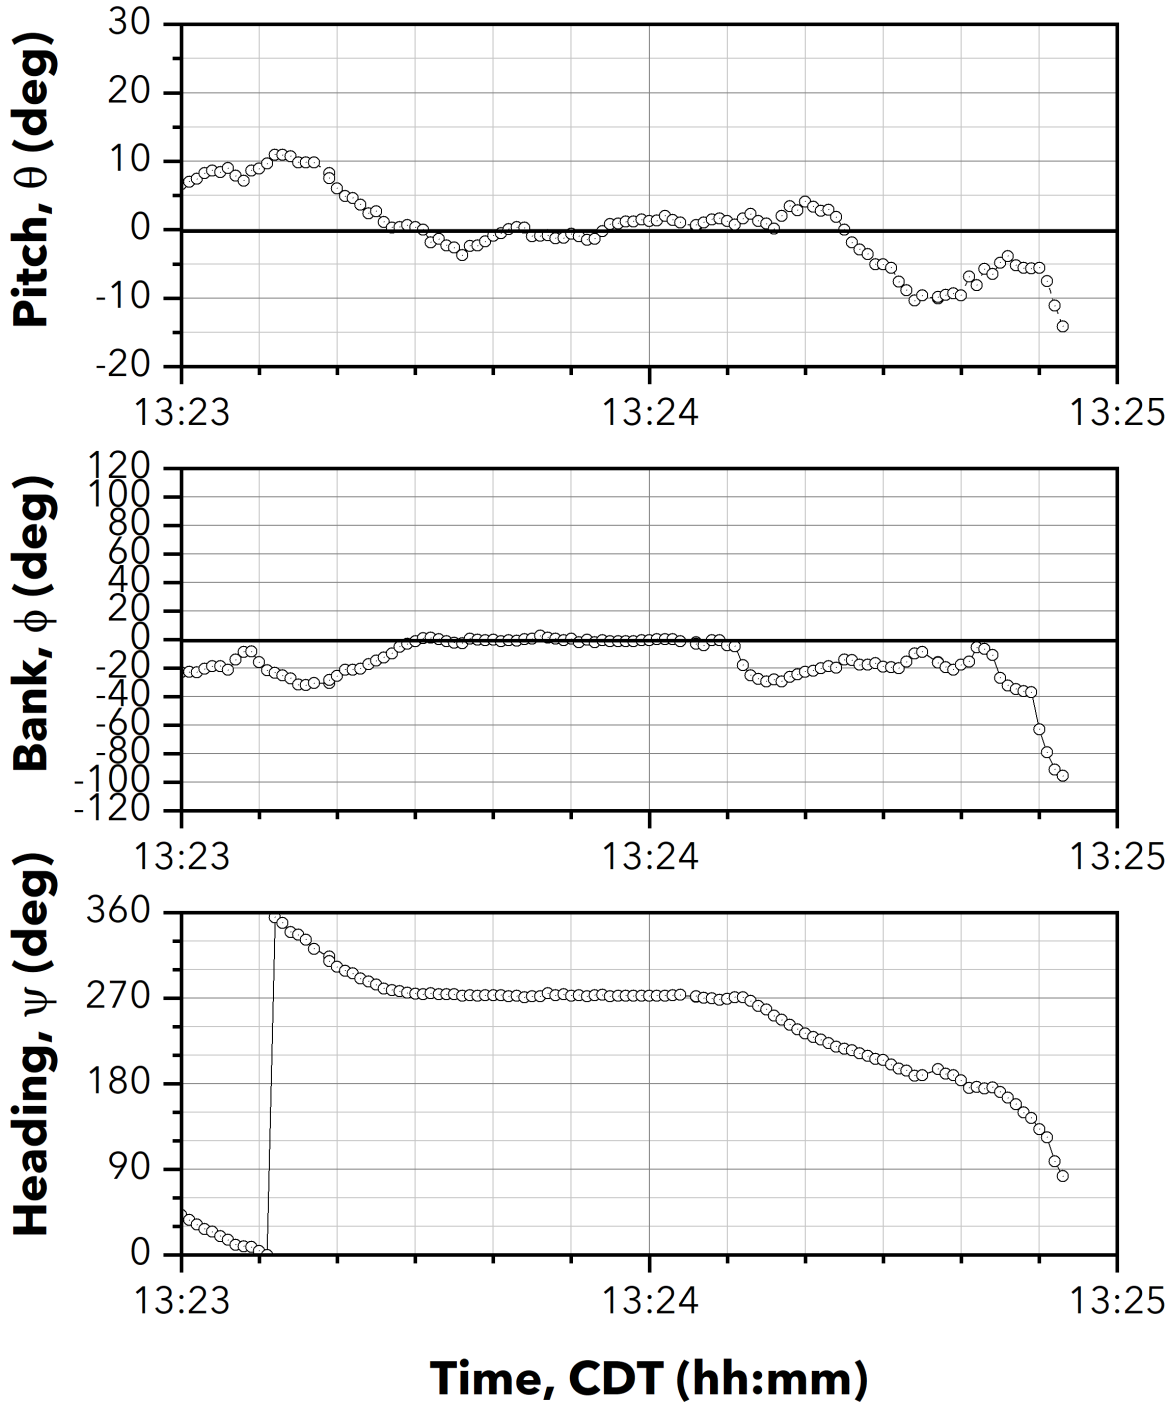
Figures 7 and 8 highlight the last two minutes of the flight. Based on recorded airspeed, attitude, and acceleration data, it does not appear that the airplane experienced an aerodynamic stall. The normal load factor ( $n_z$ ) shown in Figure 9 indicates that the wing was likely producing lift that resulted in a positive normal load factor between 1g and 2g's right before the G3X data ended<sup>1</sup>.

**Figure 7: Garmin G3X Altitude, ROC, and Airspeed for Last Approach**

**Figure 8: Garmin G3X Pitch, Bank, and Heading Angles for Last Approach**

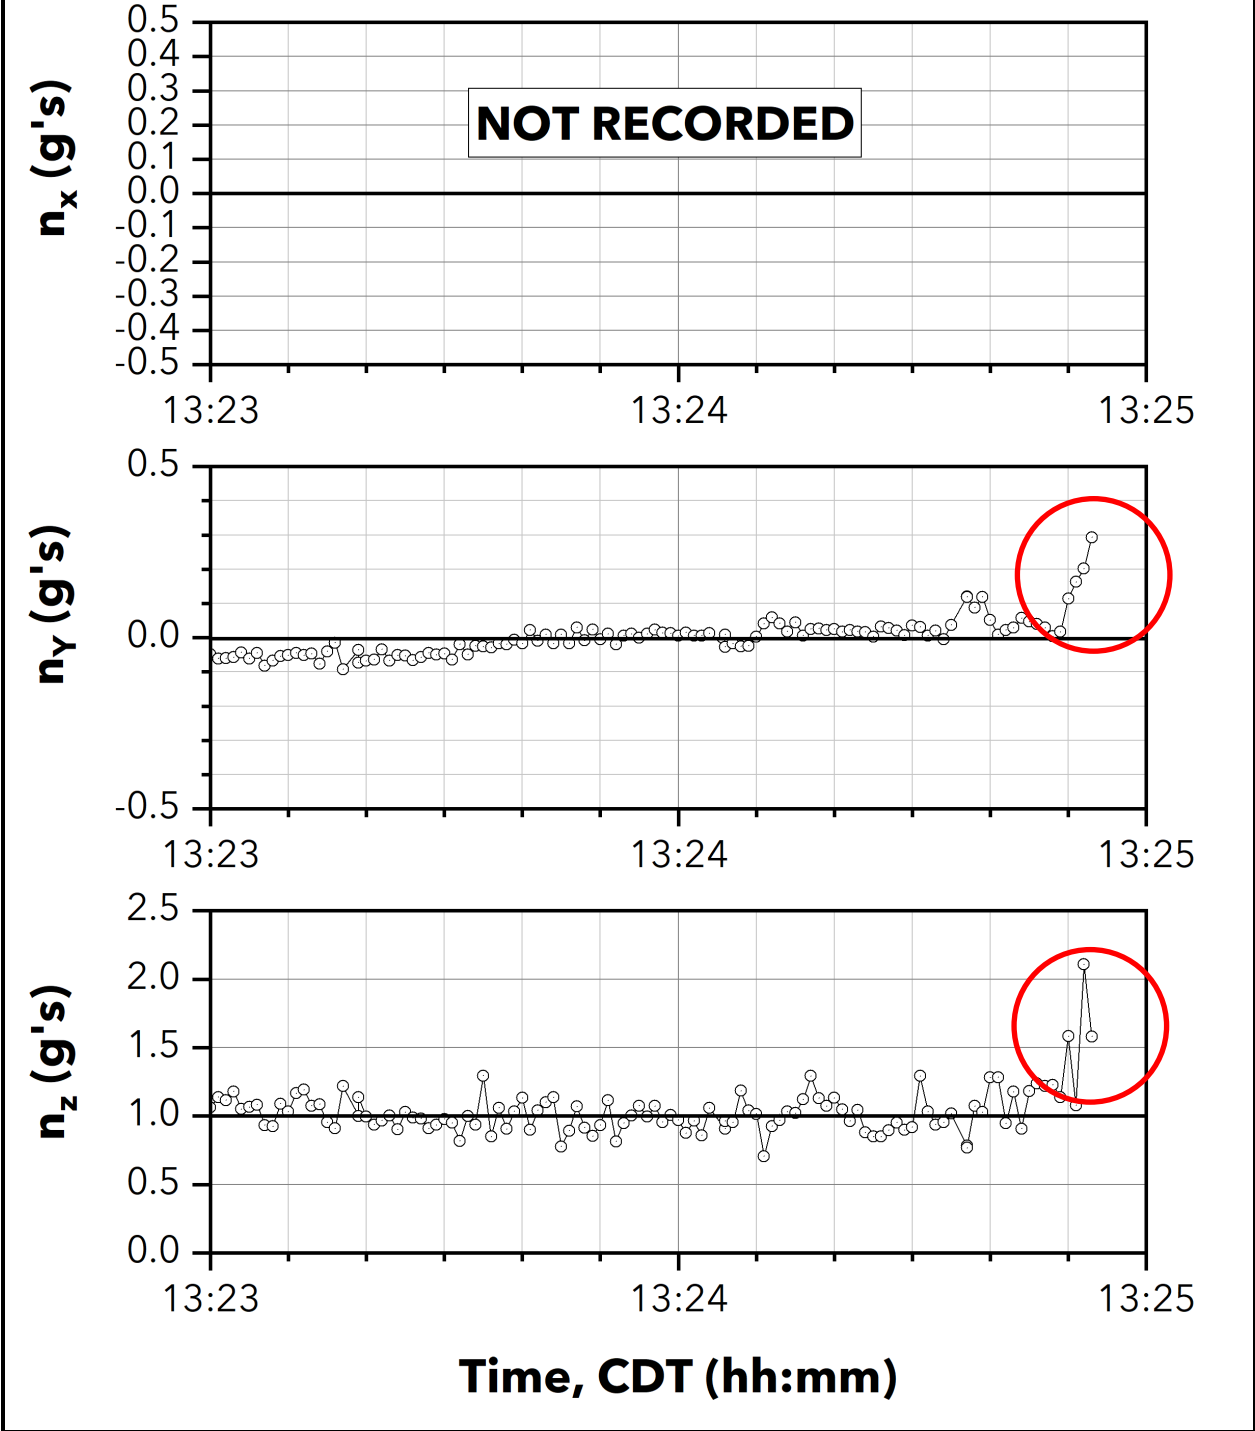
Figure 9 also indicates that the lateral acceleration was at 0.3g when the data ended. The magnitude is significant and is likely the result of a high sideslip angle.

The recorded lateral acceleration is consistent with a high sideslip angle, i.e., a forward slip. Forward slips are used to increase the descent rate while maintaining a relative constant airspeed, most commonly used when an airplane is high on approach.

**Figure 9: Garmin G3X Accelerations for Last Approach**
