NATIONAL TRANSPORTATION SAFETY BOARD
Office of Aviation Safety

Wreckage Examination Summary

A. ACCIDENT ERA22LA120

Location: Beaufort, North Carolina
Date: February 13, 2022
Time: 1402 Eastern Standard Time (EST)
Operator: Private
Aircraft: Pilatus PC-12
Registration: N79NX

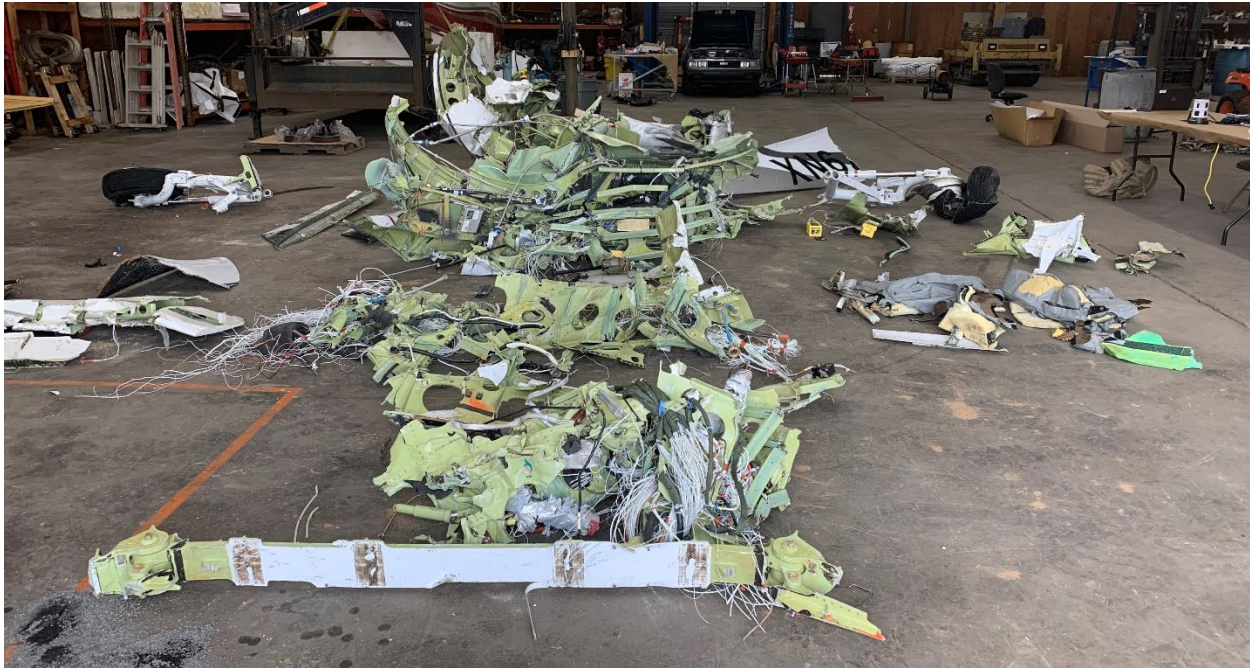
The cockpit and sections of the fuselage were not recovered. The forward and aft sections of the main wing spar were separated, recovered, and the fracture surfaces exhibited overload. The wing to fuselage interface bolts were found intact for the three locations that were recovered. Neither door was recovered, but the cargo door piano hinge remained attached to the empennage.

Figure 1. Overview of wreckage layout.

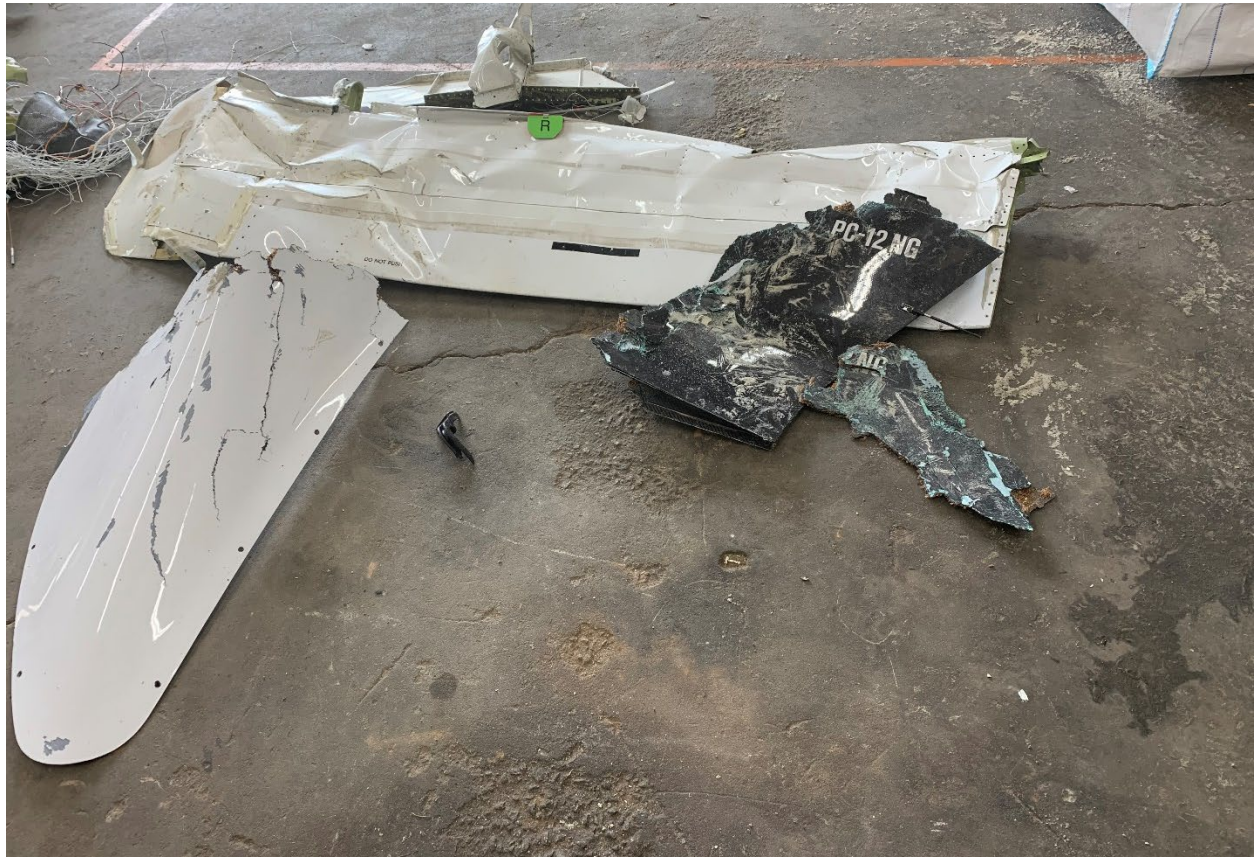
The left and right main landing gear were recovered. The landing gear actuators were not recovered. The nose landing gear was not recovered. A section of the left wing and left inboard flap actuator was located. Also, a section of the left winglet was recovered. The remaining of the left wing, aileron, and flap were not recovered. The 7.5 ft inboard section of the right wing flap and a majority of the right winglet were located. The remaining section of the right flap, right aileron, and right wing were not recovered. Aileron control continuity could not be confirmed because a majority of the aileron flight control system was not recovered.

Figure 2. View of recovered portions of right wing.

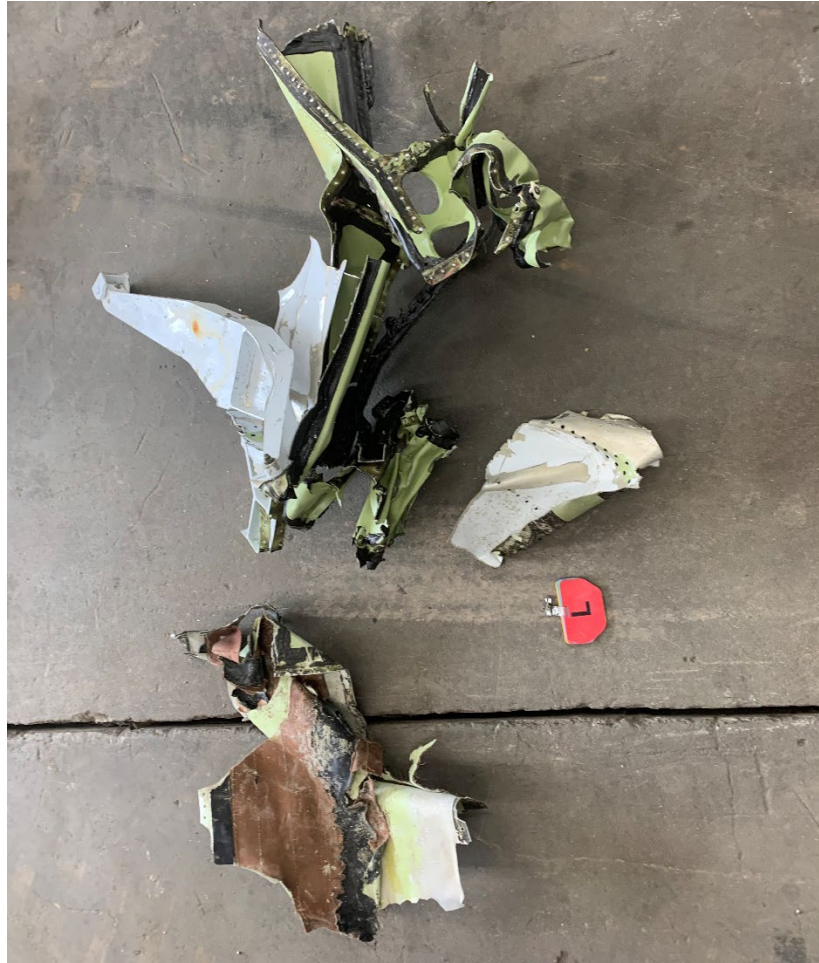
Figure 3. View of recovered portions of the left wing.

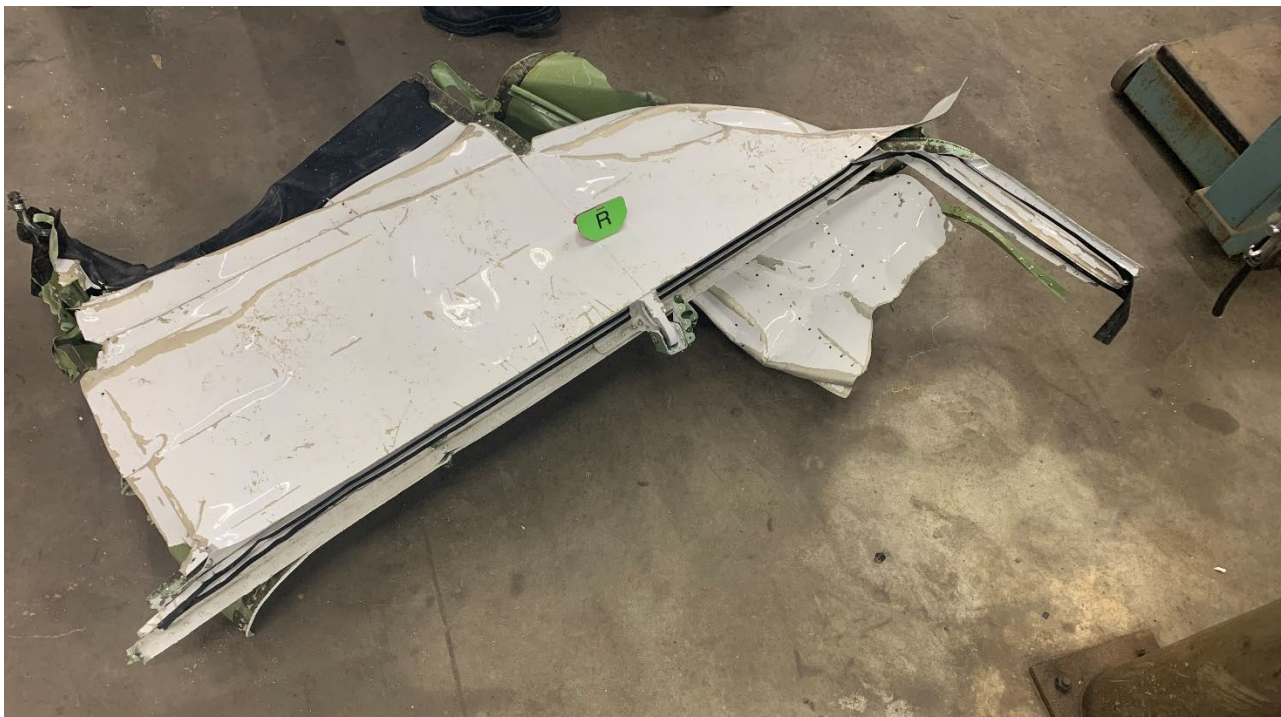
Figure 5. View of recovered section of right horizontal stabilizer.

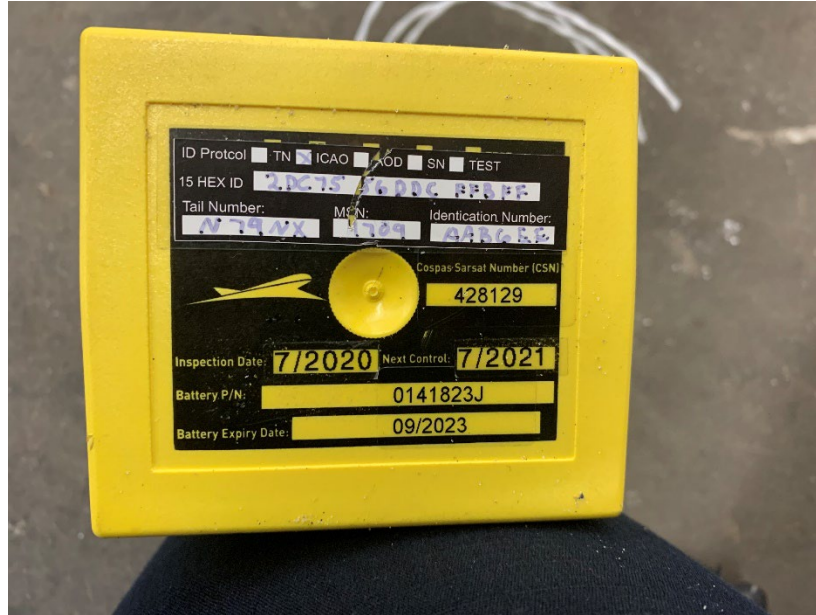
The ELT was removed from the empennage by divers after the airplane was located in the water. They turned the ELT to the OFF position.

Figure 6. Recovered ELT.

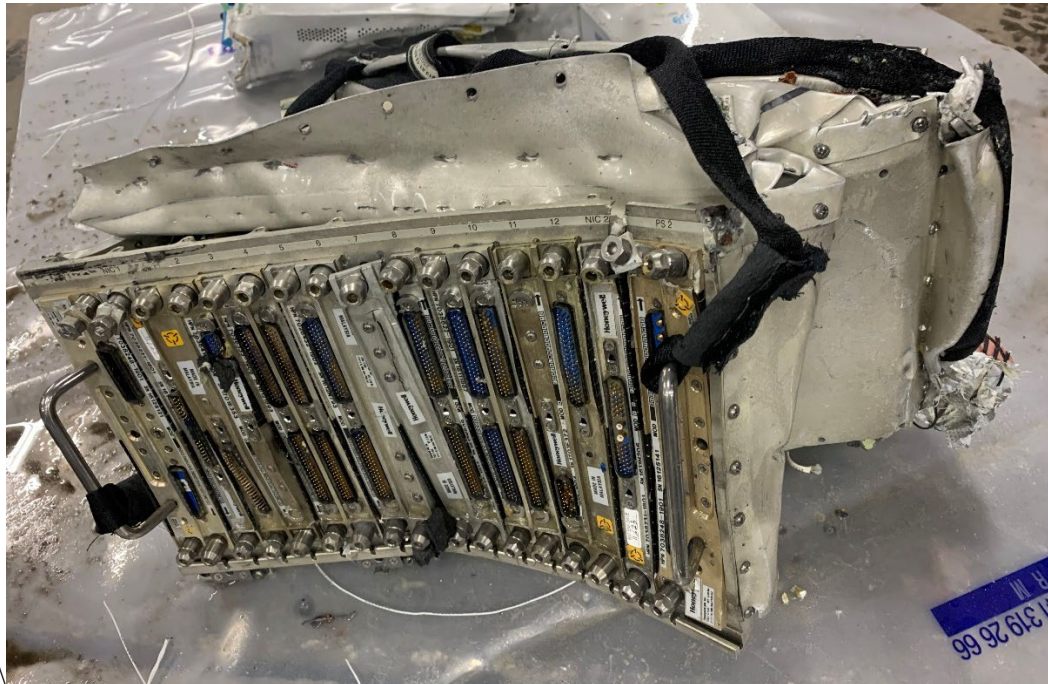
The MAU (Modular Avionics Unit) was recovered.

Figure 7. Recovered MAU.

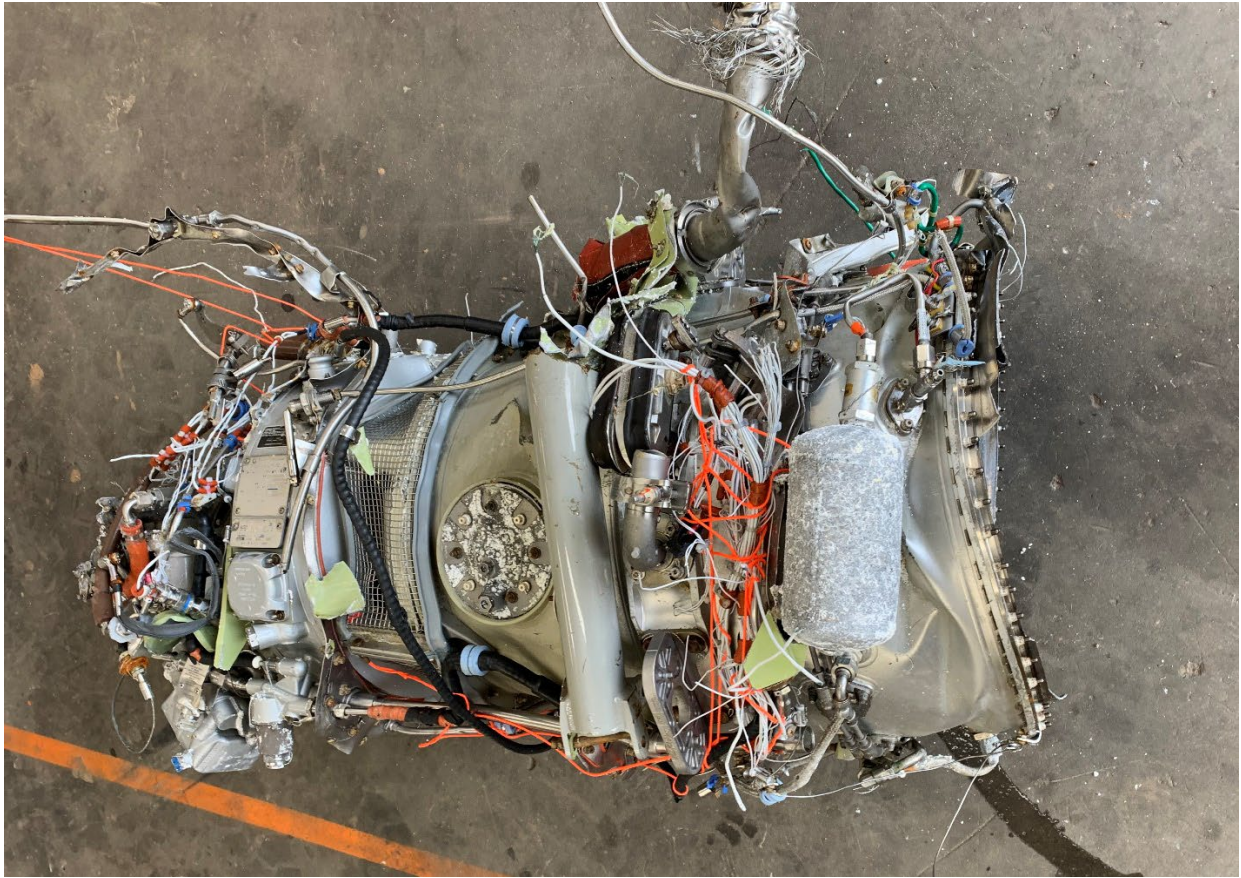
Figure 8. View of recovered section of engine.

The engine was impact separated from the airframe. The reduction gear box was not recovered. The accessory gear box was recovered and present during the engine examination. The power turbine housing and sections of the power turbine vanes exhibited rotational scoring. In addition, the power turbine vanes were bent the opposite direction of travel. The inlet case struts were fractured. The No. 1 bearing housing struts were deformed.

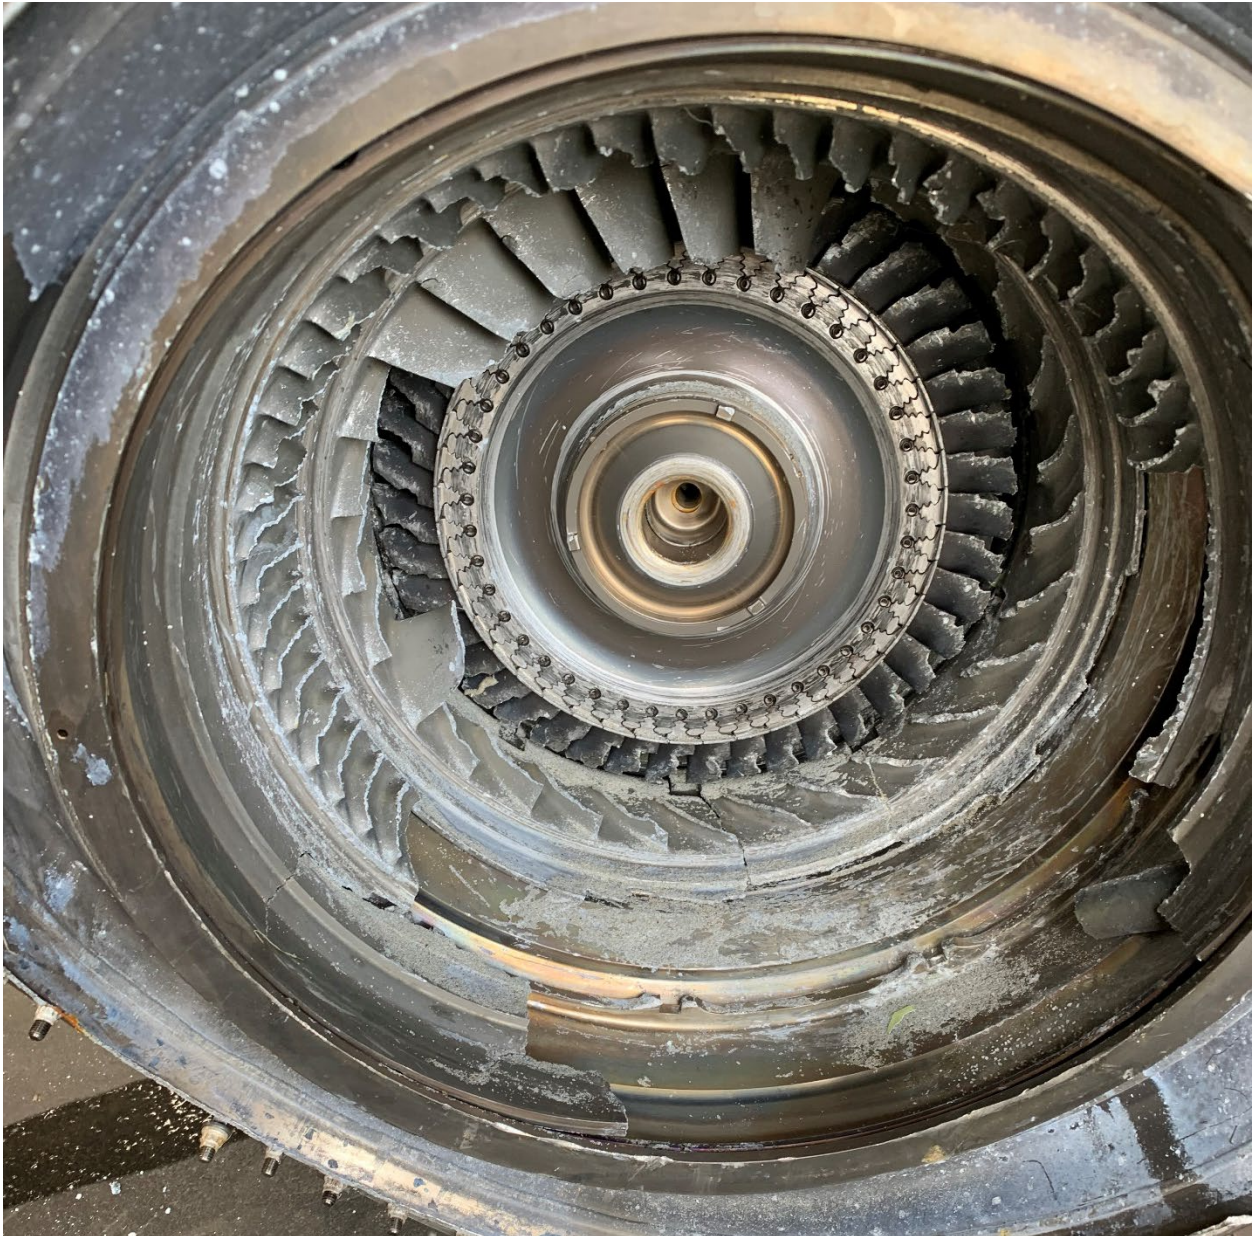
Figure 9. View of turbine vane airfoils bent the opposite direction of travel and rotational scoring throughout engine.

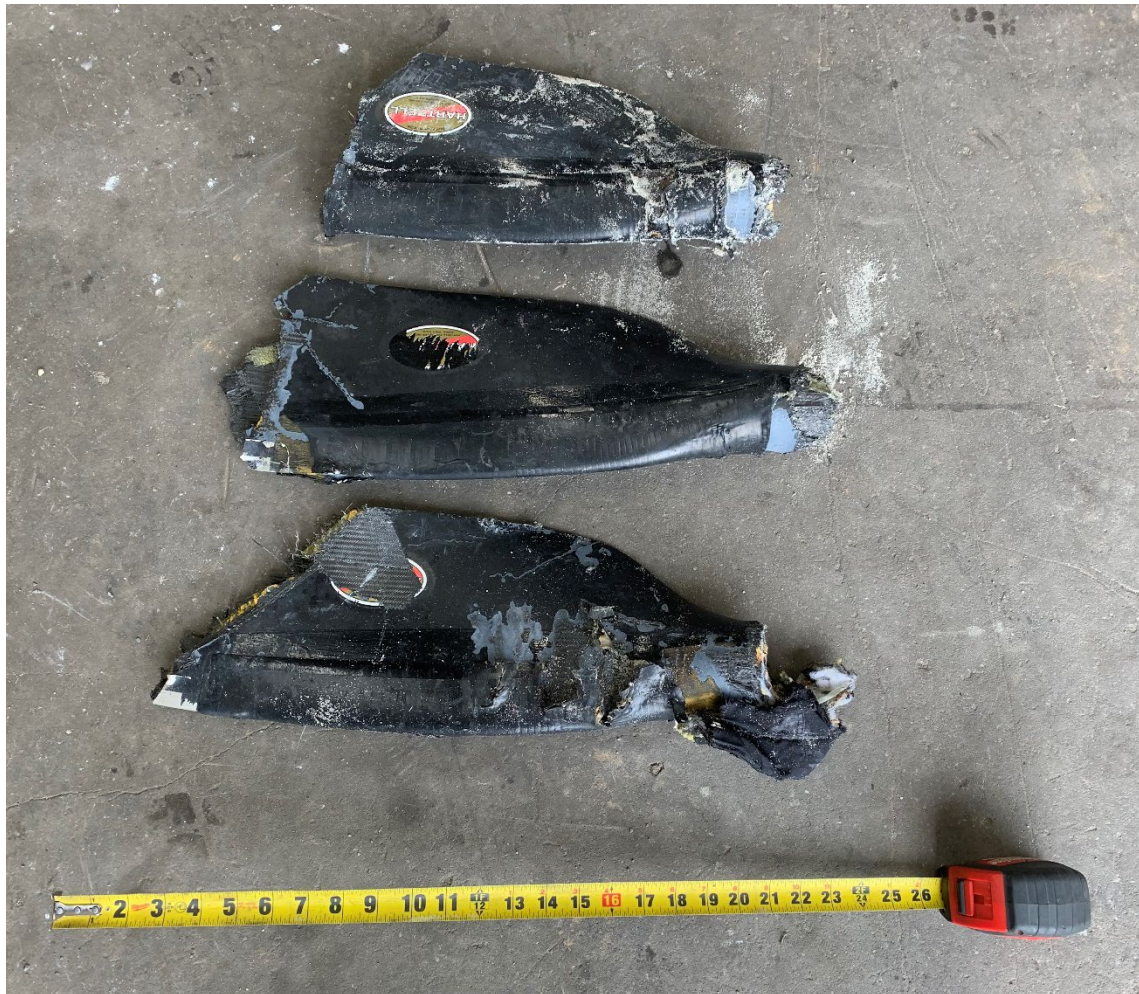
The propeller hub was not recovered. Three propeller blades were recovered with the wreckage, the two others were not. The three propeller blades were separated at the hub and about midspan of the blade.

Figure 10. View of recovered section of propeller.
