NATIONAL TRANSPORTATION SAFETY BOARD

Office of Aviation Safety
Eastern Region

Photo Array

ERA22LA129

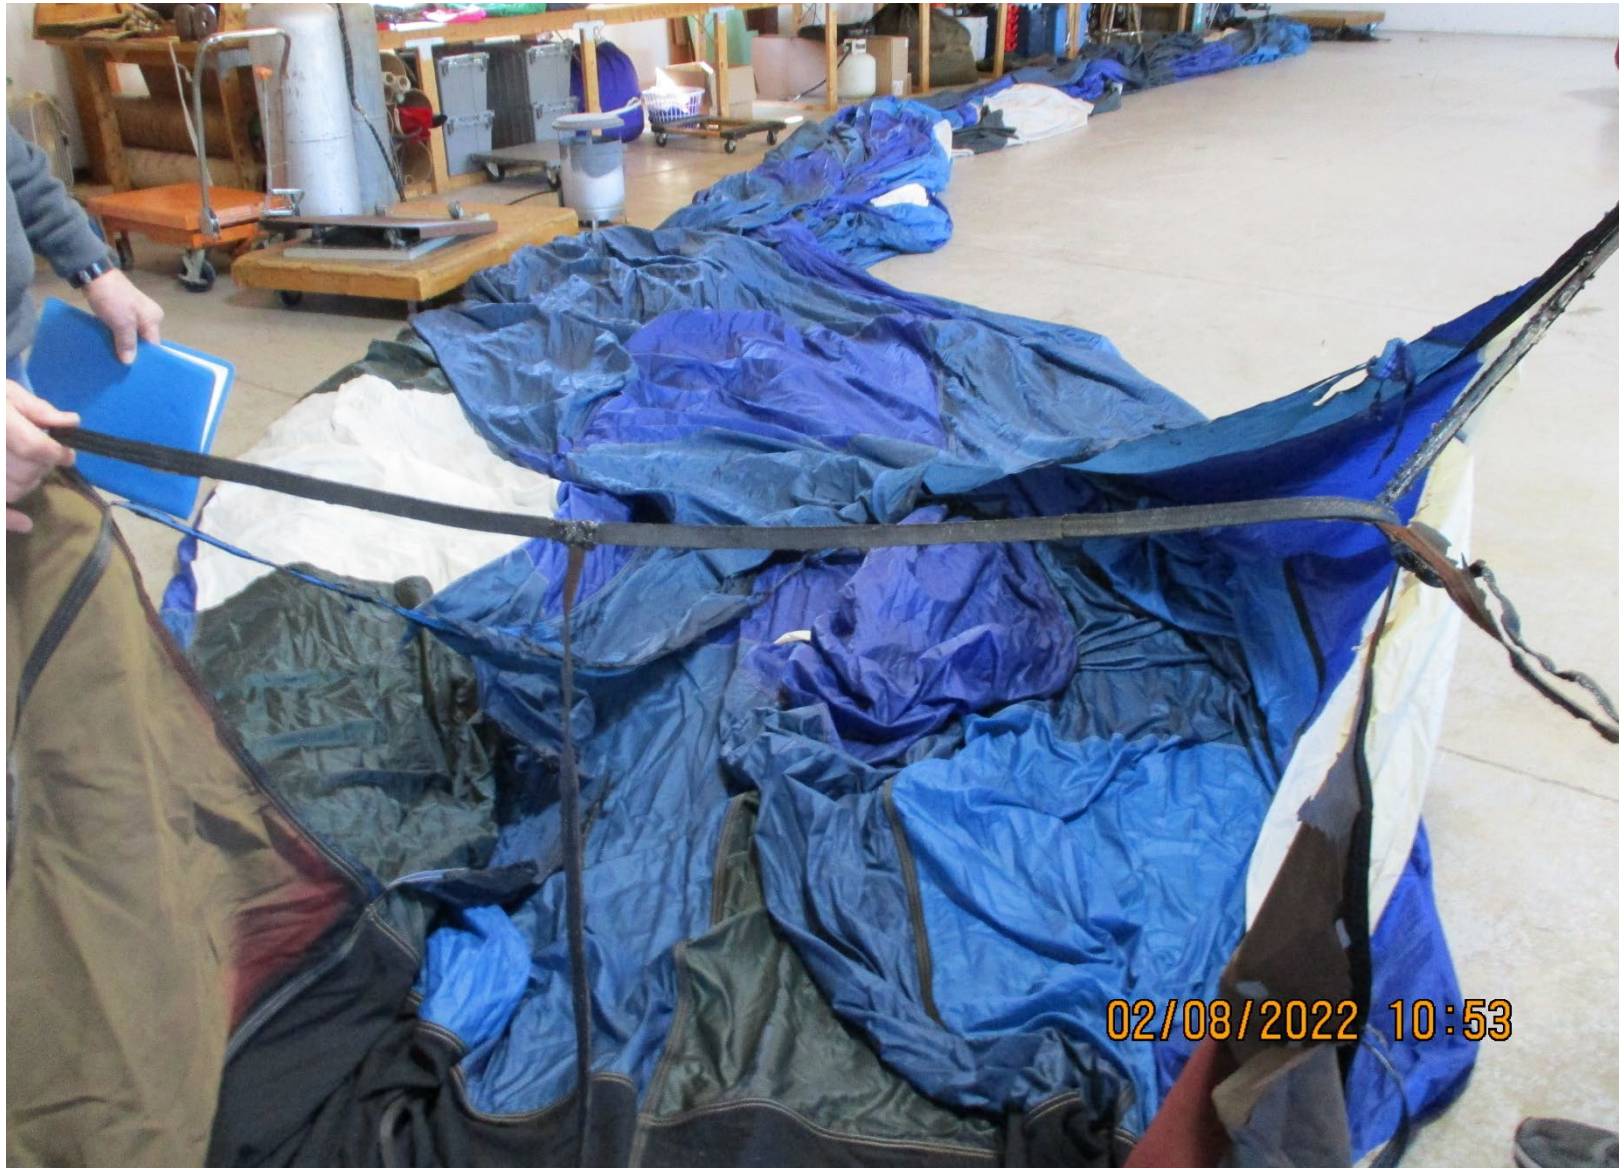
Photo 1 – View of balloon at examination (Photo Courtesy of FAA)

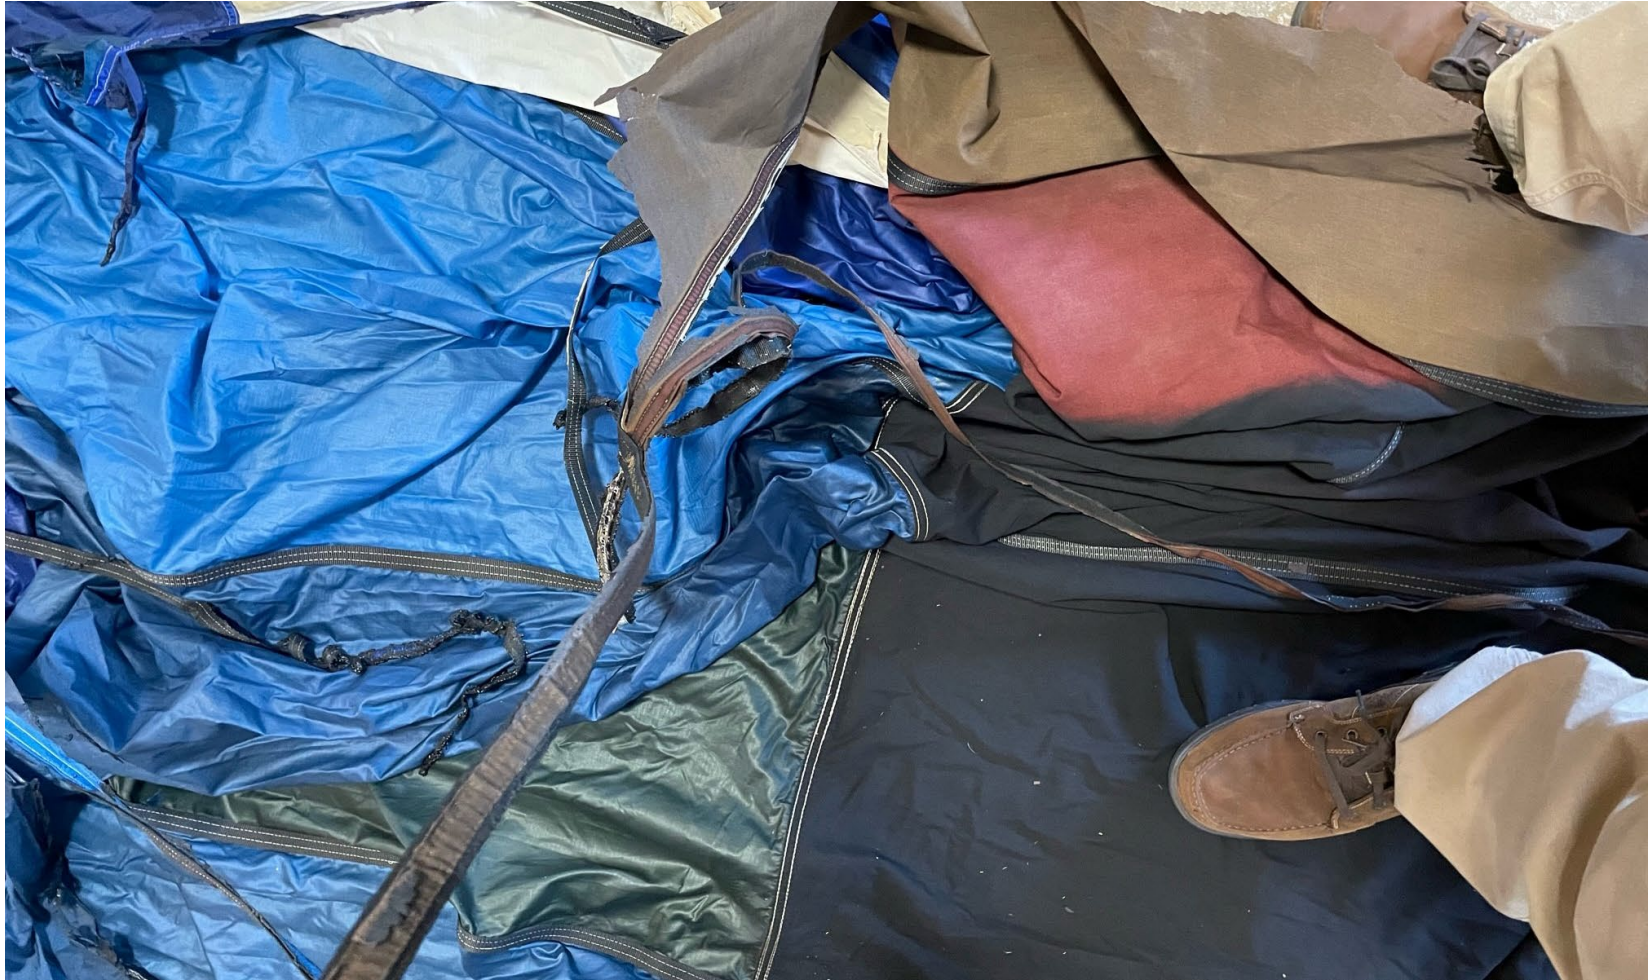
Photo 2 – View of vertical load tape damage (Photo Courtesy of FAA)

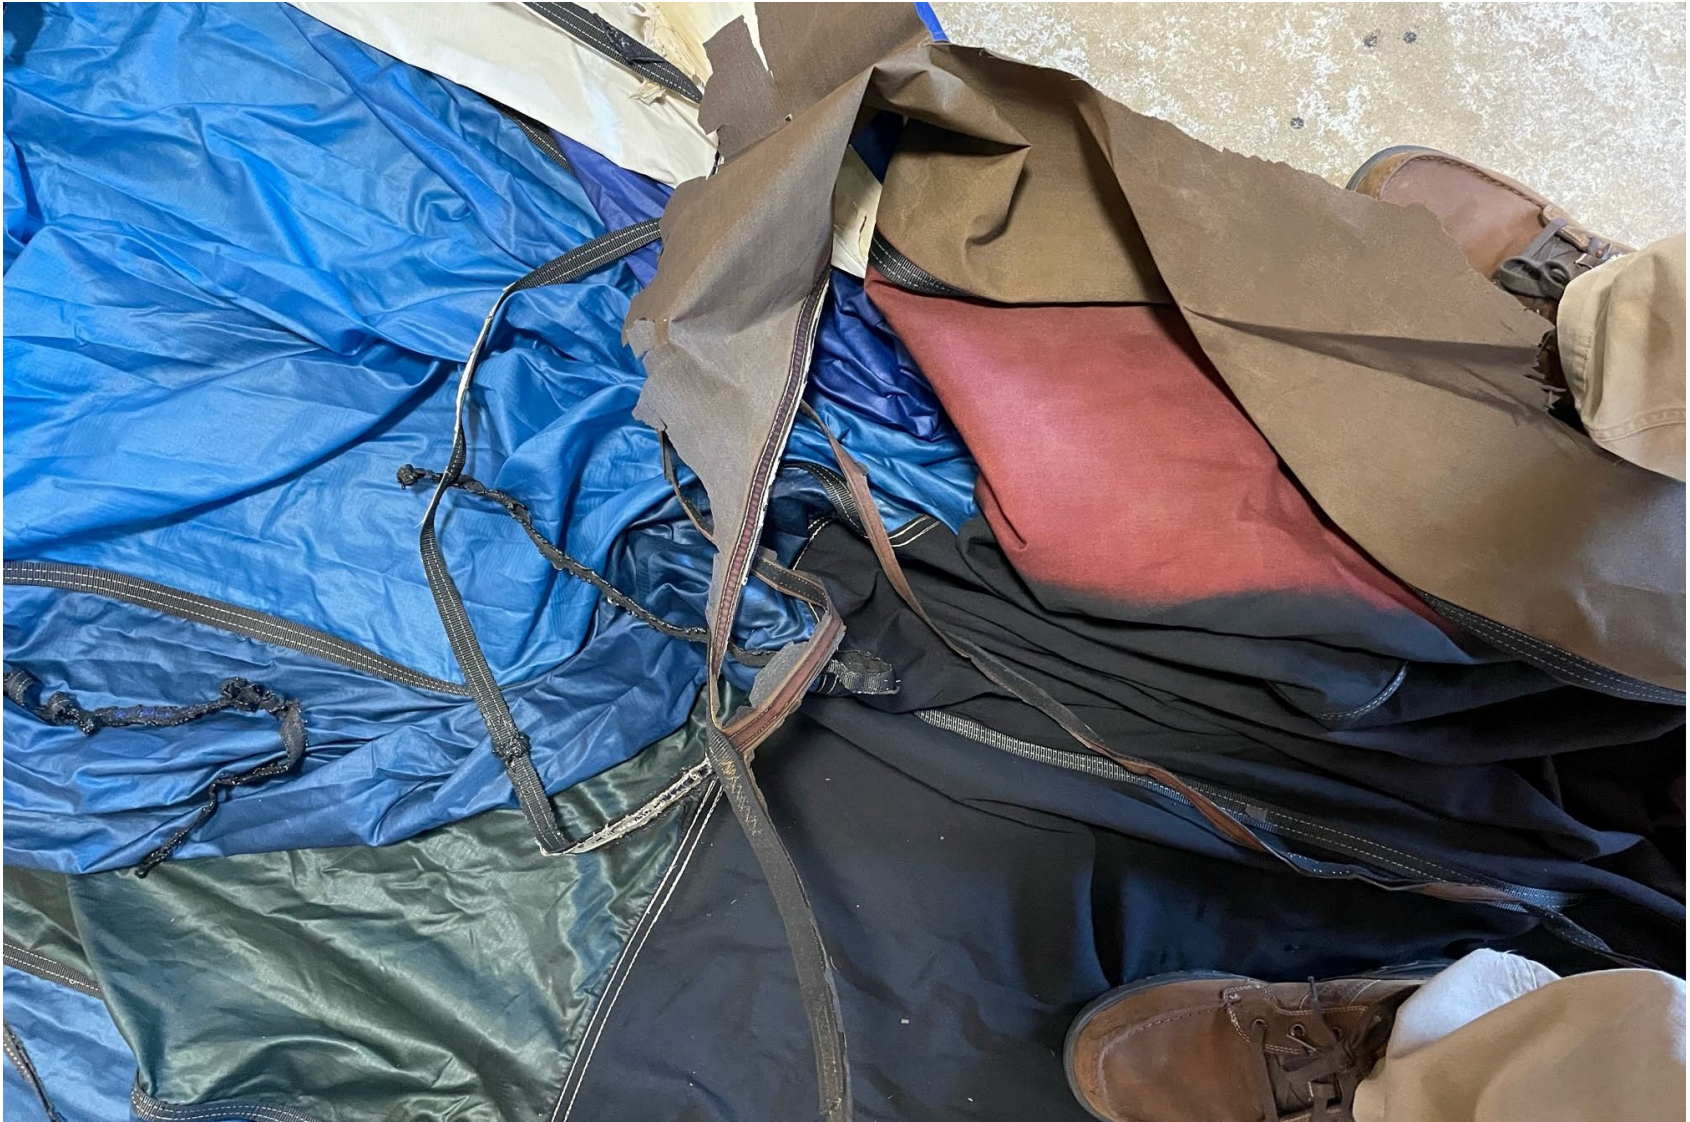
Photo 3 – View of vertical load tape damage (Photo Courtesy of FAA)

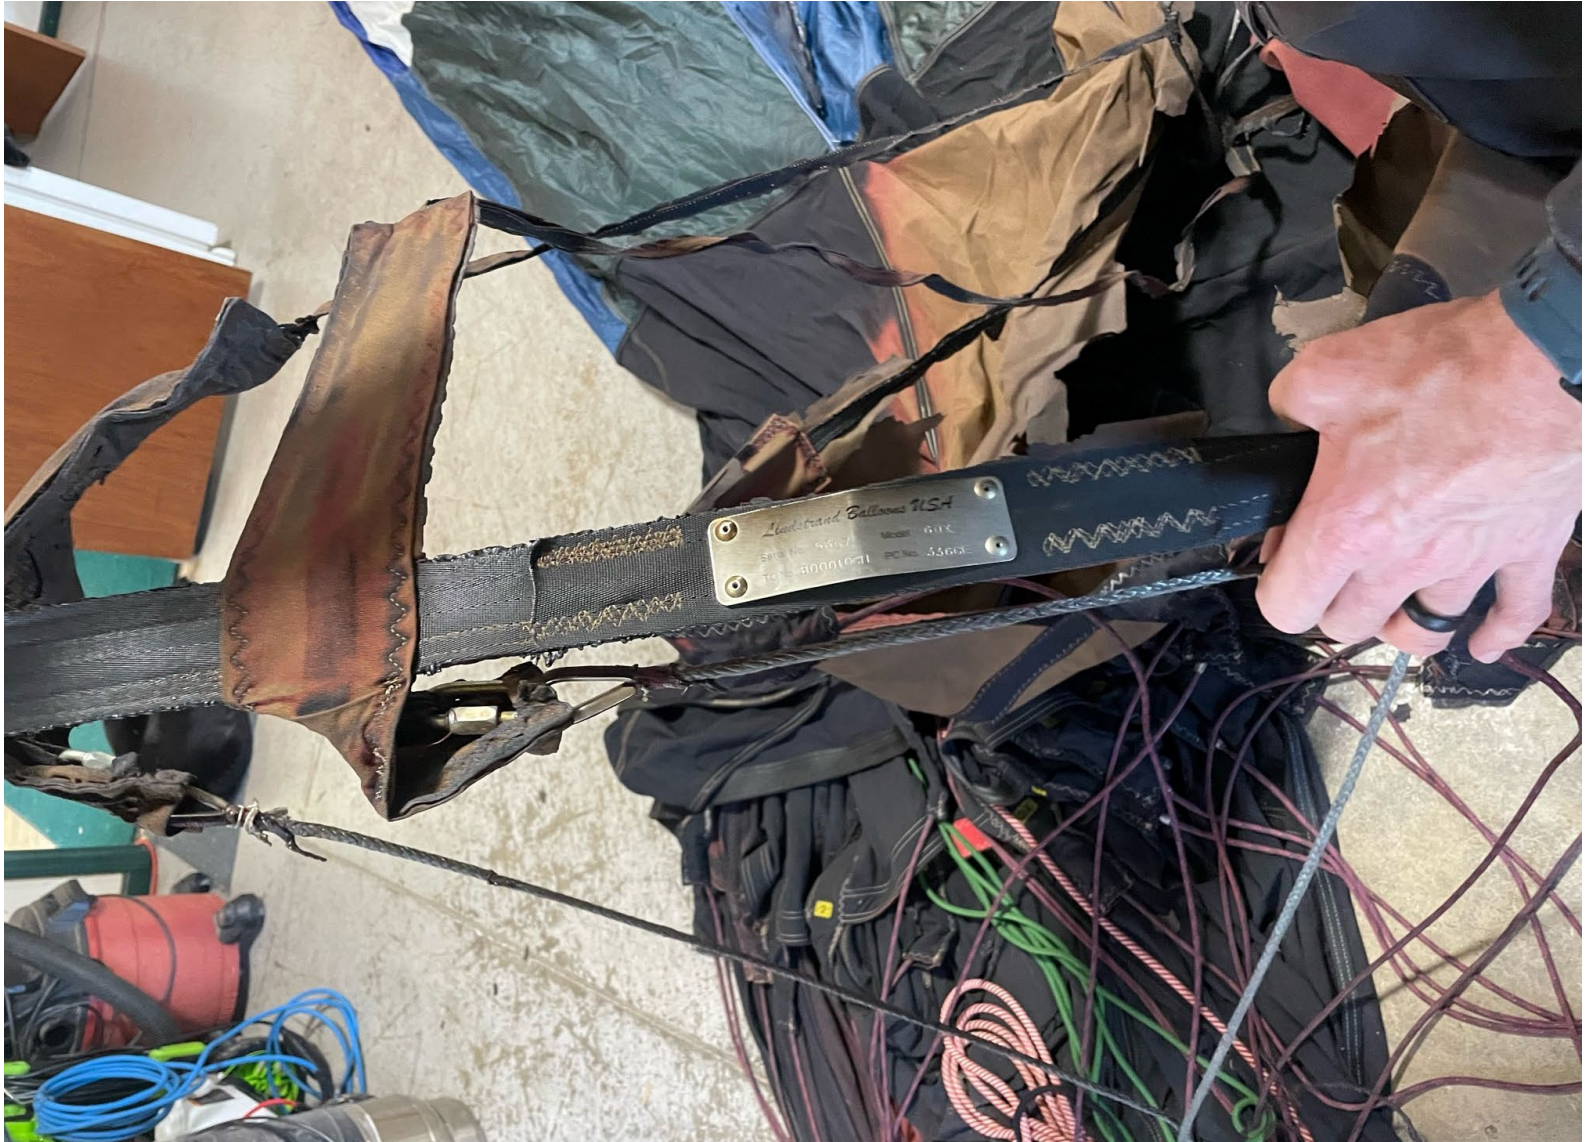
Photo 4 – View of load tape flame and heat damage (Photo Courtesy of FAA)
