National Transportation Safety Board

ERA22LA145

POWERPLANTS

Group Chair's Factual Report

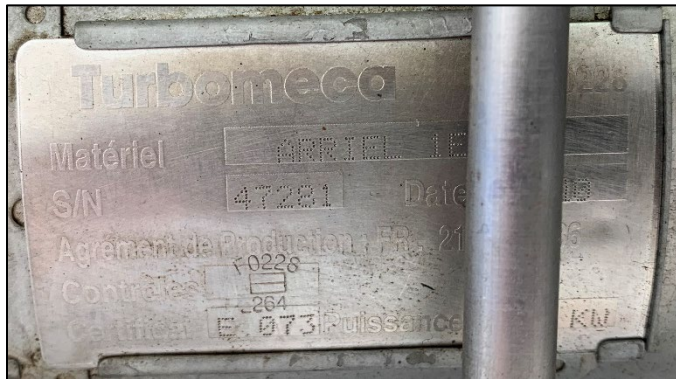
According to the NTSB Form 6120.1 Incident Report submitted by the operator, the left no. 1 engine (serial number (s/n) 47281, Photo 1) and right no. 2 engine (s/n 47285, Photo 2) engine were manufactured on February 15, 2010. Both engines had accumulated 3,695.3 hours time since new when the accident occurred, and had accumulated 559.6 hours time since last overhaul.

Photo 1: Left No. 1 Engine Data Plate.

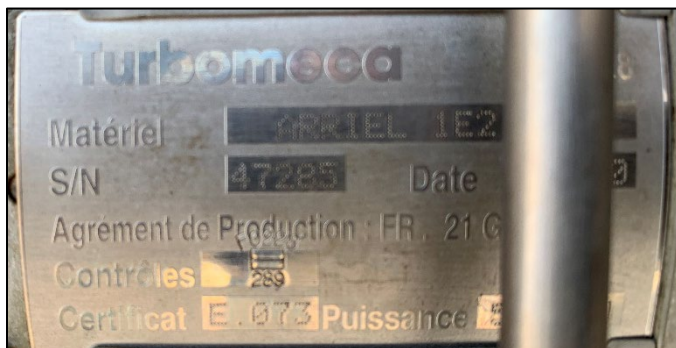
Photo 2: Right No. 2 Engine Data Plate.

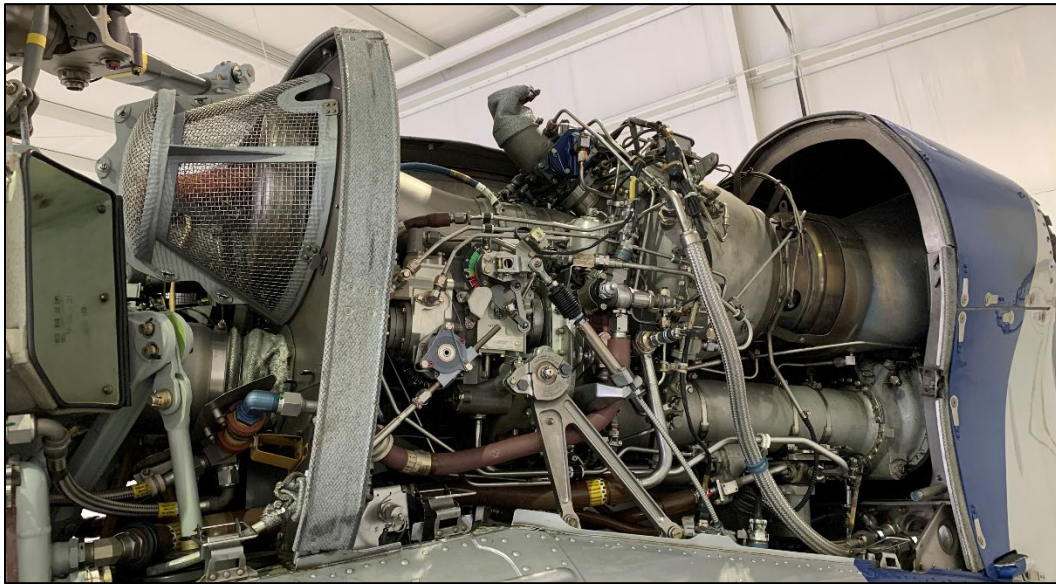
Examination of the accident engines occurred on April 26-27 in Abingdon, Virginia, USA. Both engines were still securely installed in the accident helicopter and showed no evidence of uncontainment or external fire (Photo 3 and Photo 4). The gas generator of both engines could be rotated freely by hand with no abnormal noises. The power turbines of both engines could be rotated freely by hand and corresponding rotations of their respective transmission drive shafts were observed. The axial compressor blades viewed through the engine inlet appeared undamaged on both engines. The power turbine blades viewed through the engine exhaust nozzle appeared undamaged on both engines.

Photo 3: Left No. 1 Engine As-Installed in the Helicopter.

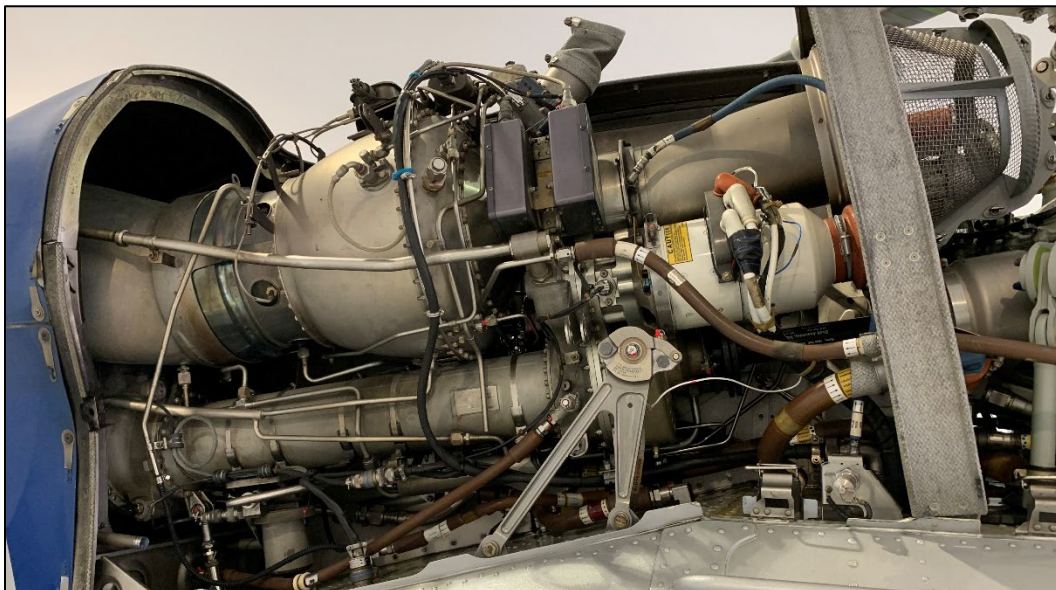
Photo 4: Right No. 2 Engine As-Installed in the Helicopter.

All oil and air line connections were torqued and safety wired. The torque stripe on the right no. 2 engine main fuel supply line connection to the main fuel filter bowl was found intact; however, the connector was not torqued and did not require any significant wrench pressure to loosen. There was no evidence of a fluid leak. Residual fuel was found still in the supply line when disconnected. All other fuel connections to the engine were tight and properly safety wired.
