**NATIONAL TRANSPORTATION SAFETY BOARD**  
Office of Aviation Safety

**Engine Examination**

**A. ACCIDENT      ERA22LA169**

Location:            Smithfield, NC  
Date:                March 25, 2022  
Aircraft:            Diamond DA-40-NG  
Engine:             Austro E4-A sn E4-A-05084  
Registration:       N471BL

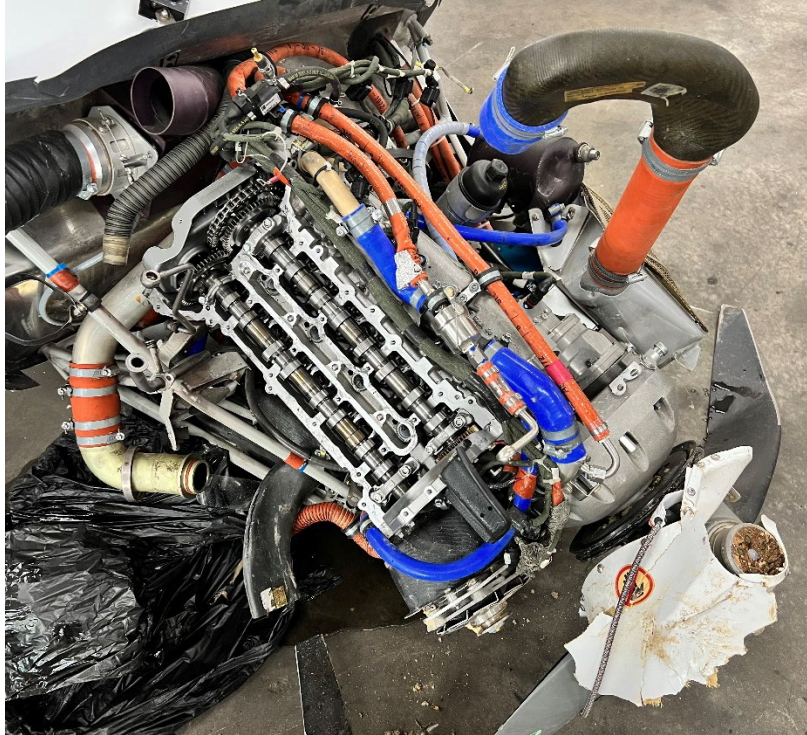
*Photo 1 - Engine pre-examination*

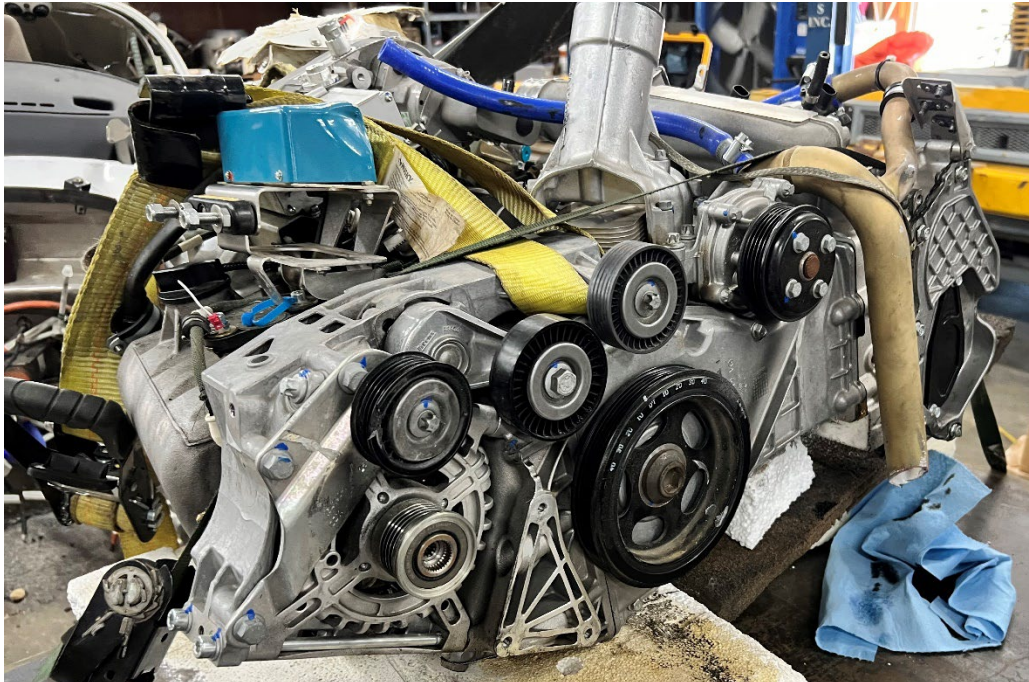
*Photo 2 - Accident engine pre-examination*

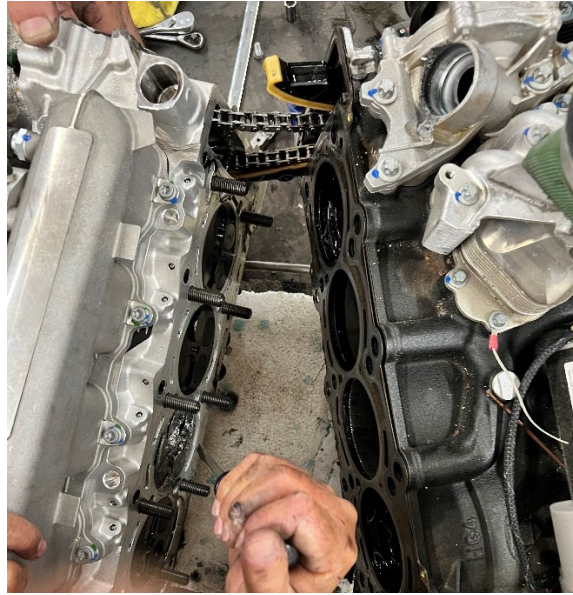
Upon examination, the engine could not be fully rotated. The timing of the engine was verified through timing marks on the front pulley and the camshaft gears. The examination revealed that

the engine was not timed correctly, and the misaligned gears resulted in the piston striking the valve. The valve had fractured off and had fallen into the cylinder, causing extensive damage to the piston.

*Photo 3- View of opened engine block and cylinder heads*

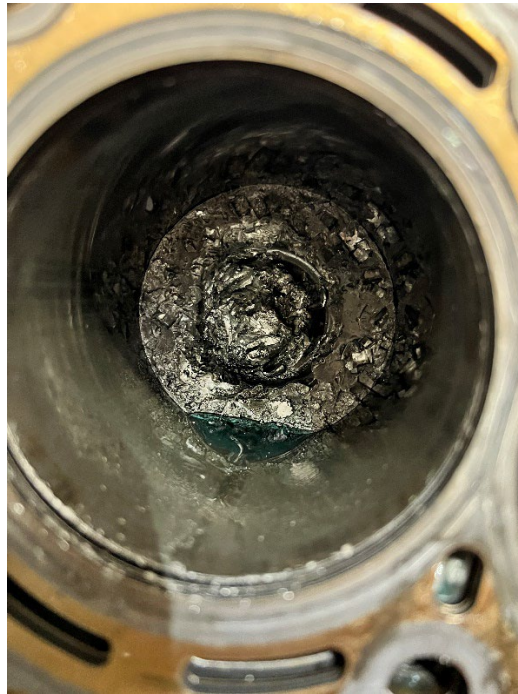
*Photo 4 – View of damaged piston*

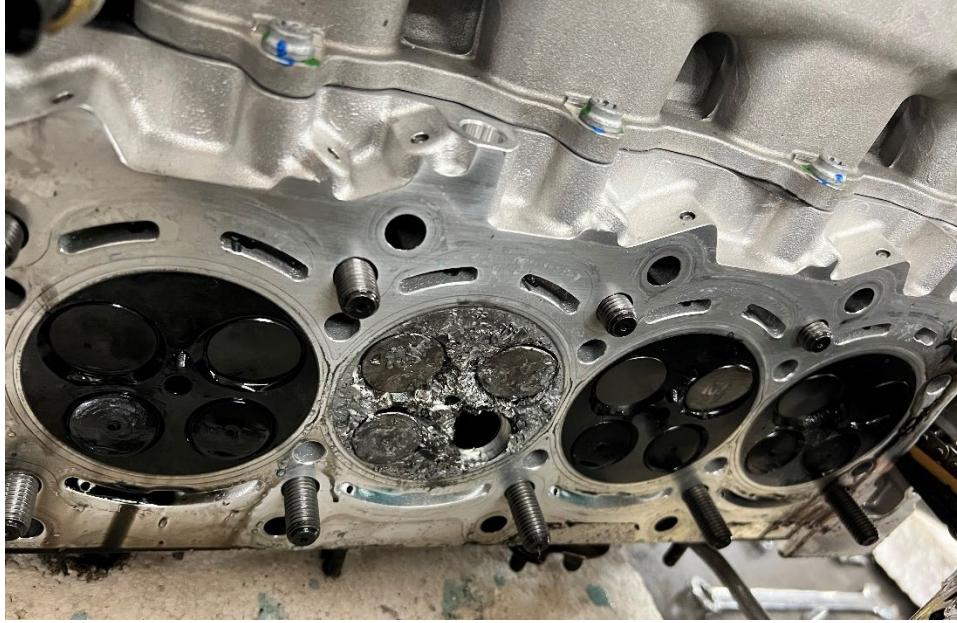
*Photo 5 – View of damaged valves*

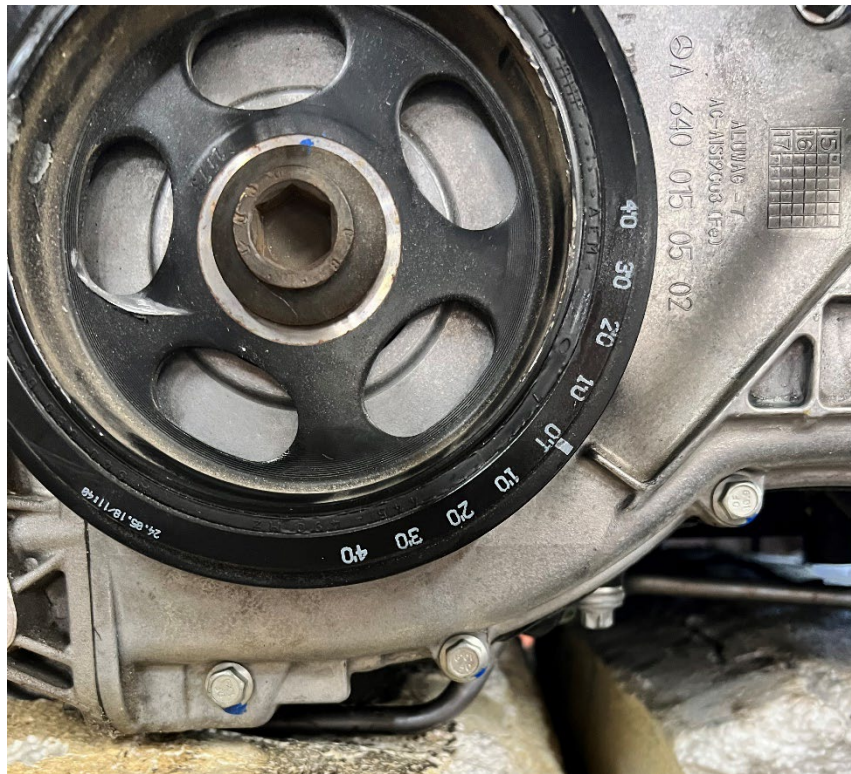
*Photo 6 – View of timing marks on front pulley*

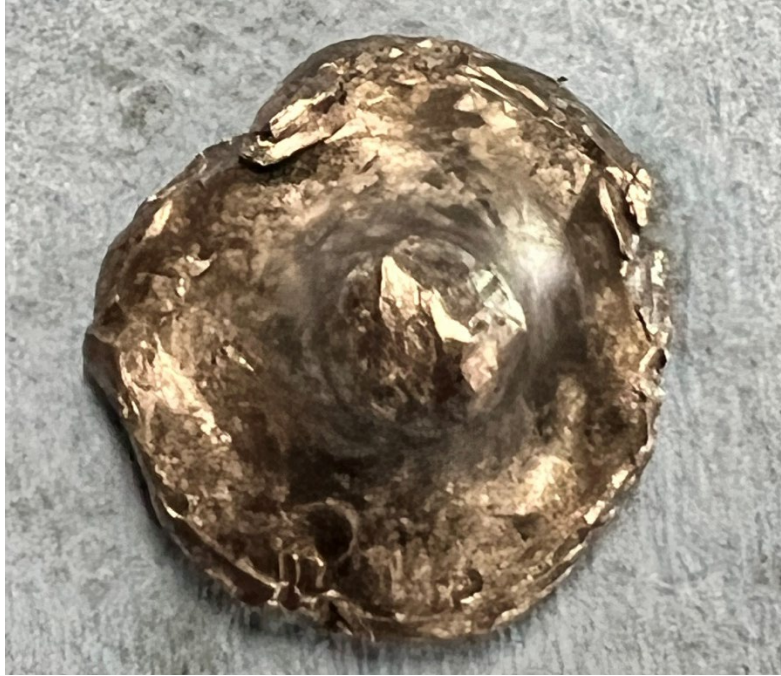
*Photo 7 – View of fractured valve*
