NATIONAL TRANSPORTATION SAFETY BOARD

Office of Aviation Safety
Eastern Region

Photo Array

ERA22LA231

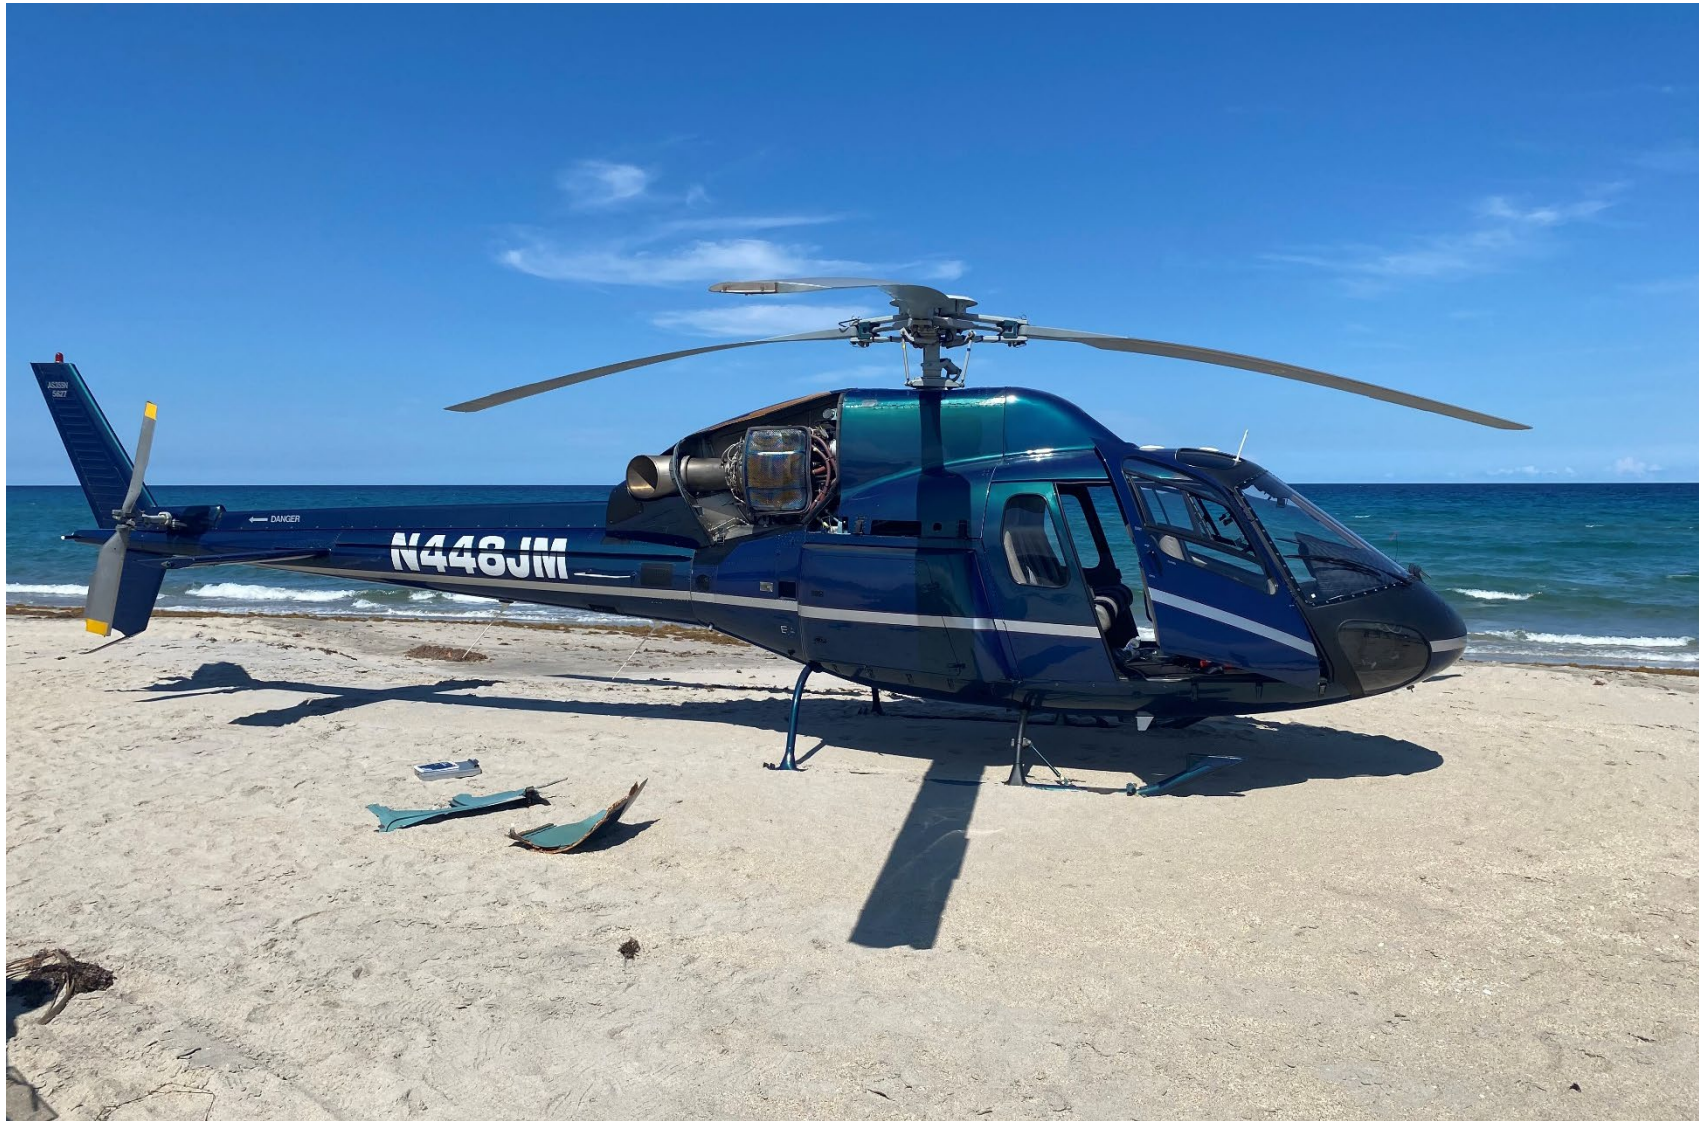
Photo 1 – View of helicopter from right side (Photo Courtesy of FAA)

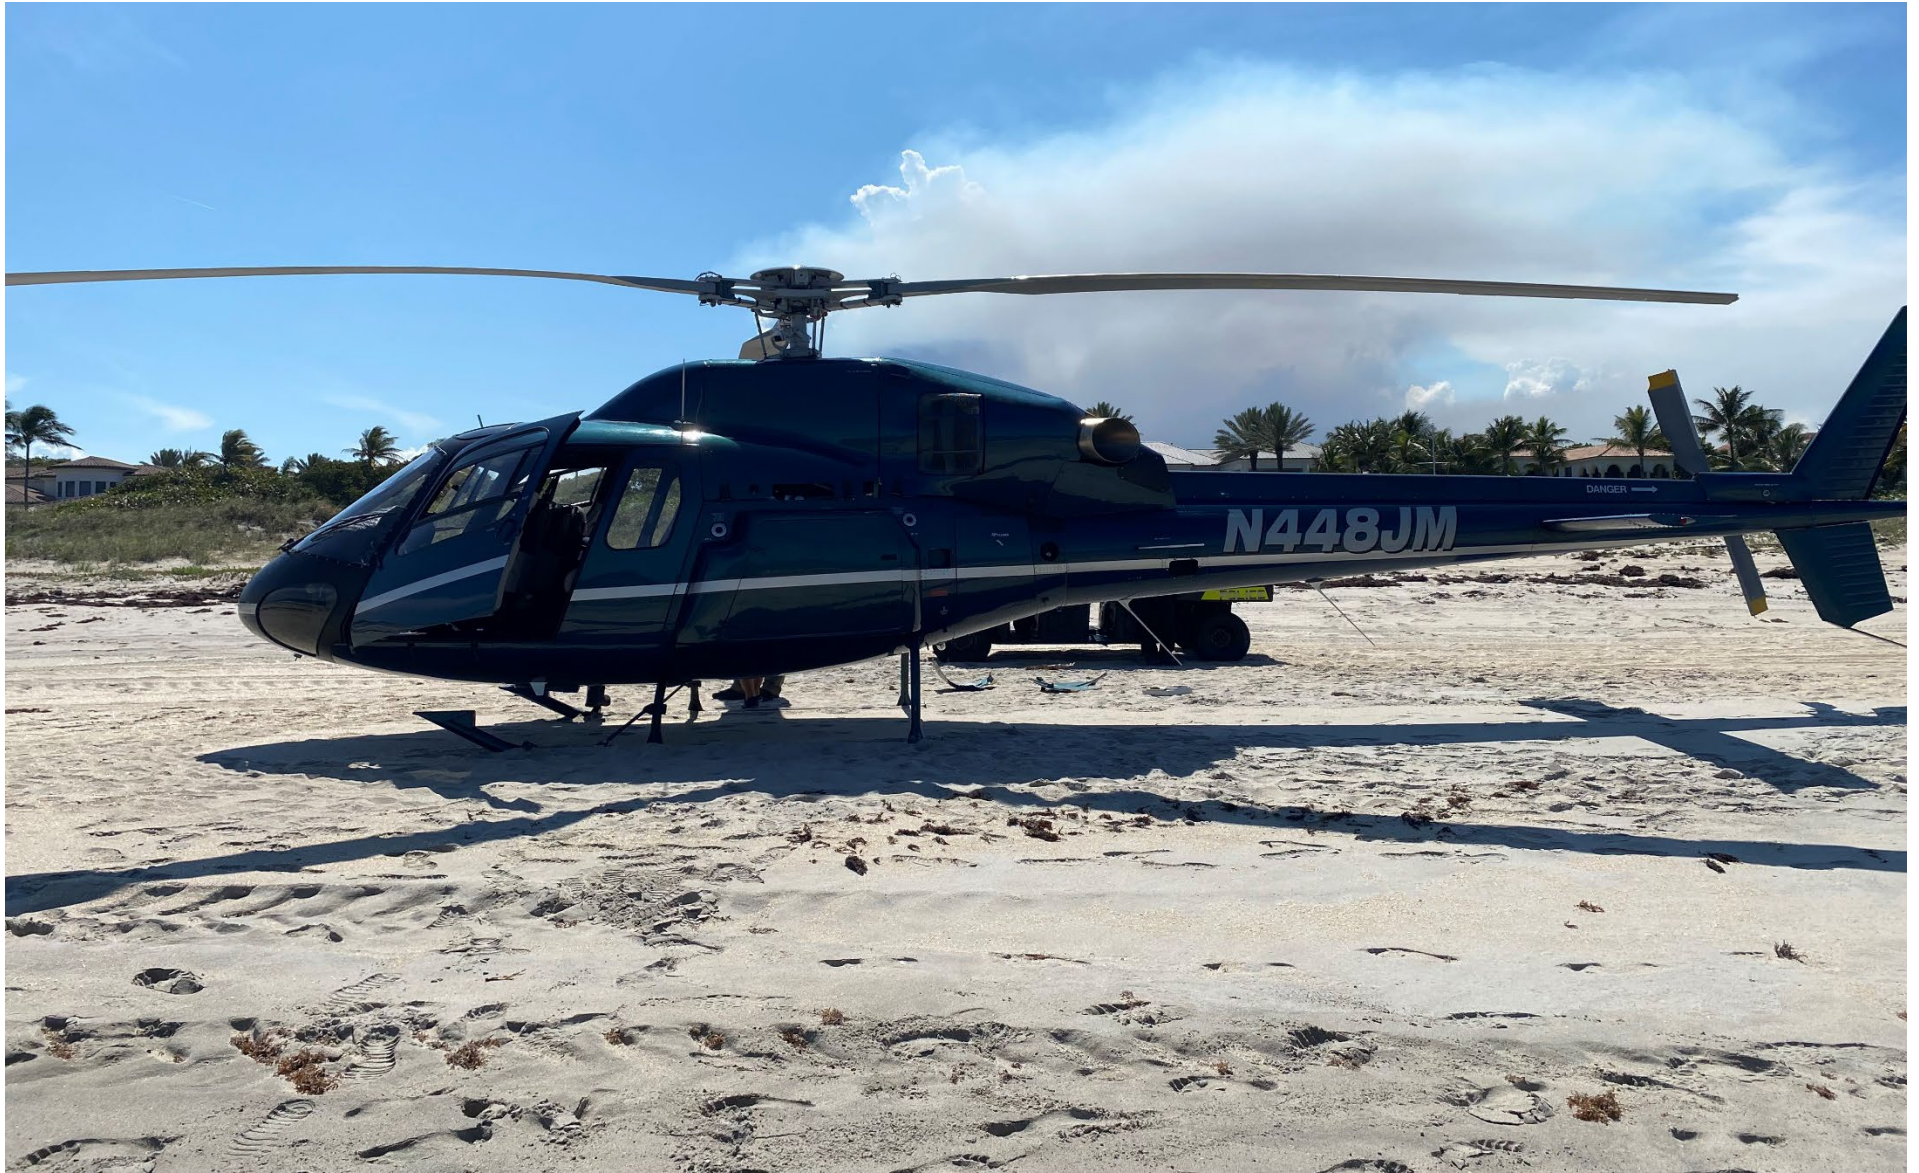
Photo 2 – View of helicopter from left side (Photo Courtesy of FAA)

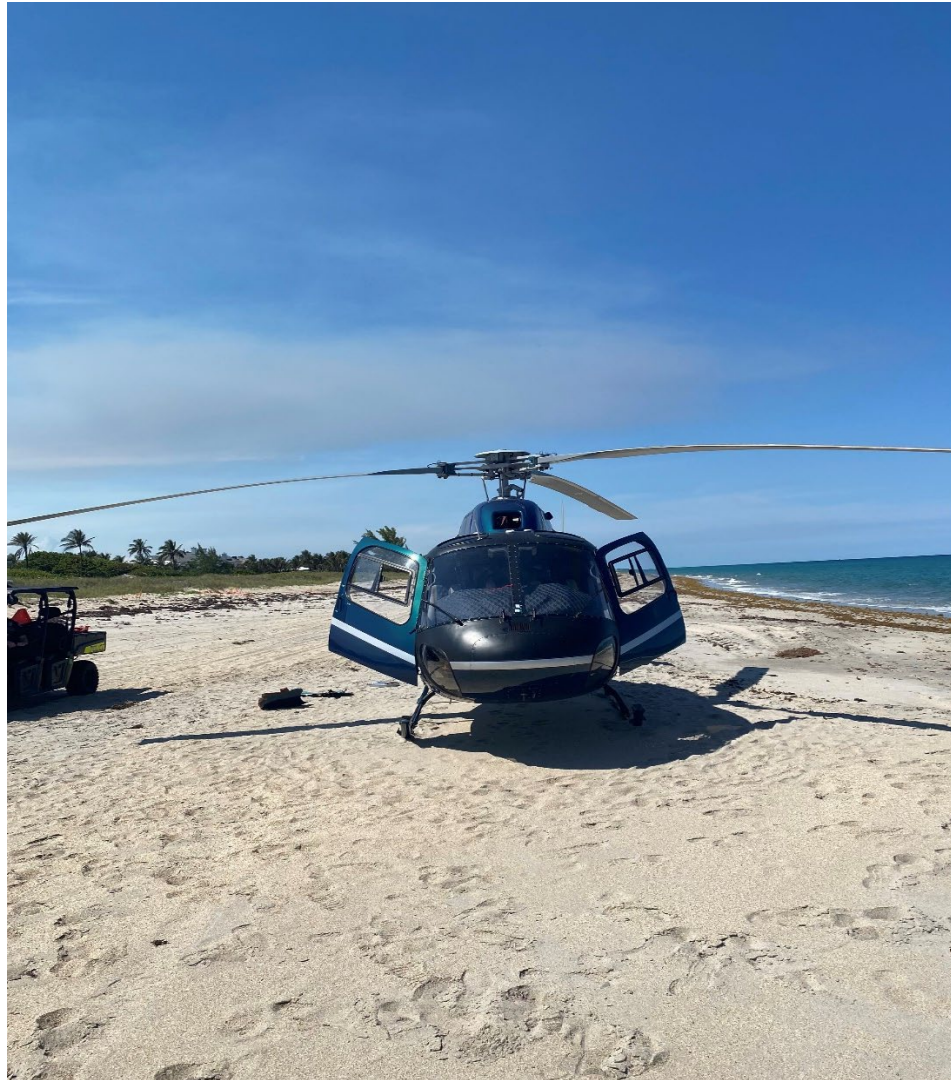
Photo 3 – View of helicopter from front (Photo Courtesy of FAA)

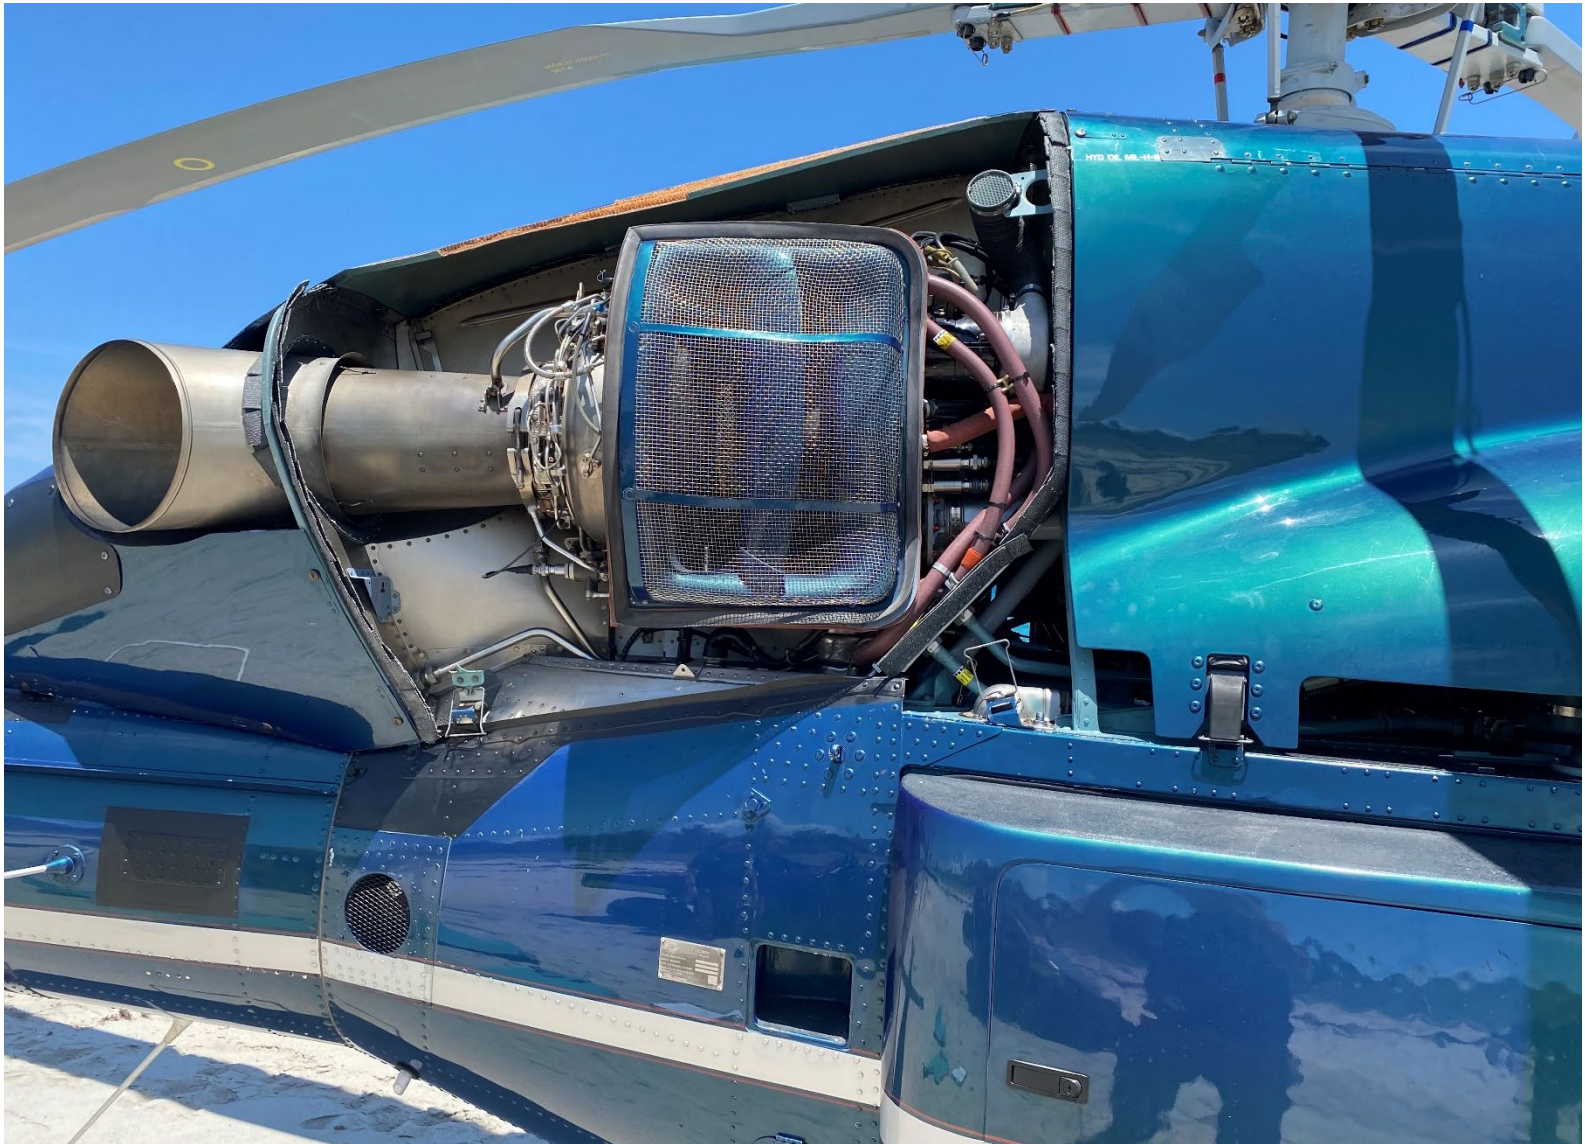
Photo 4 – View of area of missing engine cowl (Photo Courtesy of FAA)

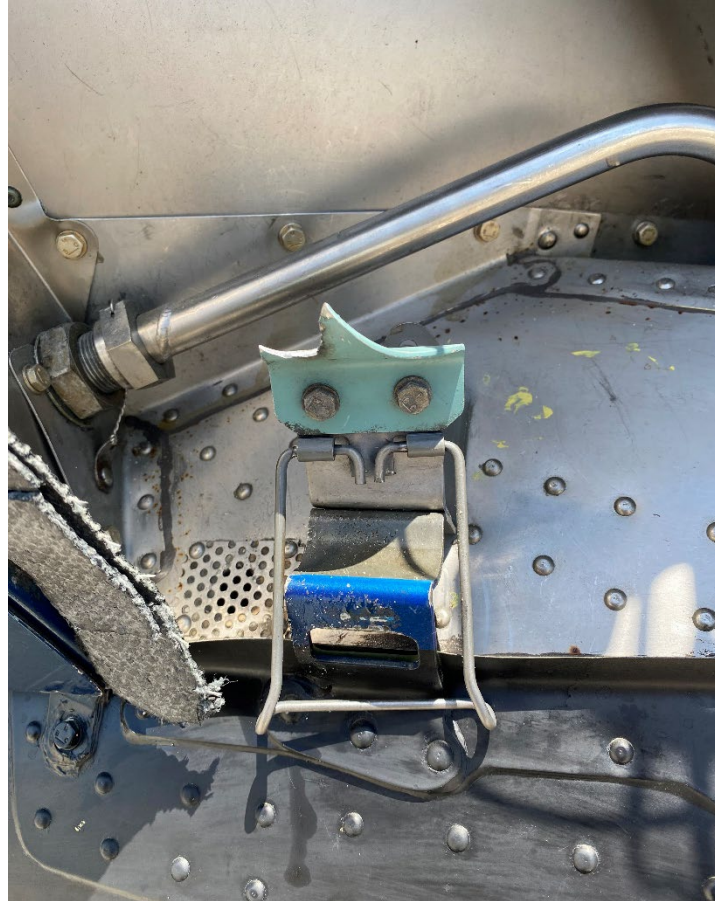
Photo 5 – View of broken cowl attachment bracket (Photo Courtesy of FAA)

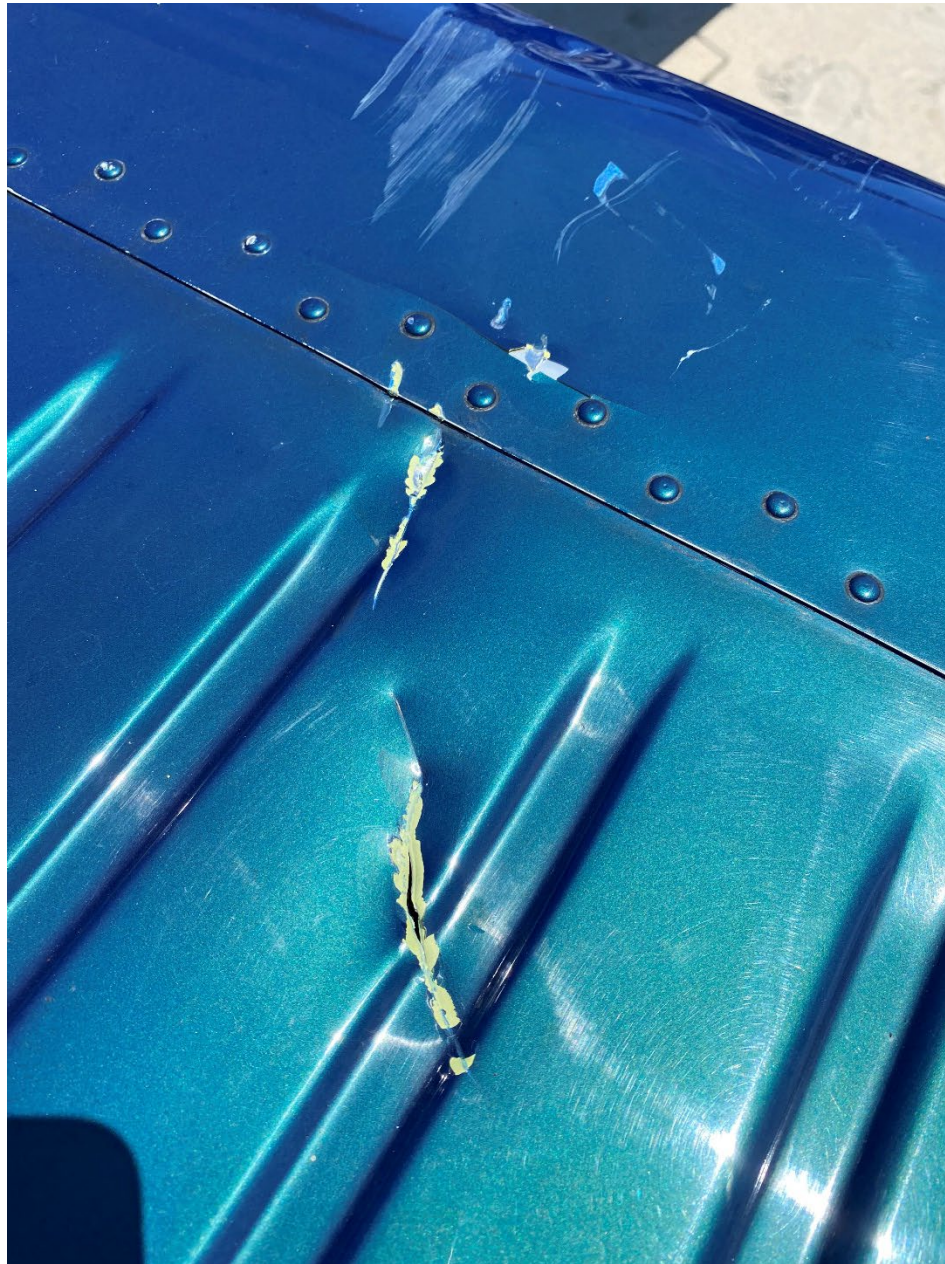
Photo 6 – Close-up view of horizontal stabilizer damage (Phot Courtesy of FAA)

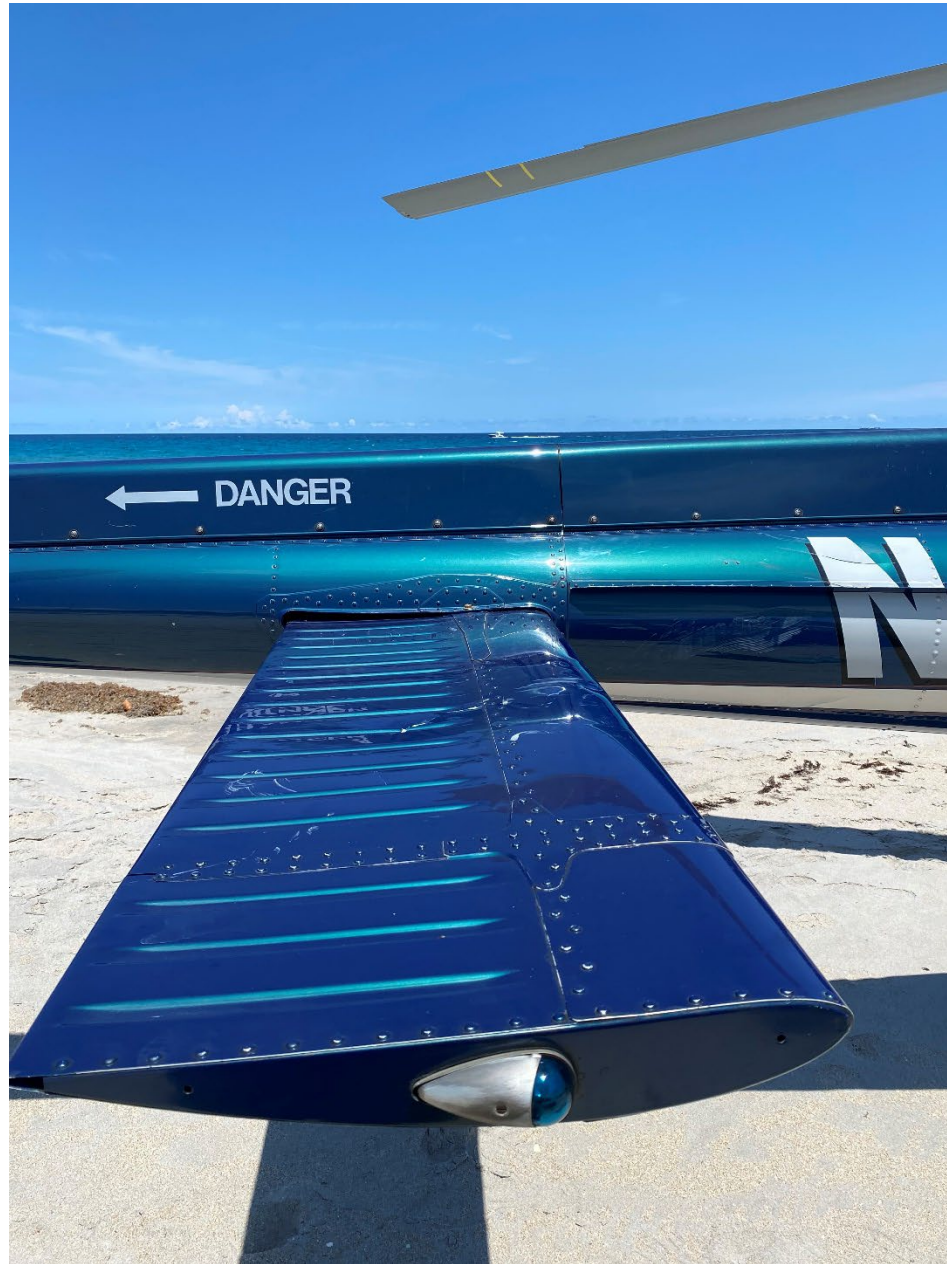
Photo 7 – View of right horizontal stabilizer (Phot Courtesy of FAA)

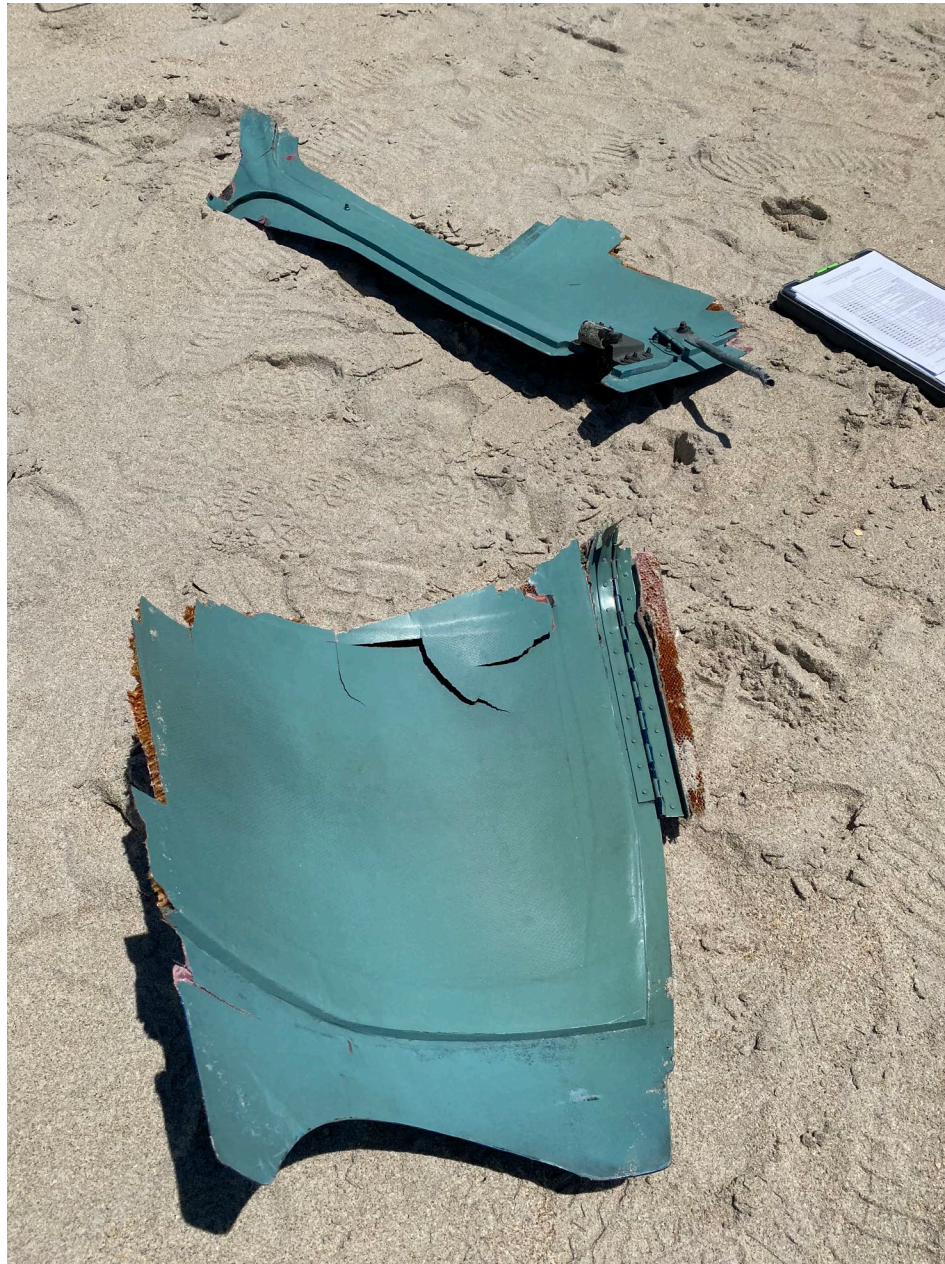
Photo 8 – View of detached engine cowl (Photo Courtesy of FAA)
