NATIONAL TRANSPORTATION SAFETY BOARD

Specialist's Report

SURVIVAL FACTORS

ERA22LA395

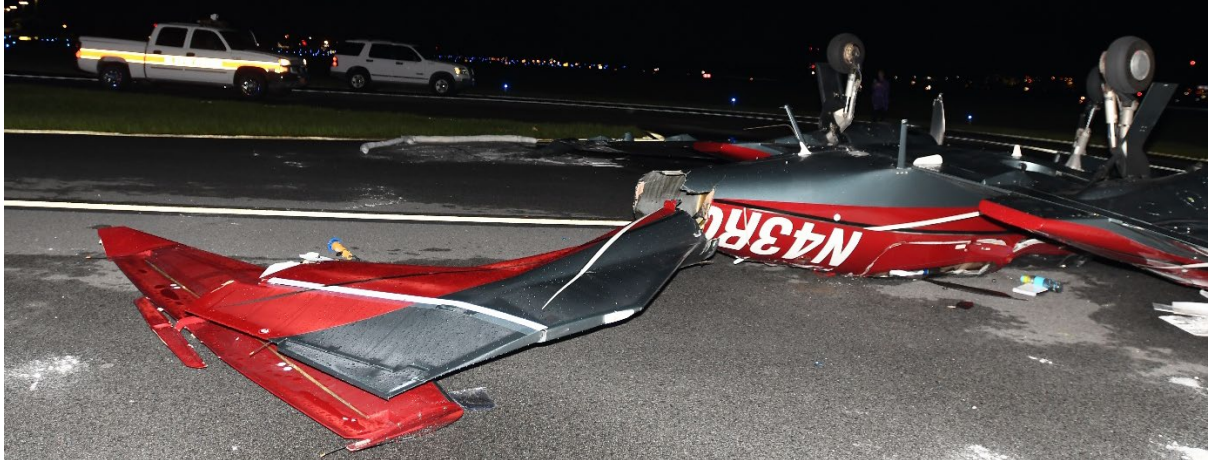
The airplane was found upside down by emergency responders and the FAA inspectors at the accident site. The tail had separated aft of the cabin, and there was crushing along the canopy (see figure 3). The airplane was recovered and transported to Florida Air Recovery. The canopy was not attached to the airplane at the salvage yard (see figure 4) but was in the associated debris that was transported with it.

Figure 3. N43RG post-crash. (Courtesy of the FAA)

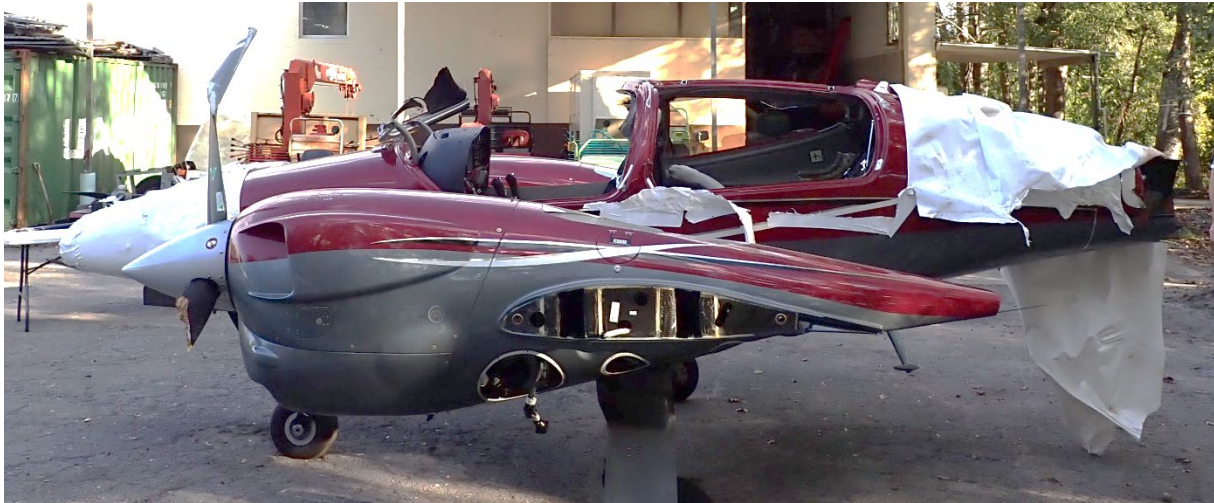
Figure 4. N43RG at Florida Air Recovery.

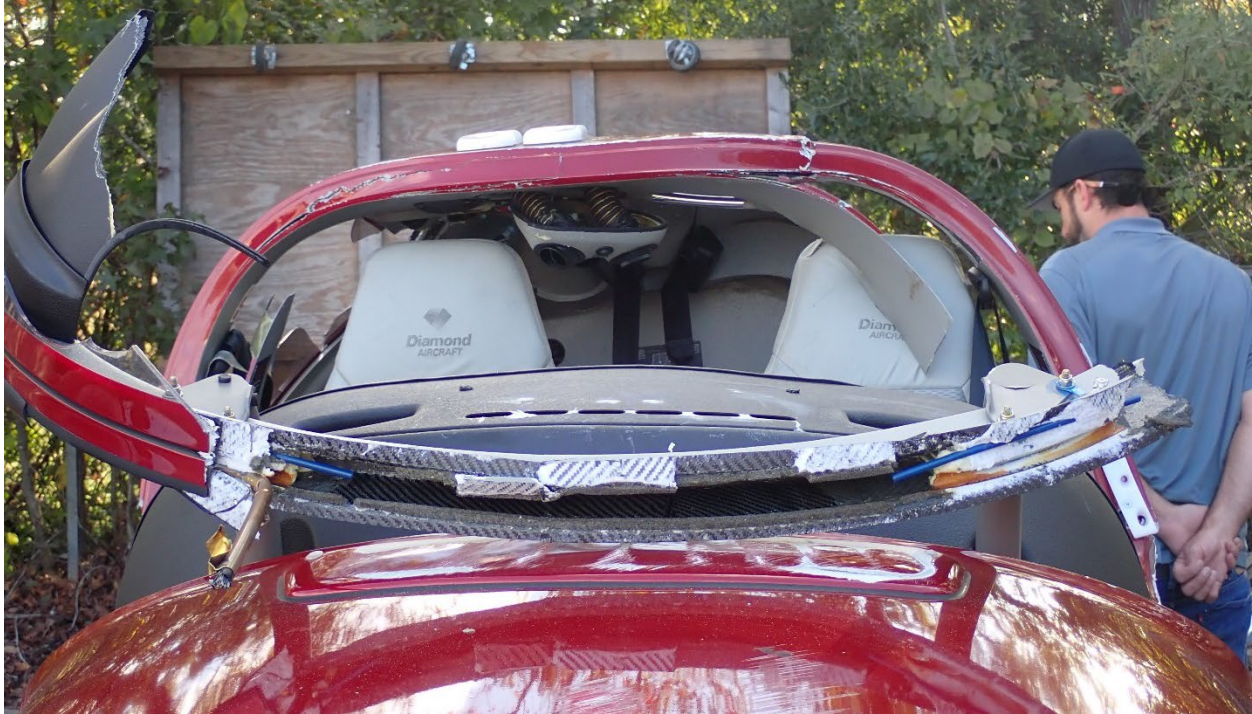
The front seats were accessed by the pilots using a canopy which hinged just forward of the instrument panel. The rear seats, which were unoccupied, were accessed by a top-hinged door located on the left side. The cabin was deformed downward at the overroll bar (see figure 5). Measurements were taken from the middle tunnel cover at the trim wheel to the overroll bar and measured 29.1 inches.

Figure 5. Front view of N43RG at Florida Air Recovery.

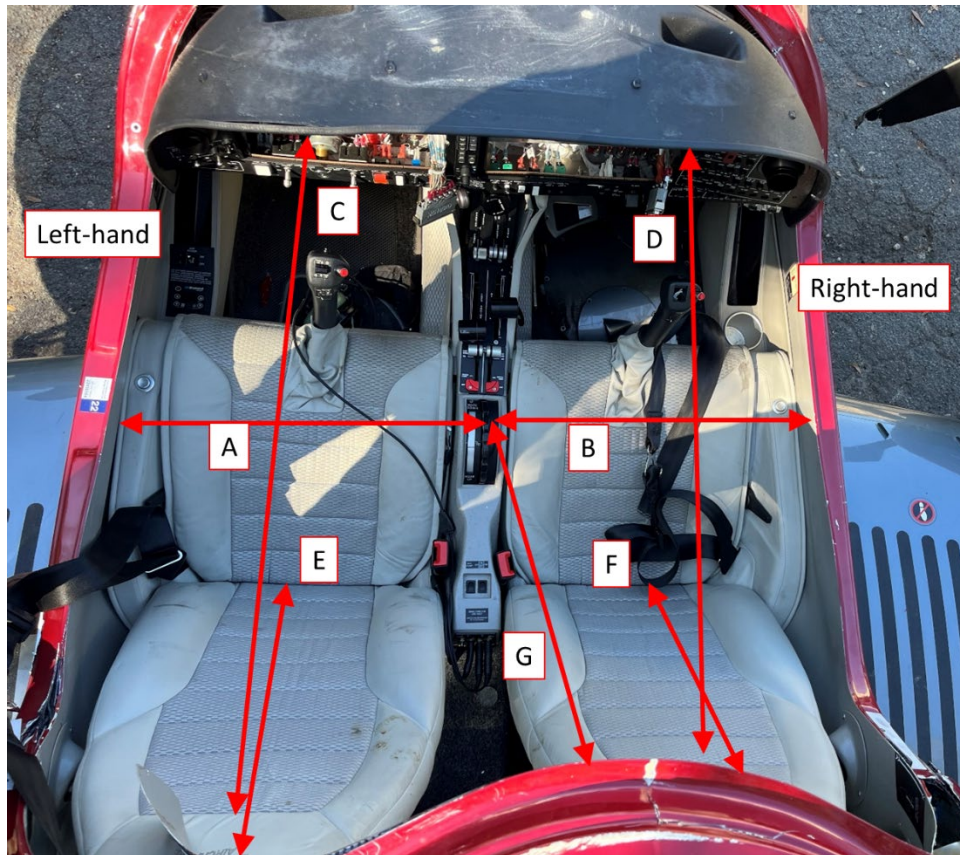
Exemplar measurements were provided by Diamond to compare with the accident airplane. Table 1 details these measurements figures 6 and 7 show where these measurements were taken.

Figure 6. Overhead view of pilot seat measurements.

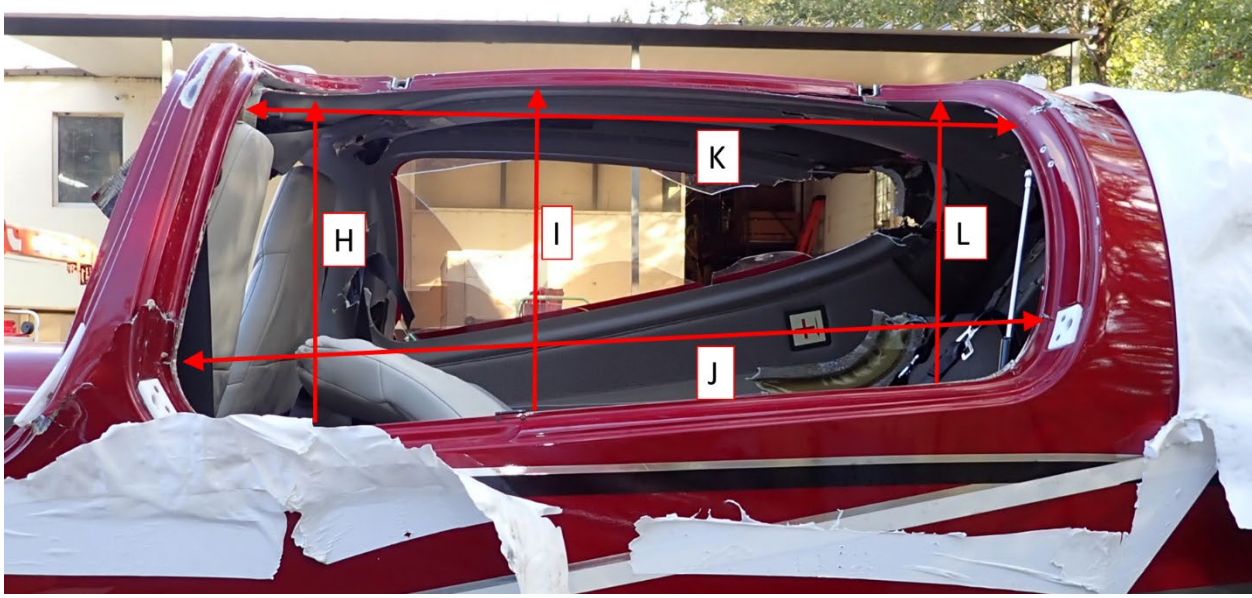
Figure 7. Measurements of left side door frame.

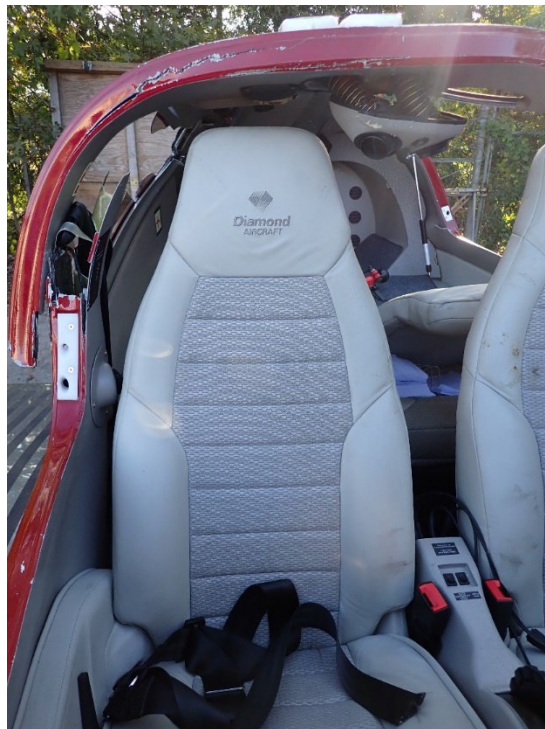
All restraints were still attached to their attachment points and the webbing appeared in good condition. The inertia reels and push button buckles functioned normally. The right-hand front seat upper torso strap was noted to have a clean, linear separation.²

² According to the FAA FSDO inspector who responded to the accident this webbing was cut by first responders to remove the occupant from the airplane.

There was no damage noted to the seat cushions or structure (see figure 8).

Figure 8. Right-hand pilot seat at salvage yard with cut upper torso webbing laying in the seat.

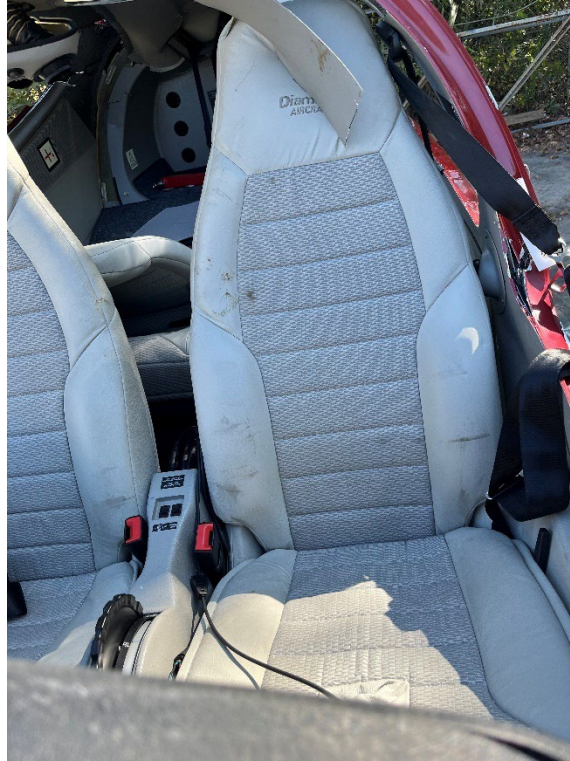
There was no damage noted to the seat cushions or structure (See figure 9).

Figure 9. Left-hand pilot seat at salvage yard.

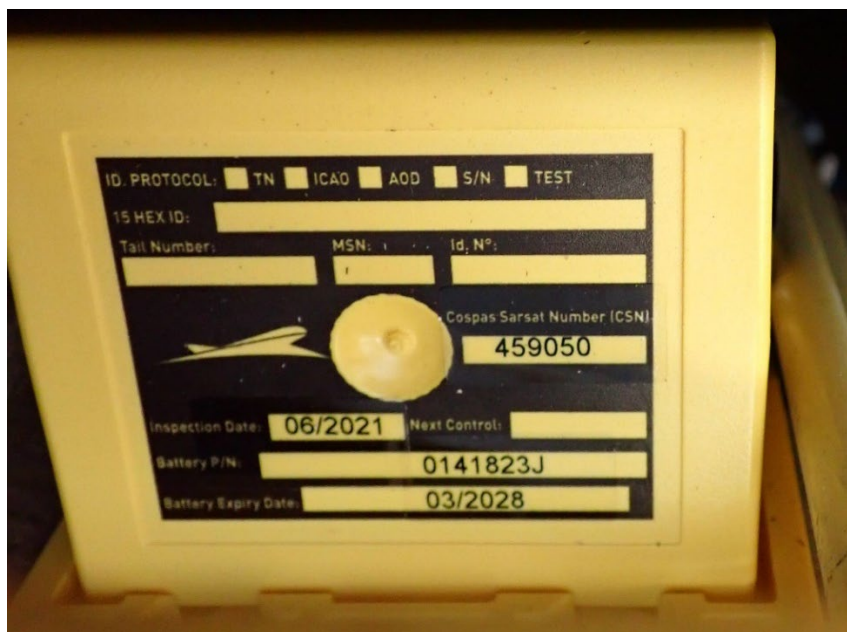
A 406 MHz Emergency Locator Transmitter (ELT) was found in the tail section of the airplane and was still secured in its cradle (see figure 10). It was manufactured by Kannad Integra ER and had a data label affixed to the aft end. The battery had an expiration date of 03/2028. The ELT was not easily accessible to determine if the switch was in the ARMED position because of significant damage in the area.

Figure 10. ELT still secured in the tail section of the airplane.
