Aircraft Accident/Incident Report No.: 221018

NTSB File No.: ERA23FA024

Aircraft: Beechcraft King Air E90

PROPELLER TEARDOWN EXAM – FACTUAL INFORMATION

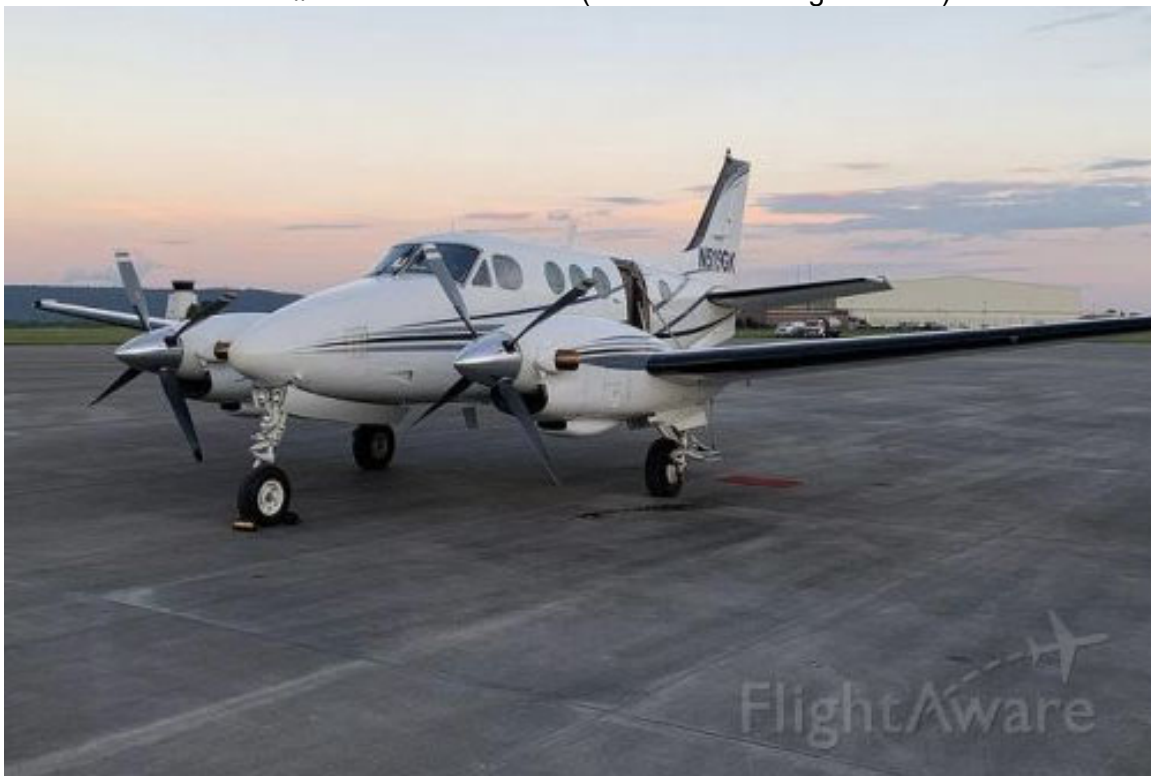
The accident aircraft is shown in Photo #1 with the Raisbeck STC SA3593NM 4-blade propeller models that were installed at the time of the accident.

Photo #1 – Accident Aircraft (obtained from Flight Aware)

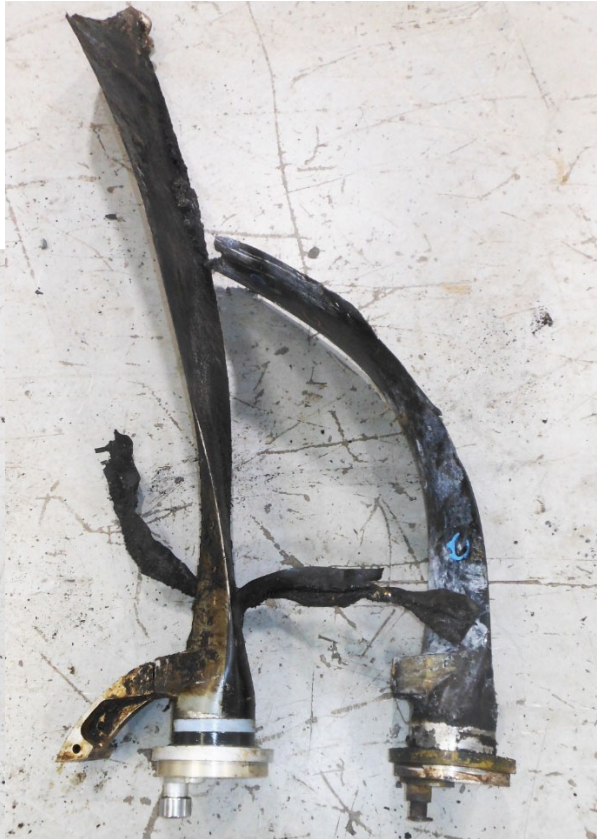
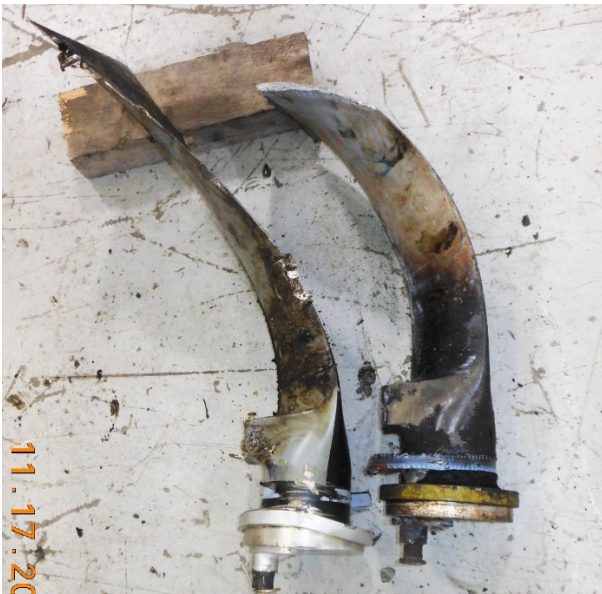
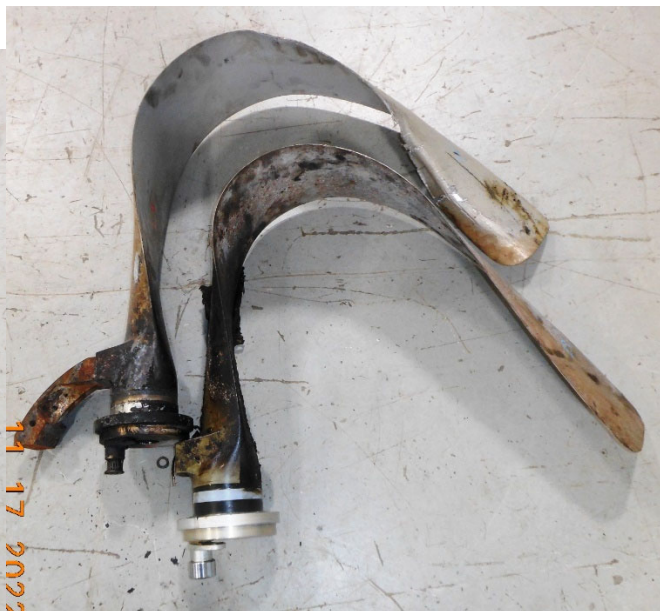
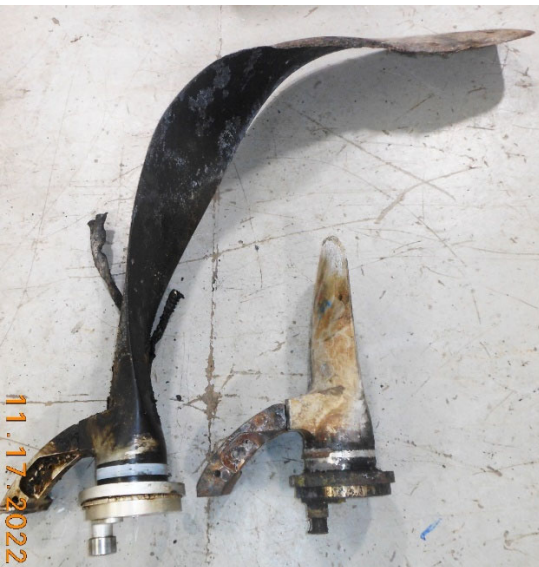
Photo #2 - Montage of left-right blade damage comparison

Both propellers exhibited similar impact damage but the left propeller was more heavily heat damaged; three blades on the left propeller were partially consumed. The montage in Photo #2 shows the relative damage between the left and right blades. Blade damage that included chordwise/rotational scoring on both camber and face sides, bending forward/thrust direction, bending opposite rotation, and leading edge gouging was consistent with impact while rotating with power ON. There was no damage to indicate either propeller was feathered or at low pitch/idle power at the time of impact.

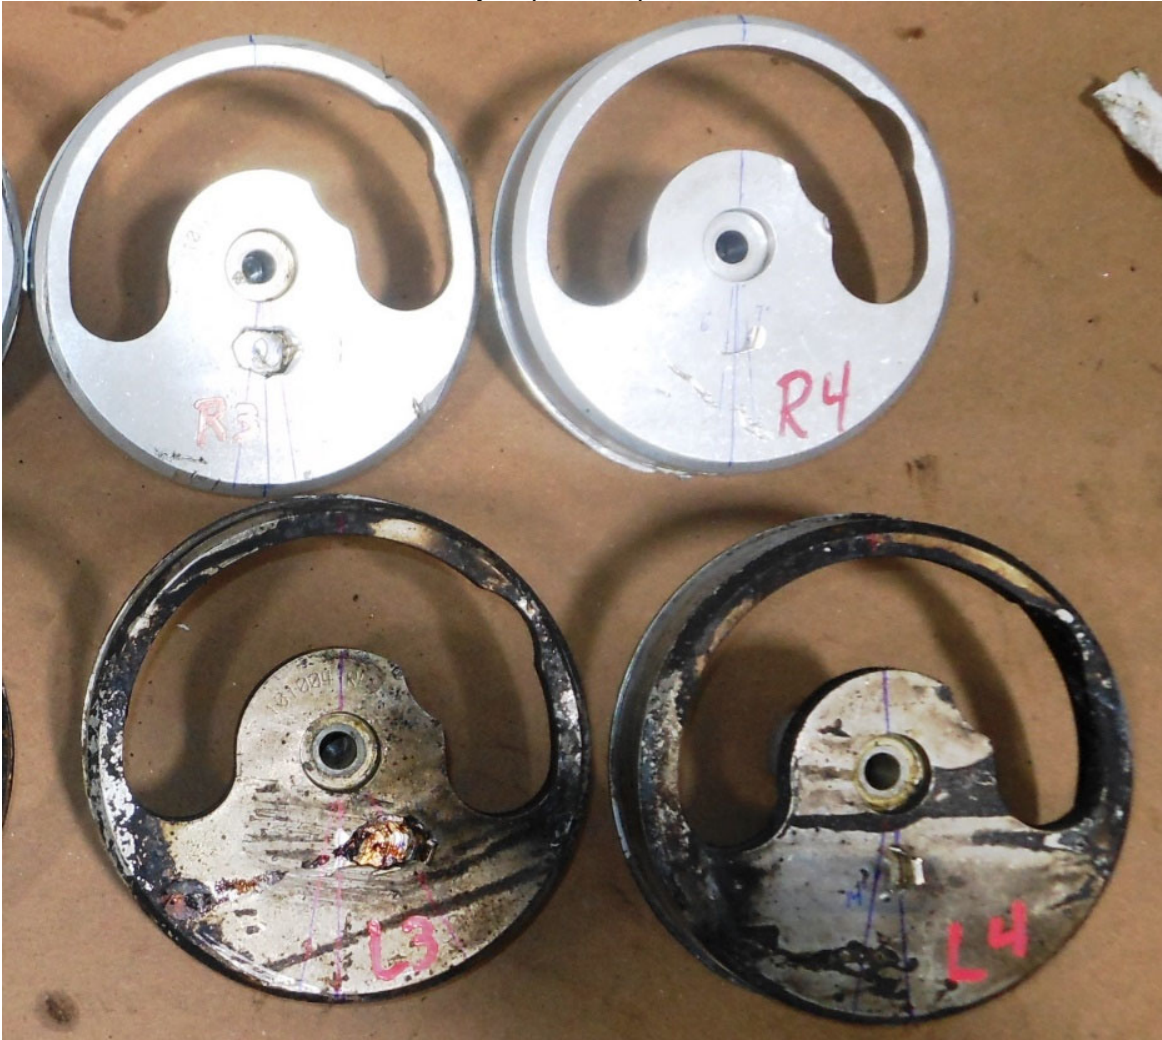
Fork anti-rotation bumper marks on the preload plates indicated both propellers were in a similar blade angle range at impact (Photo #3). Bumper impact marks on the L3 and L4 preload plates suggested the blade angle was in the range of 26-30°. At 3100 ft, 1900 RPM, and 135 KTAS those blade angles would be consistent with power levels between 166 Hp to 404 Hp. At 150 KTAS the estimated power levels are 62 Hp to 304 Hp. Similar bumper marks on the R3 and R4 preload plates indicated a blade angle range of 30-32° which is consistent with power levels of 304 Hp to 542 Hp. The Raisbeck STC SA3593NM AMFS states maximum power is 1520 ft-lbs. @ 1900 RPM which is equivalent to 550 Hp.

Photo #3 – Similarity of preload plates R3-L3 and R4-L4

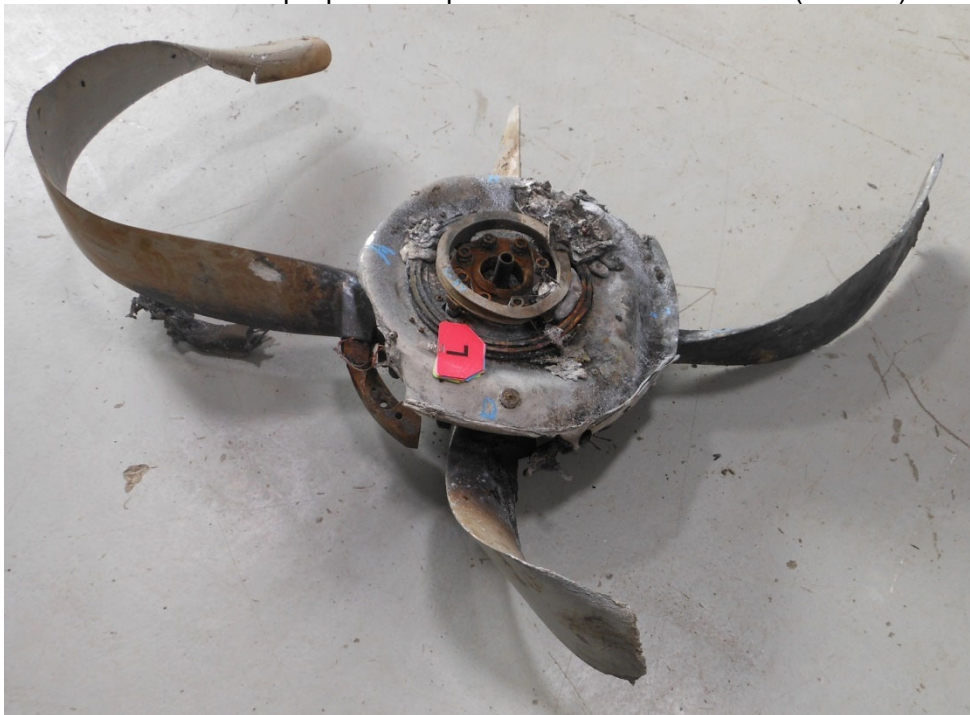
As Received: The left propeller fractured from the propeller shaft during the impact sequence, was recovered and presented for examination at Anglin's as shown in Photos #4 and #5. The propeller shaft flange remained attached to the hub with all mounting bolts present and lockwired. The entire propeller exhibited heat damage and discoloration. Three blades were partially consumed by the post-crash fire. Two blades appeared to be bent forward in the thrust direction, two blades appeared to be bent aft. The L1 counterweight was missing. The L2 counterweight had pulled from the blade but was retained by the de-ice wires. The hydraulic unit (cylinder, piston, pitch change rod, pitch stops, and feathering spring) fractured from the propeller assembly and was not presented for examination. The cylinder mounting boss was fractured and the pitch change rod was fractured in the fork thread area. The spinner dome was crushed, torn and mostly consumed. The spinner bulkhead was partially consumed. The beta ring remained attached via the beat rods but had localized bending/crushing and fractures. The beta rods were present but the forward ends were either fractured or bent as they exited the forward hub half. The de-ice boots were consumed and the de-ice wire insulation was consumed.

Photo #4 – Left propeller as-presented for examination (aft side)

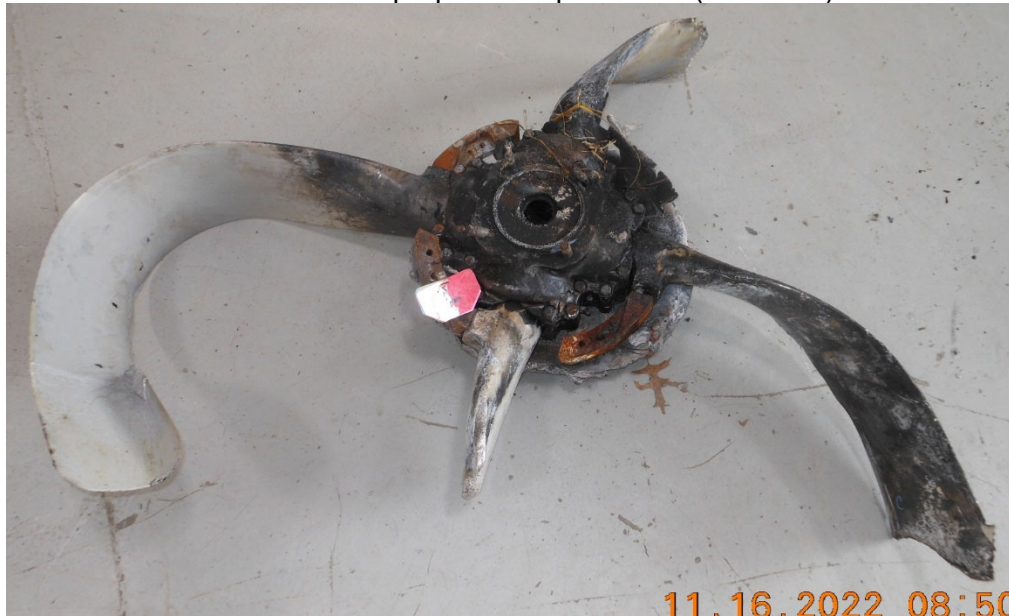
Photo #5 – Left propeller as-presented (front side)

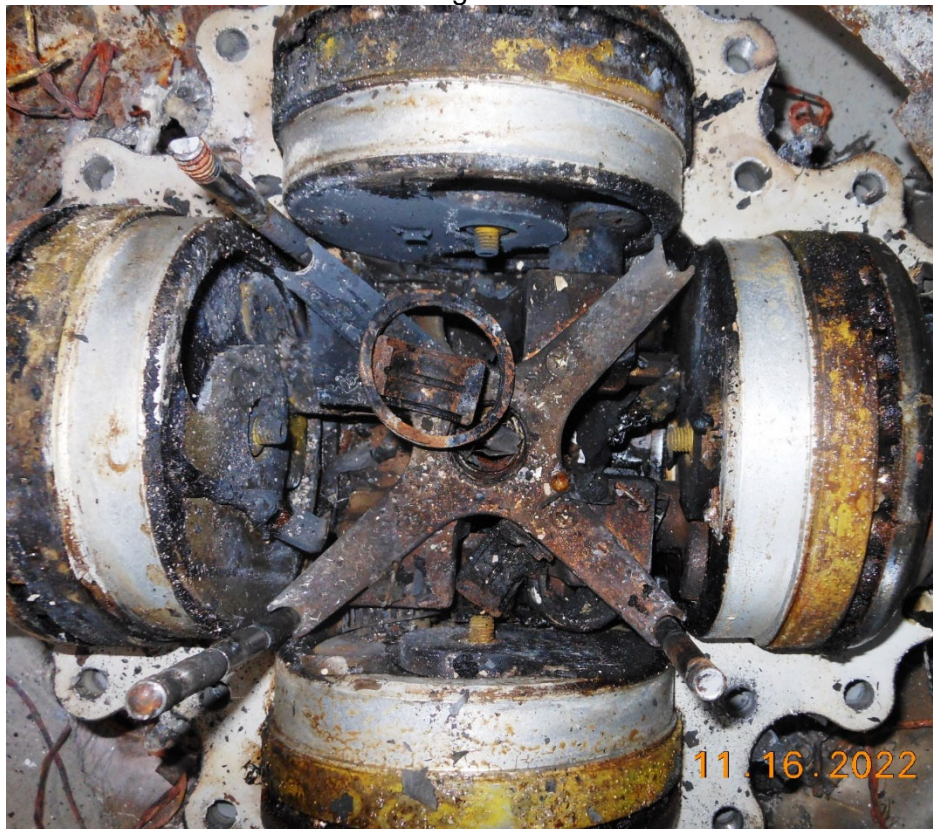
Pitch Change Mechanism: The majority of the pitch change mechanisms (fork, pitch change knobs/brackets) were fractured or exhibited heat damage (Photo #6).

Photo #6 – Pitch change mechanisms condition

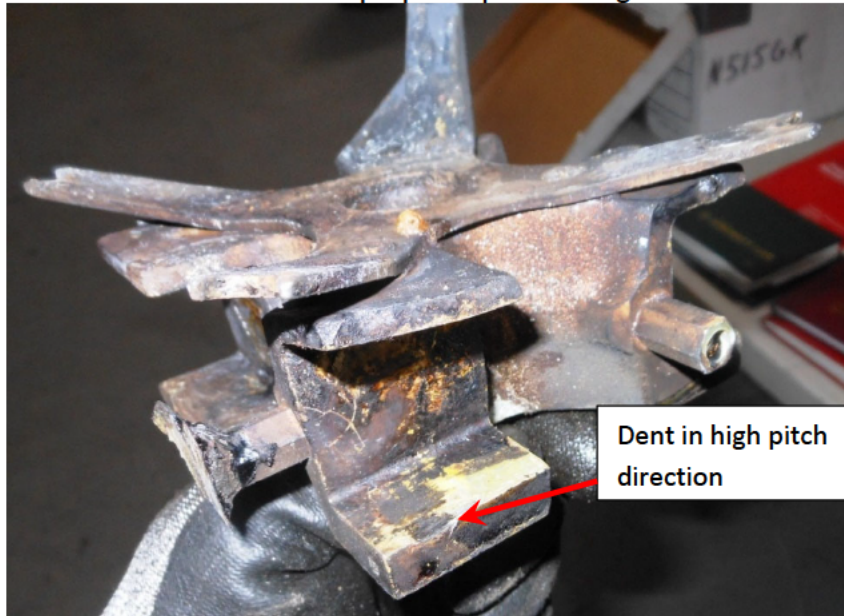
Fork: See Photo #7. The pitch change fork exhibited remarkable heat discoloration. All four legs of the beta fork were bent forward. Two forward tangs were fractured in the forward direction. Three aft tangs exhibited denting/gouging from the pitch change knob/cam follower. Two anti-rotation bumpers fractured from the fork assembly.

Photo #7 – Left propeller pitch change fork

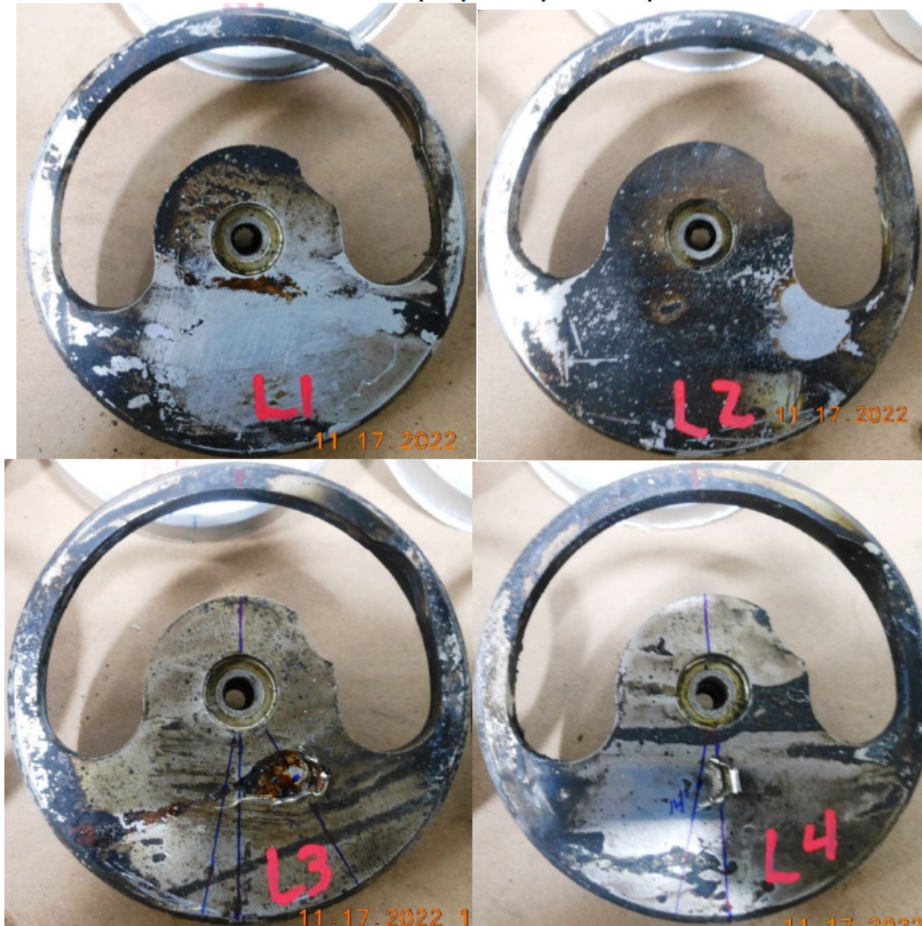
Preload Plates: See Photo #8. All four preload plates exhibited heat discoloration/shooting/charring and had varying degrees of the retention lip smashed or fractured.

Preload Plate	Condition
L1	There were no discernable fork bumper marks.
L2	There were no discernable fork bumper marks.
L3	Fork bumper mark 8.5° forward of the parting line progressing to 32° aft of the parting line which translate to blade angles of approximately 30° to 61°.
L4	Fork bumper mark 14° forward of the parting line progressing to 3-4° forward of the parting line which translate to blade angles of approximately 26° to 33°.

Photo #8 - Left propeller preload plates

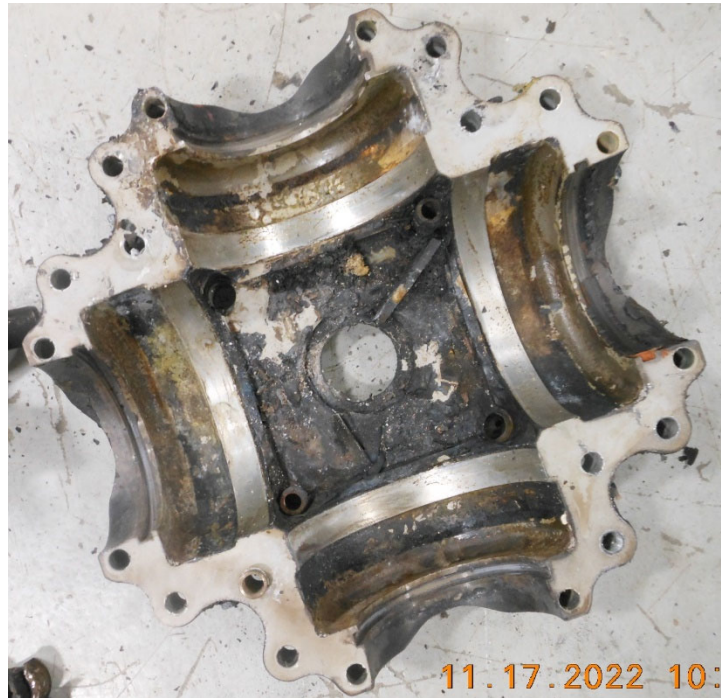
Hub Assembly: The hub assembly exhibited heat discoloration/charring/sooting on both external and internal surfaces (Photos #9 and #10). The forward pitch change rod bushing was missing; the aft bushing was partially melted. The cylinder mounting boss was mostly fractured from the forward hub half. The preload plate pockets and webs were damaged in varying degrees. Otherwise there were no remarkable fractures in the blade retention arms. There were contact marks in the blade aperture in the aft/trailing edge quadrant for blades L1 and L2.

Photo #9 – Left forward hub half internal surface

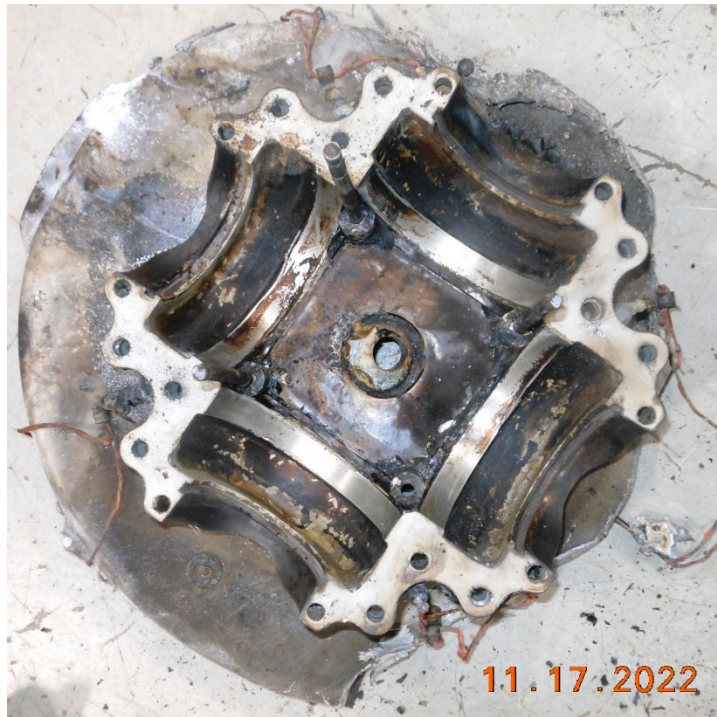
Photo #10 – Left aft hub half internal surface

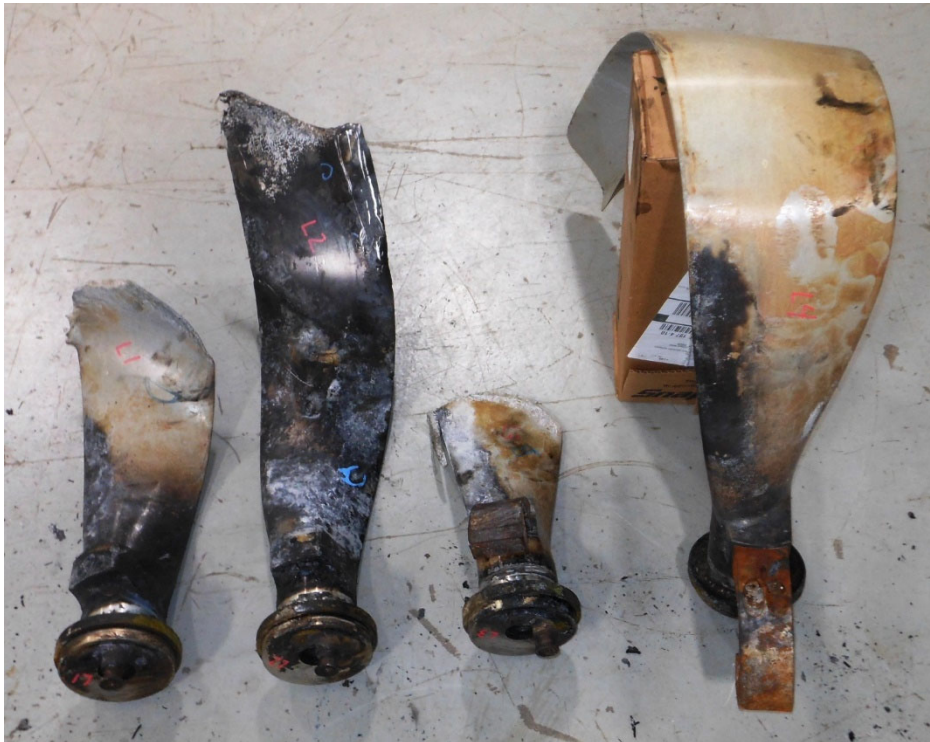
Camber side	Heat damage and discoloration
Face side	Heat damage and discoloration
Bend	Forward/thrust direction
Twist	Not discernable on remaining portion of blade.
Lead edge damage	Not remarkable on remaining portion of blade.
Trail edge damage	Not remarkable on remaining portion of blade.
Knob condition	Bracket bent, screws pulled, cam follower bearing fractured
Counterweight	Fracture separated.
Blade bearings	Intact, charred, ball spacer melted, grease hardened
Butt/shank impact marks	Heat discoloration, charred, marks in the hub aperture and shank indicating impact loads in the lead-to-trail direction at an operational blade angle
De-Ice boot	Consumed

Camber side	Chordwise/rotational scoring
Face side	Chordwise/rotational scoring
Bend	Forward/thrust direction
Twist	Not discernable on remaining portion of blade
Lead edge damage	Gouging
Trail edge damage	Local, bends and tears
Knob condition	Cam follower bearing fractured
Counterweight	Fracture separated, counterweight remained attached to propeller via the de-ice wires
Blade bearings	Intact, charred, ball spacer melted, grease hardened
Butt/shank impact marks	Heat discoloration, charred, no discernable marks
De-Ice boot	Consumed

Camber side	Charred, heat discoloration
Face side	Charred, heat discoloration
Bend	Appears to be aft
Twist	Not discernable in remaining portion
Lead edge damage	Not remarkable
Trail edge damage	Not remarkable
Knob condition	Cam follower fractured
Counterweight	Intact, displaced from boss
Blade bearings	Intact, charred, ball spacer melted, grease hardened
Butt/shank impact marks	Heat discoloration, charred, no discernable marks
De-Ice boot	Consumed

Camber side	Charred, heat discoloration
Face side	Charred, heat discoloration
Bend	Aft
Twist	Not remarkable
Lead edge damage	Nicks
Trail edge damage	Heat damage, partially consumed
Knob condition	Cam follower bearing fractured
Counterweight	Intact
Blade bearings	Intact, charred, ball spacer melted, grease hardened
Butt/shank impact marks	Heat discoloration, charred, no discernable marks
De-Ice boot	Consumed

Photo #11 – Left blades camber side

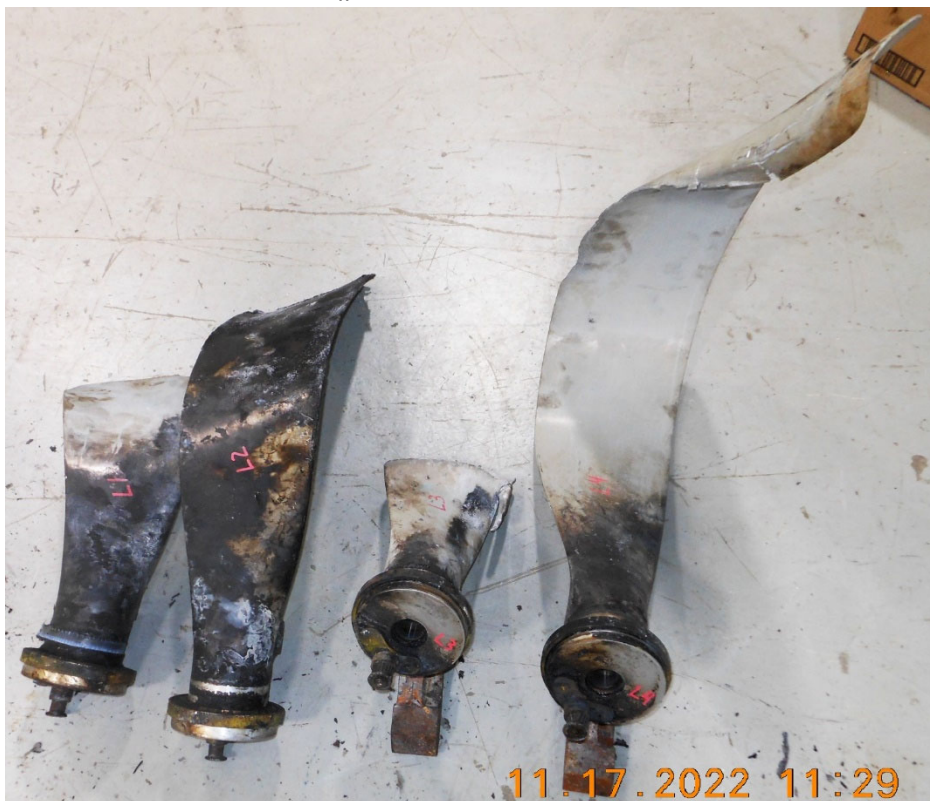
Photo #12 – Left blades face side

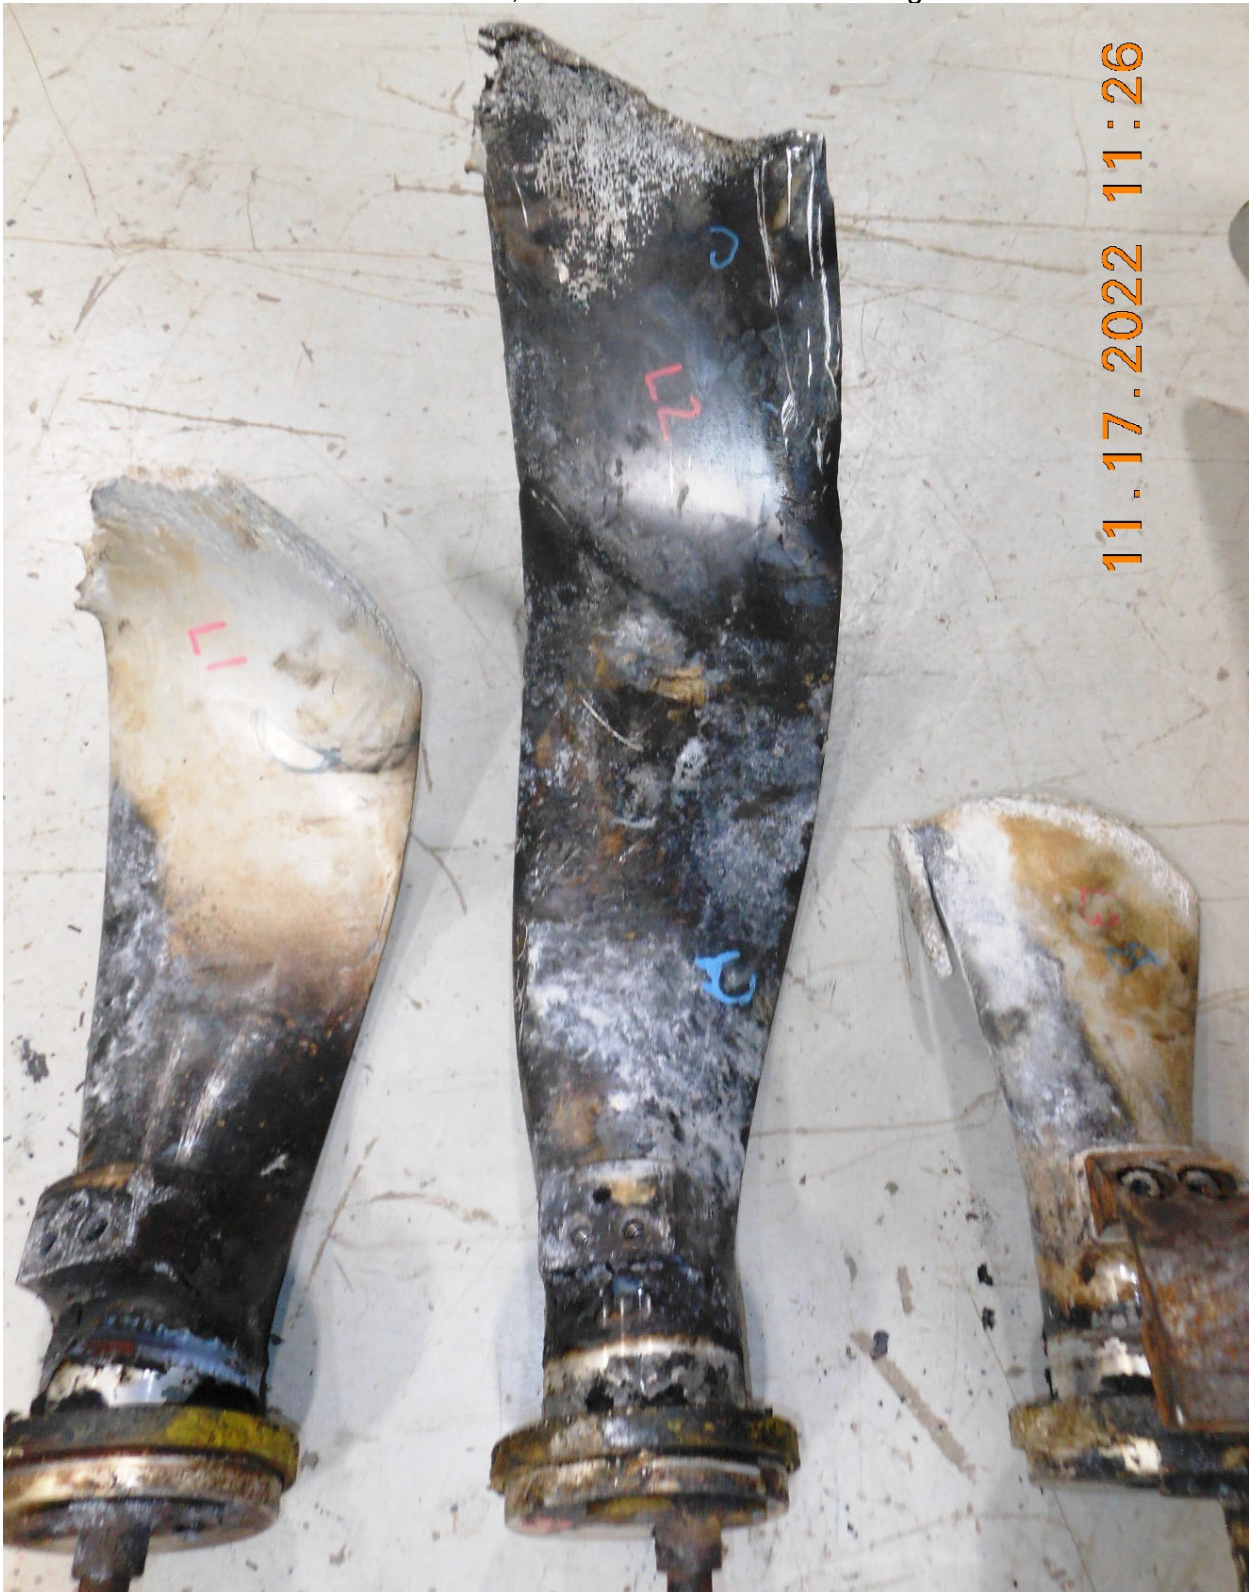
Photo #13 – L1, L2 and L3 relative heat damage

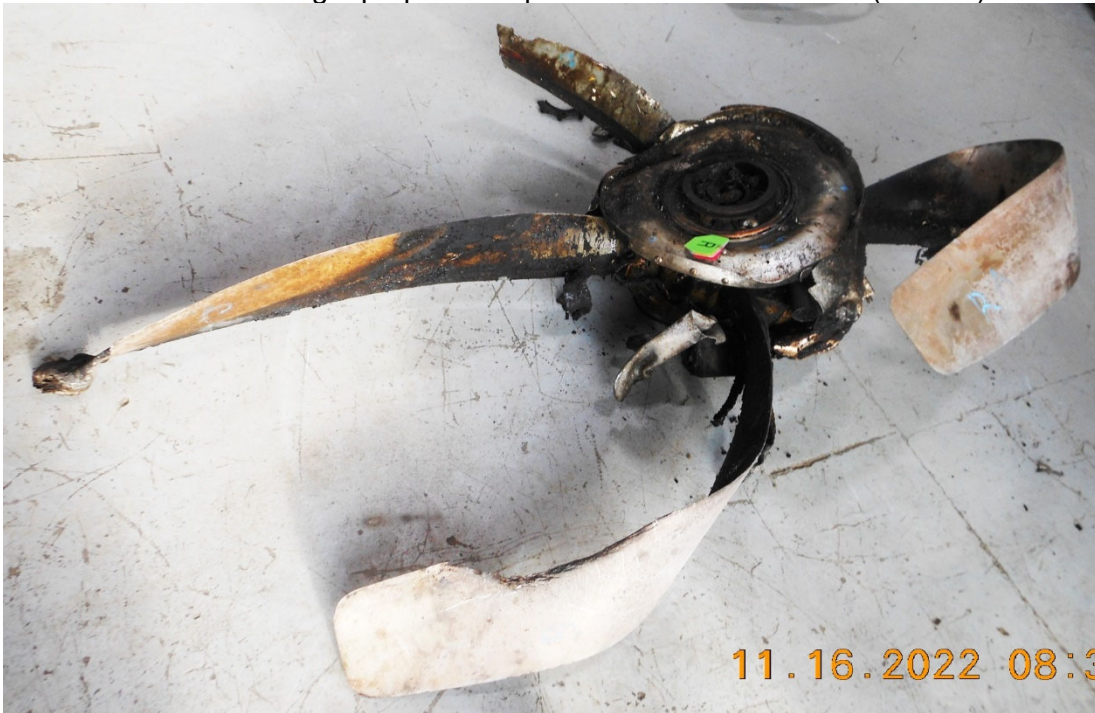
As Received: The right propeller fractured from the propeller shaft during the impact sequence, was recovered and presented for examination at Anglin's as shown in Photos #14 and #15. The propeller shaft flange remained attached to the hub with all mounting bolts present and lockwired. The forward hub half exhibited a complete fracture across the R1-R3 blade arms (Photo #16). The propeller exhibited heat damage, sooting and discoloration but did not exhibit as much heat exposure as the left propeller. Two blades (R2 and R3) were partially melted/consumed by the post-crash fire. Blades R1 and R2 appeared to be bent forward in the thrust direction, R3 and R4 blades appeared to be bent aft. Several blades had leading edge gouging. The R1 and R4 counterweights fractured from the blades but were retained by the de-ice wires. Blade R1 was intentionally cut across the Hartzell decal to facilitate recovery from the crash scene. Blade R4 could be partially rotated by hand force indicating pitch change damage. The hydraulic unit (cylinder, piston, pitch change rod, pitch stops, and feathering spring) fractured from the propeller assembly and was not presented for examination. The cylinder mounting boss was partially fractured and the pitch change rod was fractured forward of the fork. The spinner dome was crushed, torn and partially consumed. The spinner bulkhead was bent. The beta ring remained attached via the beat rods but had localized bending/crushing and fractures. The beta rods were present but the forward ends were either fractured or bent as they exited the forward hub half.

Photo #14 – Right propeller as-presented for examination (aft side)

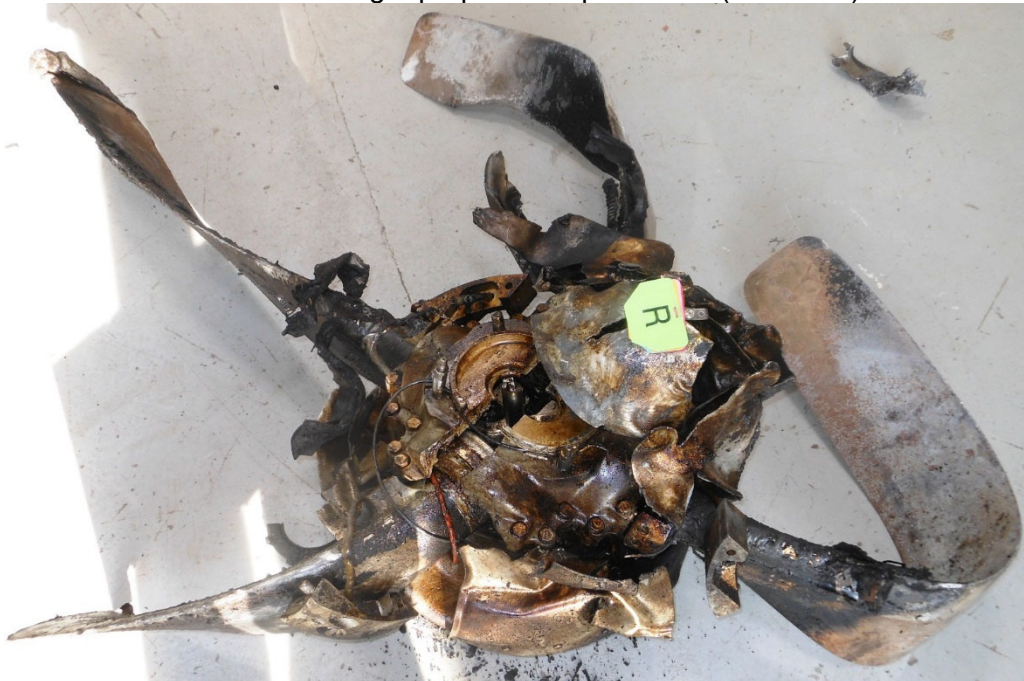
Photo #15 – Right propeller as-presented (front side)

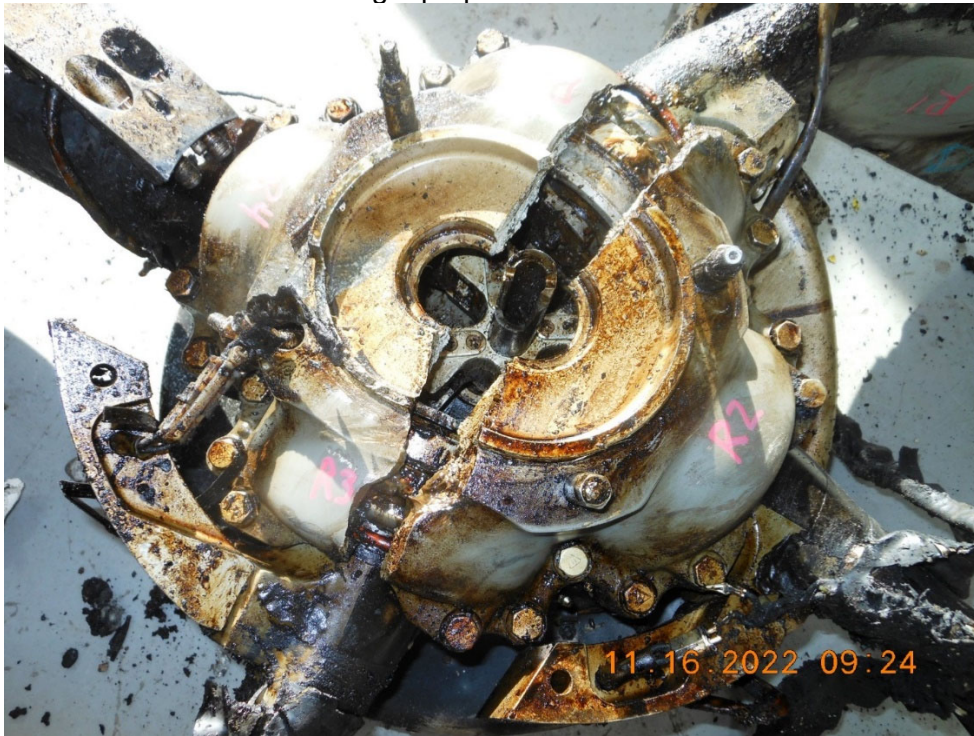
Photo #16 – Right propeller forward hub fracture

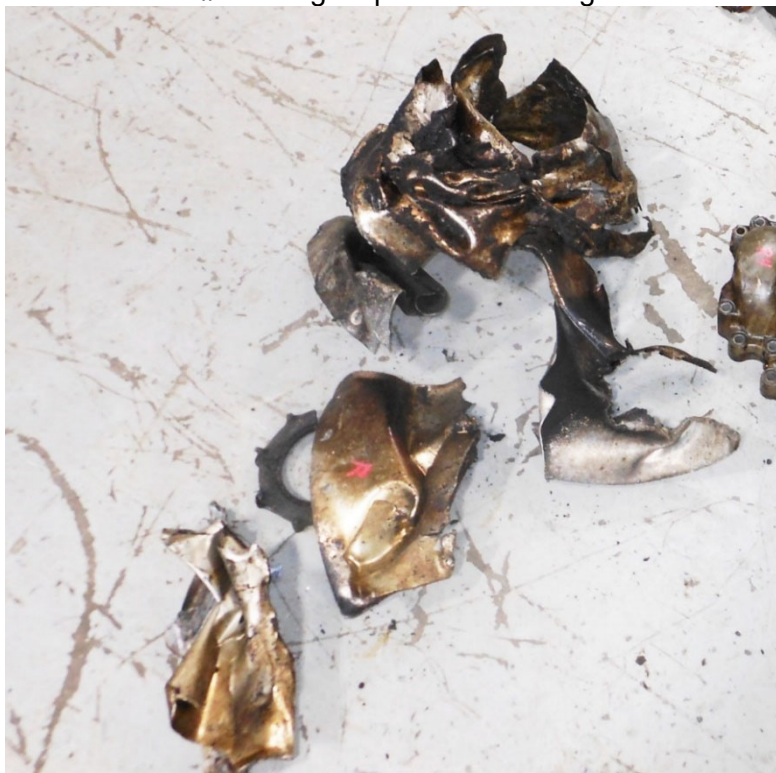
Spinner Dome: See Photo #17. The spinner dome was crushed and torn with small fragments attached to the spinner bulkhead. There were no discernable counterweight impact marks in the fragments.

Photo #17 – Right spinner dome fragments

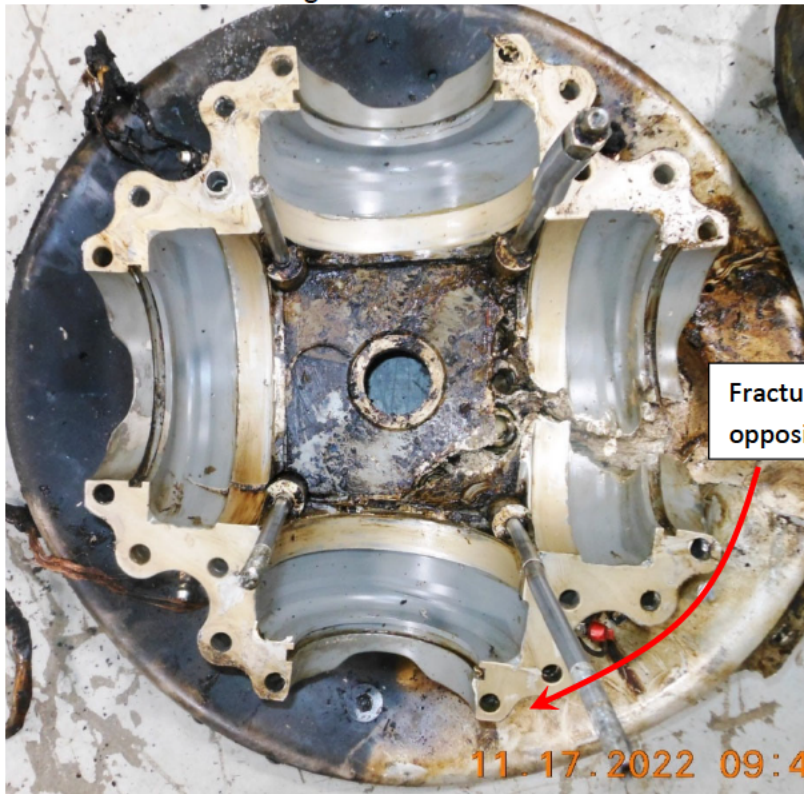
Hub Assembly: See Photos #18 and #19. The hub assembly exhibited heat discoloration/charring/sooting on both external and internal surfaces. The forward hub half was completely fractured across the R1-R3 blade arms (Photo #19). The aft hub half was fractured apart in the blade R1 aperture across the hub and partially through the blade R3 aperture. The R1 aperture was displaced opposite rotation (Photo #18). The forward change rod bushing was missing and the aft bushing was mostly melted/consumed. The cylinder mounting boss was partially fractured from the forward hub half. The preload plate pockets and webs were damaged in varying degrees. There were contact marks in the blade aperture in the aft/trailing edge quadrant for blades R1, R2 and R3.

Photo #18 – Right aft hub half internal surface

Fracture and deformation
opposite rotation

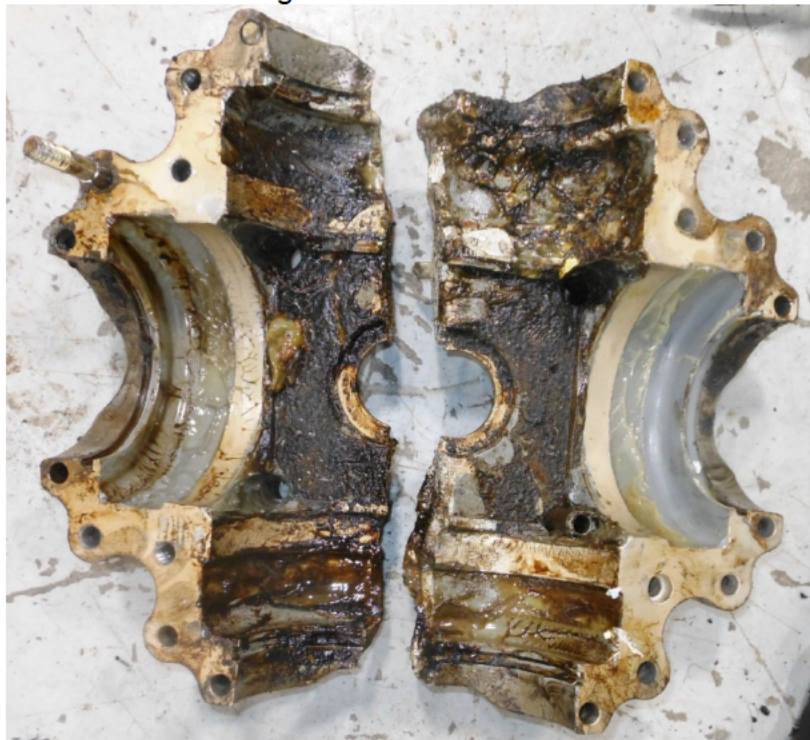
Photo #19 – Right forward hub half internal surface

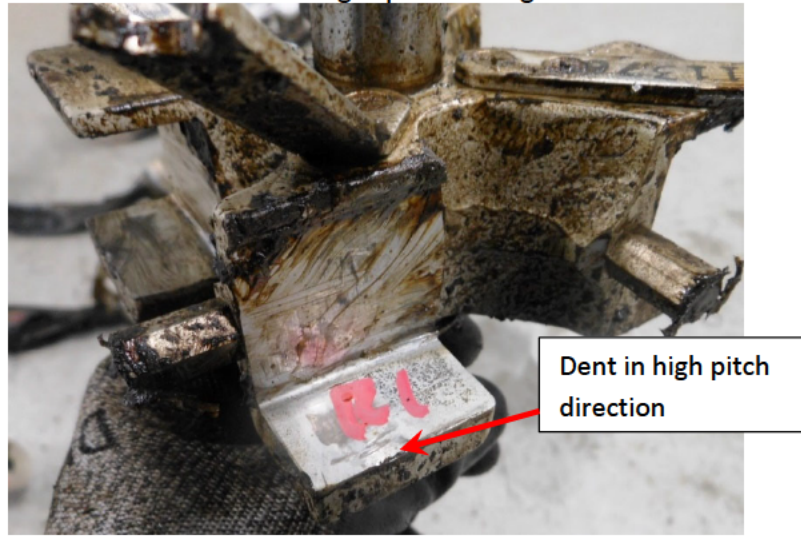
Fork: See Photo #20. The pitch change fork exhibited heat discoloration. All four legs of the beta fork were bent forward. Two forward tangs were fractured in the forward direction, the R1 forward tang was missing. Three aft tangs (R1, R2 and R3) exhibited denting/gouging from the pitch change knob/cam follower. One anti-rotation bumpers fractured from the fork assembly.

Photo #20 – Right pitch change fork

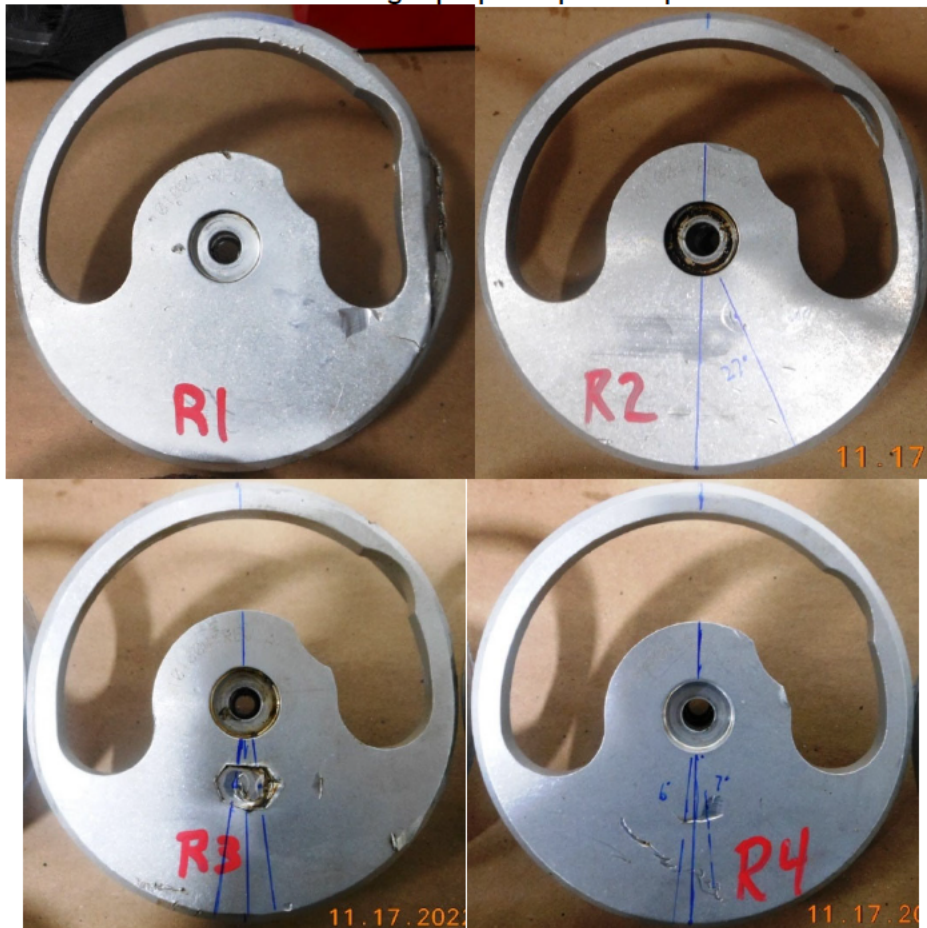
Preload Plates: See Photo #21. All four preload plates had varying degrees of the retention lip smashed or fractured.

Preload Plate	Condition
R1	No discernable bumper marks. The aft/face quadrant of the plate was fractured.
R2	Fork bumper mark 27° aft of the parting line which translates to a blade angle of approximately 56°.
R3	Fork bumper mark 8.5° forward of the parting line progressing to 7.5° aft of the parting line which translate to blade angles of approximately 30° to 41°.
R4	Fork bumper mark 6° forward of the parting line progressing to 7° aft of the parting line which translate to blade angles of approximately 32° to 41°.

Photo #21 - Right propeller preload plates

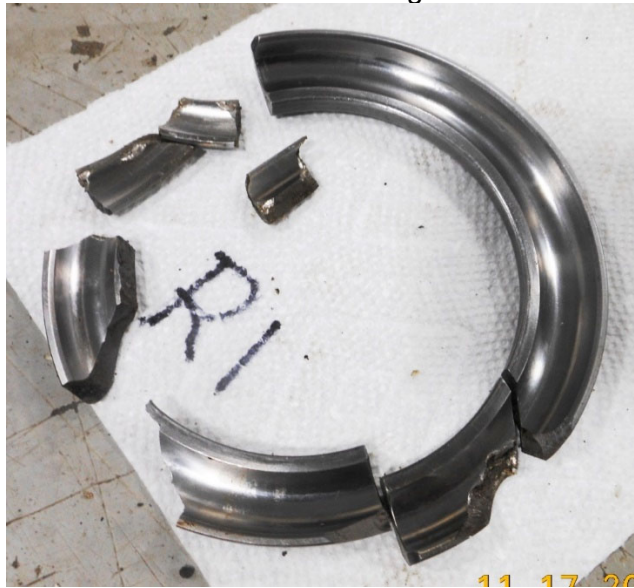
Photo #22 - Blade R1 bearing race fractures

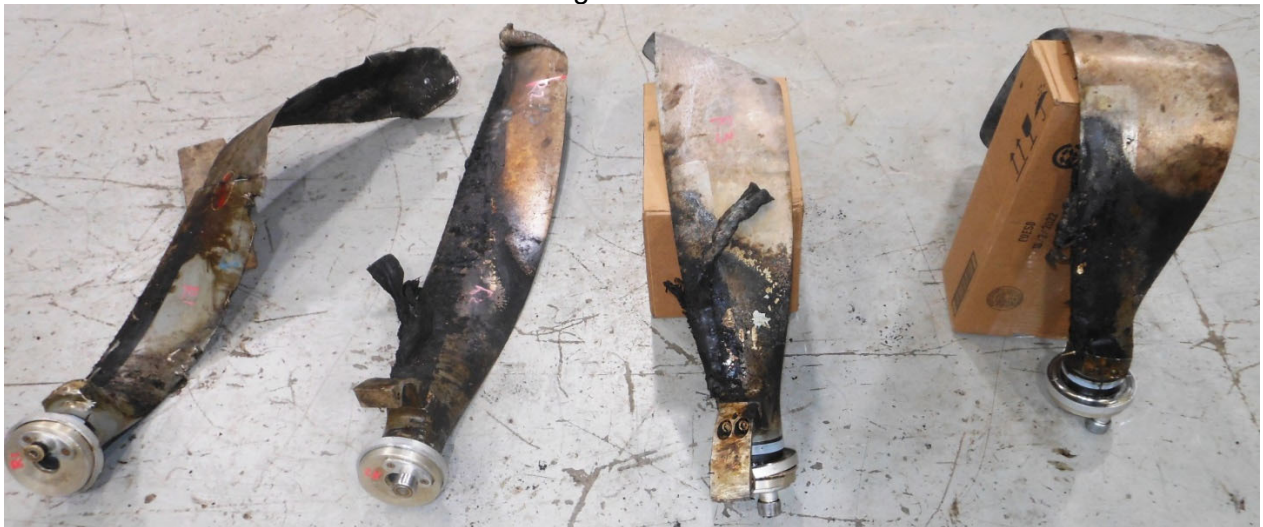
Photo #23 – Right blades camber side

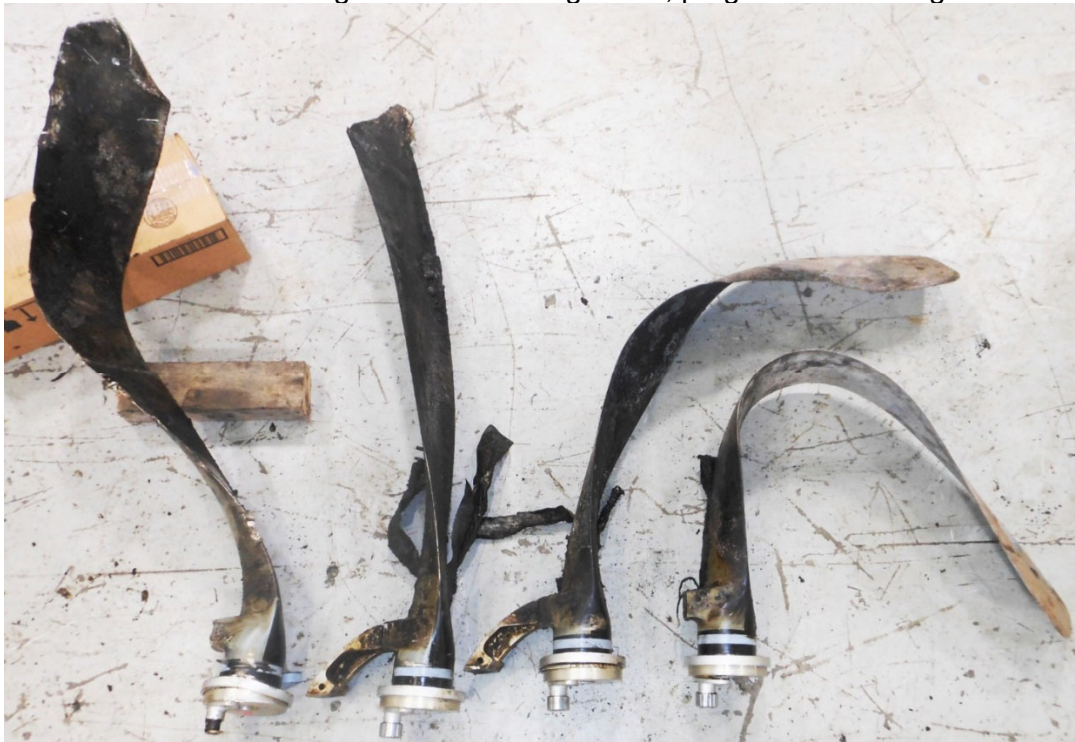
Photo #24 – Right blades trail edge view, progressive bending

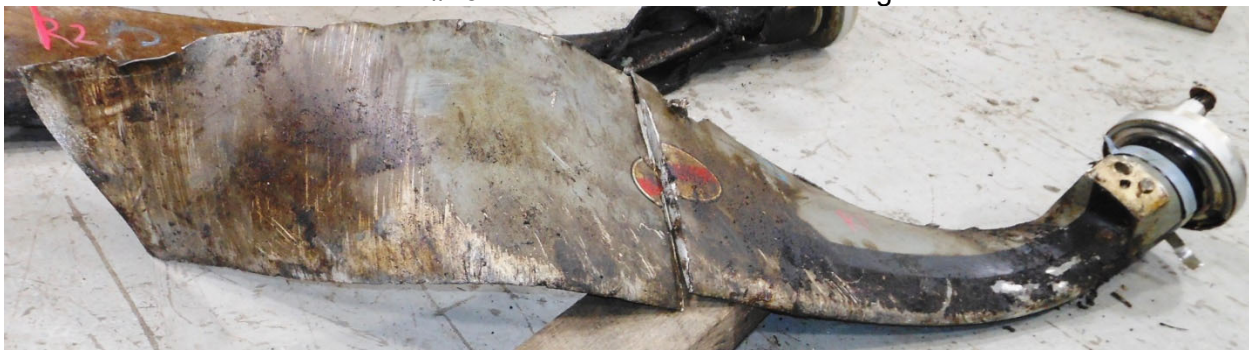
Camber side	Chordwise/rotational scoring (Photo #25)
Face side	Chordwise/rotational scoring (Photo #26)
Bend	Forward/thrust direction at shank and mid-blade, aft at the tip (S-bend shape). Remarkable bending opposite rotation in the edgewise/major axis direction (Photo #27).
Twist	Toward low pitch at tip
Lead edge damage	Gouging
Trail edge damage	Localized bending
Knob condition	Bracket intact, cam follower bearing fractured
Counterweight	Fracture separated, holes opposite rotation
Blade bearings	Fractured, some ball imprints (Photo #22).
Butt/shank impact marks	Contact marks in the hub aperture and shank indicating impact loads in the lead-to-trail direction at an operational blade angle. Bearing race retention ring fractured.
De-Ice boot	Torn off, separated

Photo #25 - Blade R1 camber side damage
