Aircraft Accident/Incident Report No.: 221018

NTSB File No.: ERA23FA024

Aircraft: Beechcraft King Air E90

PROPELLER TEARDOWN EXAM – FACTUAL INFORMATION

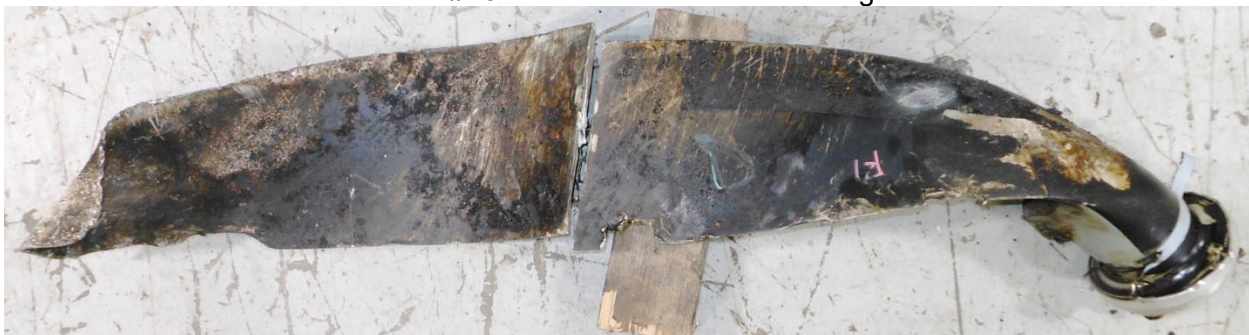
Camber side	Chordwise/rotational scoring (Photo #25)
Face side	Chordwise/rotational scoring (Photo #26)
Bend	Forward/thrust direction at shank and mid-blade, aft at the tip (S-bend shape). Remarkable bending opposite rotation in the edgewise/major axis direction (Photo #27).
Twist	Toward low pitch at tip
Lead edge damage	Gouging
Trail edge damage	Localized bending
Knob condition	Bracket intact, cam follower bearing fractured
Counterweight	Fracture separated, holes opposite rotation
Blade bearings	Fractured, some ball imprints (Photo #22).
Butt/shank impact marks	Contact marks in the hub aperture and shank indicating impact loads in the lead-to-trail direction at an operational blade angle. Bearing race retention ring fractured.
De-Ice boot	Torn off, separated

Photo #26 – Blade R1 face side damage

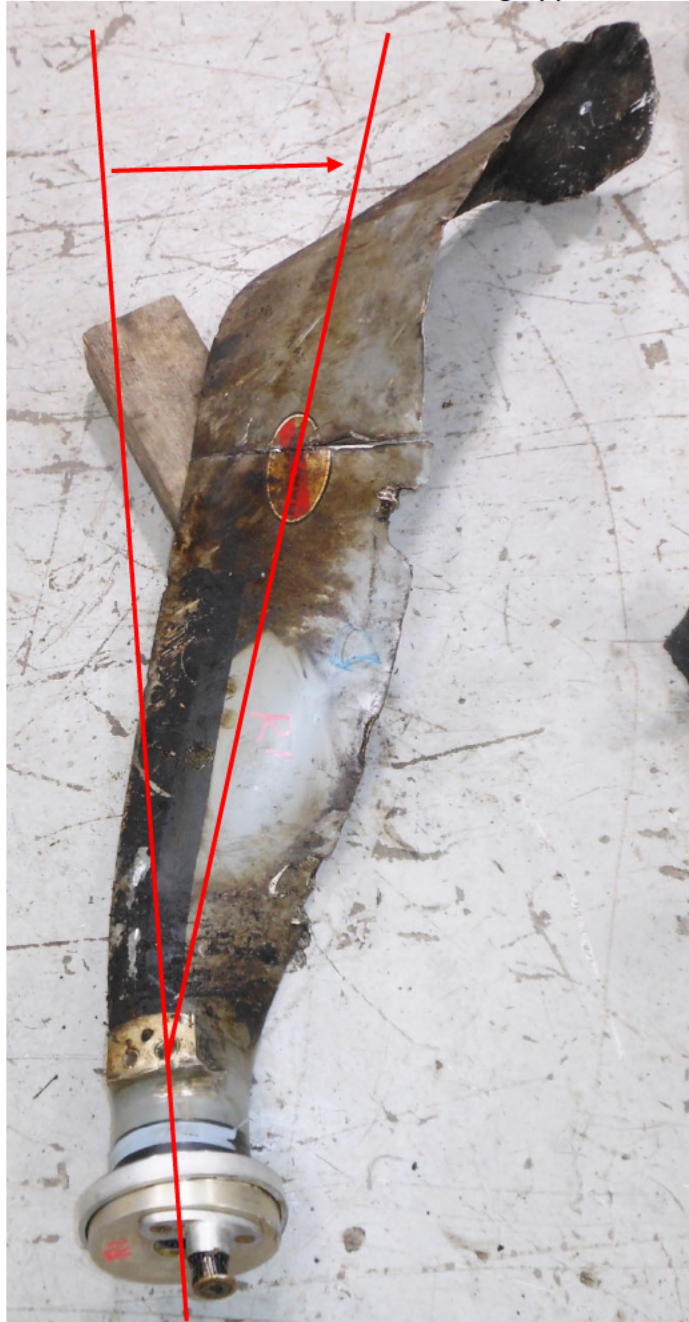
Photo #27 - Blade R1 remarkable bending opposite rotation
