National Transportation Safety Board

ERA23FA024

ACCIDENT EXAMINATION

10/18/2022

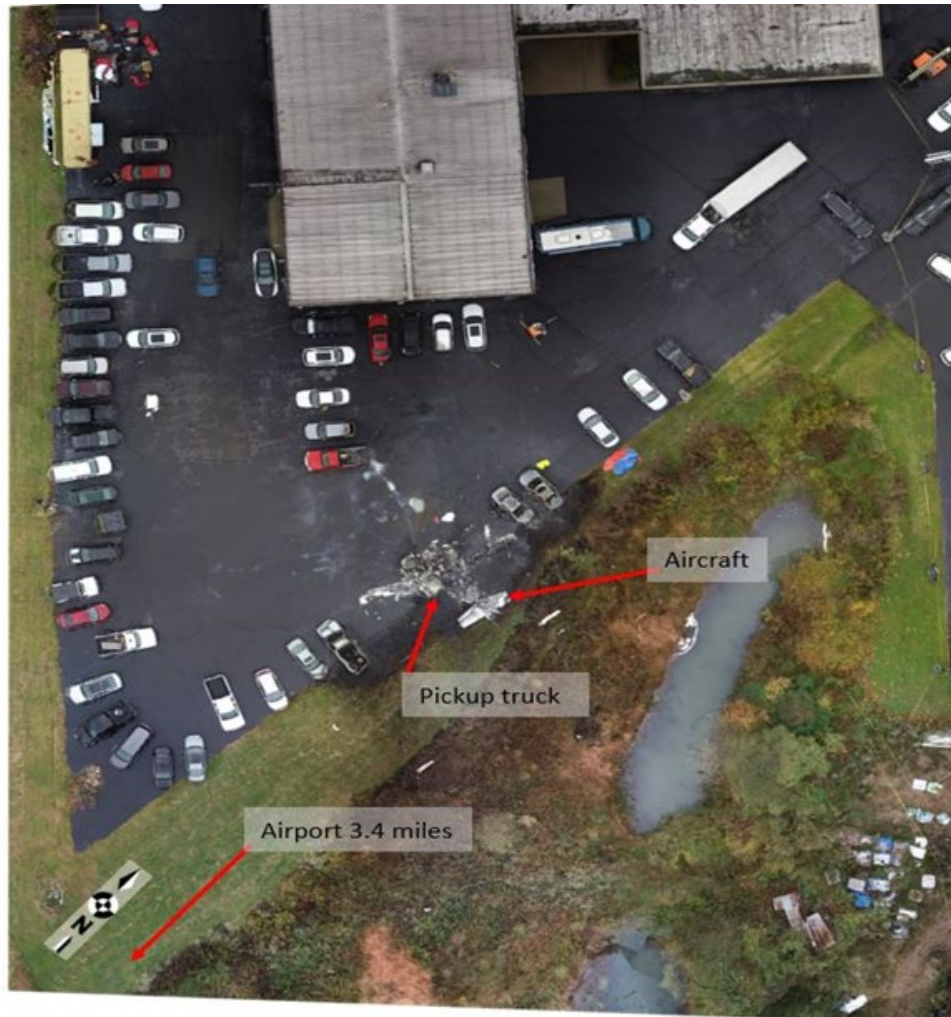
The airplane impacted an automobile dealership parking lot at an elevation of 614 ft msl, about 3 miles northeast of the approach end of runway 21 at PKB. The airplane struck several vehicles before coming to rest on level pavement. The wreckage path was compact and oriented on a heading of 305° magnetic (Figure 1) All major components of the airplane were accounted for at the accident scene. The cockpit and forward portions of the fuselage were crushed aft.

Figure 1 NTSB UAS overhead View of Accident Site

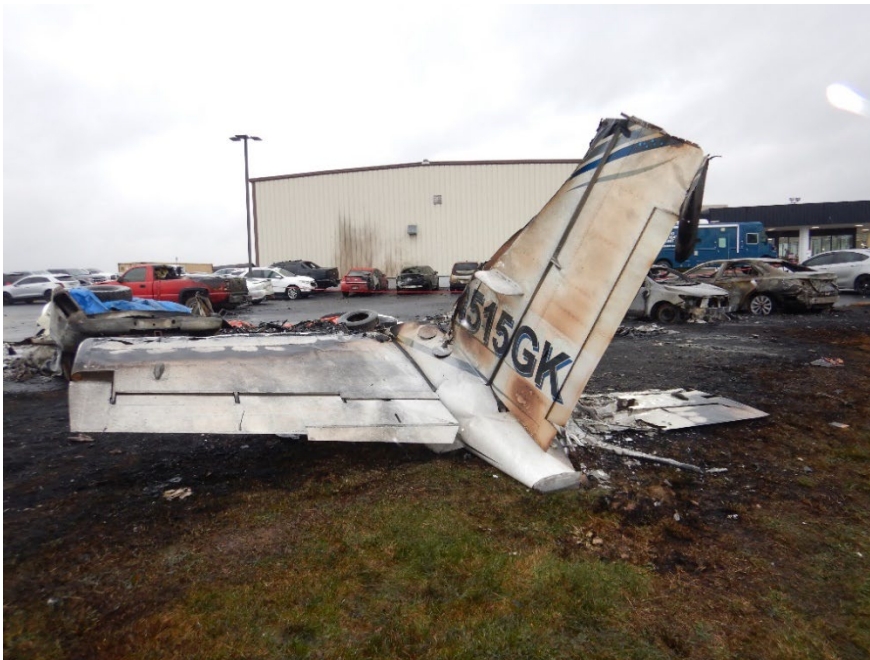
The empennage remained partially attached to the fuselage via control cables and floor structure. The rudder and elevators remained attached to the empennage at their respective hinges. The right side of the elevator was thermally and impact damaged. The elevator trim control surface remained attached. The rudder and elevator control cables were traced through the wreckage to their respective locations. All breaks in the cables were indicative of overload

Figure 2 Empennage, Rudder, Elevators and Trim

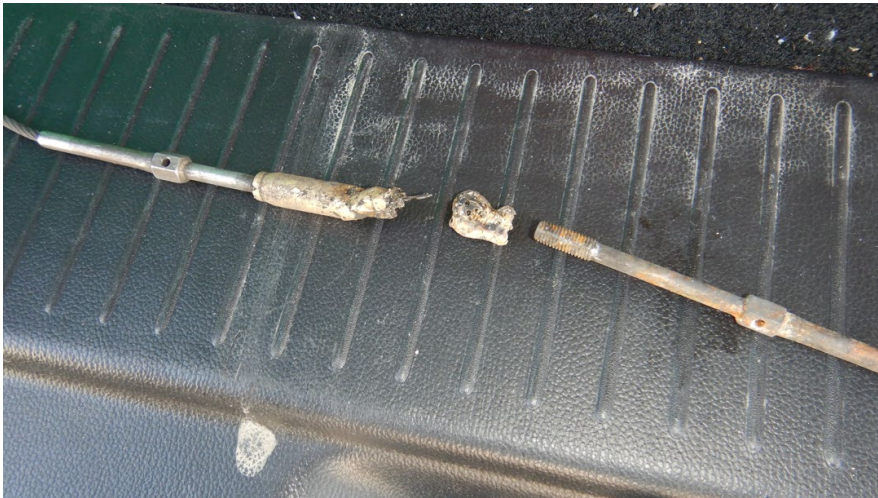
and had a “broom straw” appearance. The up elevator control cable was separated at the turnbuckle and appeared as though it was melted, and a post-accident NTSB materials visual review informed the IIC that the turnbuckle was melted post impact.

Figure 3 Elevator cable and turnbuckle. Visual exam revealed it was melted post impact.

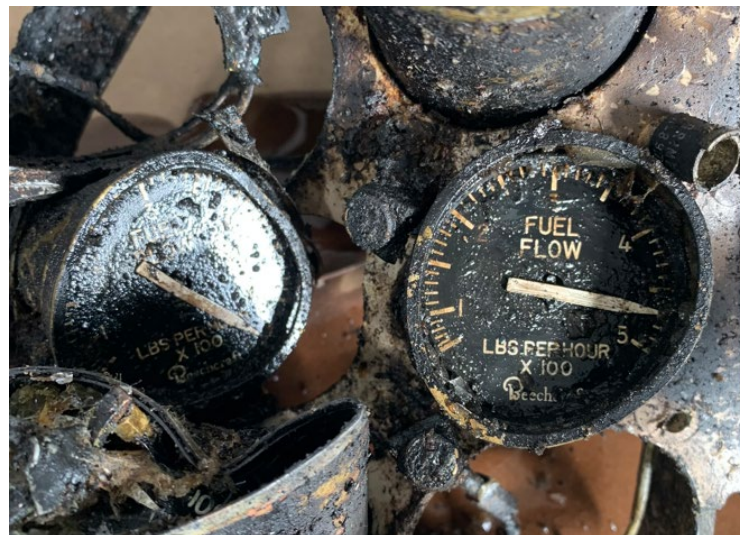
All cockpit instrumentation, gauges and switches were exposed to post-impact fire and extreme impact forces. There was limited identifying instrumentation or gauges that could be verified however, the fuel flow gauges, although damaged showed the left and right at 480 lbs. per hour and 465 lbs. per hour respectively. All other controls both electronic and manual were severely impact and thermally damaged.

Figure 4 L/R Fuel flow gauges.

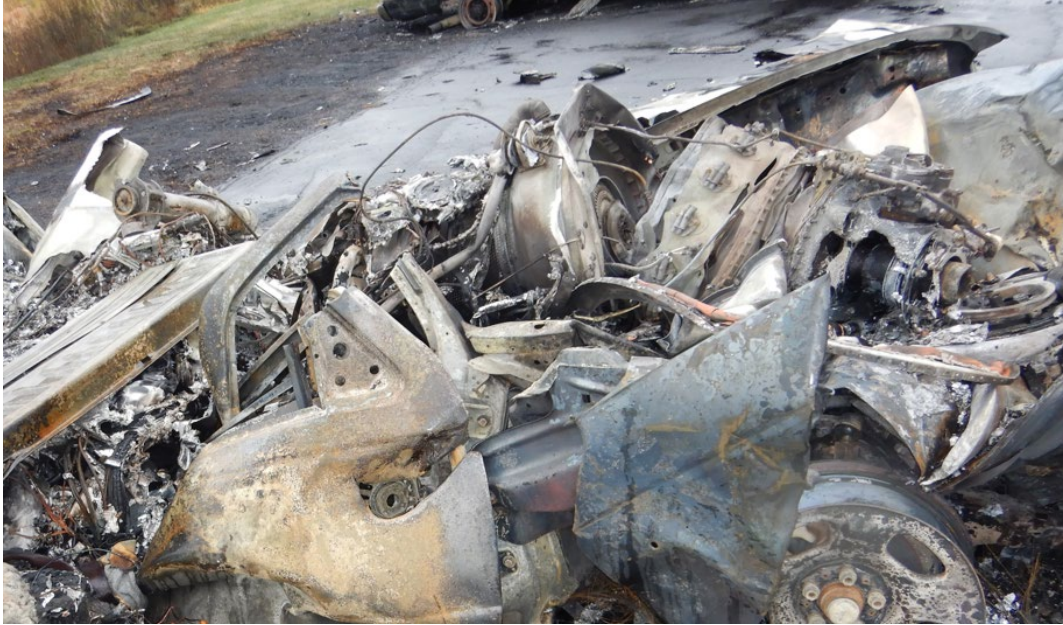
The Left engine and Components: The left engine was severely impact and thermally damaged. It is resting on top of a pickup truck that was destroyed during impact. The left-hand propeller shaft fractured adjacent to the propeller mounting flange. The shaft fracture displayed features consistent with torsional overload. Rotational scoring evident the compressor turbine, both sides of the power turbine vane, center baffle and on the upstream side of the power turbine. There are rotational contact signatures on the internal components.

- No evidence of inflight fire to the left engine.
- No evidence of FOD ingestion.
- Oil Filter damaged by heat but free of contamination.
- Fuel Filter was impact damaged.
- Compressor Turbine: Rotational scoring, rotational distress. The blades had trailing edge damage and rotational damage from contact with the nonmoving structure. Rub marks on the shroud.
- The Power Turbin Section: Overload damage, rotational scoring. On both upwind and downwind portions.
- Compressor: Blades bent in opposite direction of rotation.
- Reduction gearbox: Shaft fractured. Looks like overload.
- Accessory Gearbox: Thermally and impact damaged.
- Ignition: Present and attached although damaged by impact and fire.
- Fuel Pump and Control Unit: Impact and thermal damage.
- Fuel Nozzles: Impact and thermal damage.
- Compressor Bleed Valve: Remained attached at its respective location.

Figure 5 Left engine Assy resting on truck.

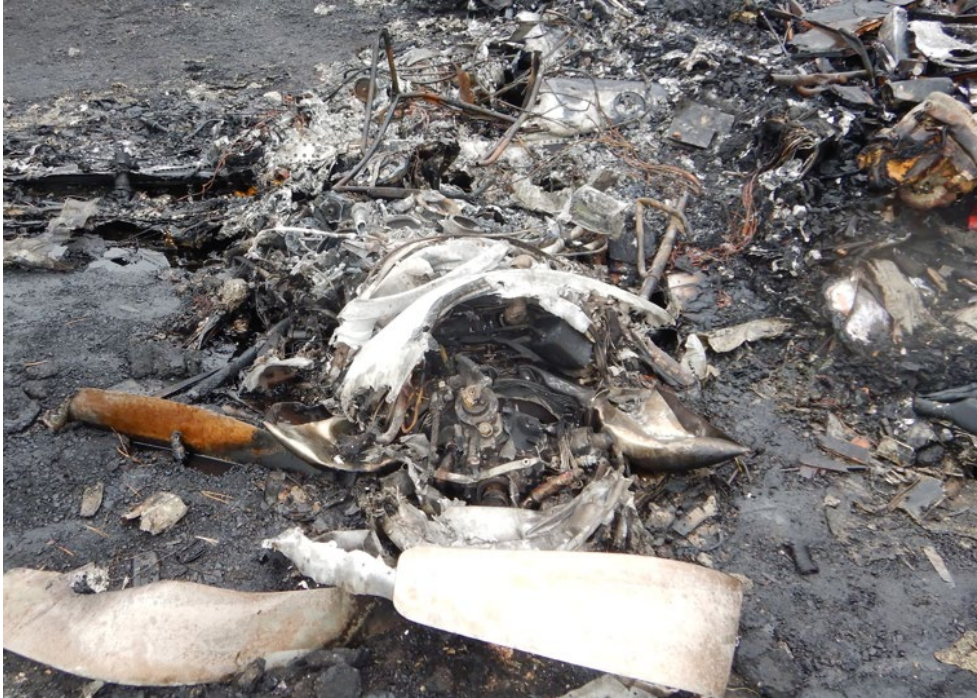
The right-hand Engine and Components: The right engine was severely impact and thermally damaged. It is partially embedded about 3 inches into the asphalt. The propeller shaft was fractured adjacent to the propeller mounting flange. The shaft fracture displayed features consistent with torsional overload. Rotational scoring was evident on the upstream and downstream side of the compressor turbine, both sides of the power turbine vane, center baffle and on the upstream side of the stage power turbine. There are rotational contact signatures to the internal components.

- Compressor Turbine: Rotational scoring, rotational distress. The blades had trailing edge damage and rotational damage from contact with the nonmoving structure. Rub marks on the shroud. The compressor turbine disk was impact separated at the front stub shaft.

- The Power Turbin Section: Overload damage, heavy rotational scoring. On both upwind and downwind portions. The power turbine blades were fractured.
- Compressor: Blades fractured with a couple that remained attached bent in the opposite direction of rotation.

- Reduction gearbox: impact damaged and torsional overload.
- Accessory Gearbox: Thermally and impact damaged. 80% consumed by post impact fire.
- Ignition: Present and attached although damaged by impact and fire.

- Fuel Pump and Control Unit: Impact and thermal damage.
- Fuel Nozzles: Impact and thermal damage.
- Compressor Bleed Valve: Remained attached at its respective location.

Figure 6 Right engine Assy embedded in pavement.

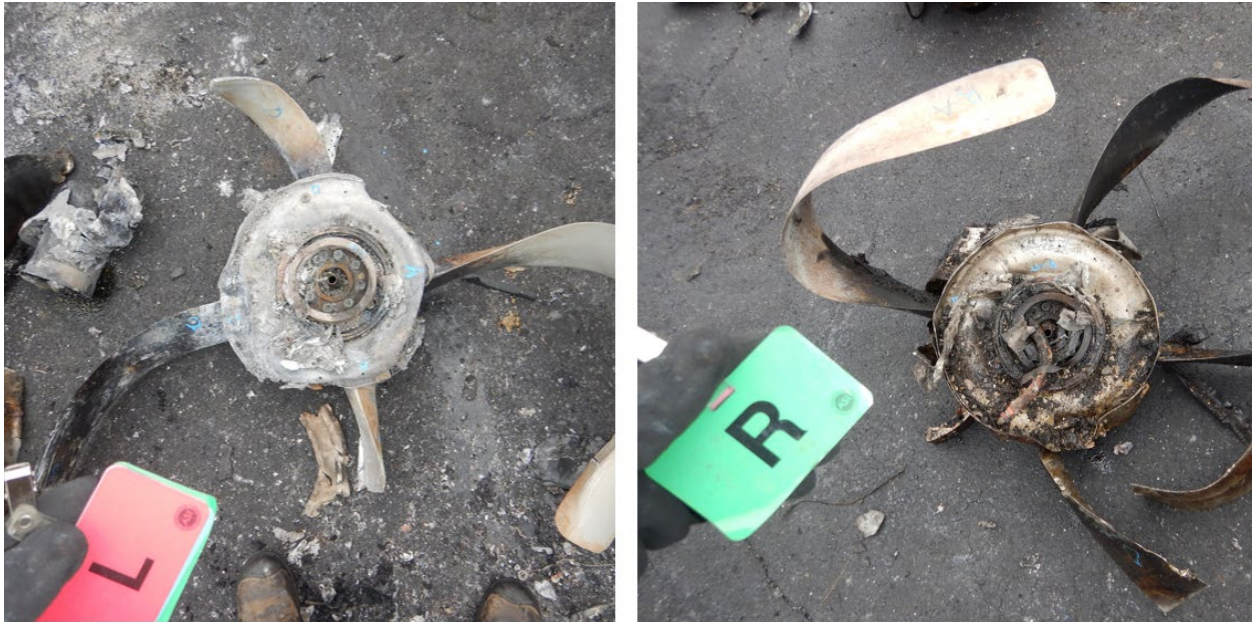
Both propellers exhibited similar impact damage. Both left and right propeller assemblies were attached on their respective engines and all 4 blades on each of the 2 assemblies remained attached to their respective flange. All four blades on both sides exhibit severe s-bending, chordwise scraping, and leading edge gouges. There were no discrepancies noted in the components examined that would prevent or degrade normal operation prior to impact with terrain. All damage was consistent with high impact forces. There was no damage to indicate either propeller was feathered or at low pitch/idle power at the time of impact. No propeller discrepancies were found on the accident site by the IIC or Textron. Hartzell provided a propeller investigator to assist with the investigation. According to Hartzell, fork anti-rotation bumper marks on the preload plates in figure 7, indicated both propellers were in a similar blade angle range at impact... Bumper impact marks on the (Left) L3 and L4 preload plates suggested the blade angle was in the range of 26-30°. and would be consistent with power levels between 166 Hp to 404 Hp. Similar marks on the (Right) R3 and R4 preload plates indicated a blade angle range of 30-32° which is consistent with power levels of 304 Hp to 542 Hp. See the public docket for Hartzell report.

Figure 7 Propellers after retrieval at accident site.

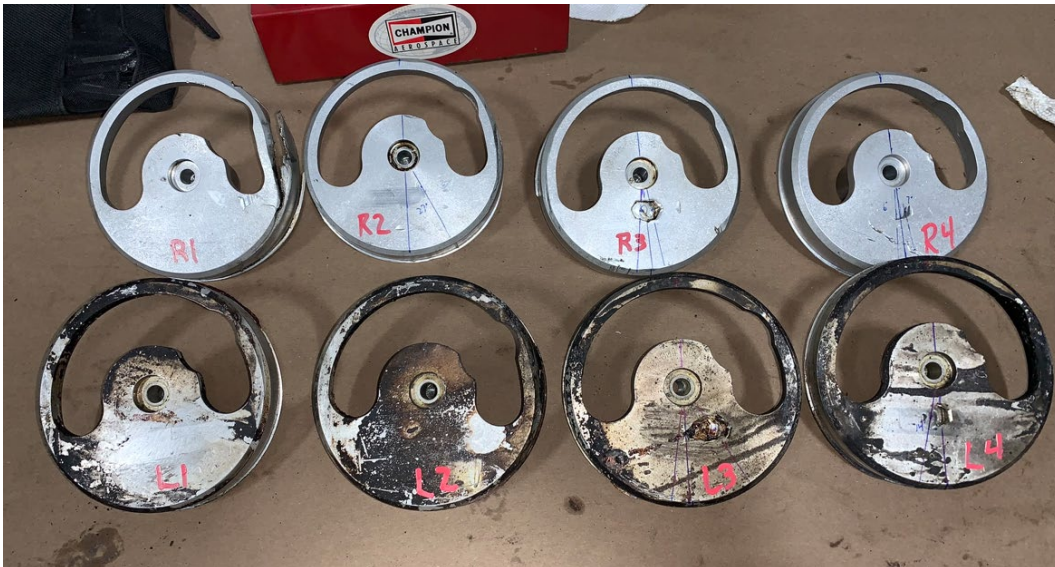
Figure 8 Propeller preload plates indicate blade angle at time of impact. Photo courtesy of Hartzell.
