ERA23FA024

## **AUTOMATIC DEPENDENT SURVEILLANCE- BROADCAST (ADS-B) STUDY**

Aircraft Performance Study

Location: Marietta, Ohio  
Date: October 18, 2022  
Time: 0709 eastern daylight time (EDT)  
1109 UTC  
Airplane: Beech E-90, N515GK

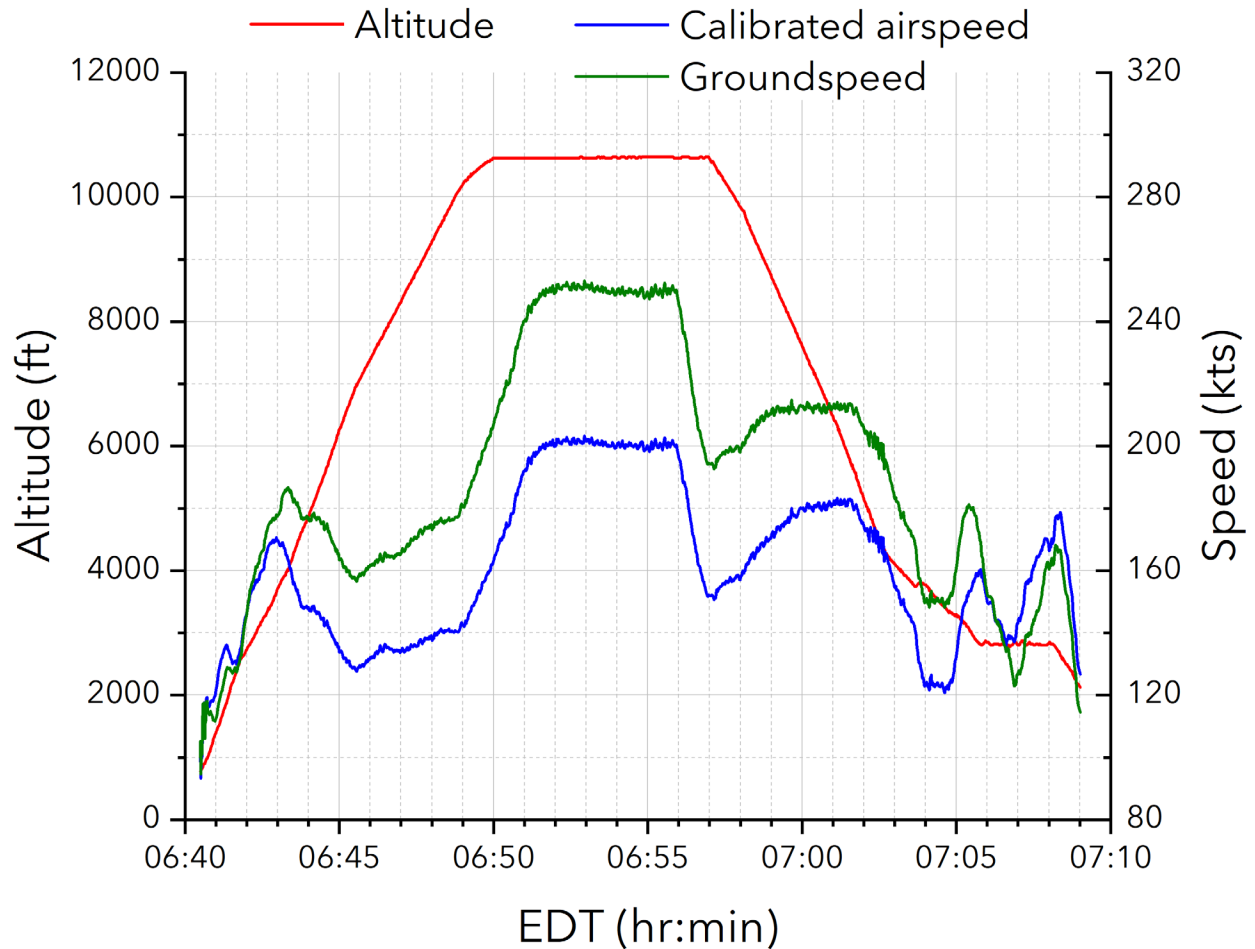
**Figure 3.** Corrected altitude, MSL, and calculated calibrated airspeed and groundspeed for the flight.

The airplane descended steadily between 1,100 and 1,200 ft/min until 07:02:30. The airplane's descent rate decreased and so did its speed, slowing from 170 kts calibrated airspeed to 122 kts by 07:04. The airplane increased its forward speed and began a right turn towards the runway heading just after 07:05.

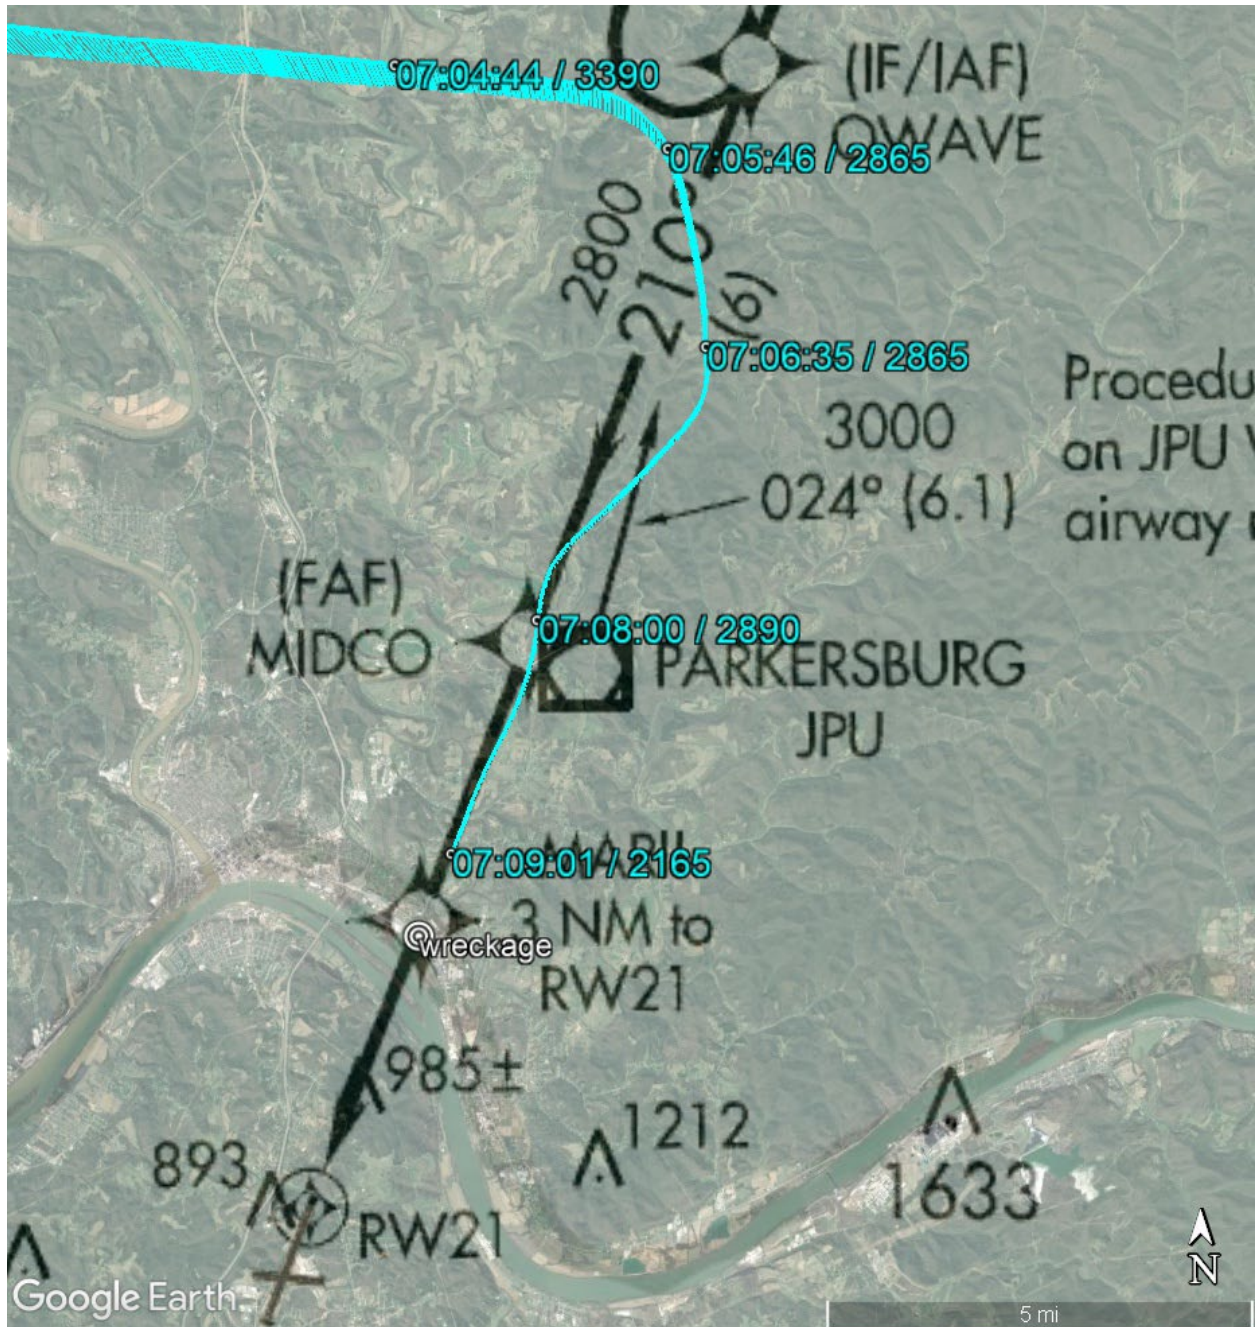
By 07:06, airspeed was 150 kts and the altitude was leveling out near 2,800 ft. The pilot contacted PKB about the RNAV approach to runway 21 and was instructed to report MIDCO (Figure 4), the Final Approach Fix (FAF) for that runway. MIDCO is 5.9 NM from the runway threshold and has a minimum crossing altitude of 2,800 ft [see References].

**Figure 4.** Airplane flight path with selected times and altitudes annotated. A portion of the RNAV (GPS) RWY 21 approach plate has been overlaid on the satellite imagery.

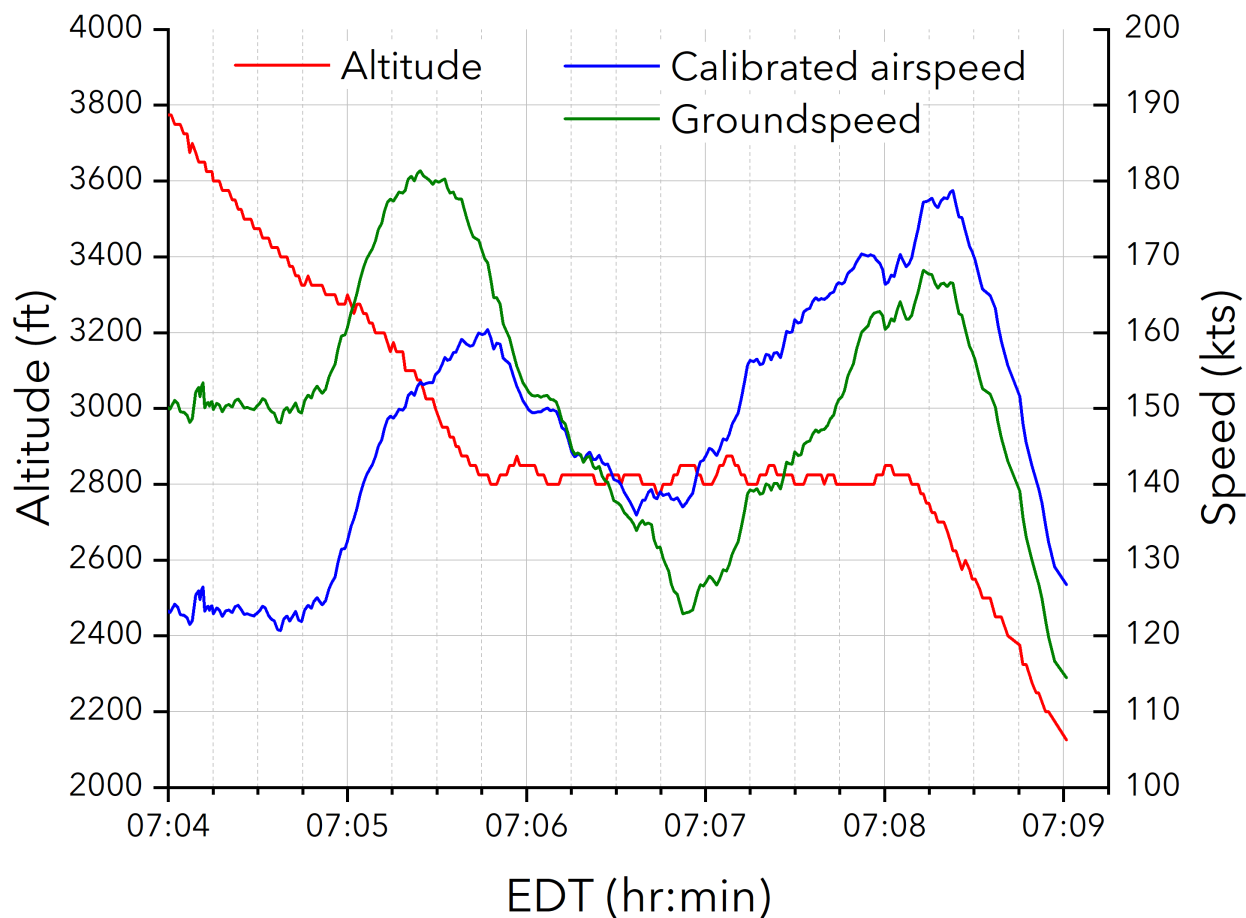
The airplane had slowed to 135 kts at 07:07 and then accelerated. At 07:08 it crossed MIDCO at 170 kts and began to descend at about 700 ft/min. The airplane reached a speed of 178 kts at 07:08:22 before it began to lose speed. The final calculated airspeed, 48 seconds later, was 126 kts. The airplane's approach speed is between 80-100 kts. The airplane's wings-level, power-idle stall speed is between 65 kts (full flaps, light weight) and 88 kts (no flaps, heavy weight) [2].

**Figure 5.** Corrected altitude, MSL, and calculated calibrated airspeed and groundspeed for final five minutes of flight.

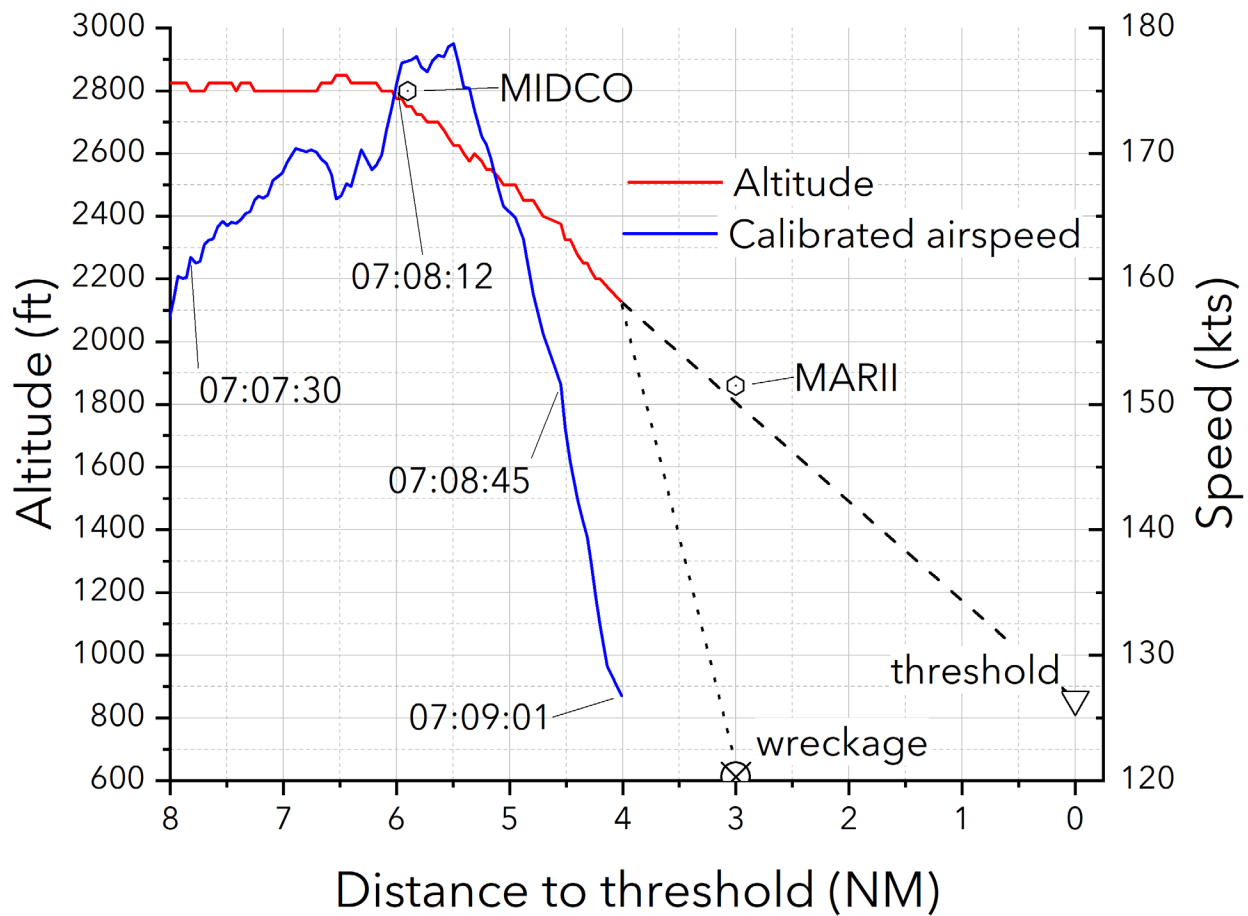
The airplane's descent from 2,800 ft was on target for the runway 21 approach (Figure 6). The final ADS-B return was at 07:09:01 at an altitude of 2,125 ft, about 4 NM from the runway threshold. The wreckage was at an elevation of 614 ft, about 1 NM from the last return along the runway heading. The airplane lost 1,500 ft of altitude in 1NM.

**Figure 6.** Corrected altitude, MSL, and calculated calibrated airspeed versus distance to runway threshold. Wreckage location is also noted.

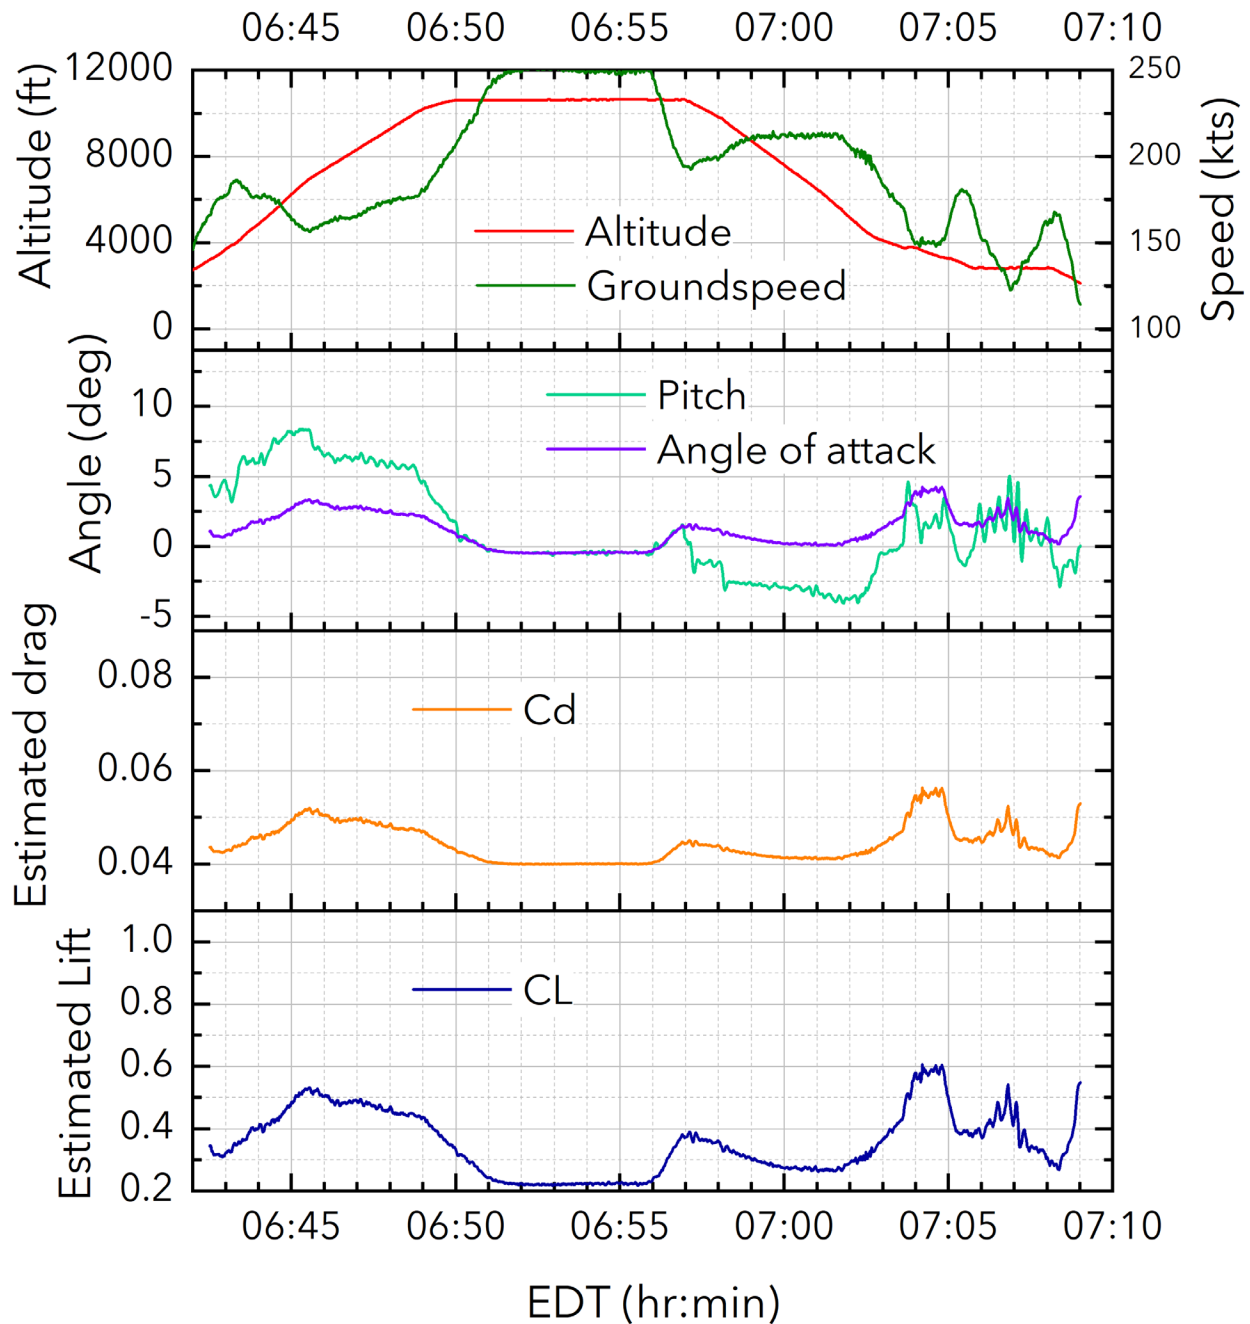
Pilot reports throughout the area stated trace to moderate icing conditions and AIRMETs based on upper air soundings reported moderate or greater icing potential (rime, clear, mixed) from 2,600 ft through 9,000. The final ten minutes of flight may have been affected by icing.

A simplified aerodynamic model of the airplane was constructed to estimate body attitudes and aerodynamic coefficients during the flight. Absolute values of each parameter should be considered estimates, but the trends are reflective of aerodynamic behavior. Figure 7 shows how lift and drag increased with pitch as the airplane climbed and then leveled during cruise flight. Drag also increased during descents when the airplane maintained or decreased speed. However, drag did not increase enough during the flight to indicate a build up of ice on the airframe. If icing was present, the calculations made from the ADS-B flight path data were not able to capture its effects. Icing effects localized to a control surface would not be discernible from just flight path data.

**Figure 7.** Airplane altitude, speeds, pitch and angle of attack, and estimated drag and lift coefficients for the flight.
