# National Transportation Safety Board

ERA23FA033

## **VIDEO & SOUND SPECTRUM**

Location: Keene, New Hampshire  
Date: October 21, 2022  
Time: 18:45 eastern daylight time (EDT)  
Aircraft: Beech A24-R, private operator, N8020R

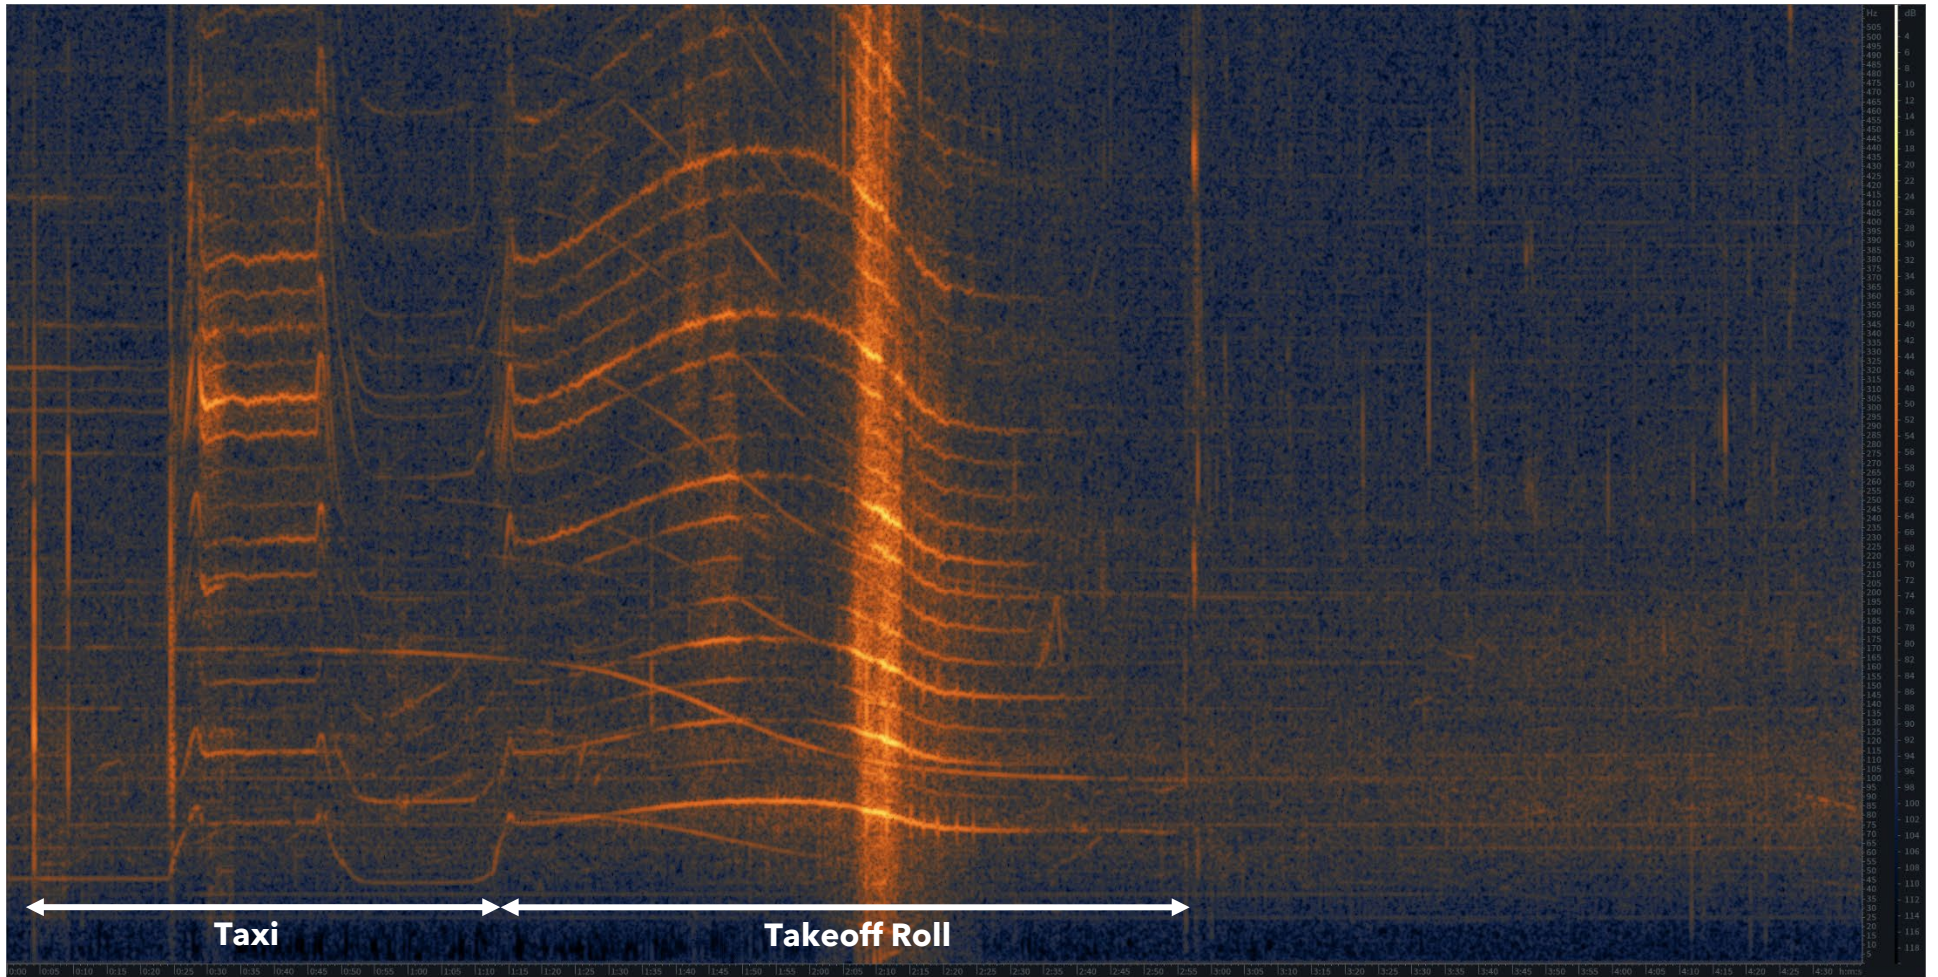
The first portion of the spectrogram, marked 'Taxi', is consistent with the accident aircraft back-taxiing to the approach end of runway 02. The second portion, marked 'Takeoff Roll', is consistent with the aircraft accelerating for takeoff on runway 02. Of note in the spectrogram in the section marked 'Takeoff Roll' is the gradual upward and then downward slope of the lines of intense frequency as time passes. This pattern suggests that the influence of the Doppler effect should be considered.

The aircraft was closest to camera 1 during its takeoff roll near the intersection of runway 02/20 and runway 14/32 (about 5200 to 5400 feet from the approach end of runway 02) at a video elapsed time of 02:10 to 02:15 (18:44:18 to 18:44:23 EDT).

**Figure 2.** 3D spectrogram of audio from camera 1.

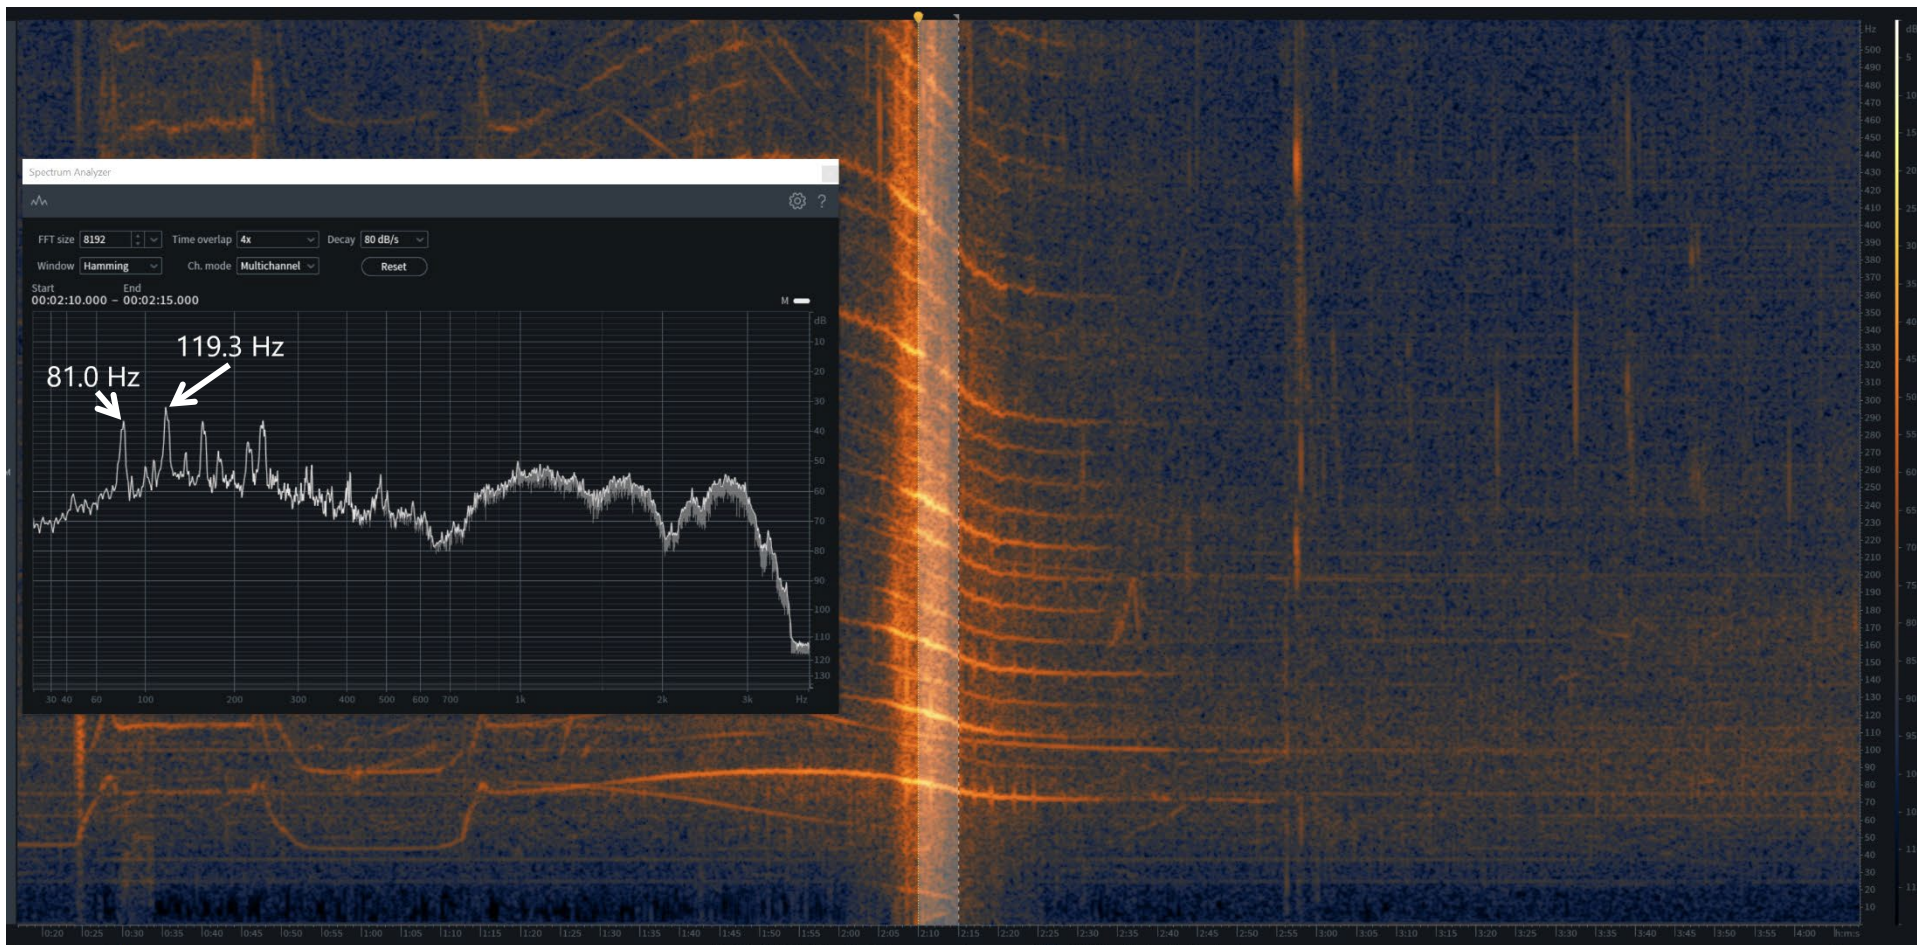
Figure 3 is the same spectrogram as Figure 2, with an overlay containing a two-dimensional (2D) plot of the spectrum from 02:10 to 02:15 video elapsed time. The two fundamental frequencies of note on the 2D spectrum are 81.0 Hz (engine exhaust) and 119.3 Hz (BPF). As the aircraft was closest to the camera during this time, the influence of the Doppler effect could be ignored. Using equation 1 and equation 2, these fundamental frequencies correspond to an engine speed of about 2400 rpm during that time.

As the aircraft moved further away from the camera, the signal-to-noise ratio was low enough that the fundamental frequencies were no longer discernable on the spectrogram after about 02:43 video elapsed time (18:44:51 EDT).

**Figure 3.** 2D spectrogram of audio from 02:10 to 02:15 video elapsed time (18:44:18 to 18:44:23 EDT) - camera 1.

The calculated engine rpm at two moments during the accident flight: (1) as the aircraft departed runway 02 at KEEN and (2) immediately before the aircraft impacted a structure, appeared to be consistent with the engine operating at or near 2400 rpm, which is below its published takeoff and maximum continuous power setting of 2700 rpm.

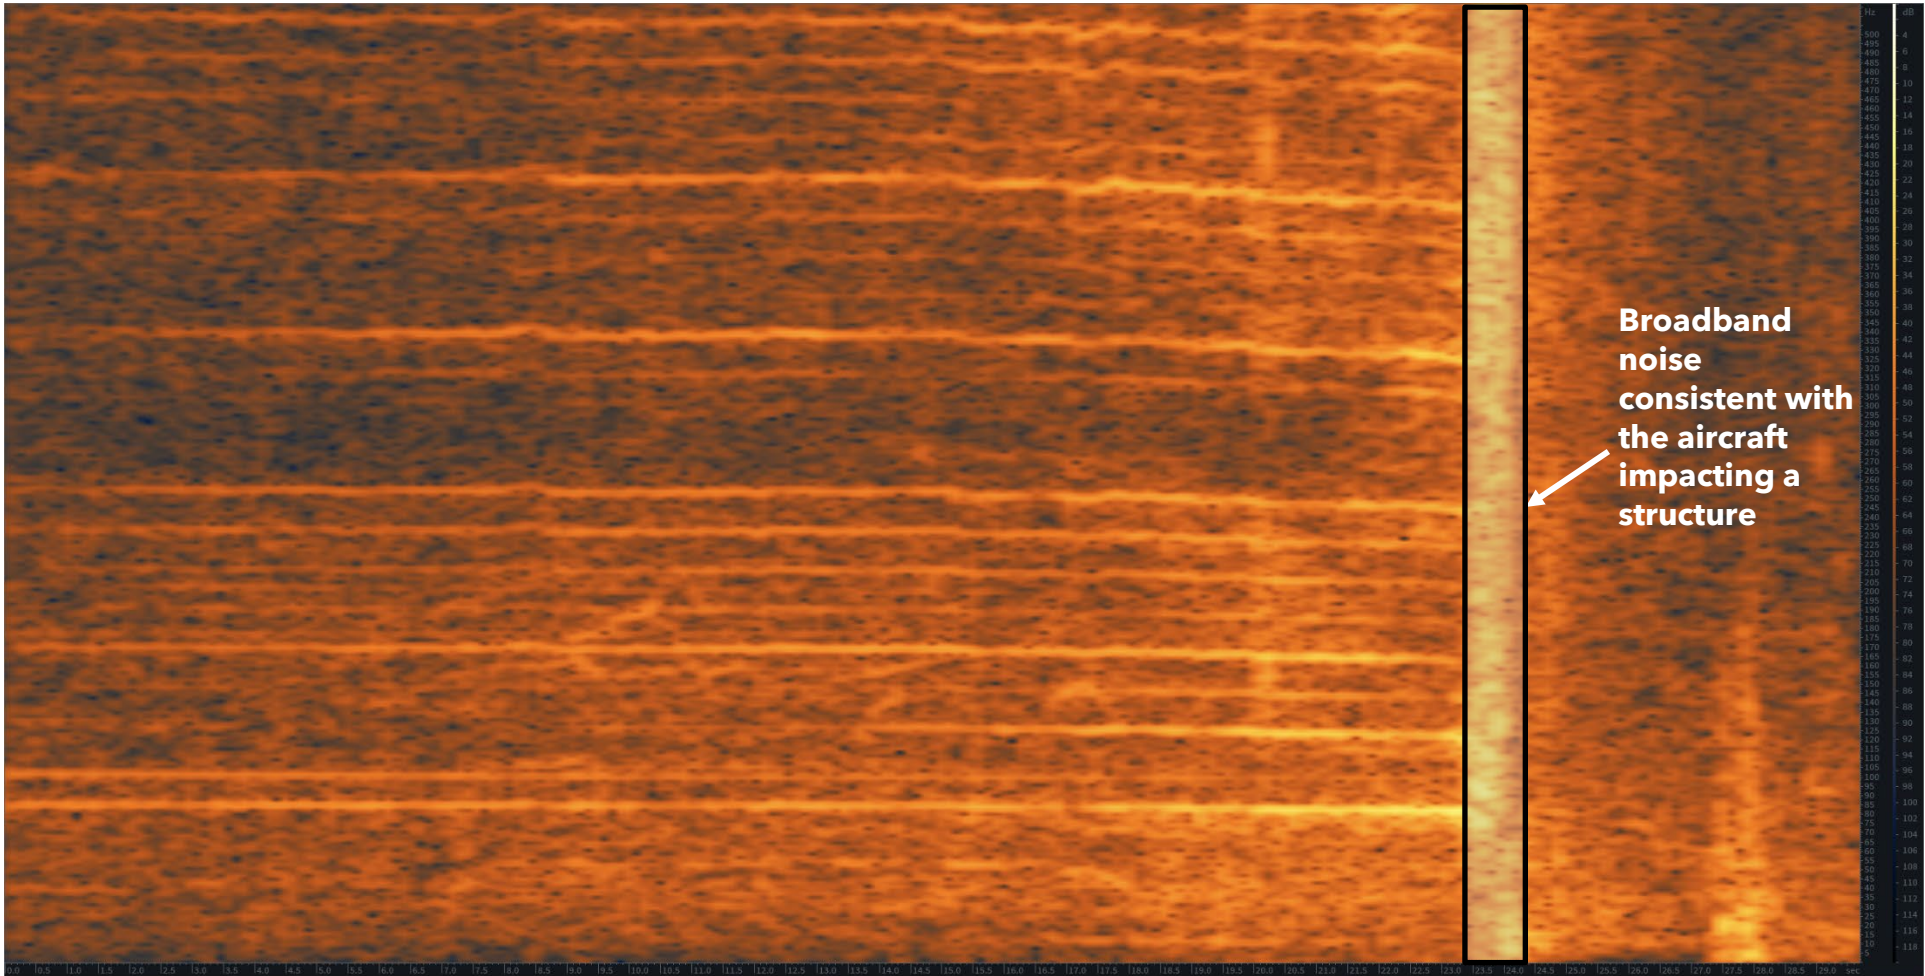
The accident aircraft's landing lights were visible through the trees at 00:14 video elapsed time (18:44:56 EDT). Broadband noise consistent with the aircraft impacting a structure is noted in the spectrogram at a video elapsed time of about 00:23 (18:45:05 EDT).

**Figure 4.** 3D spectrogram of audio from camera 4.

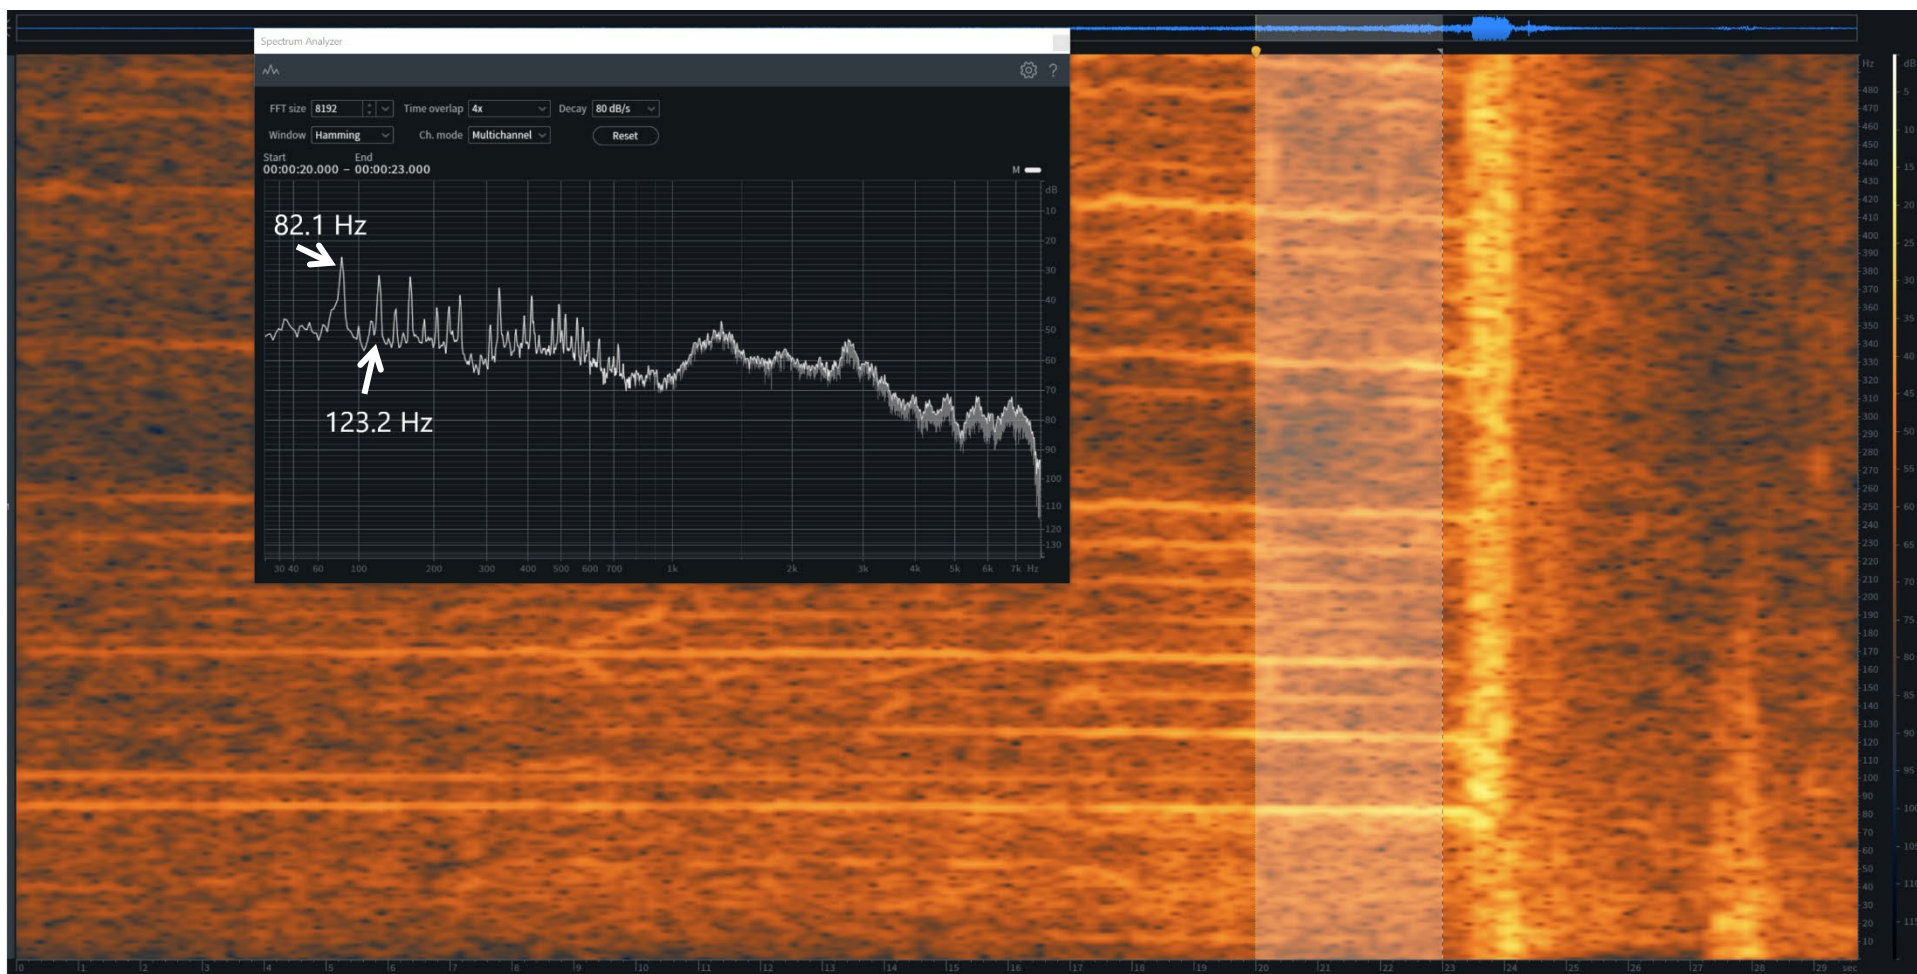
Figure 5 is the same spectrogram as Figure 4, with an overlay containing a 2D spectrogram from 00:20 to 00:23 video elapsed time (18:45:02 to 18:45:05 EDT). The two fundamental frequencies of note on the 2D spectrogram are 82.1 Hz (engine exhaust) and 119.3 Hz (BPF). As the aircraft was closest to the camera during this time, the influence of the Doppler effect could be ignored. Using equation 1 and equation 2, these fundamental frequencies correspond to an engine speed of about 2400 rpm immediately before the aircraft impacted a structure.

**Figure 5.** 2D spectrogram of audio from 00:20 to 00:23 video elapsed time (18:45:02 to 18:45:05 EDT) – camera 4.
