Date of Event (UTC) May 5, 2023	Review Date Jul 7, 2024
Time of Event (UTC) 1957 UTC	Time of Event (LCL) 1457 EST
Investigation Number ERA23FA137	Keys Number 106819

ATC Services Review Worksheet

On March 5, 2023, at 1459 eastern standard time, a Piper PA-28-161, N8149R, was destroyed when it was involved in an accident in Lindenhurst, New York. The flight instructor and one passenger were seriously injured, and the second passenger was fatally injured. The airplane was operated as a Title 14 Code of Federal Regulations Part 91 instructional flight.

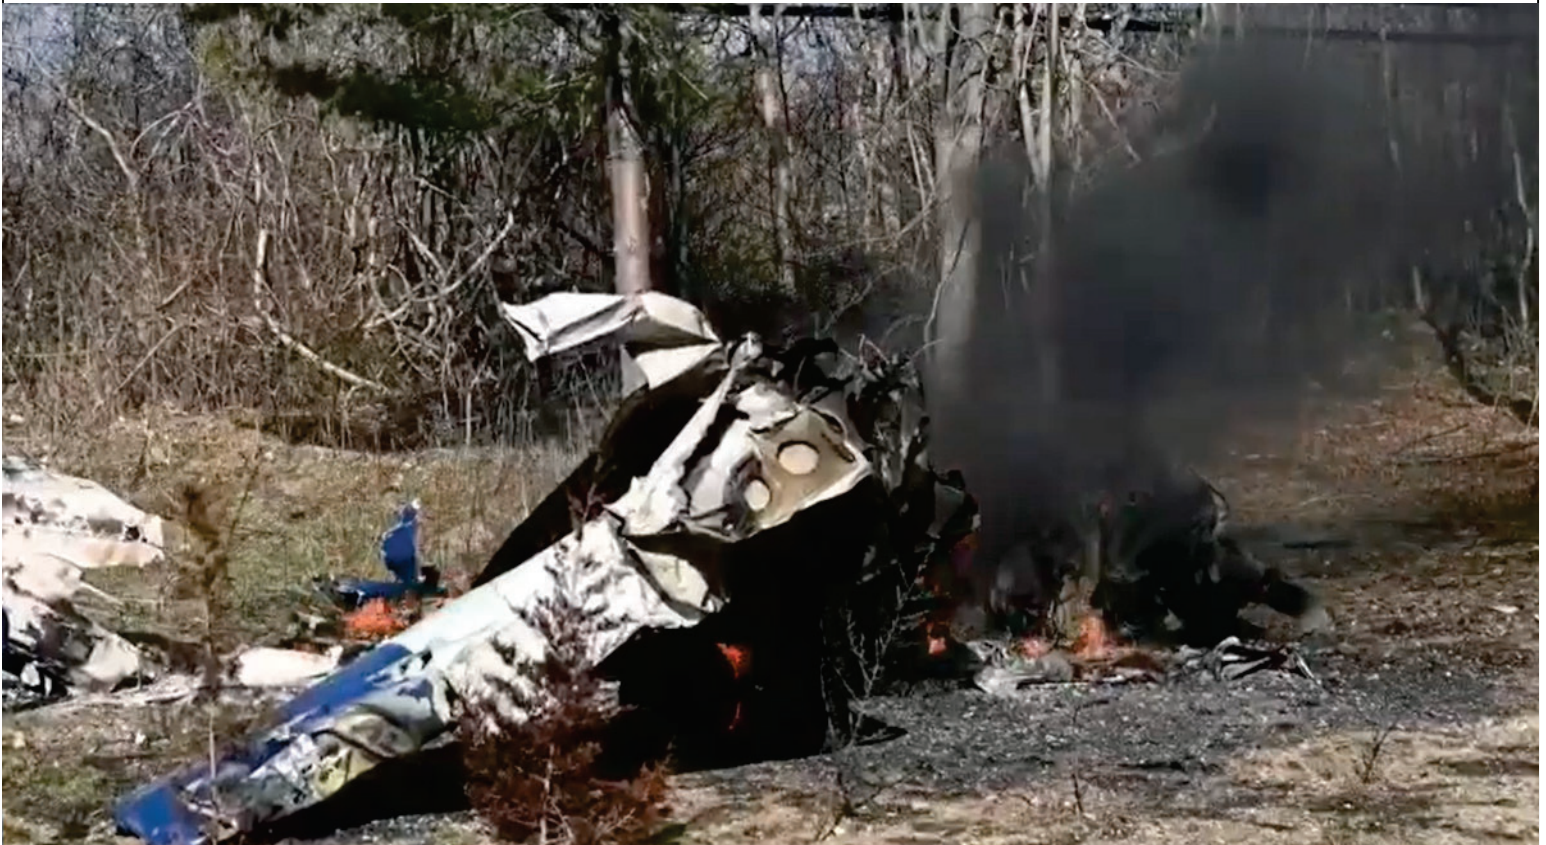
Figure 2

Caption: Wreckage picture of the accident airplane. Screen capture from New Jersey News 12 newsreel footage.

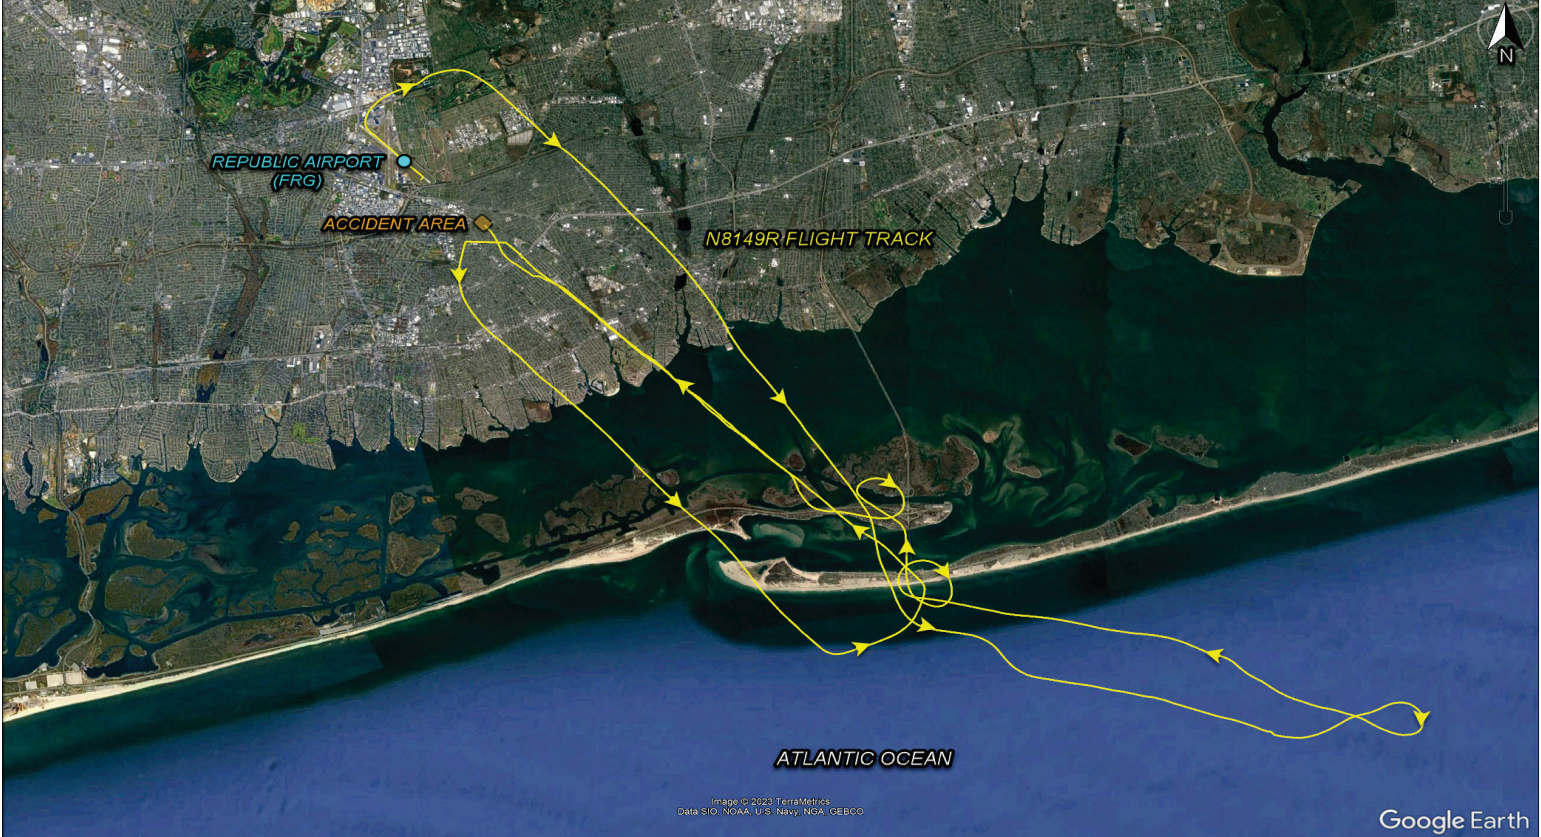
Figure 4

Track data indicates that the accident airplane departed runway (RWY) 32 at Republic Airport (FRG), Farmingdale, NY, at about 1419. The airplane made a right turnout and flew southeast bound until crossing the coastline and proceeding out over the Atlantic Ocean, then returning northwest bound toward FRG. The track was consistent with an approach to RWY 32 until reaching about 1-2 nm from the RWY when the aircraft turned left and entered a left downwind to return for another approach. The track continued on an extended downwind, then turned back in toward FRG and was again lined straight in for RWY 32 on the second approach never ascending higher than about 2,000 feet. The airplane continued straight in to RWY 32 @ FRG until reaching a point about 1 nm from the runway when track data was lost at about 1457 EST and approximately coincident with the reported area of the accident.

Caption: Overhead view of the entire accident flight track overlaid on satellite imagery.

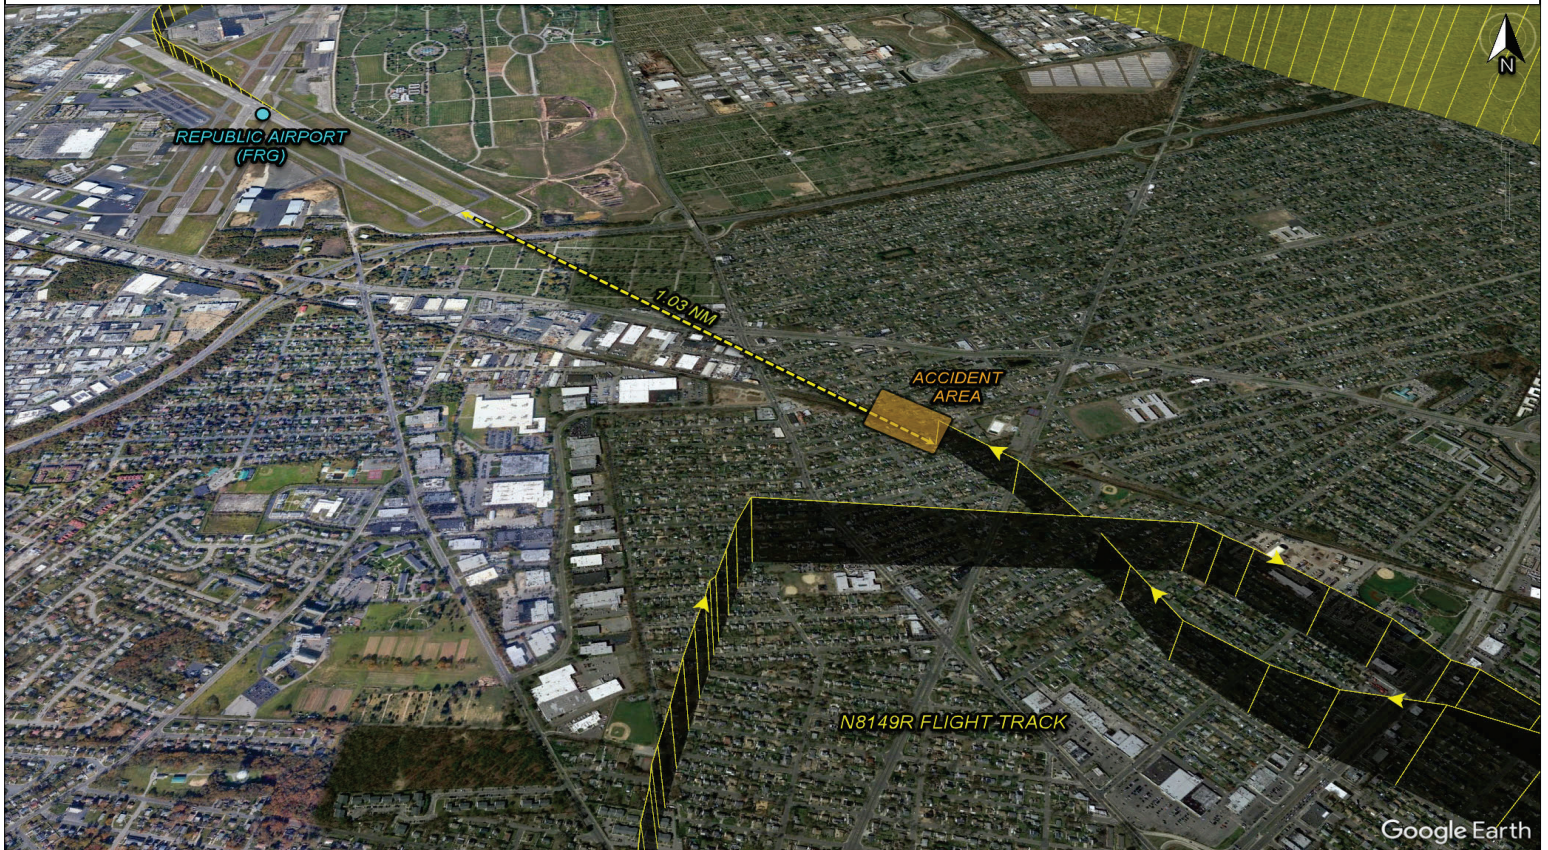
Figure 5

- Last Track Data: 1457:07 EST // 350 ft msl // 101 kts // H328 // About 1 nm short of RWY 32 @ FRG

Caption: Profile view of the final segment of the accident flight track overlaid on satellite imagery.

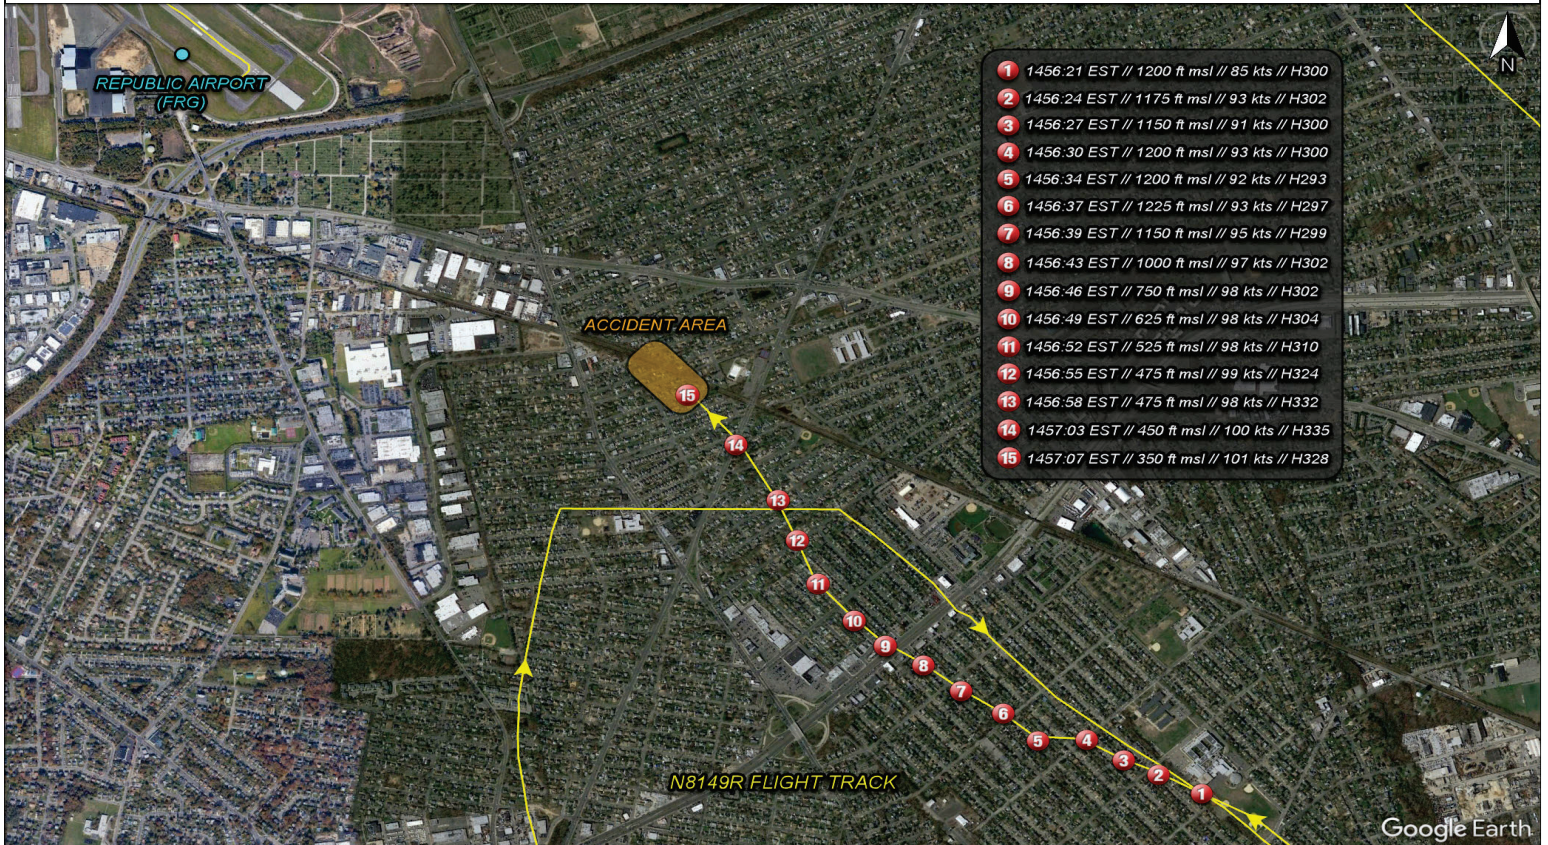
Figure 6

Caption: Detail view of the final segment of the accident flight track overlaid on satellite imagery.
